Asset #D6926(Routine)

I-30 W.B. Service over Crooked Creek

Location: 2.9 M West Jct SH 338

Team Lead: Chris Doggett, Inspection Date: 08/16/2021

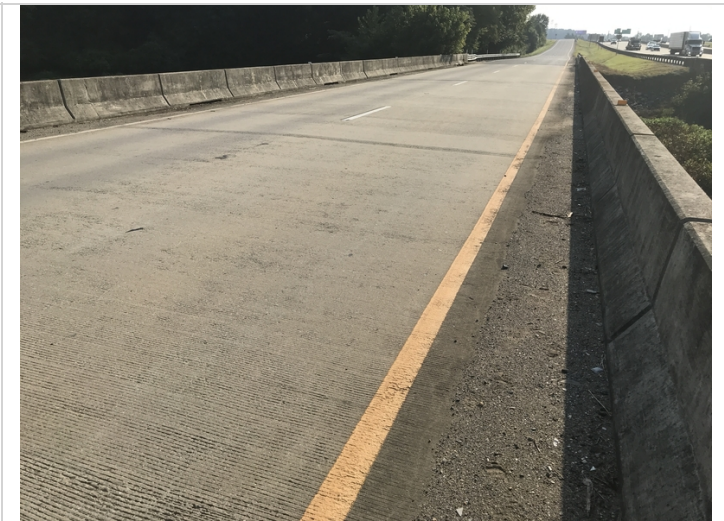
Deck view

ELEMENTS	DESCRIPTION	UNITS	TOTAL	CS1	CS2	CS3	CS4
12	Reinforced Concrete Deck	SF	6330	5030	1300	0	0
1130	Cracking (RC and Other)	SF	1300	0	1300	0	0
(12) Deck all spans scattered cracks up to 0.020 wide.

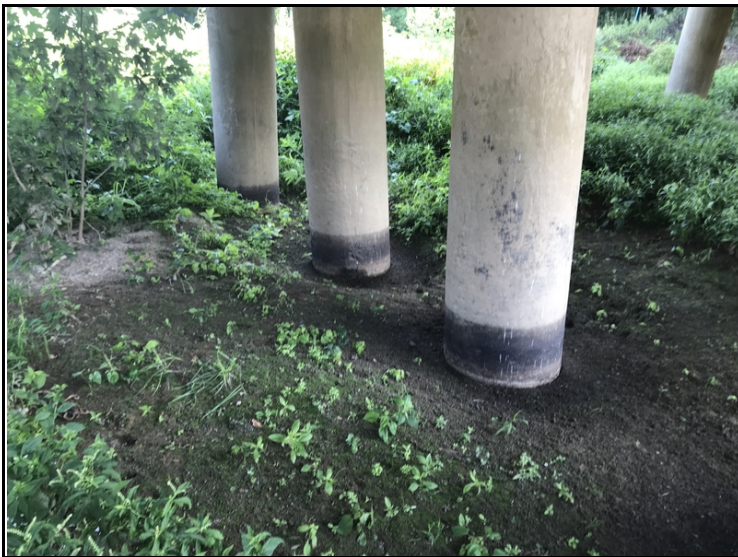
All interior bents have local scour action at each column.

Bent 4: local scour at all columns at this bent.  
Common to each interior bent.

**Date Reported:** 08/16/2021  
**Priority:** C - Important  
**Type of Work:** Repair (General)  
**Status:** Open  
**Component:** Element
