Bridge #03942(Routine)
CR 15 Midway road over I-30 Log 91.11
Location: .66 MI SW SOCIAL HILL

Team Lead: Shane Byrd Inspection Date: July 13, 2020

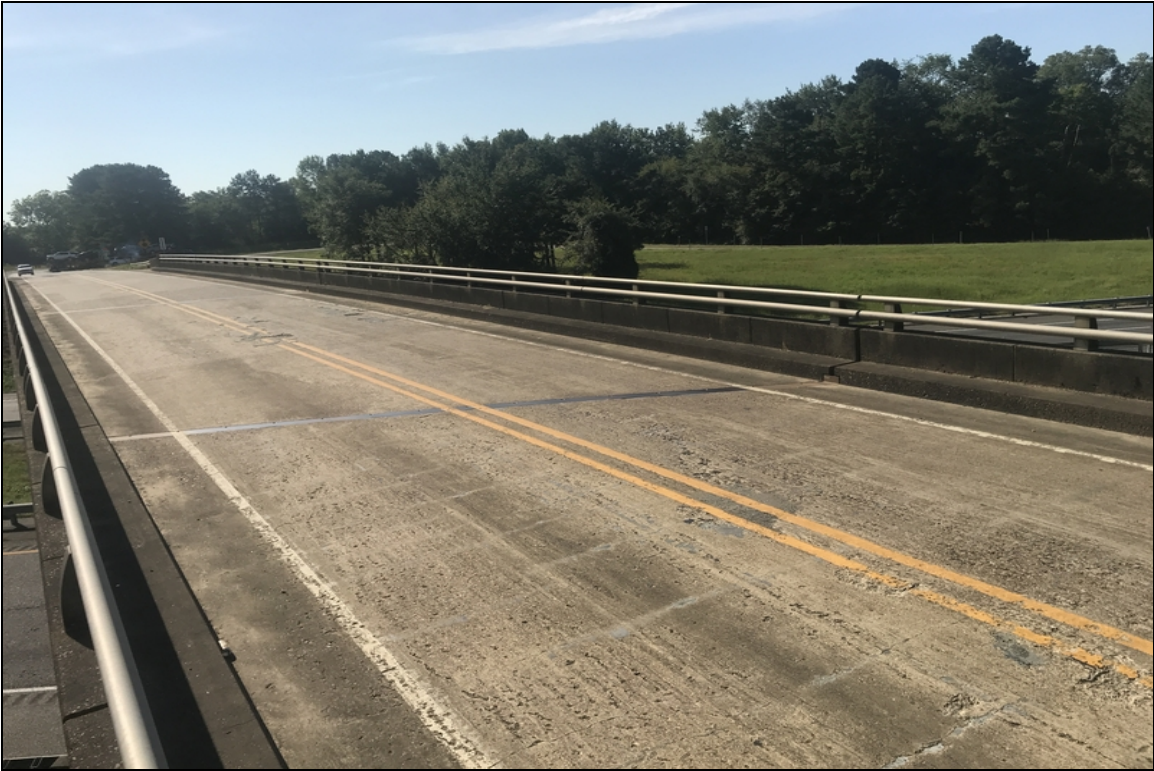
Deck overview.

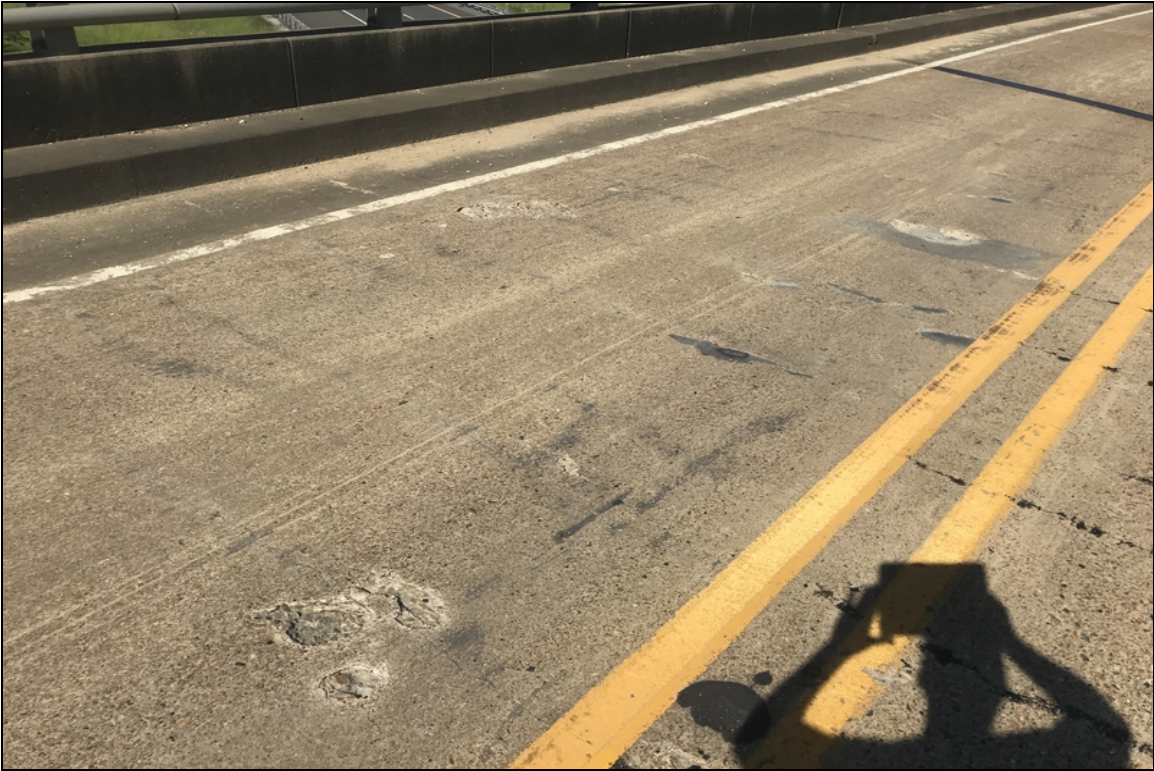
Deck span 4 has spalls in the right lane.

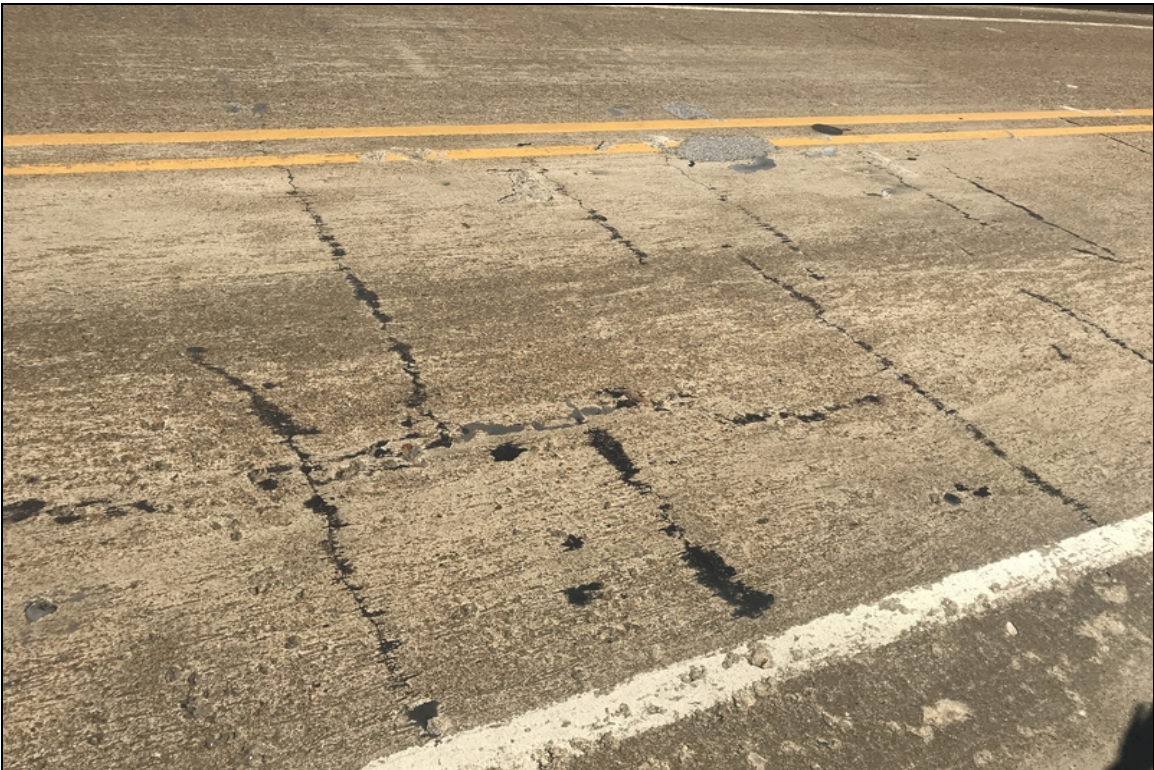
Deck span 3 has sealed transverse cracks, common all spans.

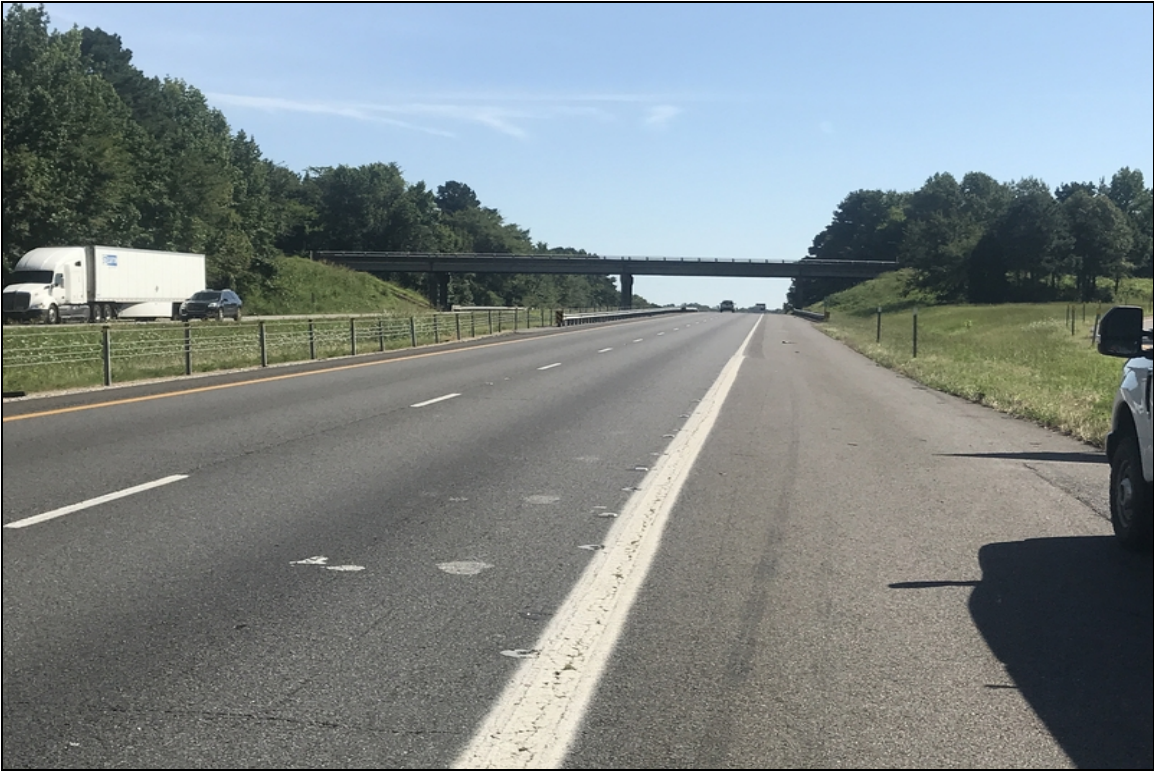
Elevation.

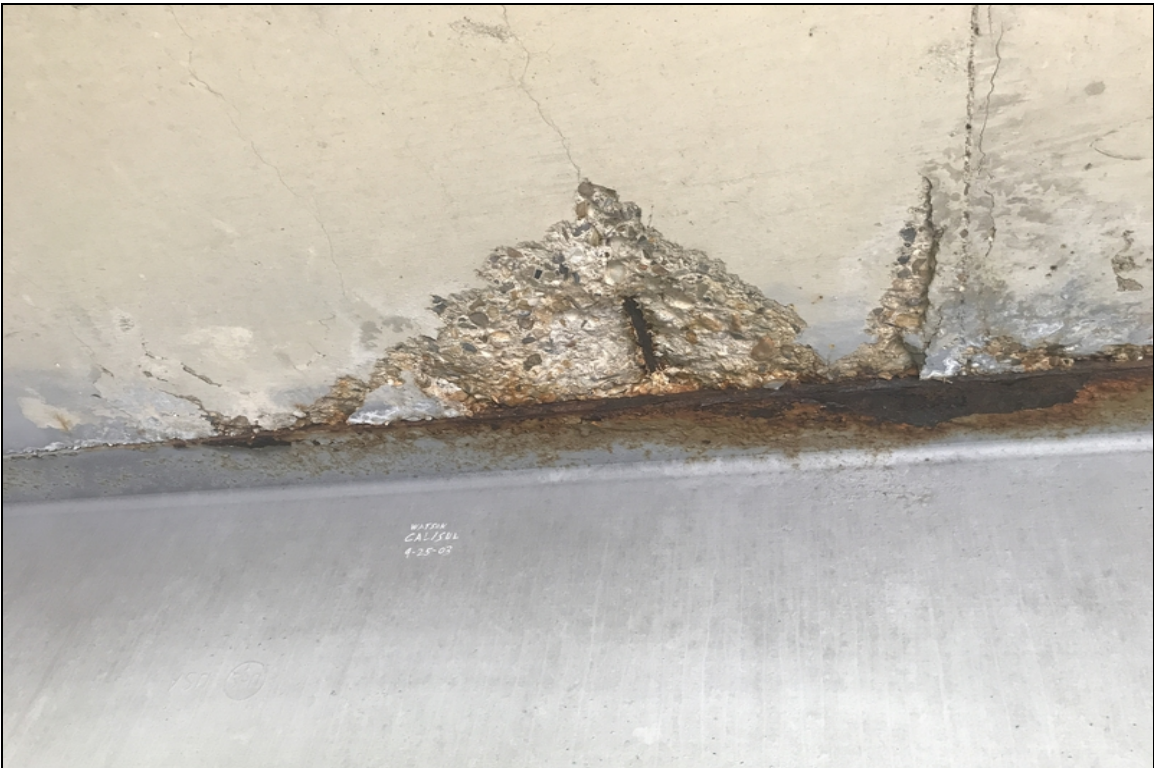
Span 1 soffit bay 1 has spall with exposed rebar.

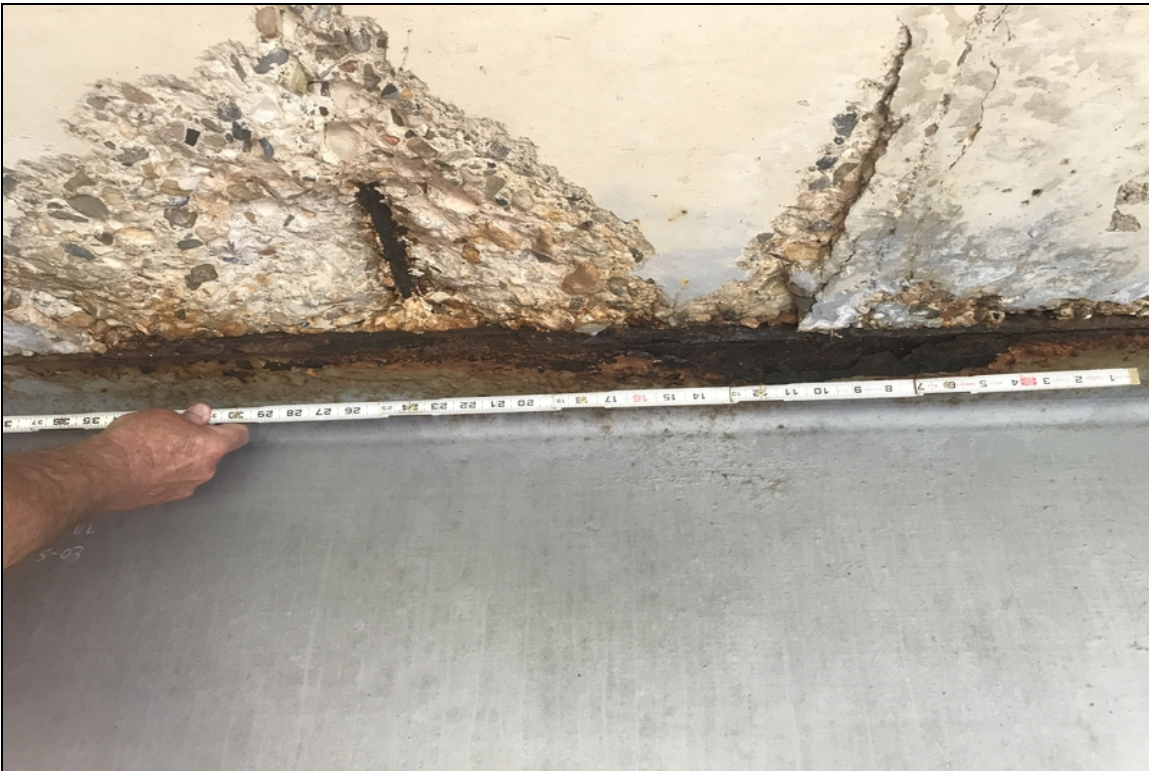
(107)							
Top flanges in all spans have active corrosion. Protective coating is peeling and has lost its effectiveness.							
Beam ends and the outside faces of the exterior beams were repainted 9/25/2003 by HBM.							
205	Reinforced Concrete Column	EA	6	3	2	1	0
1080	Delamination/Spall/Patched Area	EA	1	0	0	1	0
1130	Cracking (RC and Other)	EA	2	0	2	0	0

Span 1 beam 1 has corrosion, pitting up to 1/16".

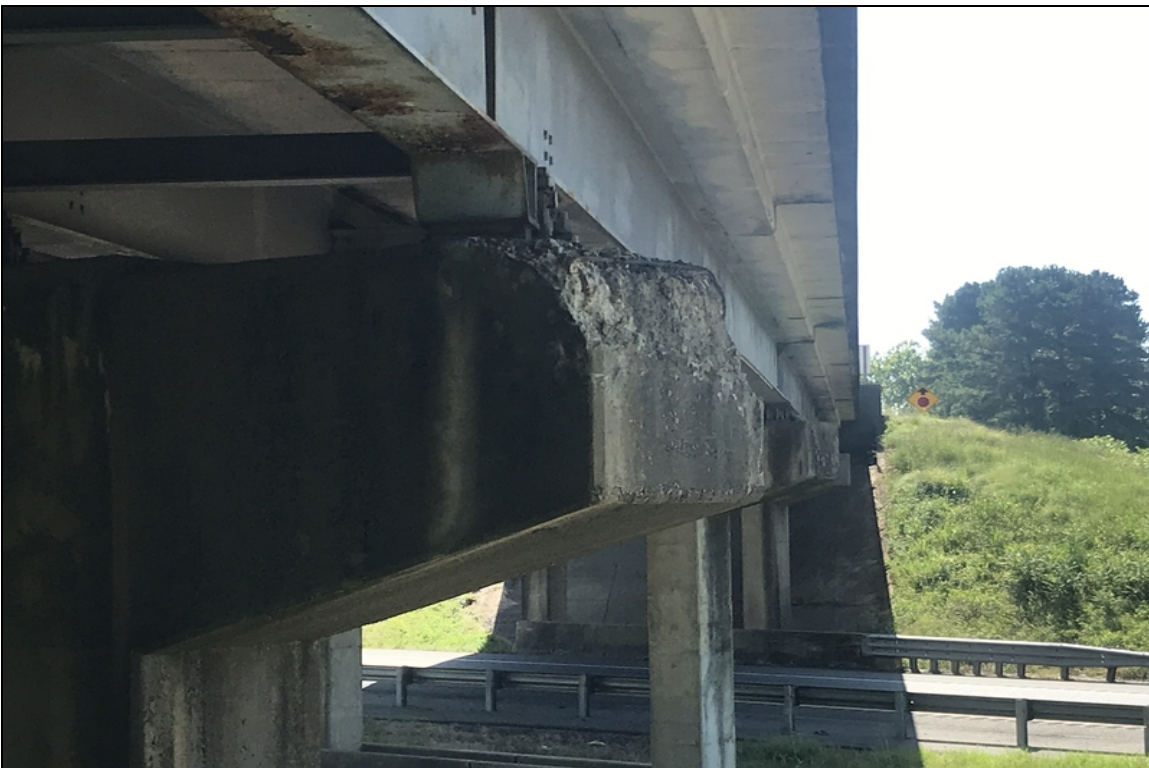
Bent 2 cap right side has spall with exposed rebar.

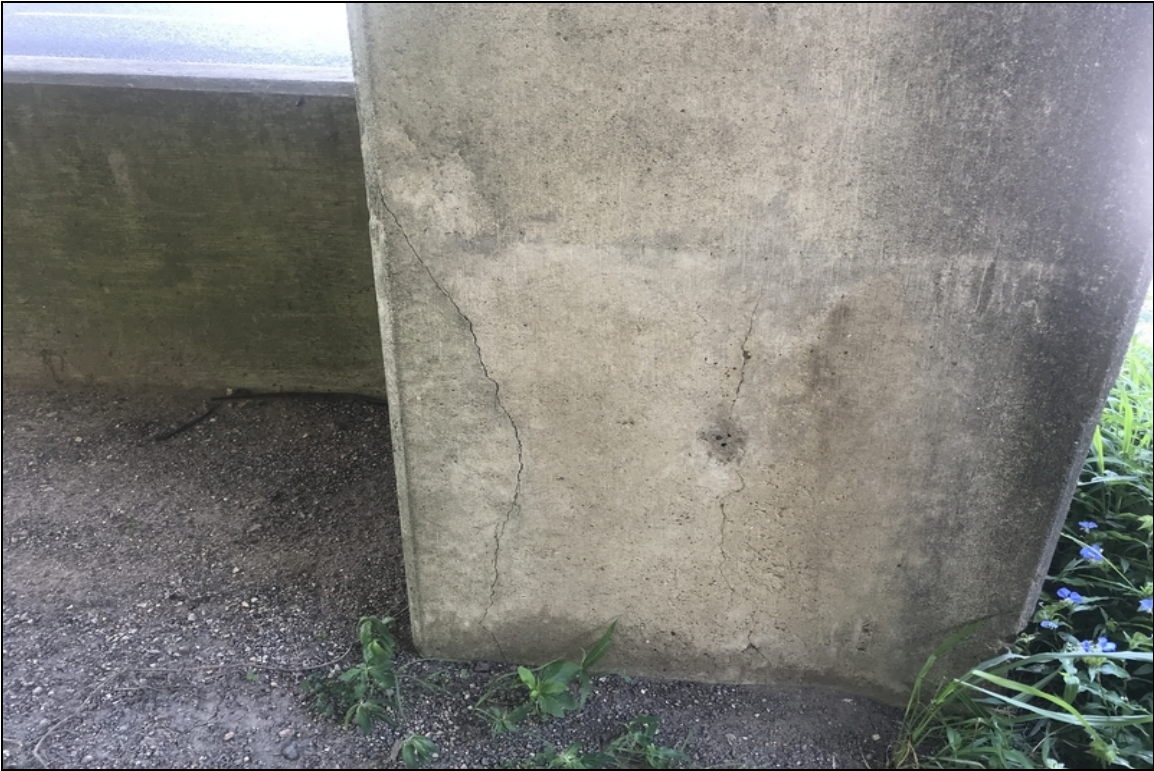
(205)							
Bents 2 and 3 have cracks and spalls.							
215	Reinforced Concrete Abutment	LF	72	68	4	0	0
1120	Efflorescence/Rust Staining	LF	2	0	2	0	0
1130	Cracking (RC and Other)	LF	2	0	2	0	0

Bent 2 column 2 has cracks near the bottom of the column.

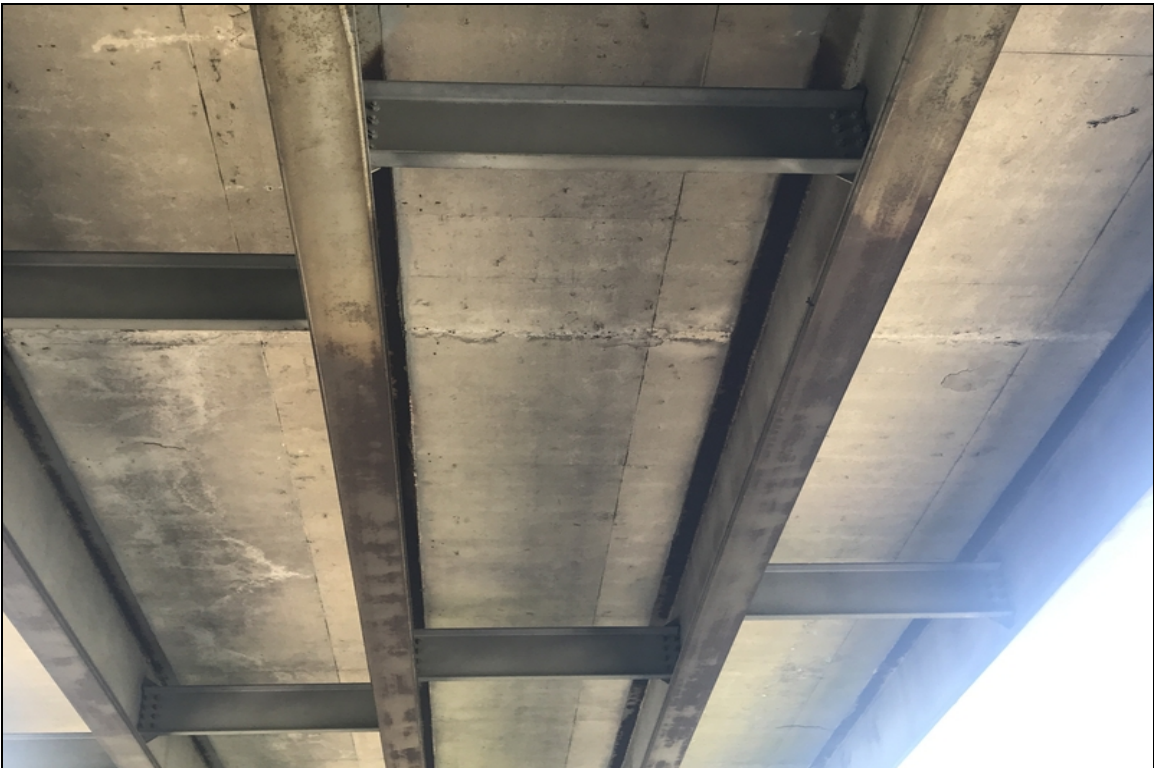
Span 2 soffit over west bound traffic small delams.

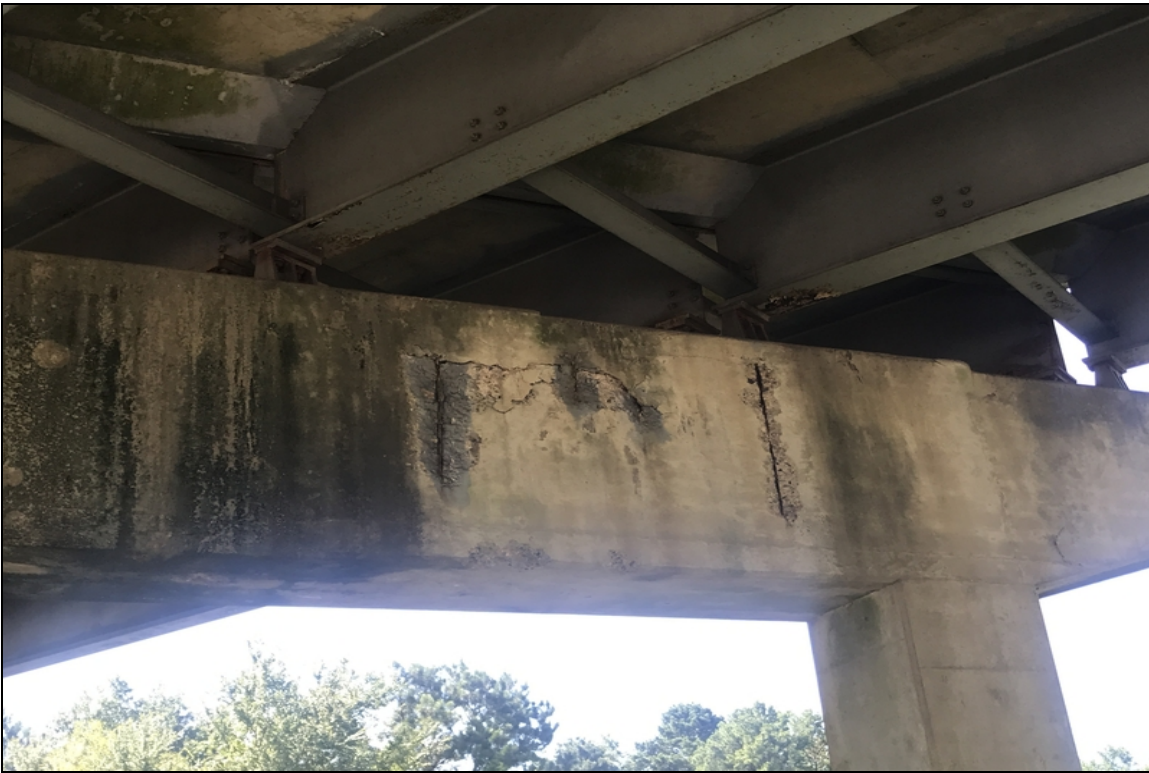
Bent 3 cap back has spalls with exposed rebar.

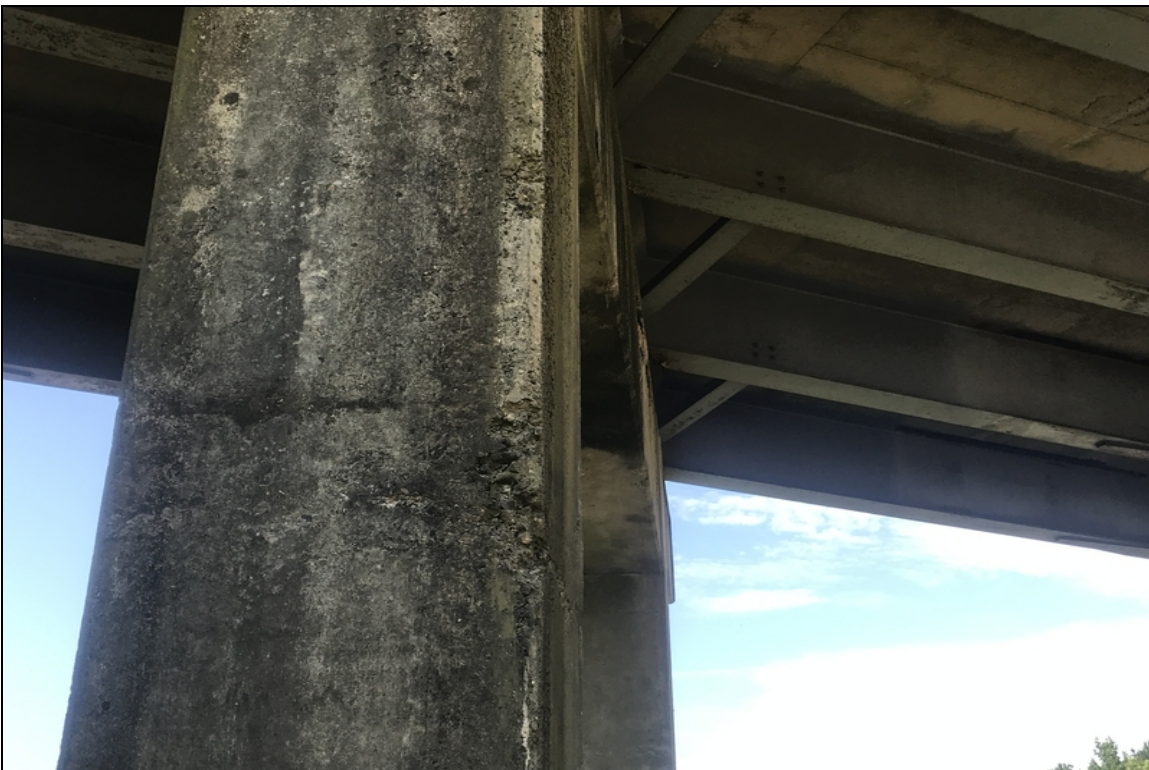
Bent 3 column 1 has spalls.

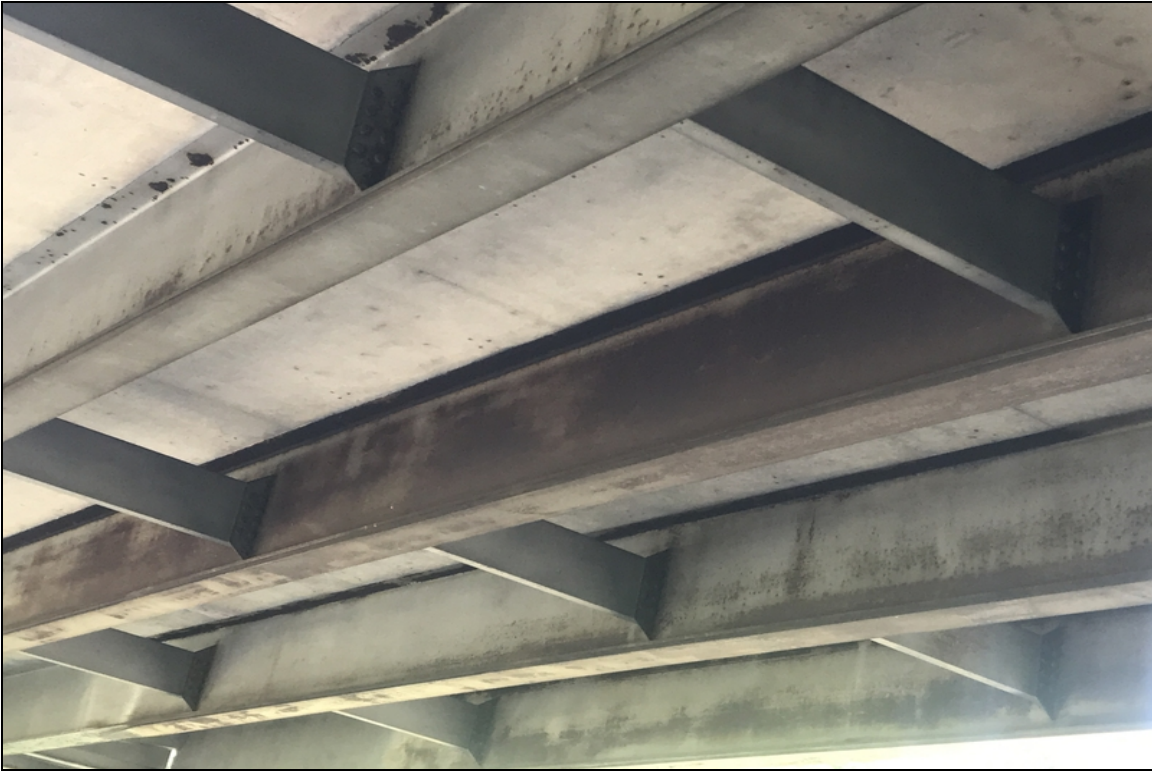
Span 2 beam 3 has surface rust mid span.

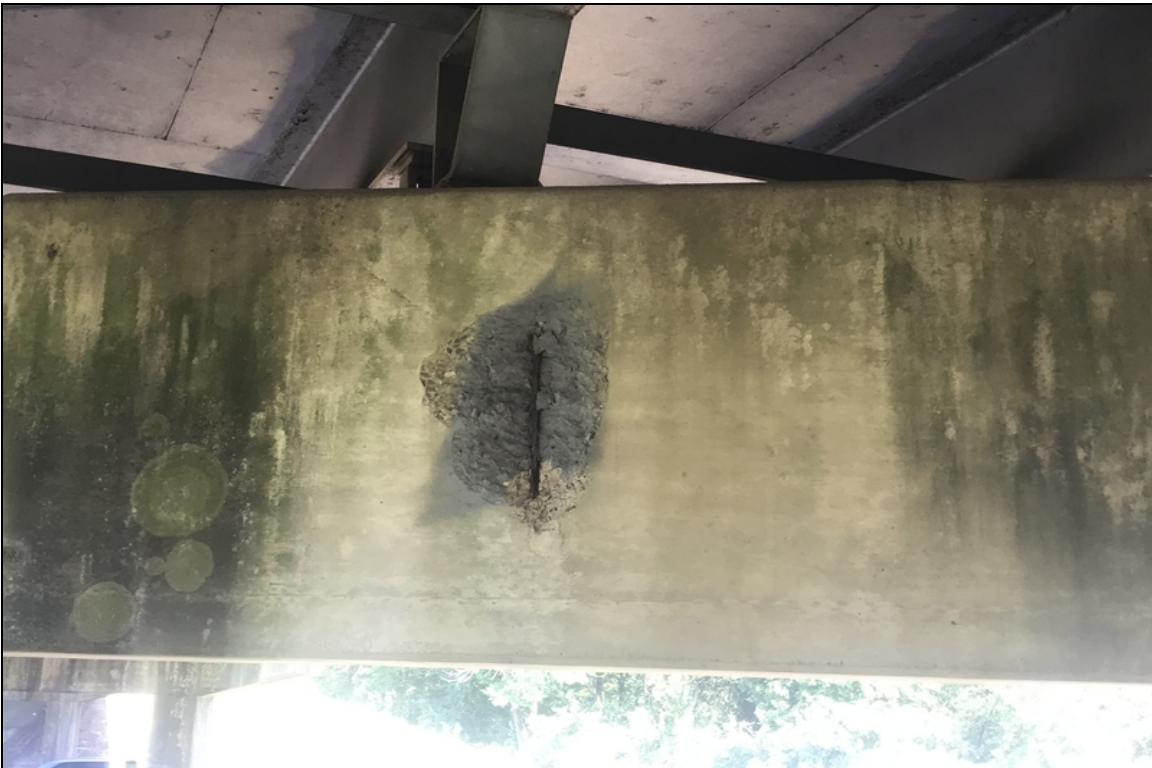
Bent 4 cap ahead has spall with exposed rebar.

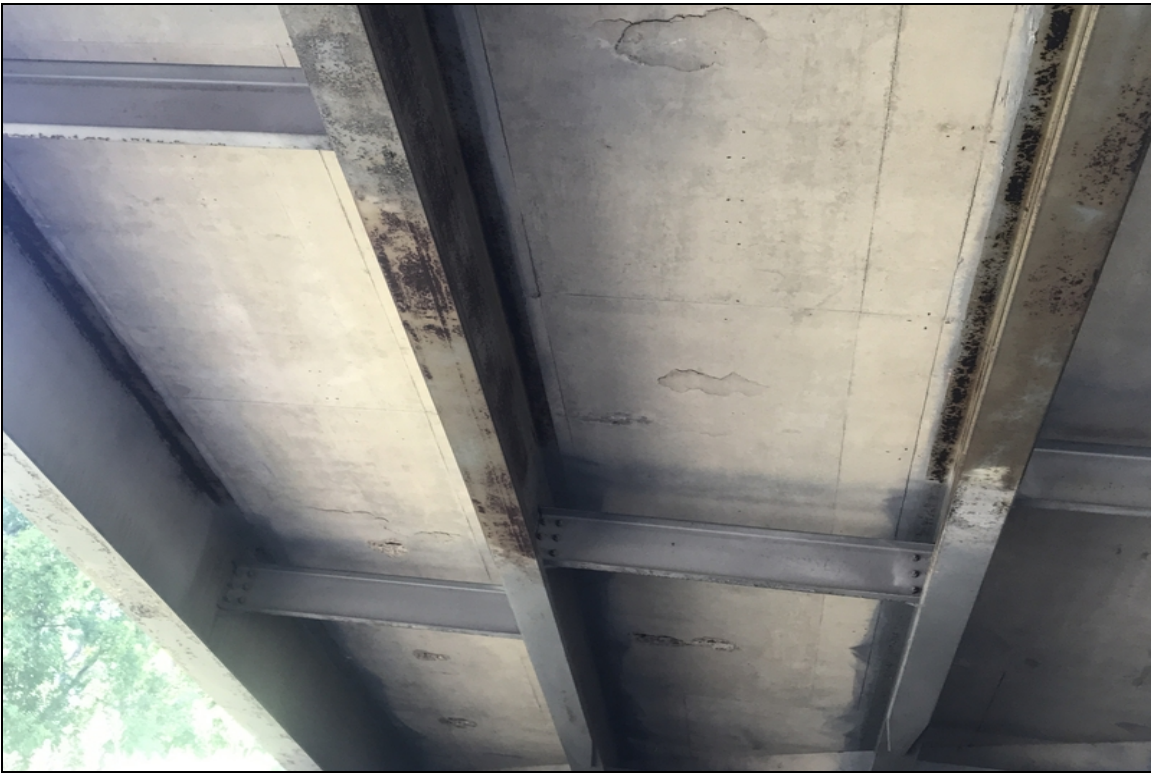
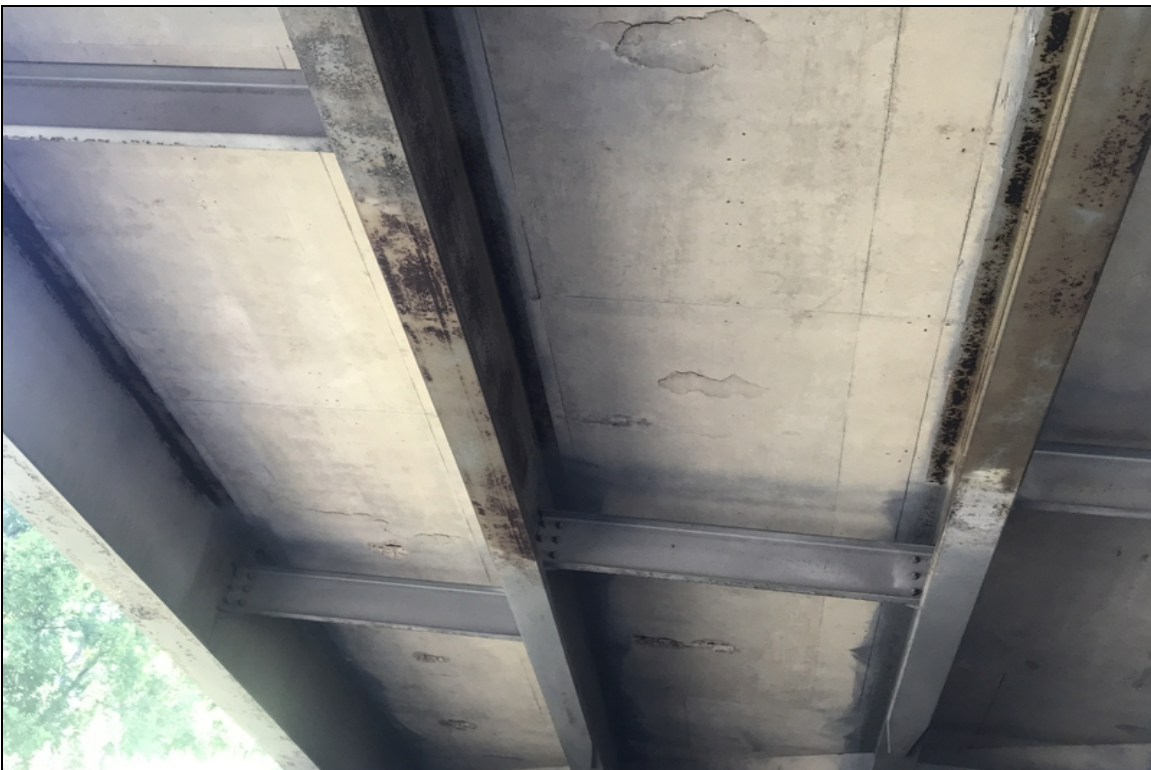
Soffit span 4 has spalls, spalls with exposed rebar, and delams in the soffit.

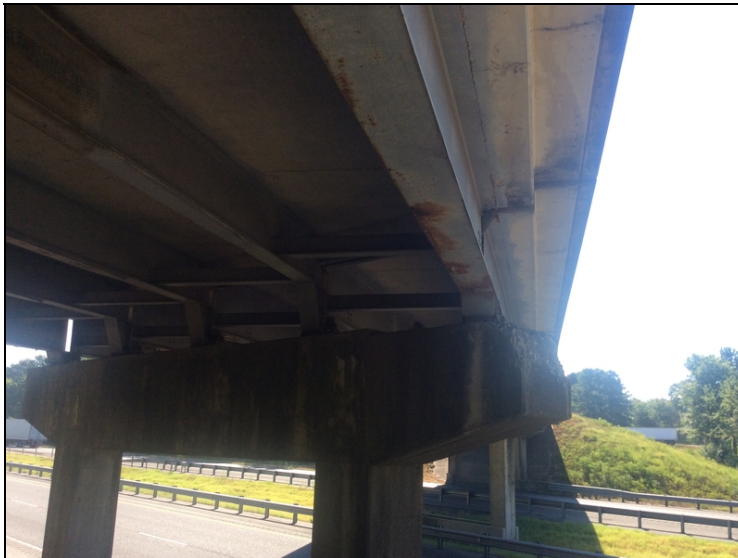
Cap at bents 2, 3, & 4 have spalls with exposed rebar.

Bent 2 right side, end of cap is deteriorating exposing the reinforcing steel.

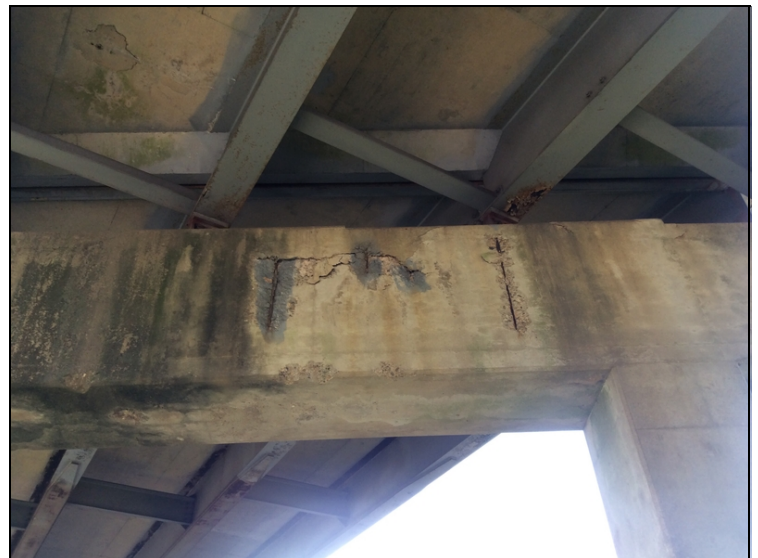
Bent 3 cap spalls with exposed rebar

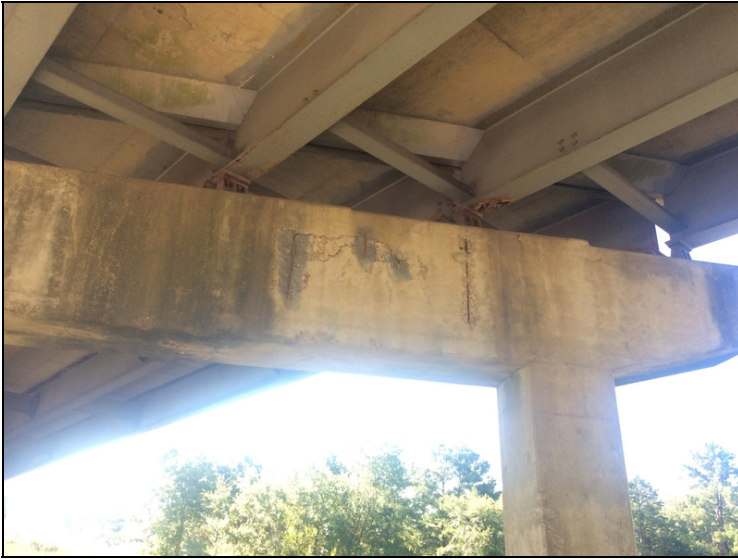
Bent 3, 9' of spall with exposed reinforcing steel that has section loss.

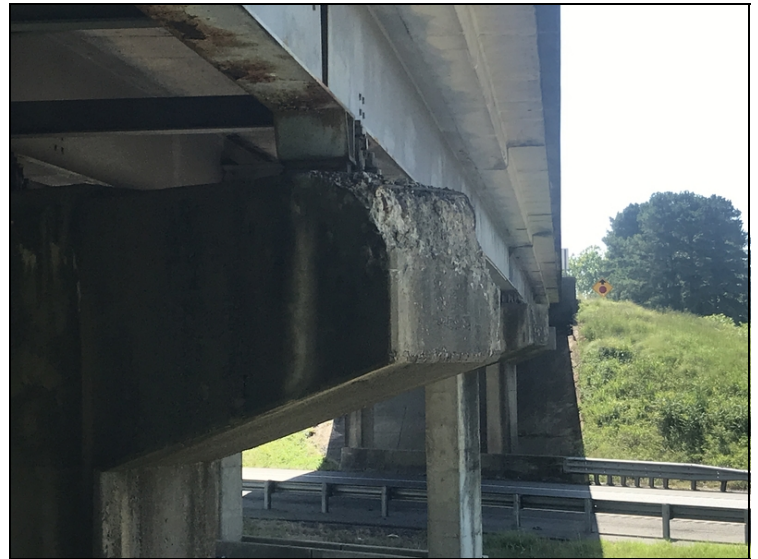
Bent 2 cap right side has spall with exposed rebar.

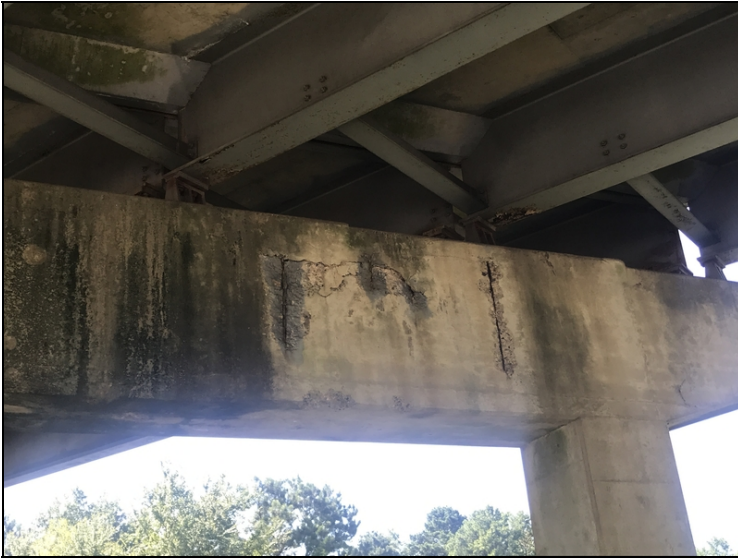
Bent 3 cap back has spalls with exposed rebar.

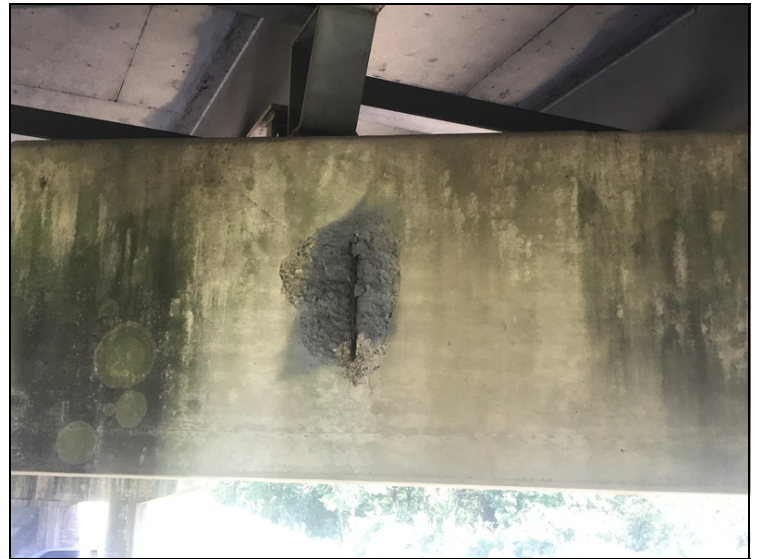
Bent 4 cap ahead has spall with exposed rebar.

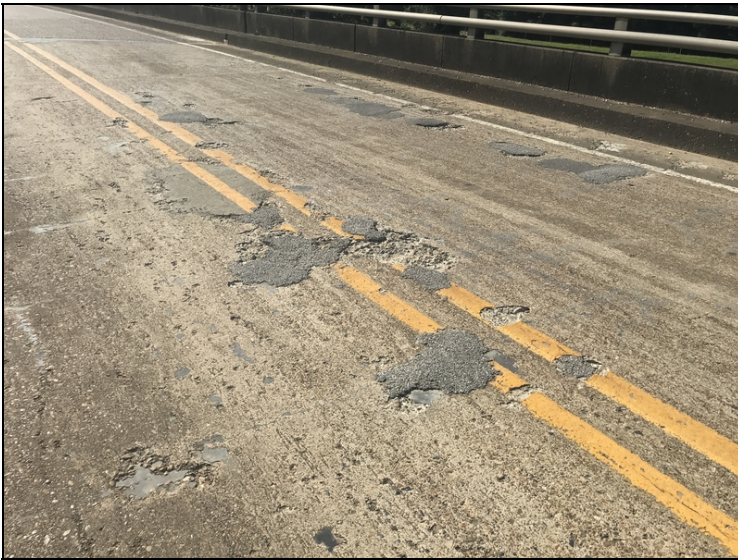
All spans have spalls and spalls filled with asphalt.

Deck span 2 has spalls and spalls filled with asphalt.

Date Reported: 07/13/2020
Priority: C - Important
Type of Work: Repair
Status: Open
Component: Deck

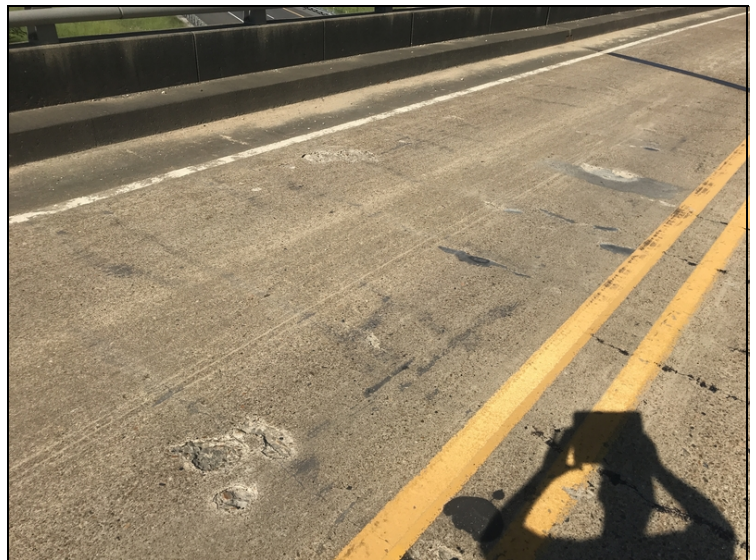
Deck span 4 has spalls in the right lane.

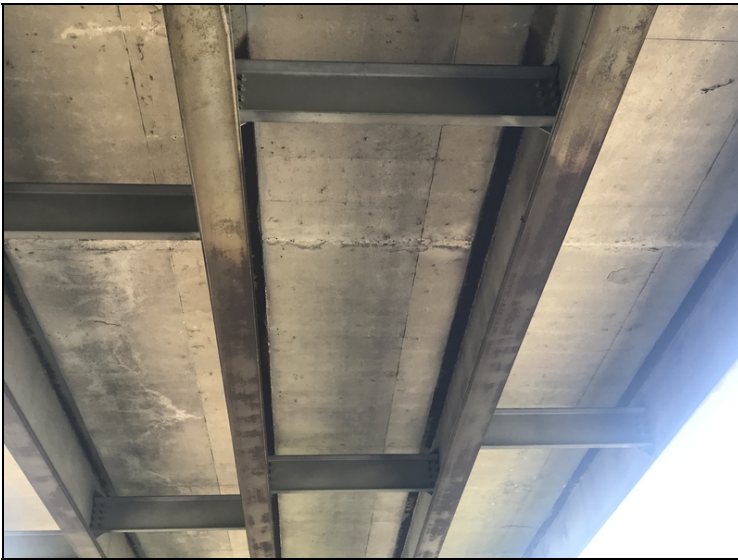
Span 2 soffit small delamination over west bound traffic.

Span 2 soffit over west bound traffic small delams.

Date Reported: 07/13/2020
Priority: B - Pressing; 6 month completion goal
Type of Work: Repair
Status: Open
Component: Deck
