**Bridge #A3941 (Routine)**  
**I-30 WB log 89.65 over PRAIRIE BAYOU**  
**Location: 8.35 MI SW OF SH 270**  
**Team Lead: Shane Byrd Inspection Date: July 14, 2020**

IDENTIFICATION	
(1) State Names	Arkansas
(8) Structure Number	A3941
(5) Inventory Route	30
(2) Highway Agency District	06
(3) County Code	59-Hot Spring County, Arkansas

**Bridge #A3941 (Routine)**  
**I-30 WB log 89.65 over PRAIRIE BAYOU**  
**Location: 8.35 MI SW OF SH 270**  
**Team Lead: Shane Byrd, Inspection Date: July 14, 2020**

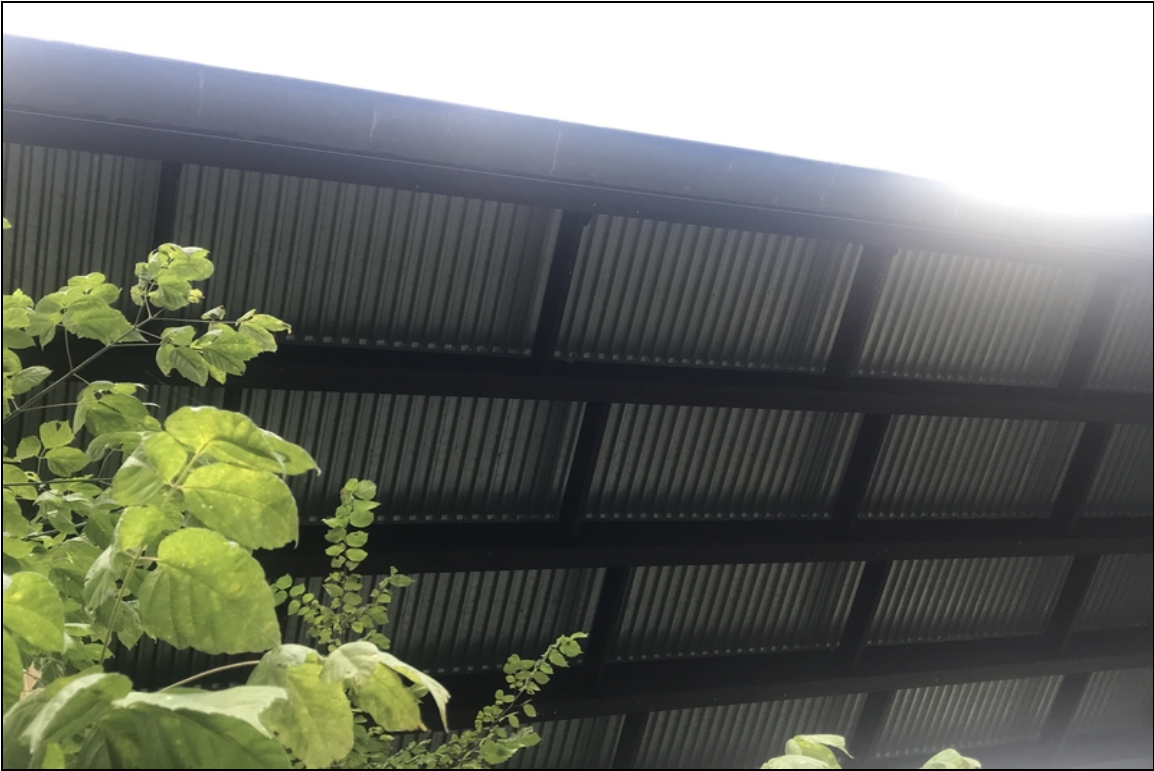
(12)	All spans have transverse cracks and longitudinal cracks that parallel the top flanges of the girders. Soffits have cracks with efflorescence.						
107	Steel Open Girder/Beam	LF	1680	1644	36	0	0
1000	Corrosion	LF	36	0	36	0	0
515	Steel Protective Coating	SF	13692	13399	293	0	0
3430	Oxide Film Degradation Color/Texture Adherence(Steel Protective Coatings)	SF	293	0	293	0	0

Span 3 left side soffit overhang has cracks with efflorescence.

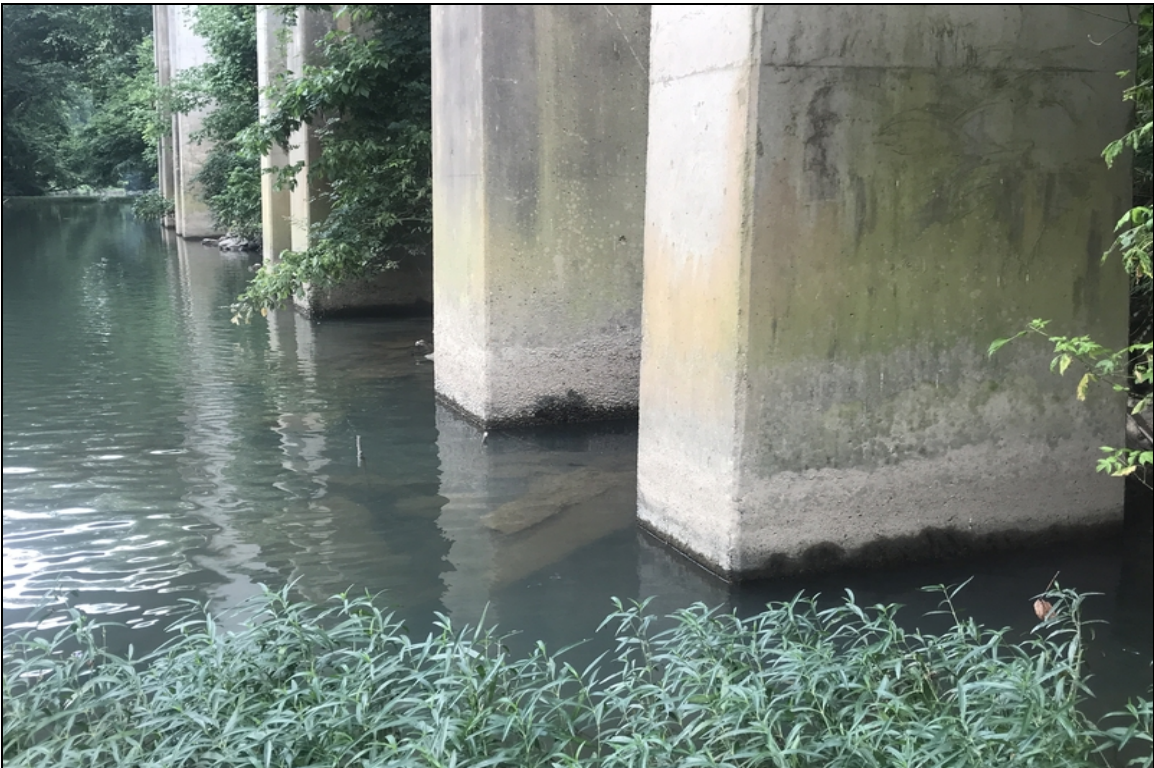
(205)	Bents 3 & 4, the original columns have abrasion at the bottom , bent 5 column 2 is cracked.						
210	Reinforced Concrete Pier Wall	LF	32	32	0	0	0

Bent 3 columns have abrasion, common bent 4.

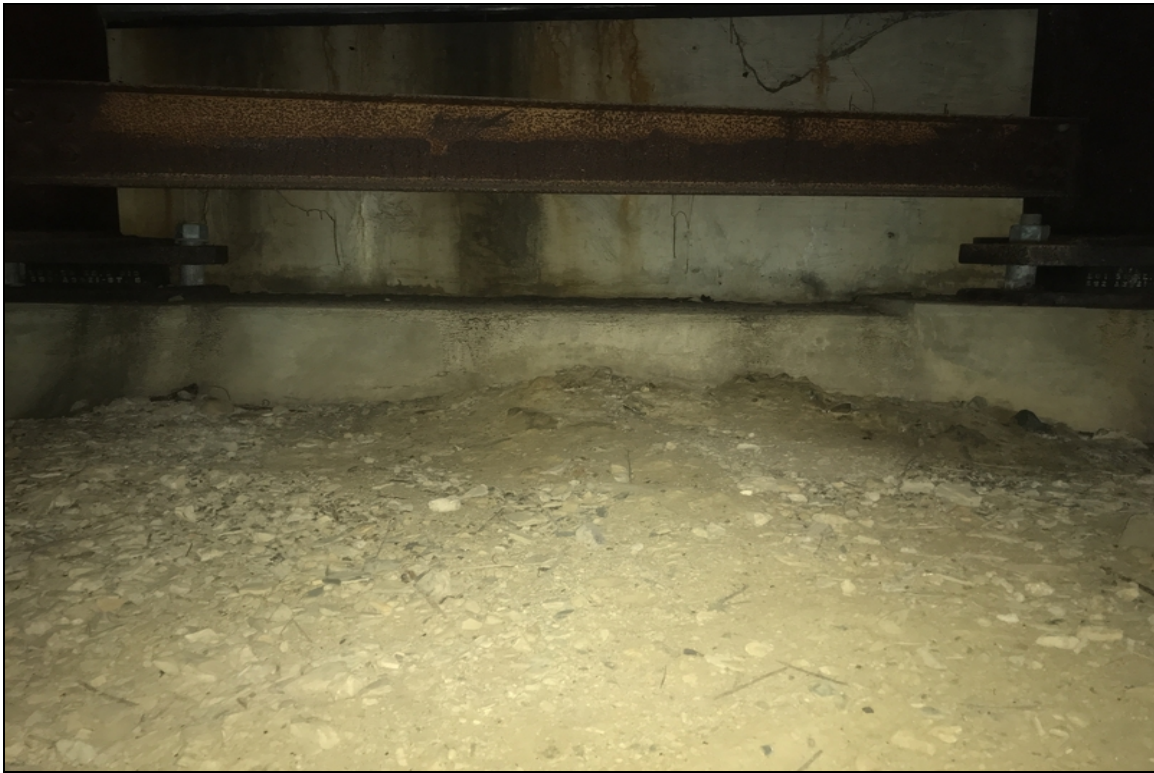
(215)	Cracks with efflorescence in both abutments.						
234	Reinforced Concrete Pier Cap	LF	176	175	1	0	0
1080	Delamination/Spall/Patched Area	LF	1	0	1	0	0

Bent 6 abutment has cracks with efflorescence in the back wall.

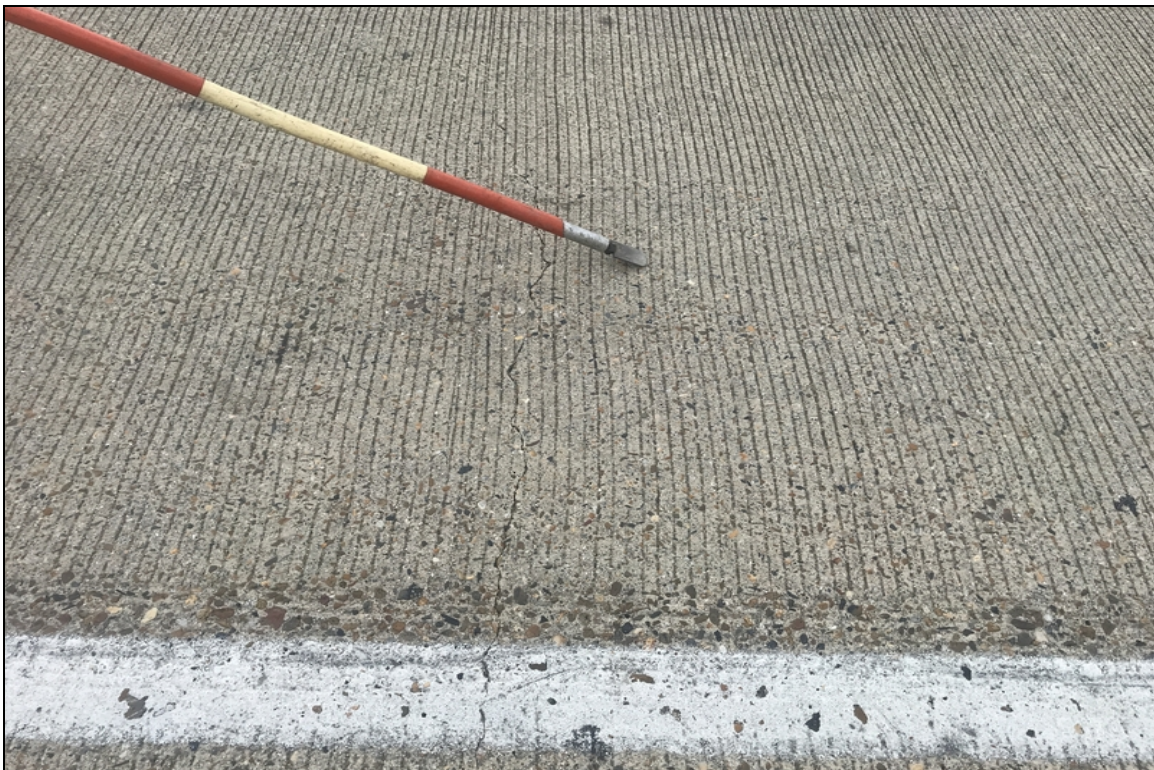
Span 1 has transverse cracks in the deck.

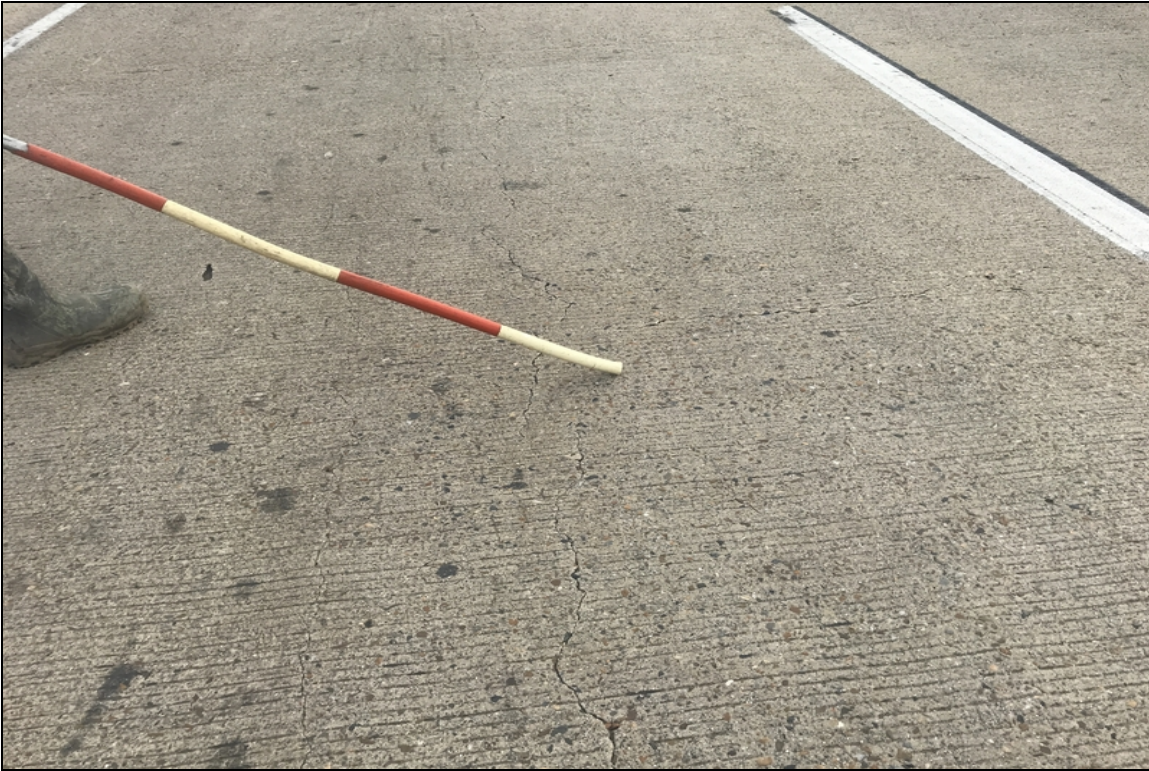
Span 3 deck has longitudinal and transverse cracks in the deck.

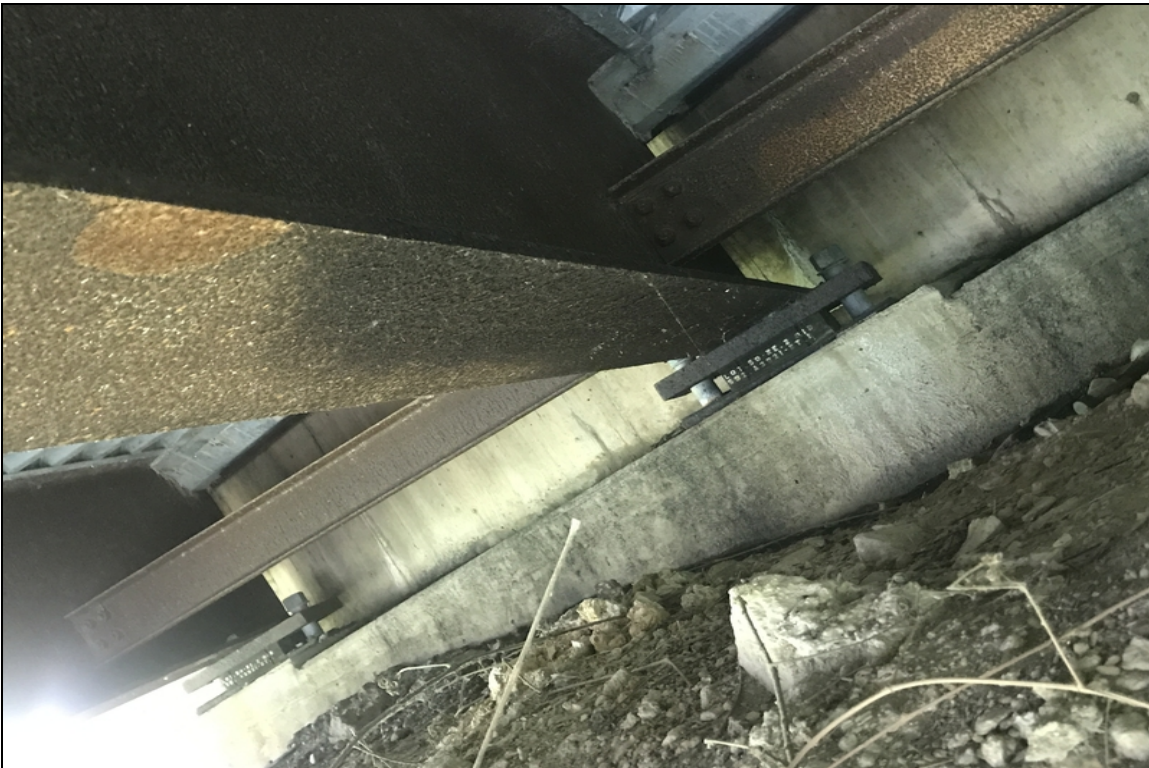
(107)	Beam ends at bent 1 and 6 have minor rust on bottom flange and lower web.						
205	Reinforced Concrete Column	EA	16	11	5	0	0
1130	Cracking (RC and Other)	EA	2	0	2	0	0
1190	Abrasion/Wear (PSC/RC)	EA	3	0	3	0	0

Span 1 beam 4 has small flakes of rust on the bottom flange.

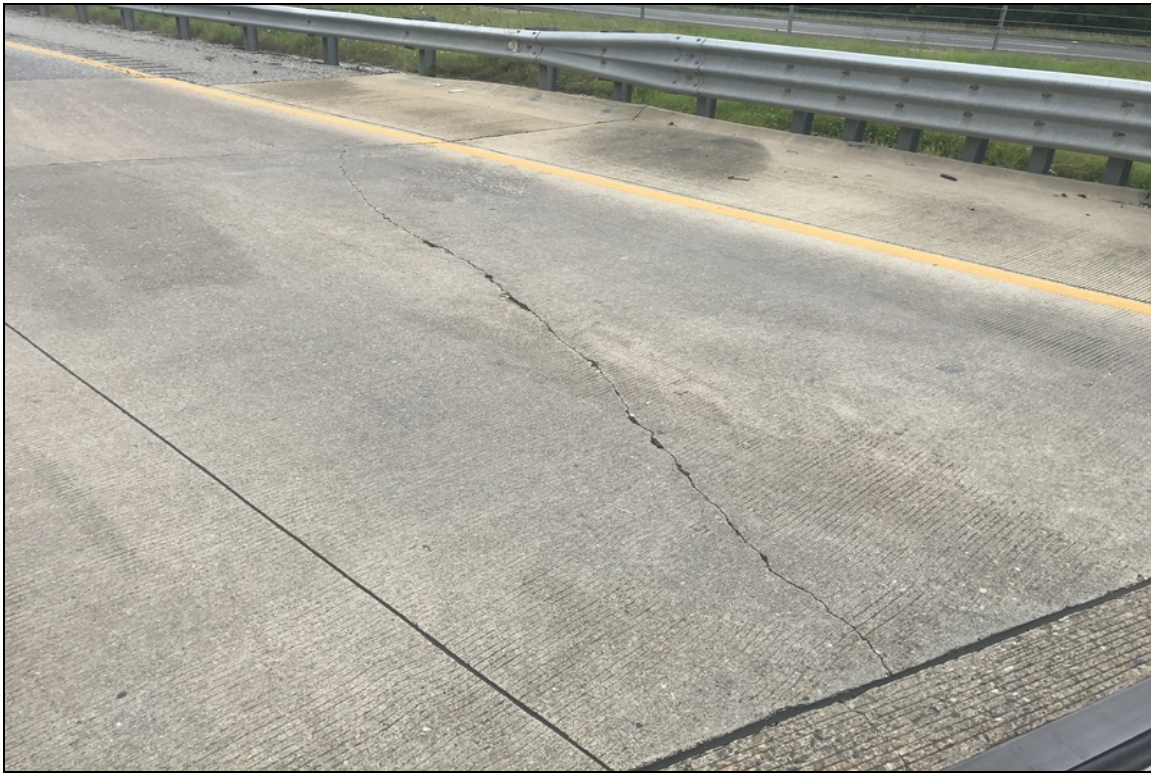
East approach slab has large unsealed longitudinal crack.

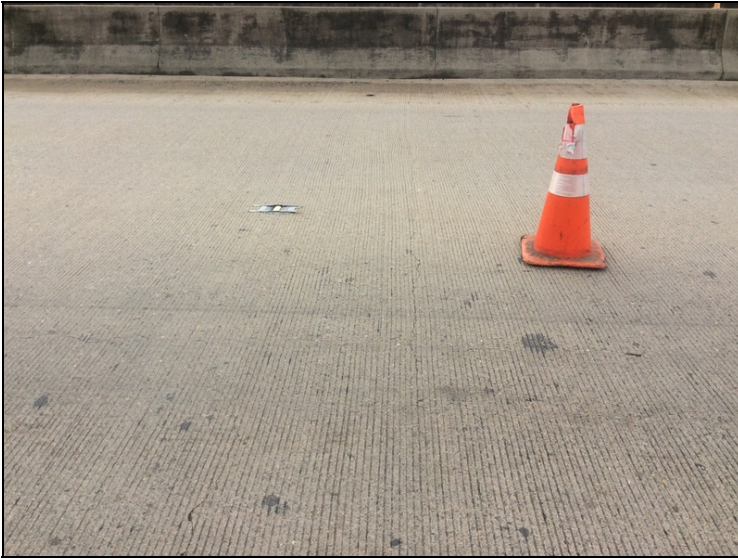
Deck all spans unsealed transverse and longitudinal cracking, 0.025 to 0.035 inch width.

Span 2 transverse cracks.

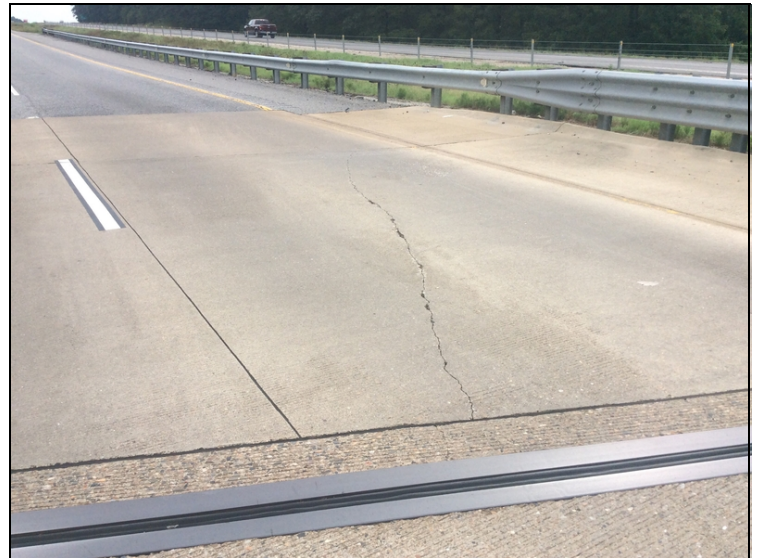
Large longitudinal crack east approach left lane.

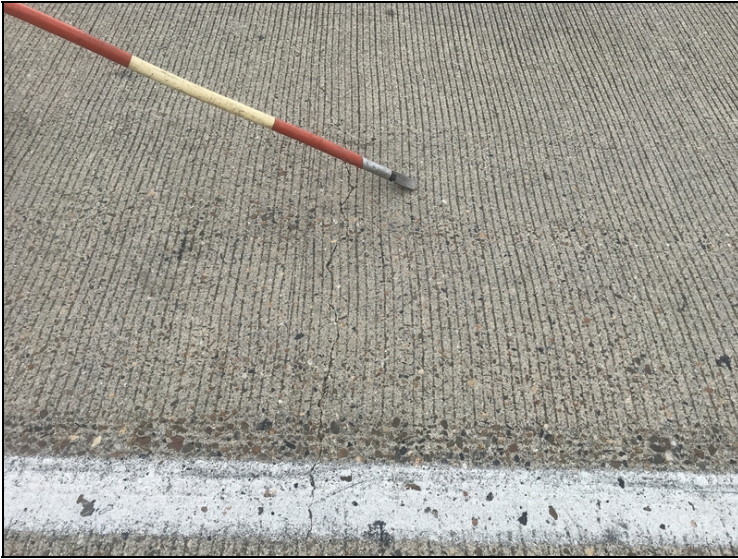
Span 1 has transverse cracks in the deck.

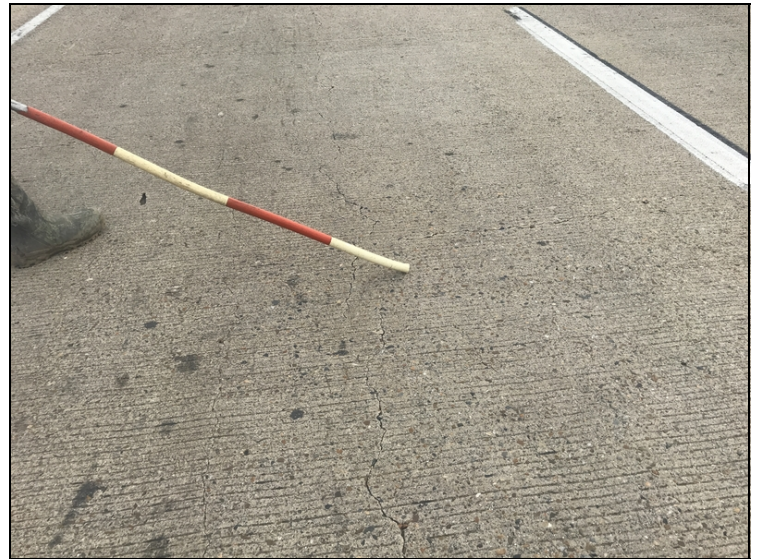
Span 3 deck has longitudinal and transverse cracks in the deck.

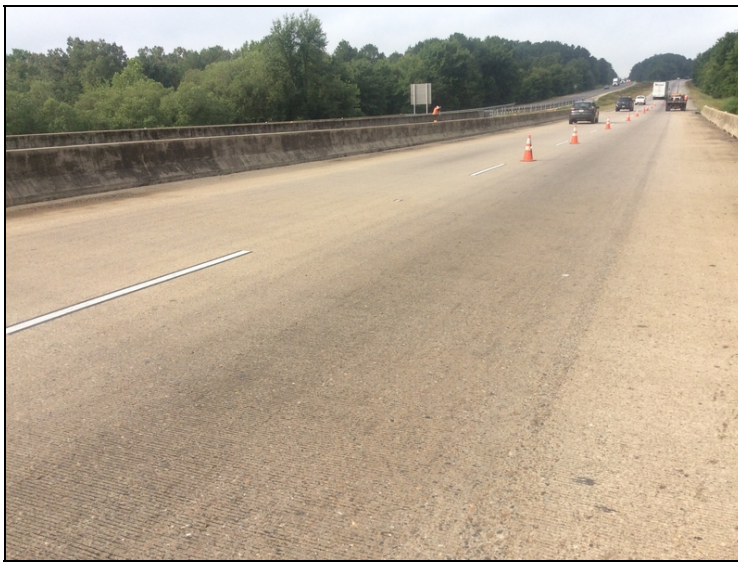
The left and right edge stripes are worn off and not visible. Photo attached

Striping on inside and outside lanes are missing.

State forces have place new edge stripes. See photo.

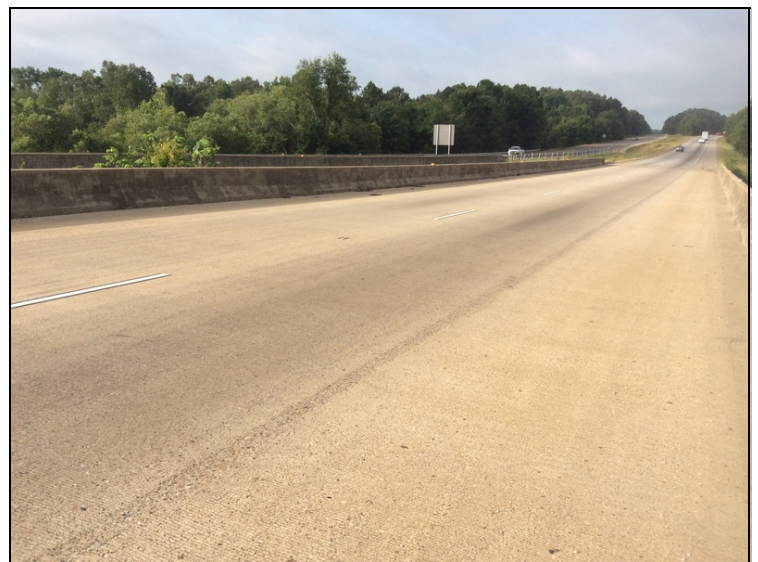
The left and right edge stripes are worn off and not visible.

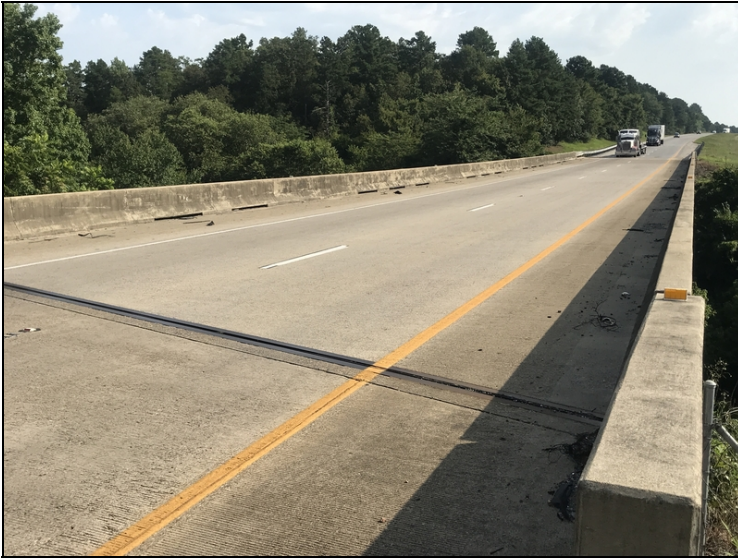
State forces have repainted the white and yellow lines on bridge.

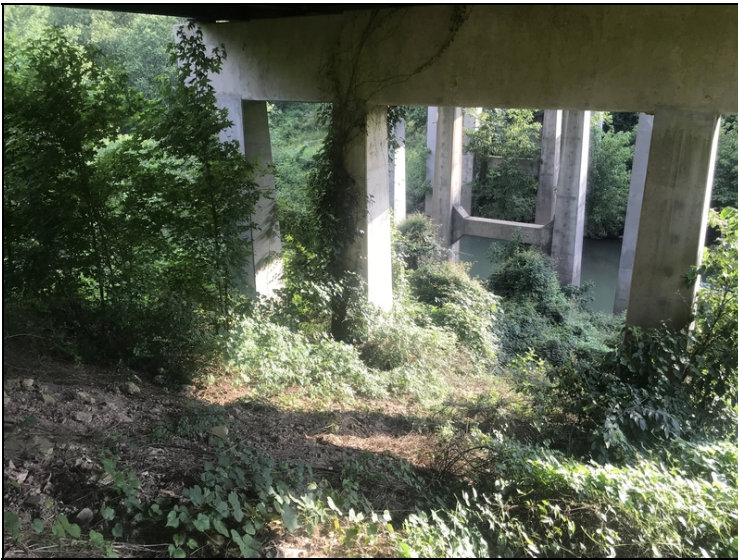
Trees and vines growing on and under bridge, all spans.

Span 1 has trees and vines growing on and under bridge.

**Date Reported:** 07/14/2020  
**Priority:** C - Important  
**Type of Work:** Clean  
**Status:** Open  
**Component:**
