Bridge #B3941 (Routine)
I-30 EB Log 89.63 over PRAIRIE BAYOU
Location: 8.35 MI SW OF SH 270

Team Lead: Shane Byrd Inspection Date: July 14, 2020

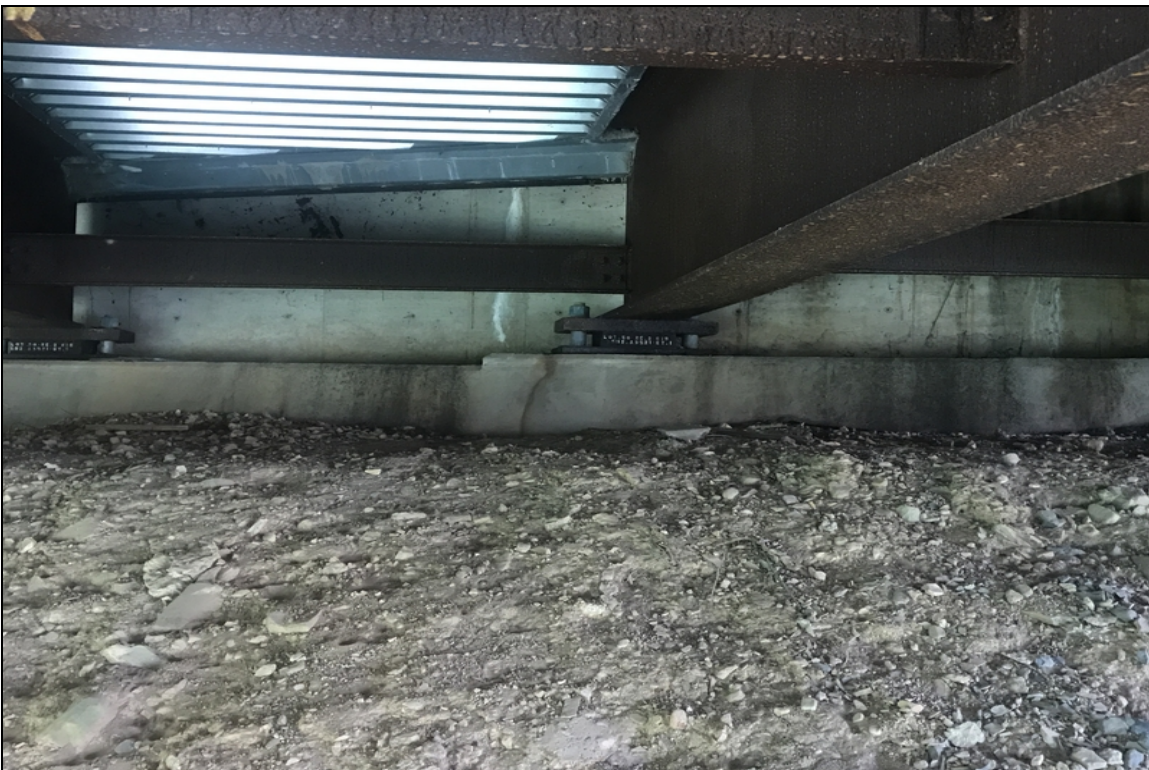
(215)	7/18/2018 - KRM & RLS - Both abutments have vertical cracks and cracks with efflorescence.						
234	Reinforced Concrete Pier Cap	LF	176	176	0	0	0

Bent 1 abutment has cracks with efflorescence in the back wall.

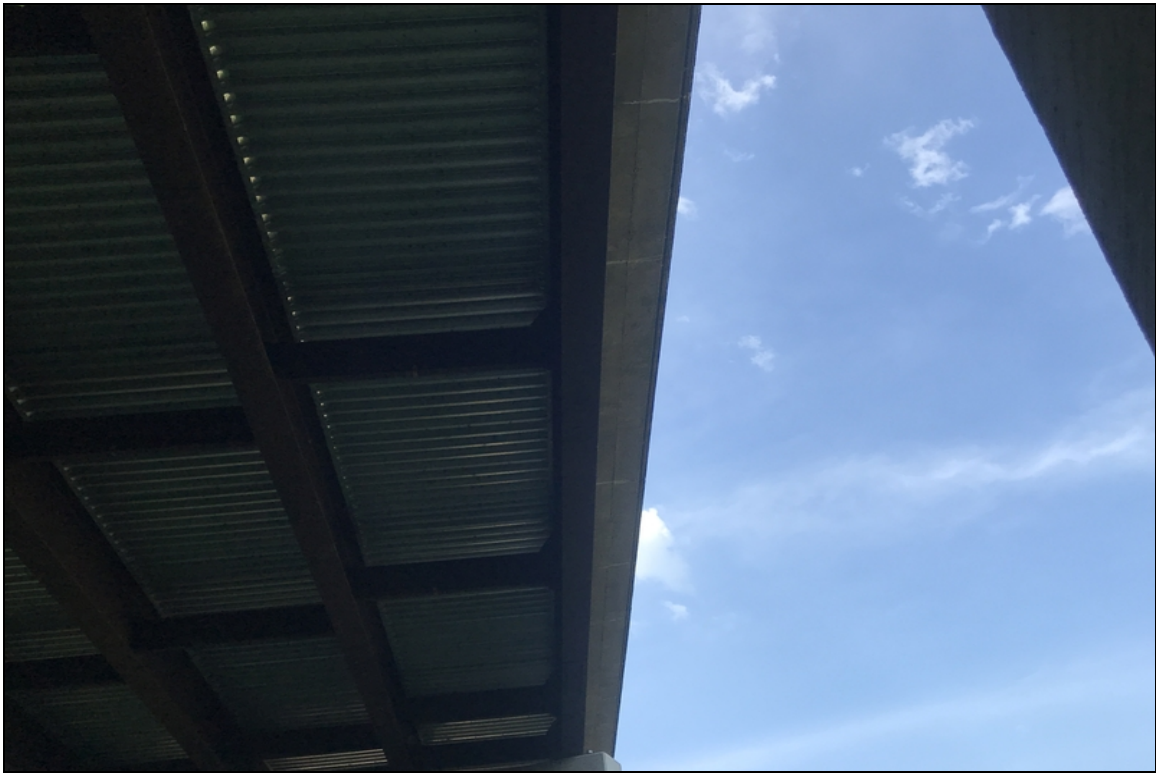
(12)	All spans have transverse cracking and longitudinal cracks that parallel the flanges of the girders, Soffits have cracks with efflorescence.						
107	Steel Open Girder/Beam	LF	1680	1654	26	0	0
1000	Corrosion	LF	26	0	26	0	0
515	Steel Protective Coating	SF	13692	13480	212	0	0
3430	Oxide Film Degradation Color/Texture Adherence(Steel Protective Coatings)	SF	212	0	212	0	0

Span 4 left side soffit overhang has cracks with efflorescence.

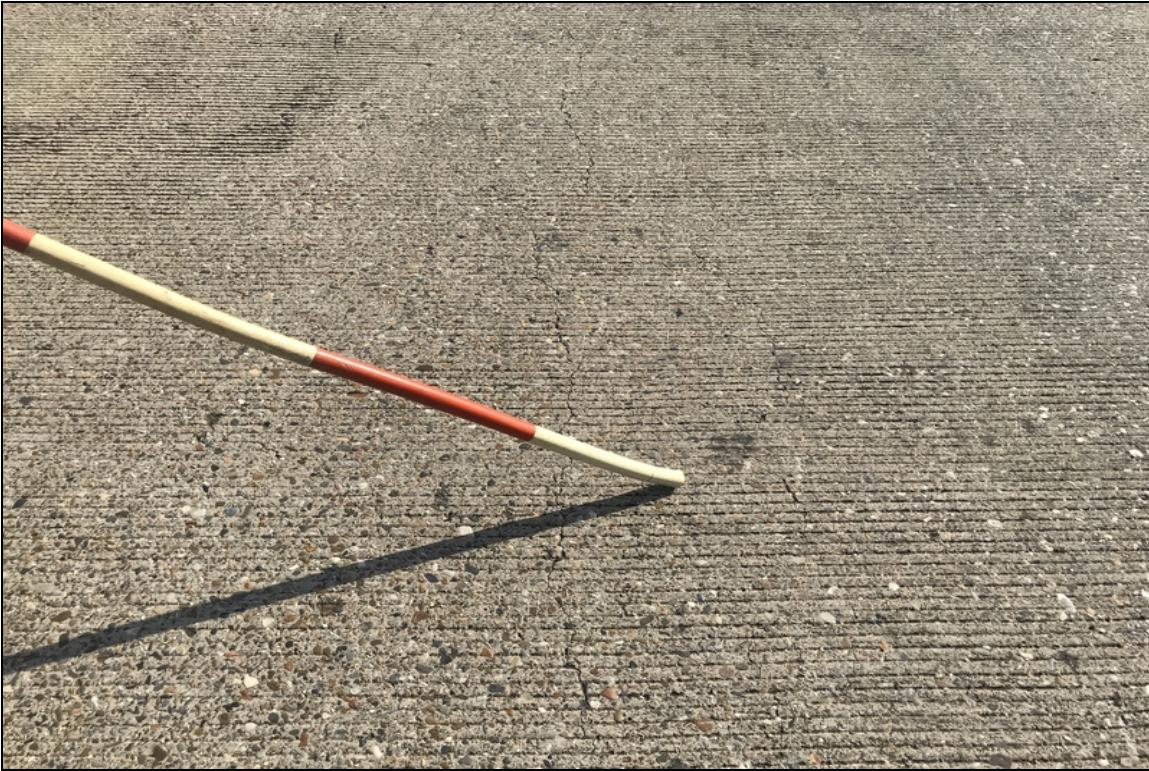
Span 1 has longitudinal cracks in the deck.

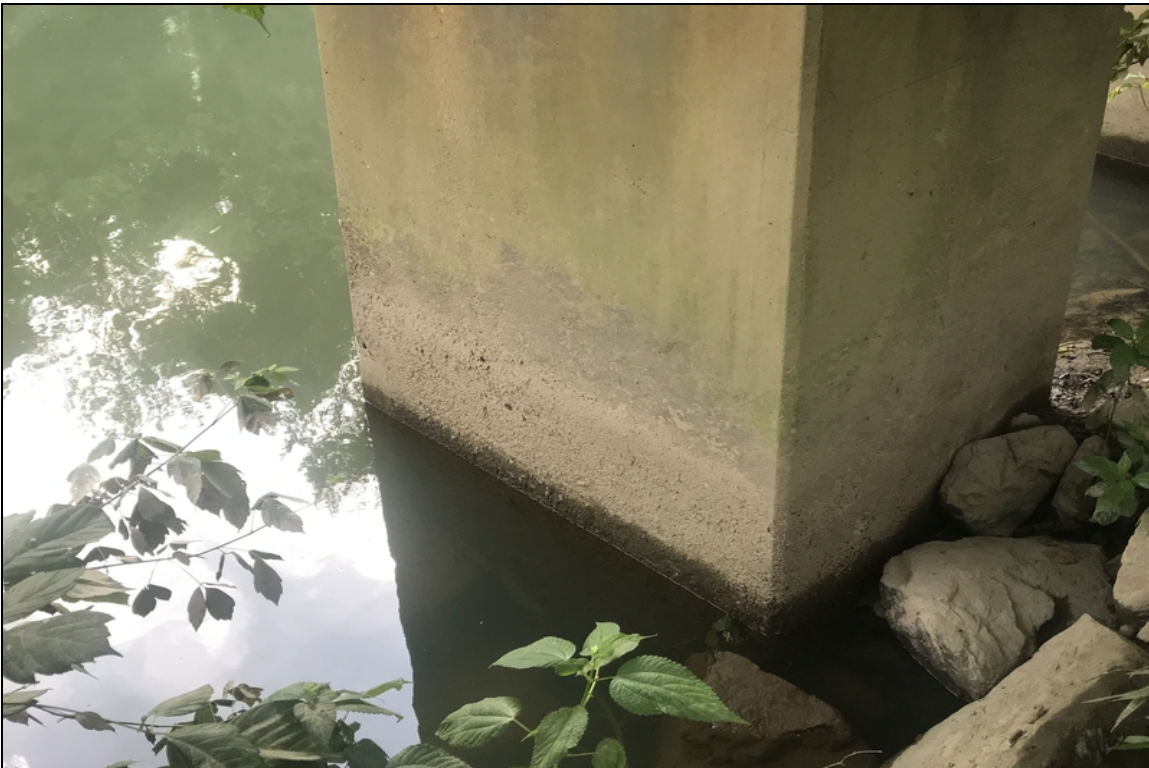
(205)	Bent 2, column 3 has one small exposed rebar on the back side, Bents 3 & 4, columns 2 & 3 have abrasion at the bottom.						
210	Reinforced Concrete Pier Wall	LF	32	22	10	0	0
1130	Cracking (RC and Other)	LF	10	0	10	0	0

Bent 3 column 3 has abrasion at the bottom of column, common bent 4 columns.

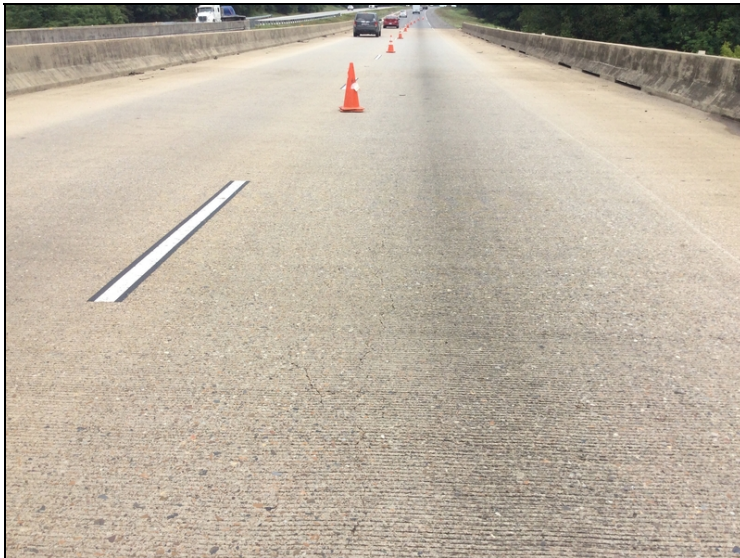
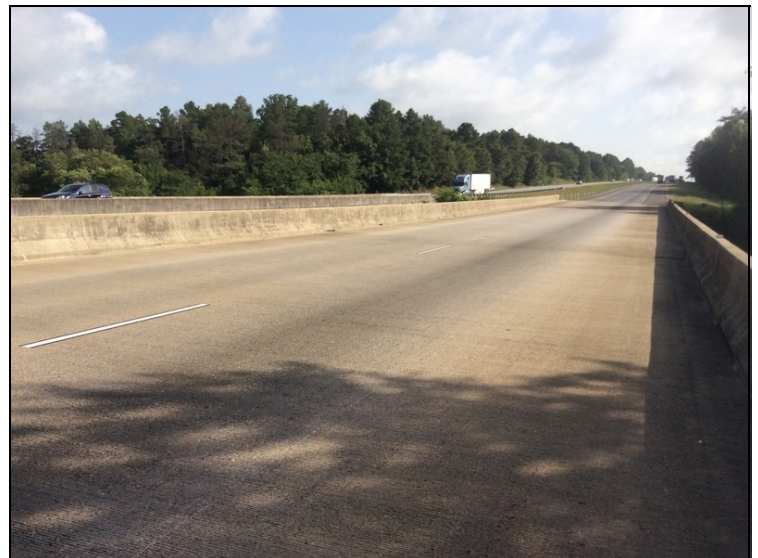
The edge stripes on the bridge are worn and not visible. Photo attached.

Both edge stripes on the bridge are worn and not visible.

Assigned Hot Springs 06301 10/31/18
State forces have placed new edge stripes. See photo.

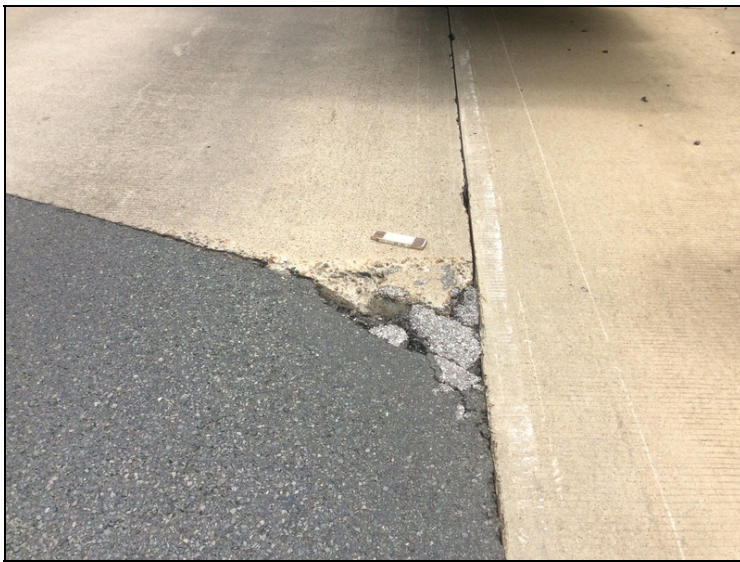
Large spall in west approach right lane.

Large spall at the west approach right lane.

Assigned Hot Springs 06301 10/31/18
State forces have patched pot hole with asphalt.

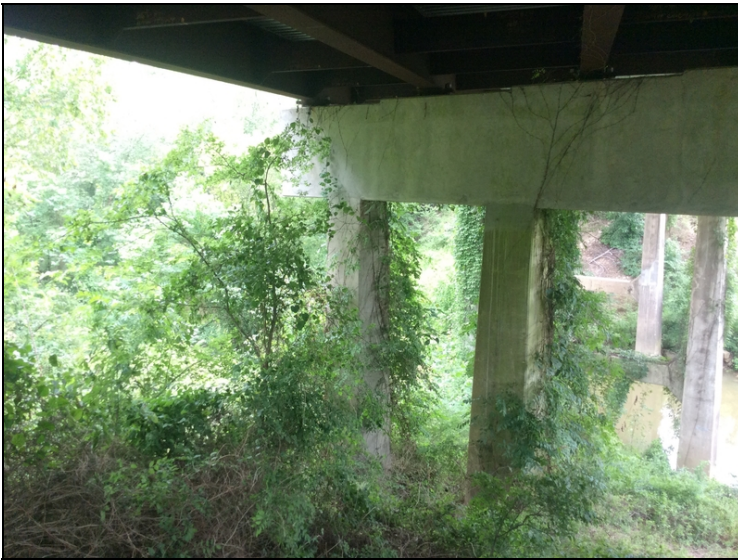
Vines growing in columns, caps and soffit at bents 2, 4 and 5. Small trees growing under the bridge in span 5.

Span 5, bent 5, small trees growing under the bridge, vines growing on columns and cap.

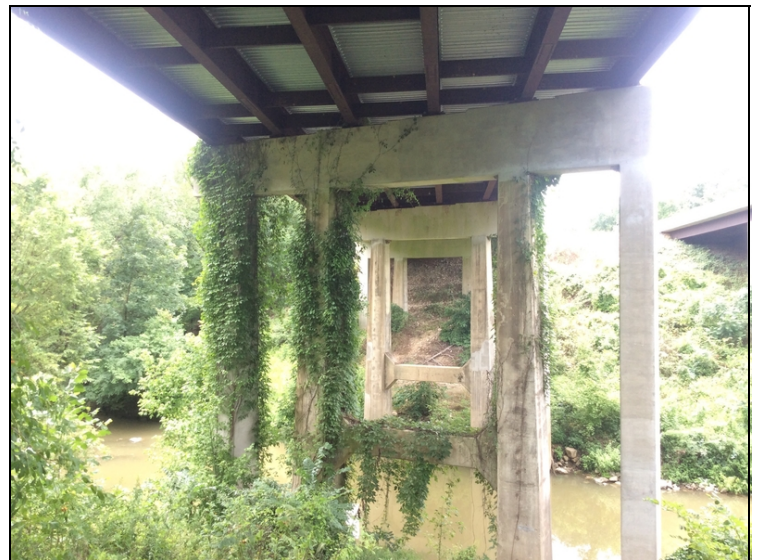
Bent 4, vines growing on columns and cap.

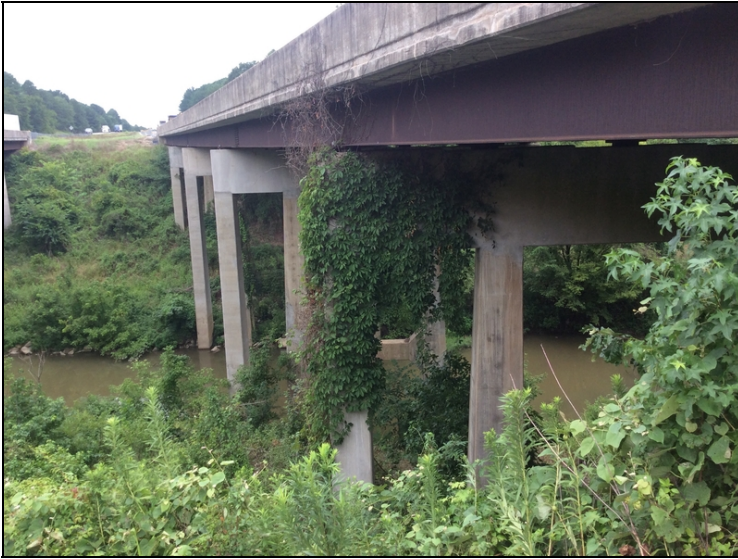
Bent 2, vines growing on column 1, cap and soffit.

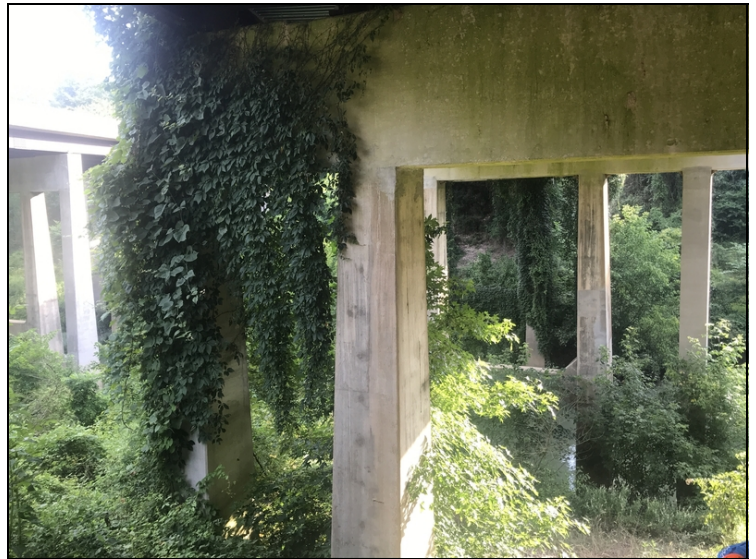
Bent 2 has vines and trees growing under and against bridge.

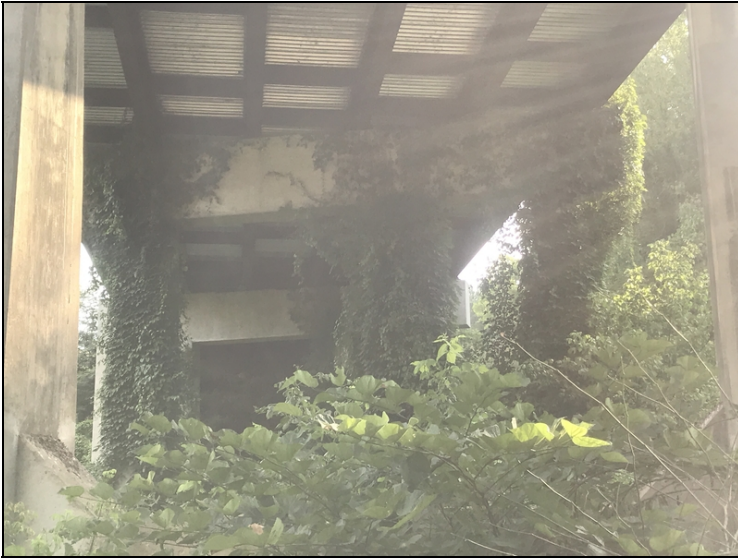
Bent 4 has vines growing on all columns under bridge.
