Bridge #A5025(Routine)
I-30 WB Log 91.76 over Blakley Crk, Acme Pit Rd
Location: 6.24 MI SW OF SH 270

Team Lead: Bryan Saunders Inspection Date: February 25, 2020

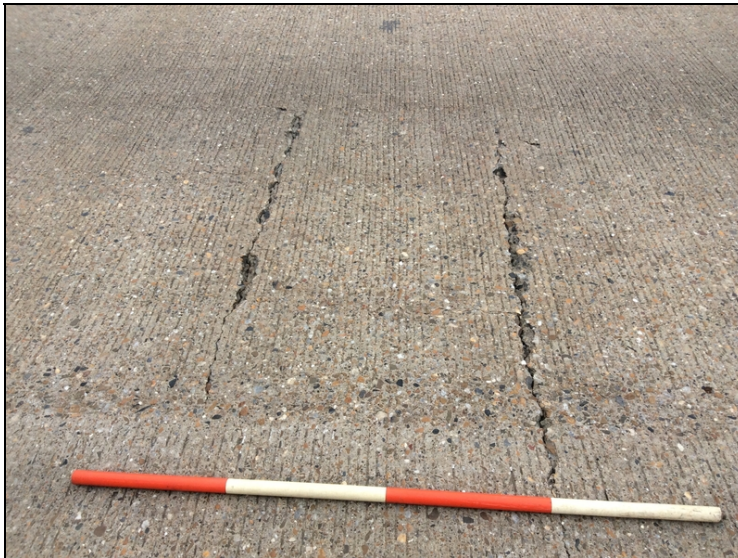
Deck all spans have unsealed longitudinal and transverse cracks up to 1/8".

Span 6, 1/8" cracks that have spalled at the top.

Date Reported: 03/16/2011
Priority: C - Important
Type of Work: Repair
Status: Monitor
Component: Deck

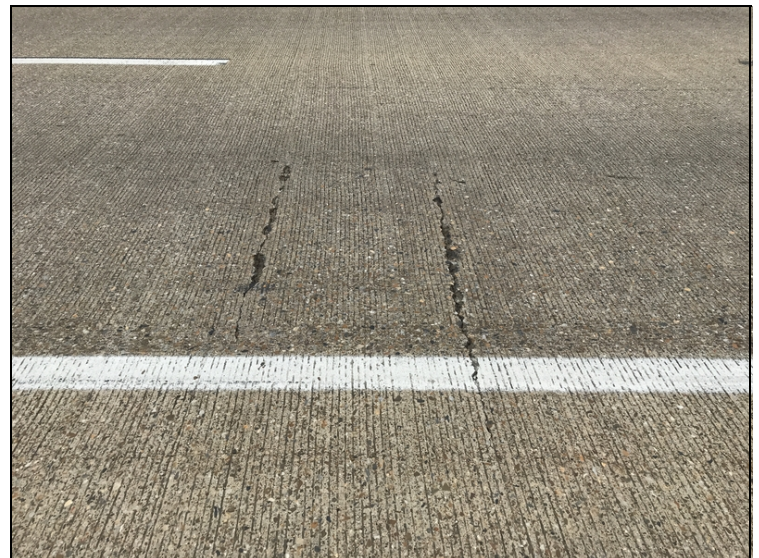
Span 6 left lane, large transverse cracks.

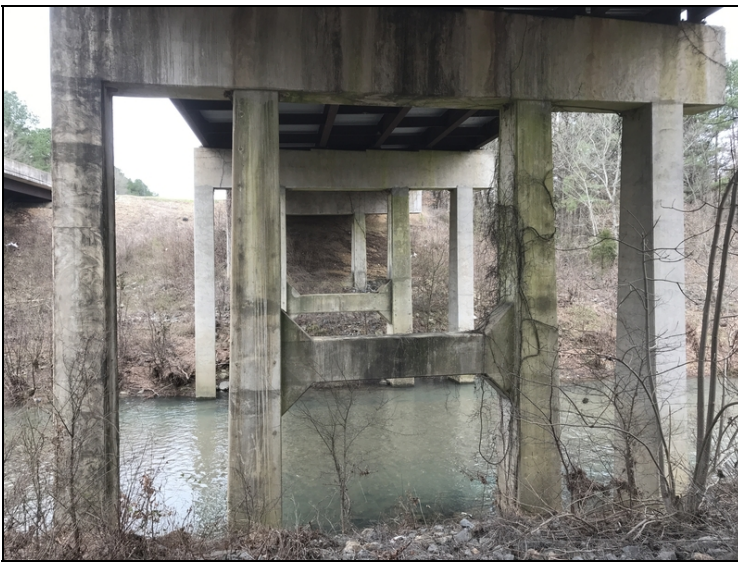
Vines growing on bents 2-6 columns and cap and small trees growing under the bridge in span 4.

Bent 4, vines on column and cap
Span 4, trees growing under bridge.

Date Reported: 02/25/2020
Priority: C - Important
Type of Work: Clean
Status: Open
Component: Superstructure
