Bridge #03197(Routine)
SH 391 GALLOWAY over I 40 LOG 160.81

Location: I-40 & SH 391

Team Lead: Shane Byrd Inspection Date: July 23, 2019

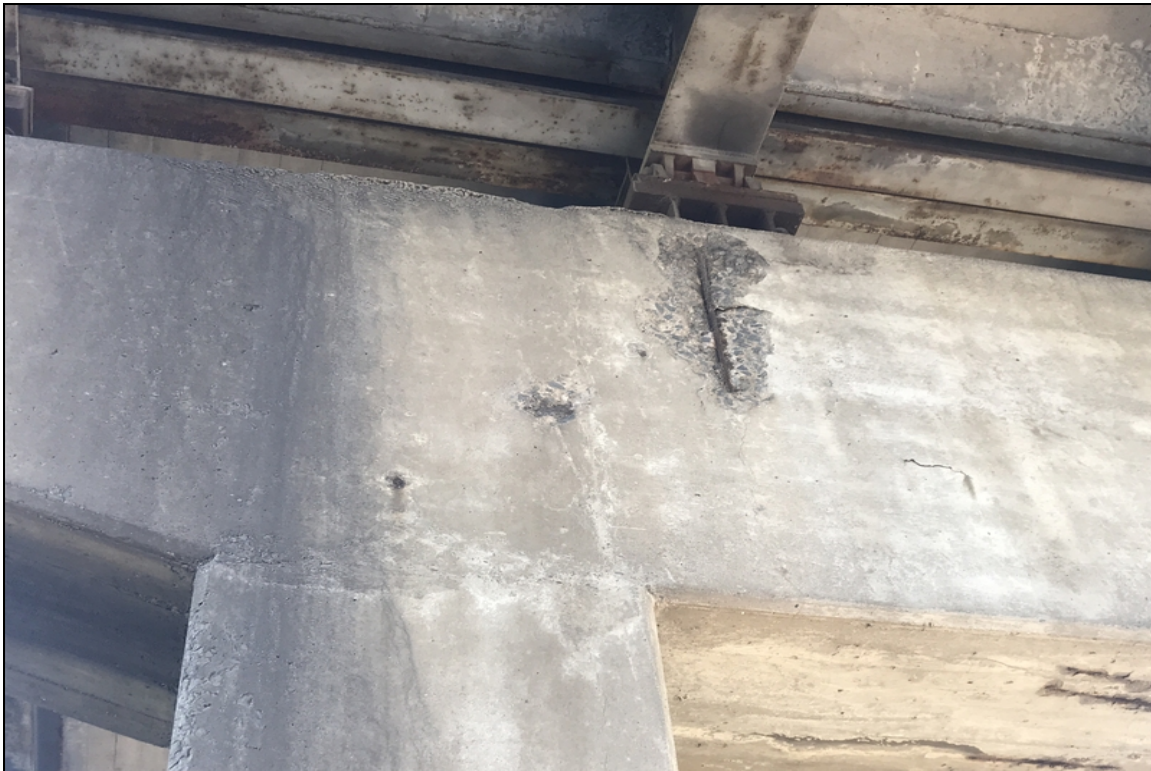
| ELEM | DESCRIPTION | UNITS | TOTAL | CS1 | CS2 | CS3 | CS4 |
|---|--|---|---|---|---|---|---|
| (234) | Bent 2, back side, Spalls with exposed rebar. Moderate cracking on the bottom of the cap between the columns. Bent 3 ahead and back, Spalls with exposed rebar, ahead, delams. Bent 4, back side, Spalls with exposed rebar. | | | | | | |

Bent 4 cap back spall with exposed rebar.

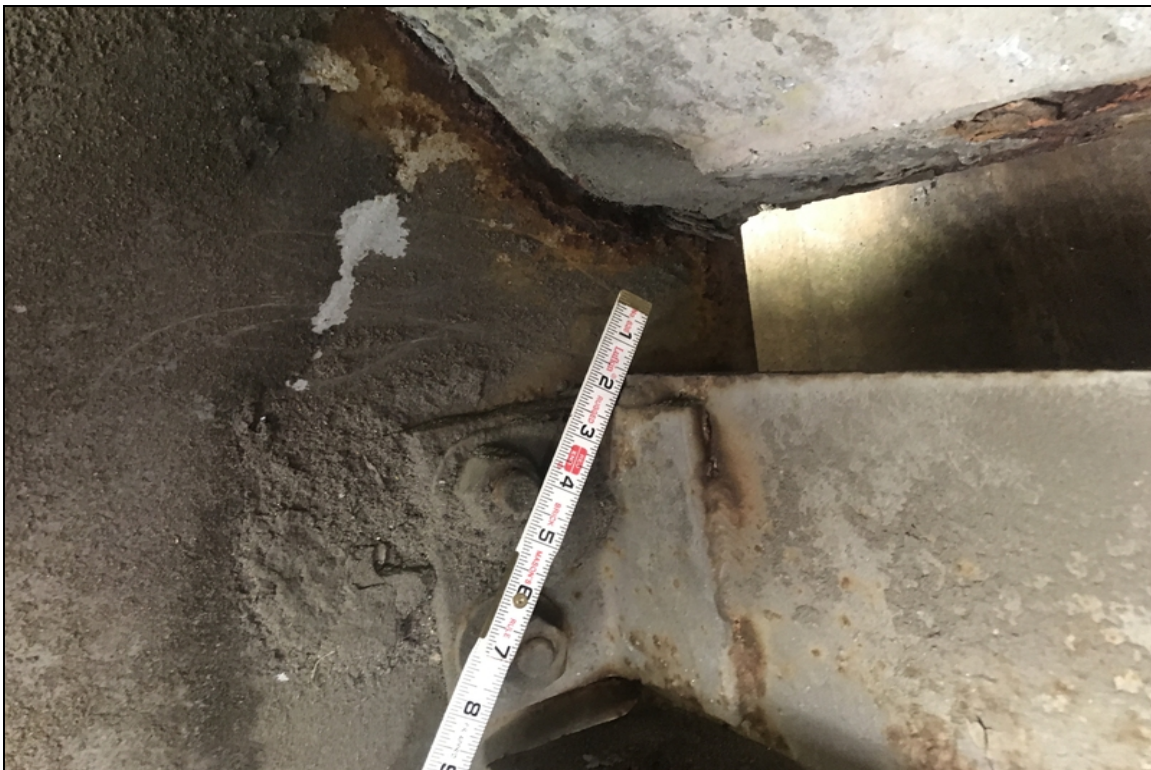
| ELEM | DESCRIPTION | UNITS | TOTAL | CS1 | CS2 | CS3 | CS4 |
|---|--|---|---|---|---|---|---|
| (107) | Scattered areas of active rust on the flanges and webs, most common at or near the joints. | | | | | | |

Bent 1 beam 3 active corrosion with pitting to upper web. Common all beam ends.

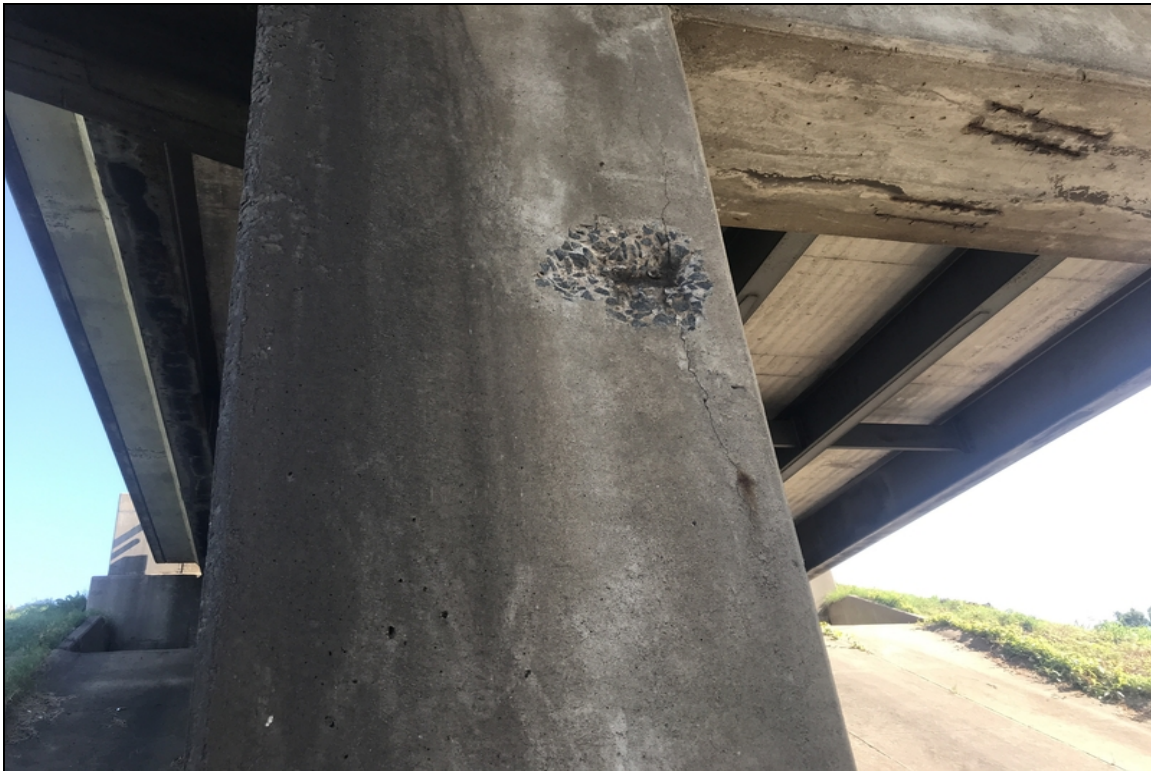
| ELEM | DESCRIPTION | UNITS | TOTAL | CS1 | CS2 | CS3 | CS4 |
|---|--|---|---|---|---|---|---|
| (205) | Bent 3, left column, Spalls with exposed rebar. Bent 4 left column, Spalls with exposed rebar. | | | | | | |

Bent 4 column 1 spall with exposed rebar.

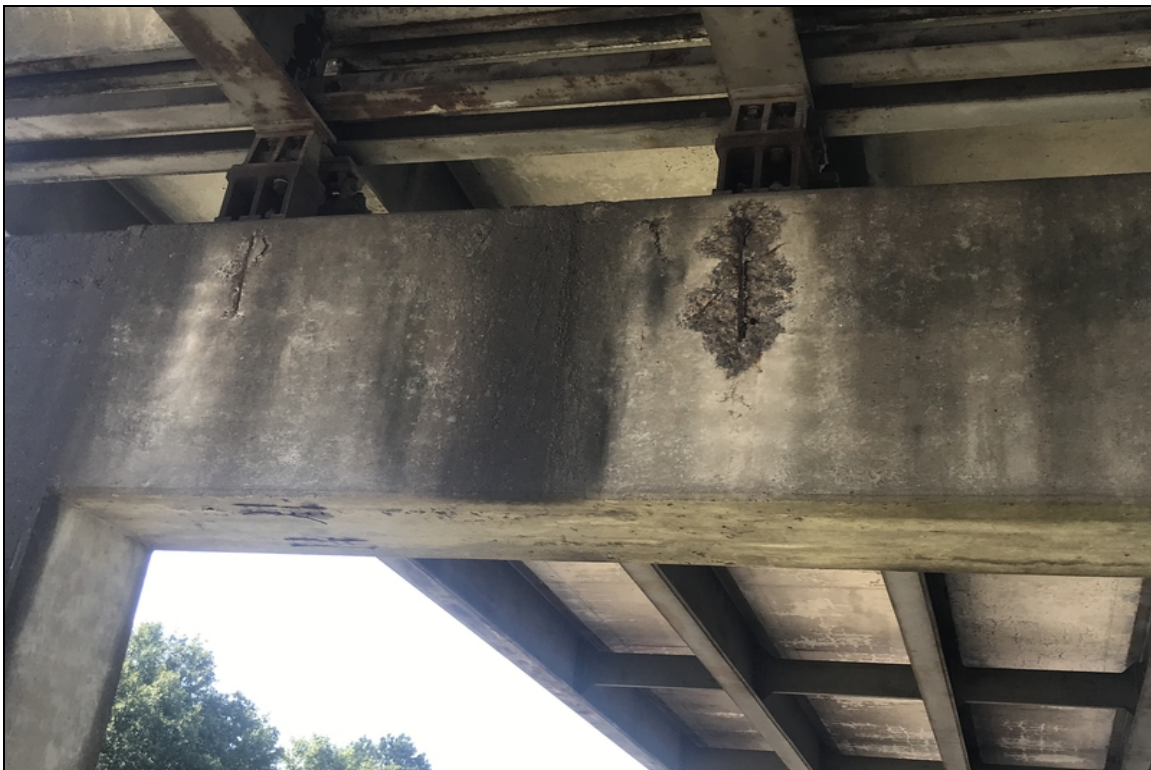
Bent 3 cap ahead face spall with exposed rebar.

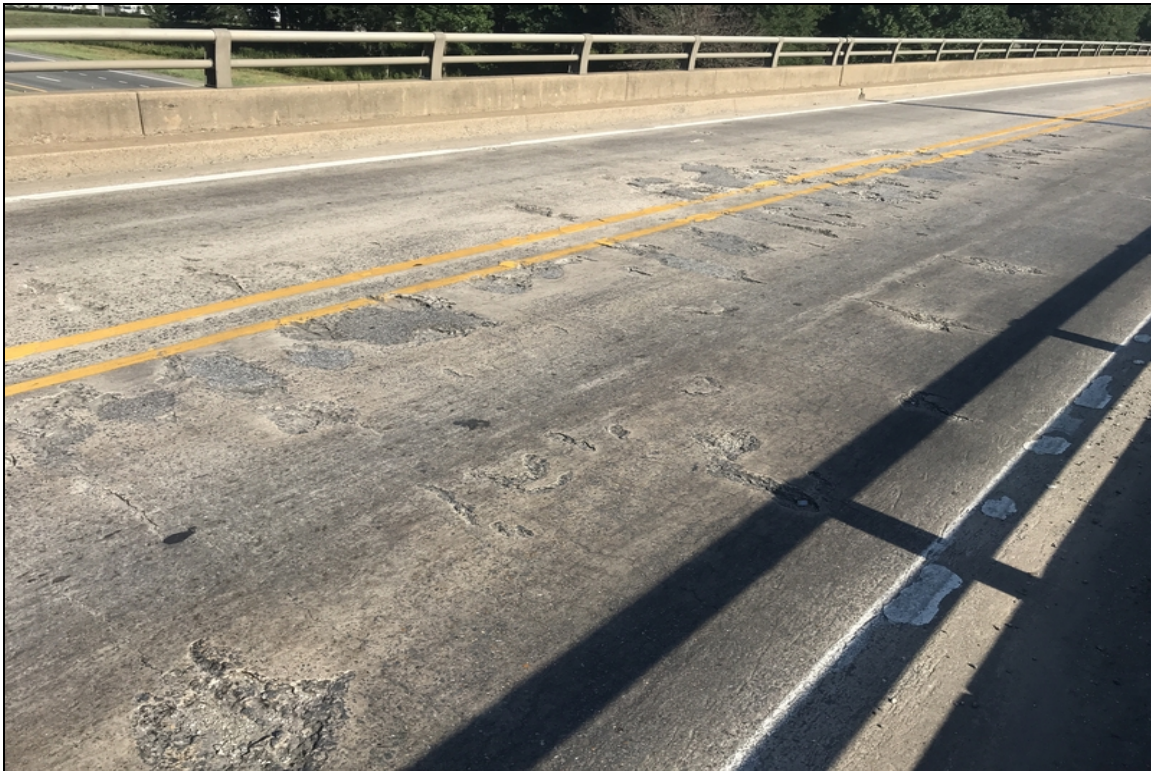
| ELEM | DESCRIPTION | UNITS | TOTAL | CS1 | CS2 | CS3 | CS4 |
|---|--|---|---|---|---|---|---|
| (12) | The deck surface has some abrasion due to the high truck volume. All spans have spalls and spalls filled with asphalt material and all spans have cracks on one foot centers. 0.075 inch max | | | | | | |

Span 2 spalls with exposed rebar.

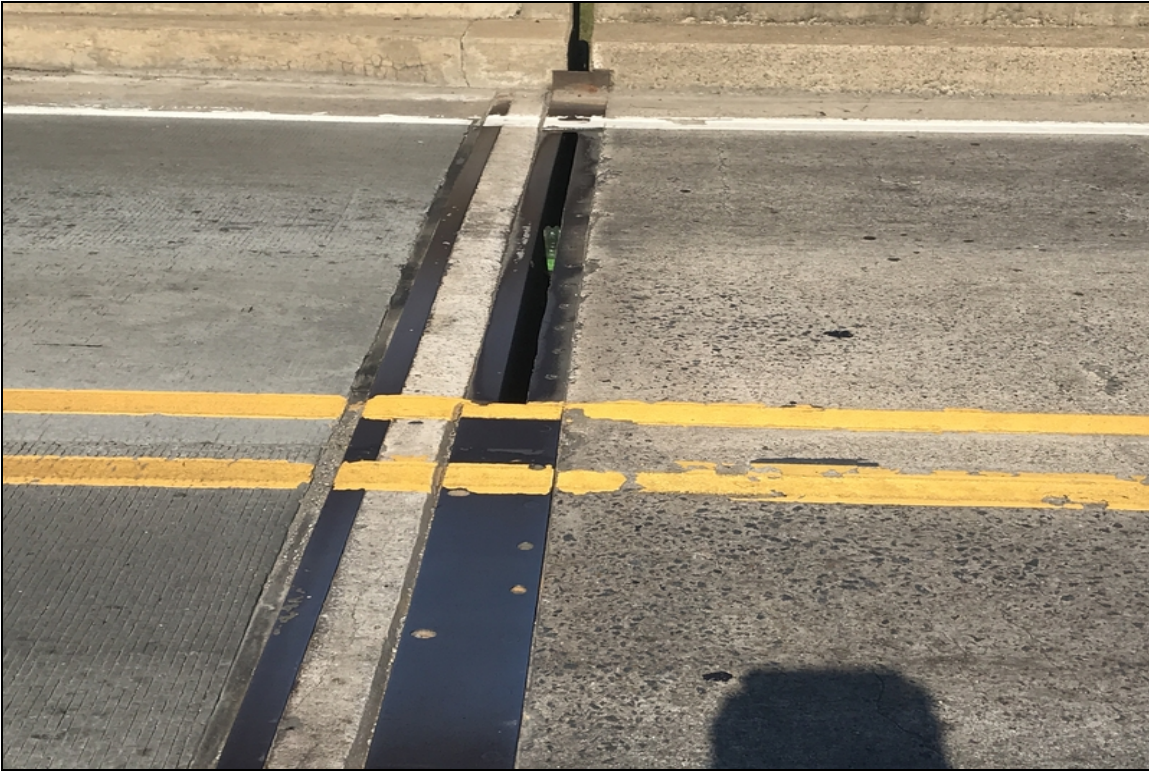
| ELEM | DESCRIPTION | UNITS | TOTAL | CS1 | CS2 | CS3 | CS4 |
|---|--|---|---|---|---|---|---|
| (303) | The sliding plates are loose under traffic at bents 1 and 3. The left half of the sliding plate at Bent 1 is missing. | | | | | | |

Bent 1 sliding joint plate missing.

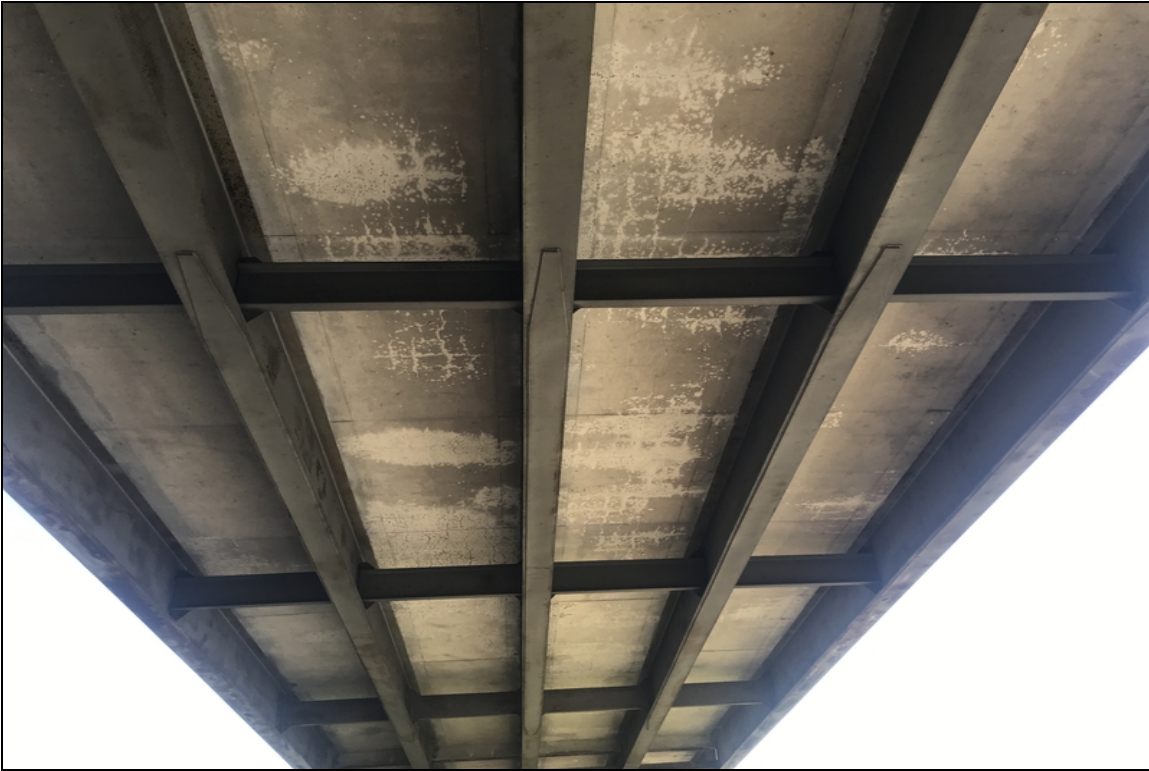
Span 2 soffit has areas of map cracks.

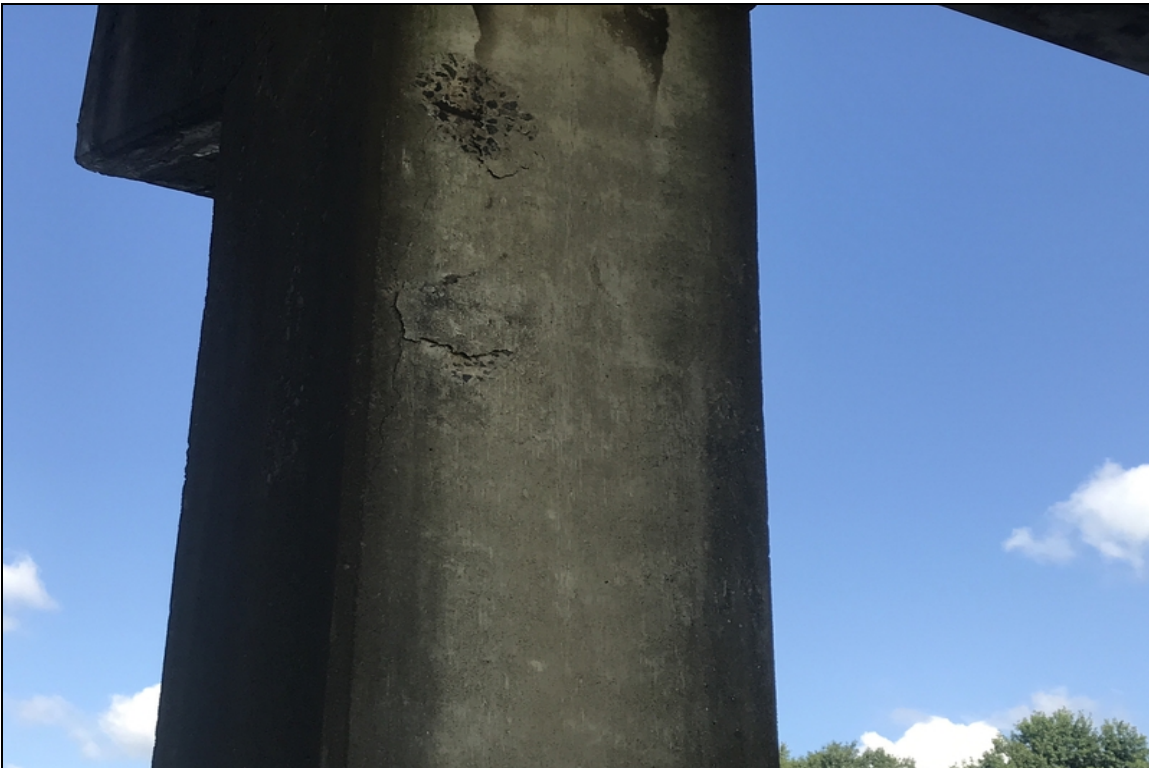
Bent 3 column 1 spall with exposed rebar right side.
