Bridge #03198(Routine)

CR 79, Valentine over I-40 Log 162.39

Team Lead: Shane Byrd Inspection Date: December 17, 2019

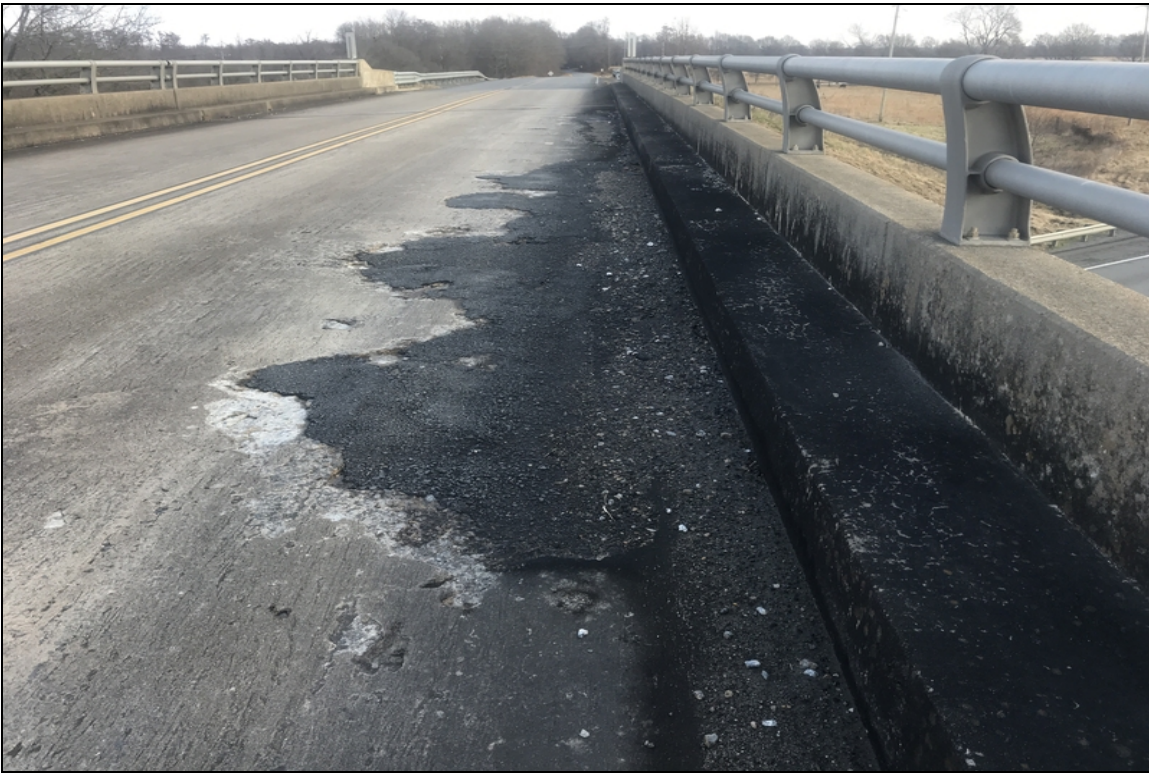
(12)							
The deck surface has spalls and spalls filled with asphalt in spans 2,3&4. All spans have transverse cracks, avg width 0.05 inch with some to 1/8 inch in width. Common spacing approx four foot centers with spacing to two foot centers in spans 2&3. A few small cracks with efflorescence in the soffit of spans 1-3.							
107	Steel Open Girder/Beam	LF	1280	600	624	56	0
1000	Corrosion	LF	675	0	619	56	0
7000	Damage	LF	5	0	5	0	0
515	Steel Protective Coating	SF	11213	1	6371	4350	491
3420	Peeling/Bubbling/Cracking	SF	1350	0	0	1350	0
3440	Effectiveness (Steel Protective Coatings)	SF	9862	0	6371	3000	491

Span 3 deck has spalls filled with asphalt.

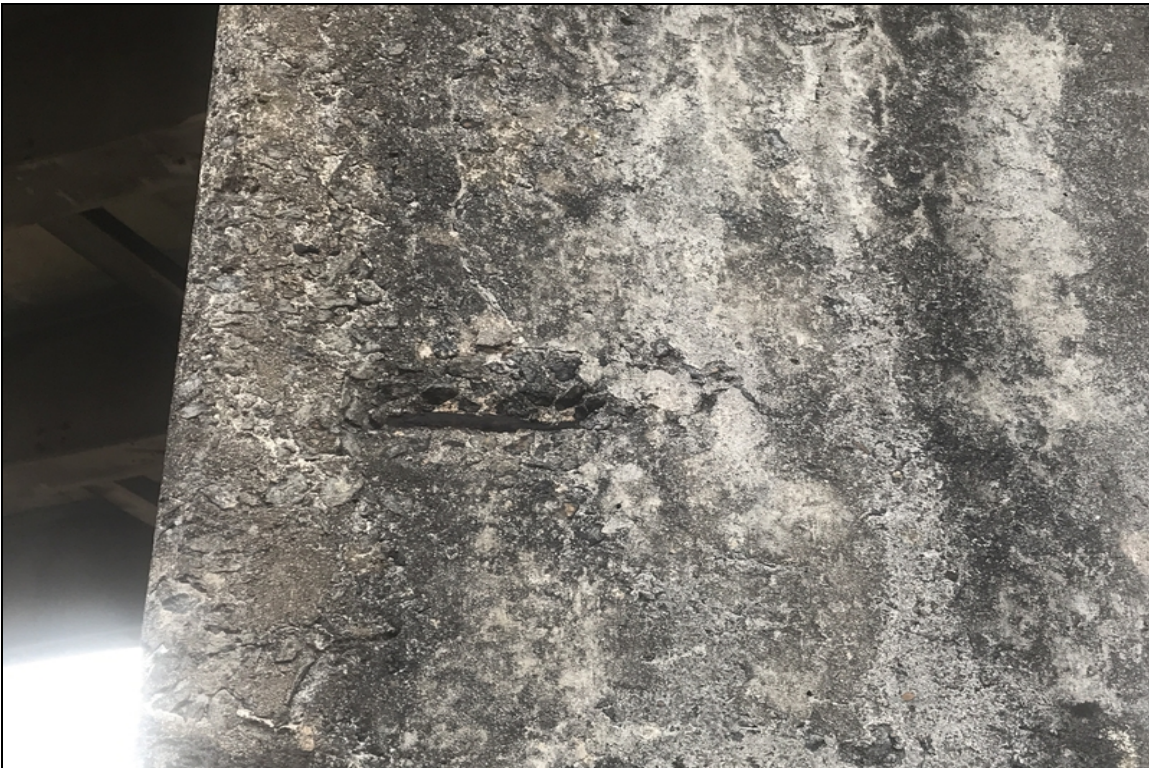
(205)							
Bent 2, left column has 2 exposed rebar. Right column has cracks. Bent 3, left column has an exposed rebar and horizontal cracks. Bent 4, left column has a delam on the right side, the right column has a spall at the pier protection wall.							
215	Reinforced Concrete Abutment	LF	85	78	7	0	0
1090	Exposed Rebar	LF	2	0	2	0	0
1130	Cracking (RC and Other)	LF	5	0	5	0	0

Bent 3 column 1 has spall with exposed rebar.

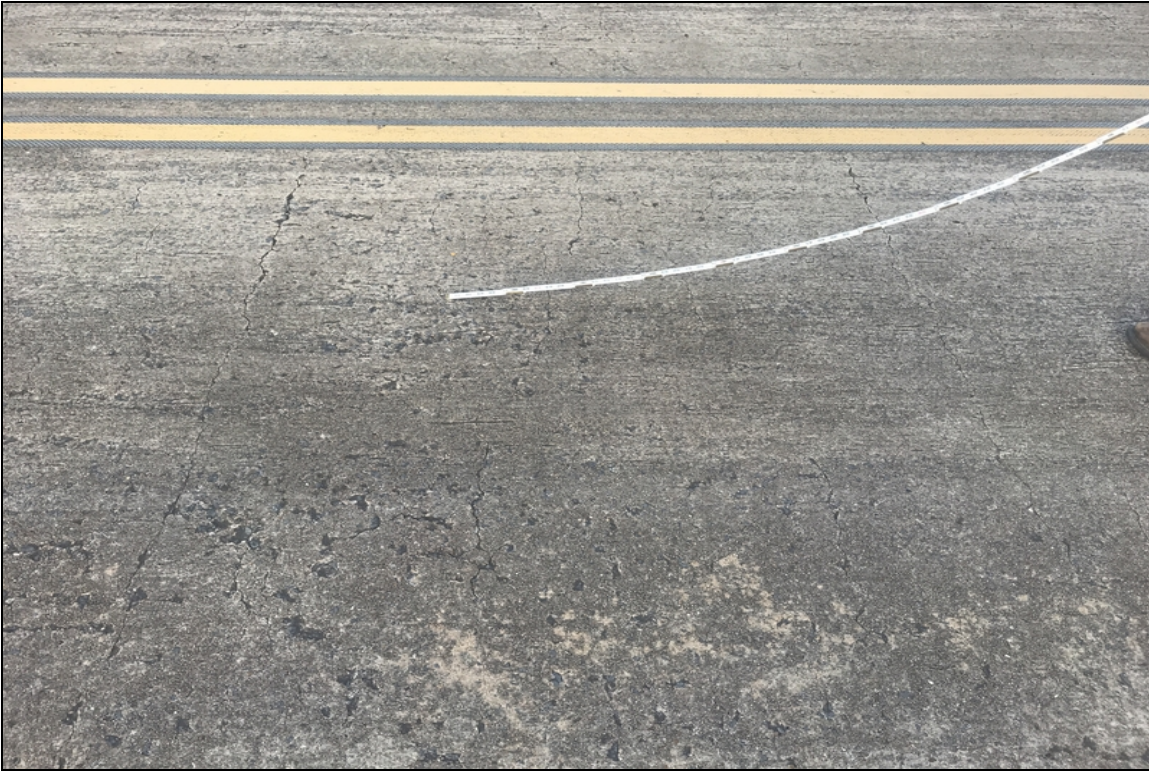
Deck span 3 has Longitudinal cracks up to 1/8". Common all spans.

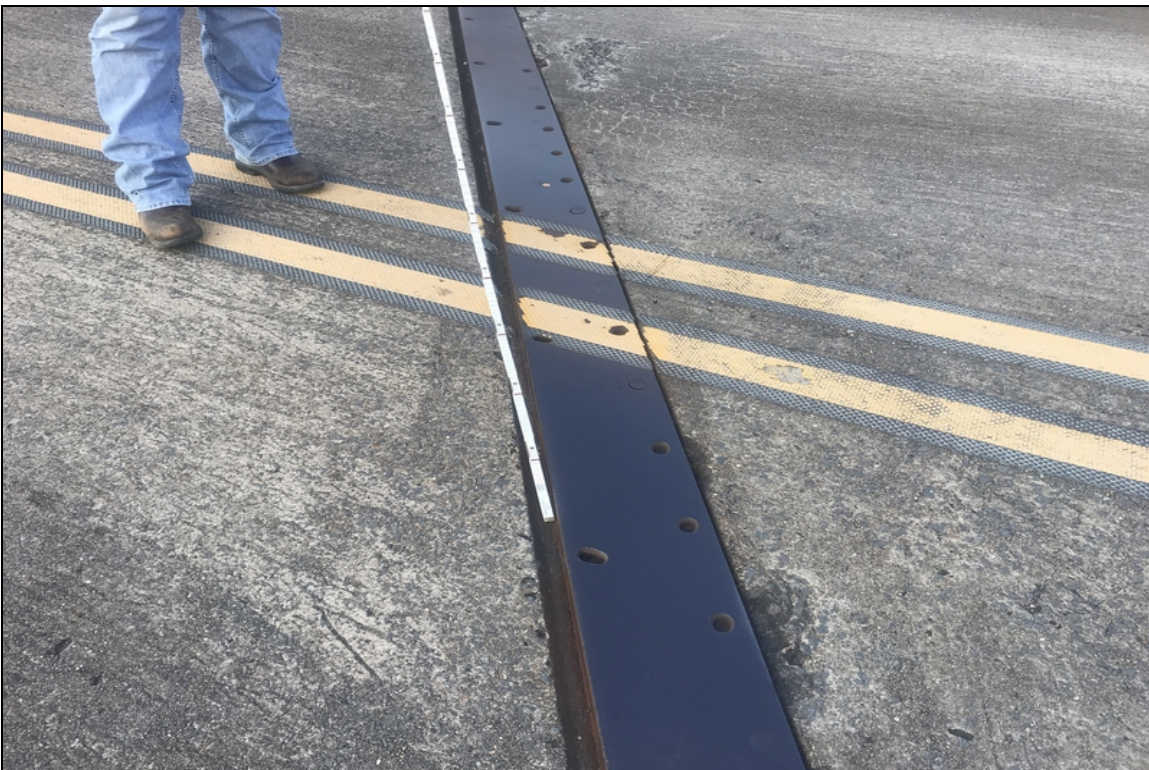
Sliding plate joint at bent 2 loose under traffic.

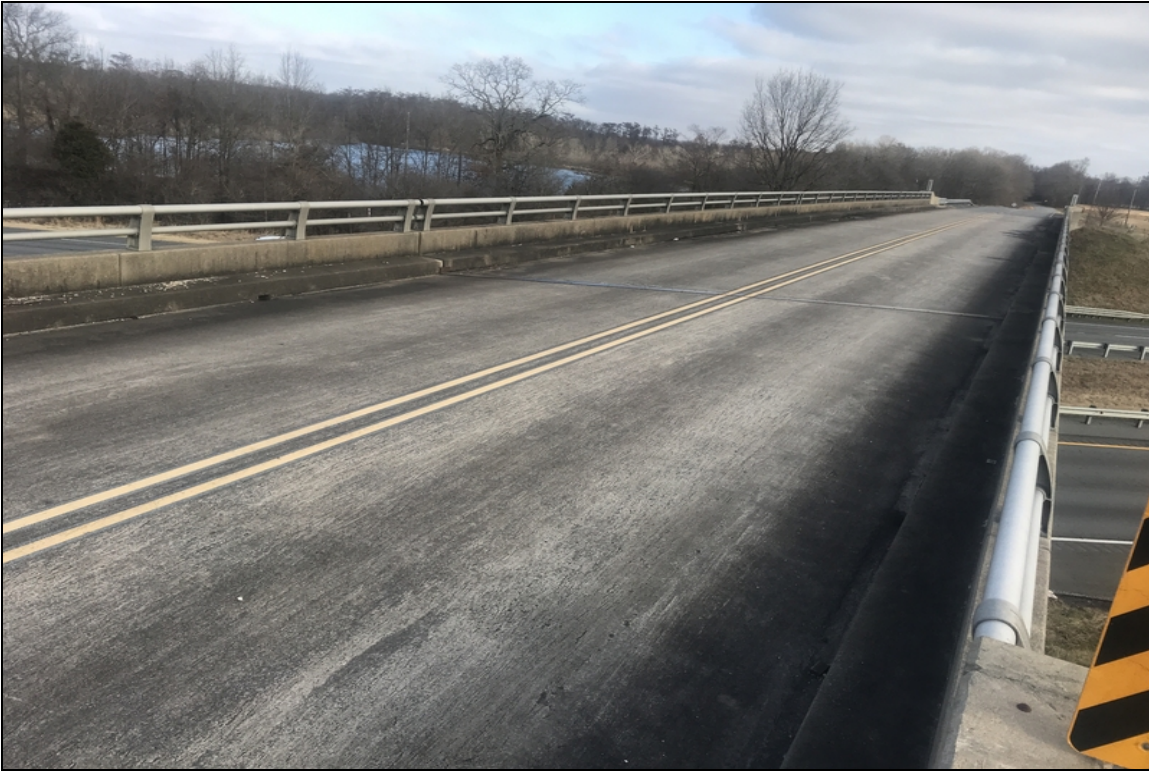
Deck overview.

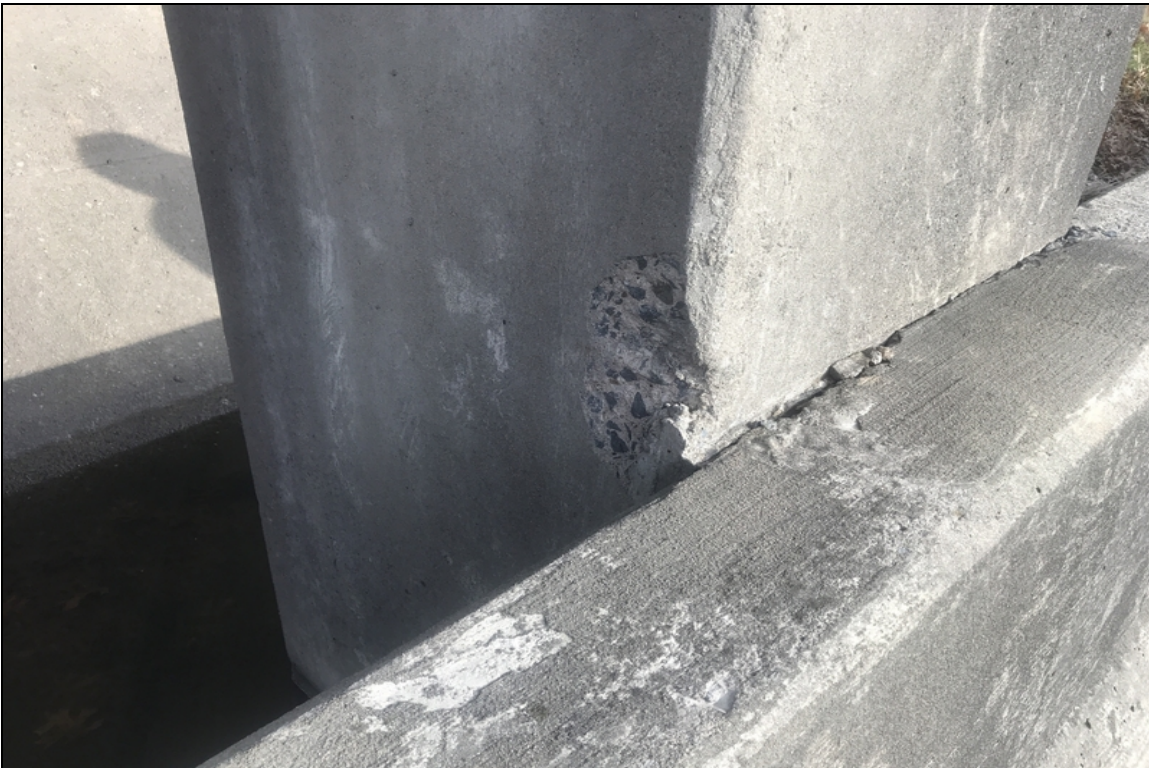
Bent 4 column 2 has spall.

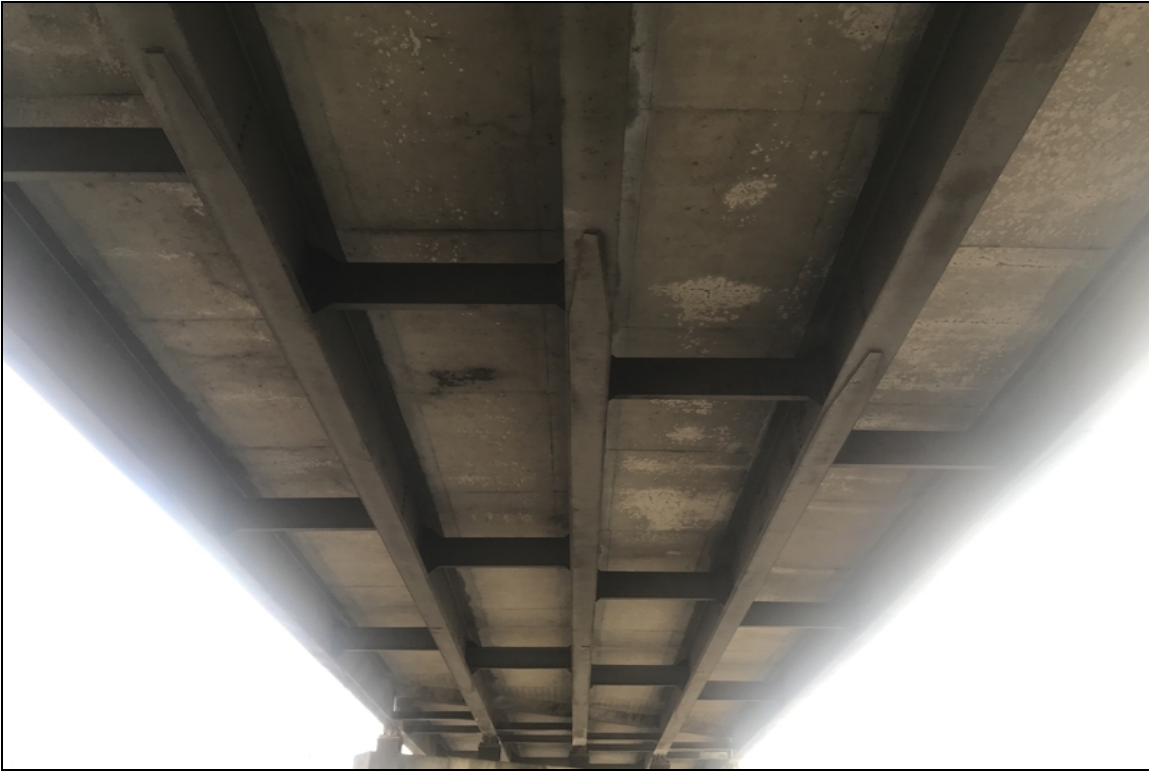
Span 2 soffit overview.

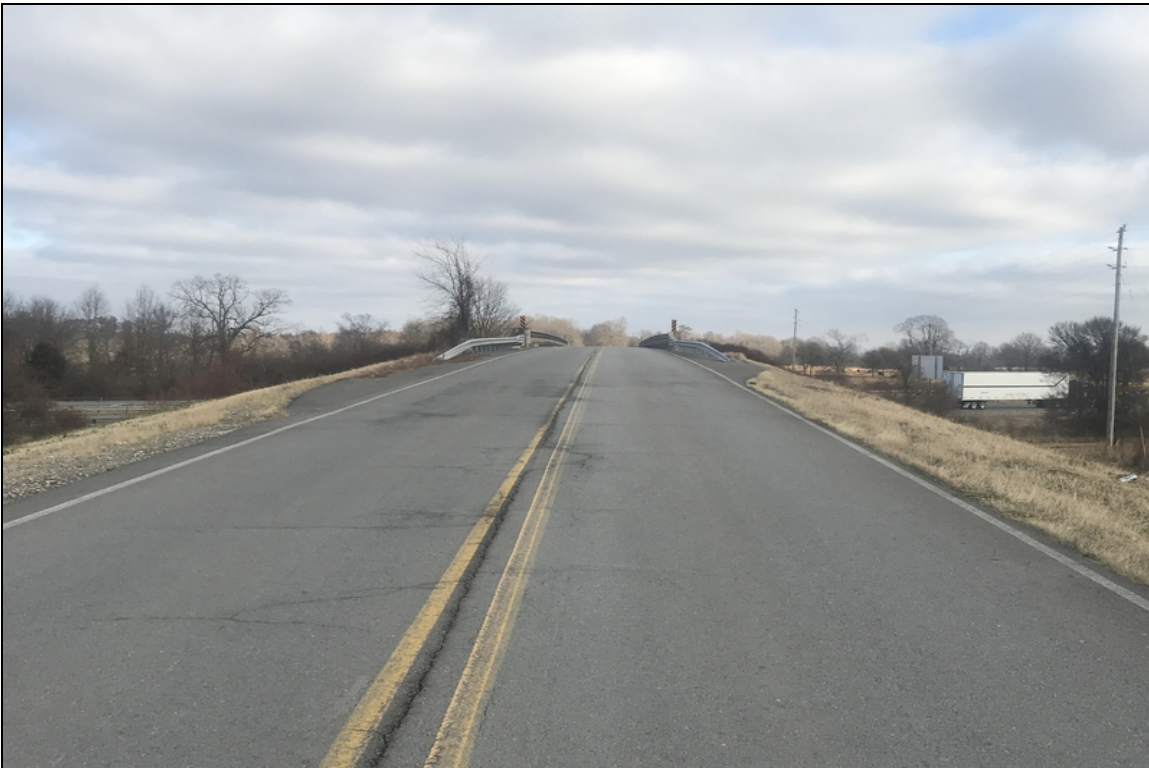
Approach Northbound.

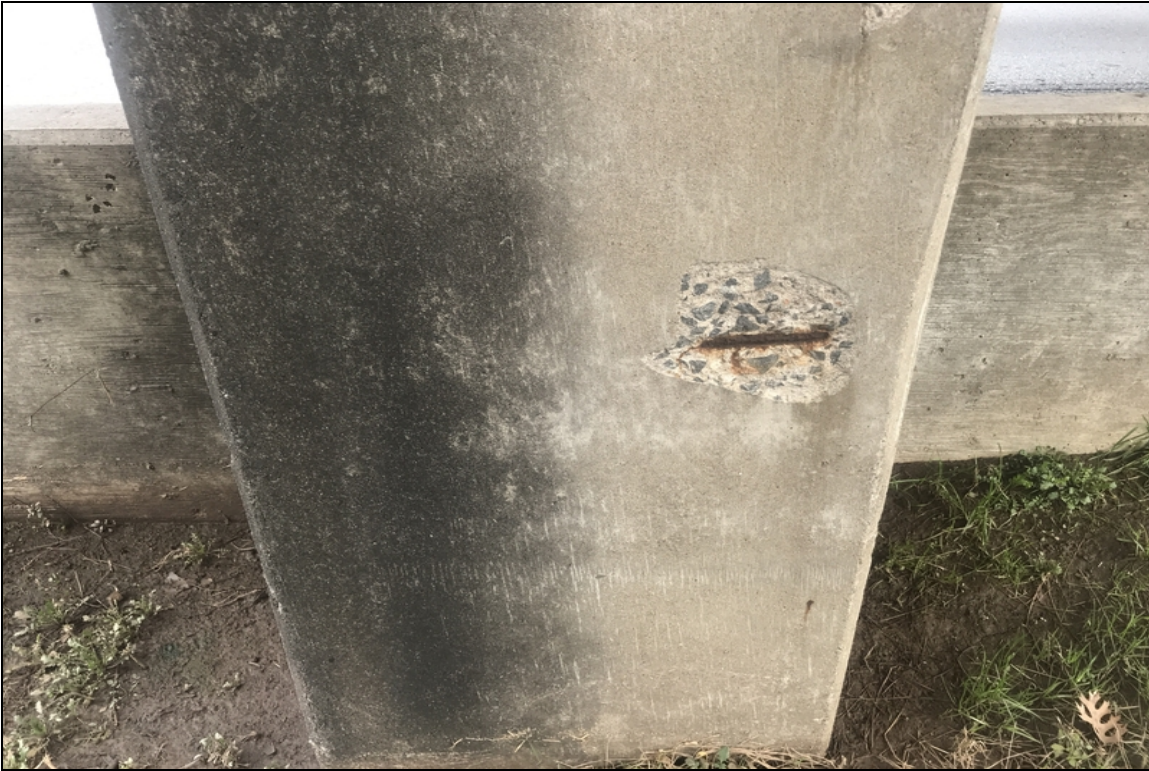
Bent 2 column 1 has spall with exposed rebar.
