Bridge #03222(Routine)

CR 61 KERR RD over I-40 LOG 164.81

Team Lead: Keith Harris Inspection Date: May 06, 2021

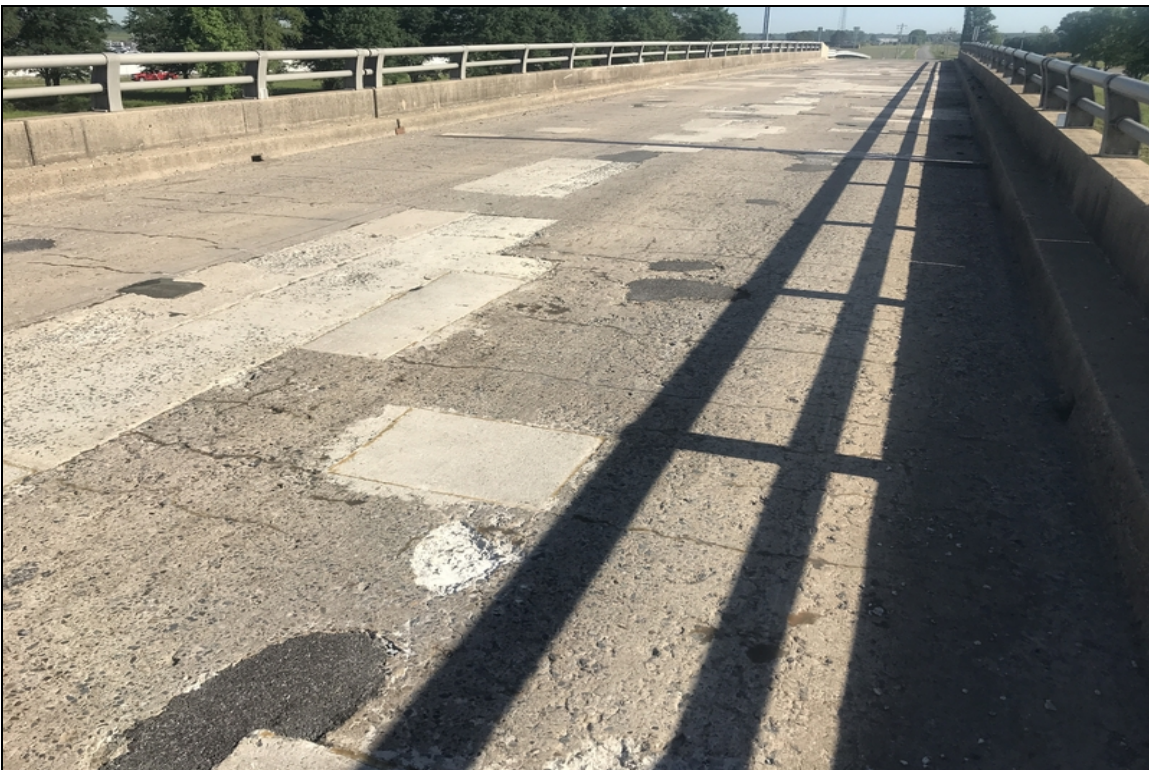
Deck overview

(12)	Deck all spans have spalls and spalls filled with asphalt. The deck has approximately 749 sq ft of patches. State forces have sealed the deck cracks but most cracks reflect thru to the soffit with some rust stains and effloresces.						
107	Steel Open Girder/Beam	LF	1040	0	845	195	0
1000	Corrosion	LF	1040	0	845	195	0
515	Steel Protective Coating	SF	7706	0	3517	3215	974
3440	Effectiveness (Steel Protective Coatings)	SF	7706	0	3517	3215	974

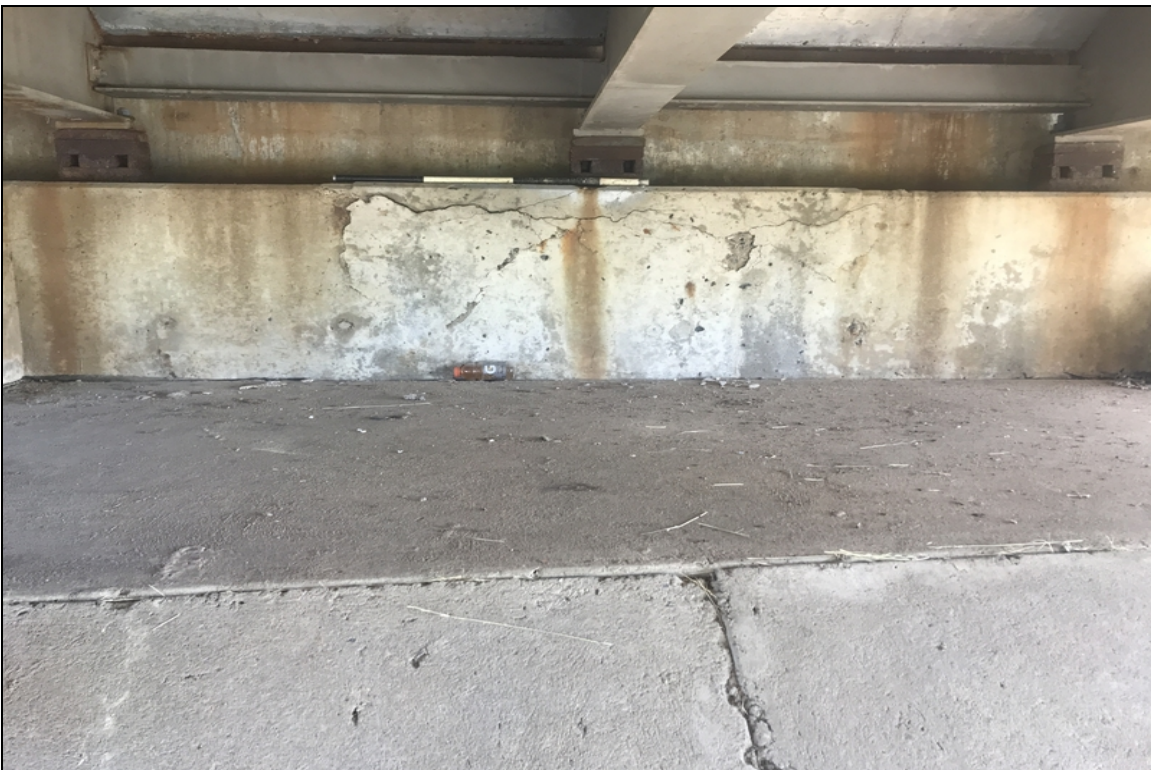
(215)	Spalls with exposed rebar on the face of the back wall of bent 1. Bent 5 has a delamination on the face of the beam seat.						
234	Reinforced Concrete Pier Cap	LF	72	64	8	0	0
1090	Exposed Rebar	LF	7	0	7	0	0
1130	Cracking (RC and Other)	LF	1	0	1	0	0

Bent 5 large delam in center of abutment

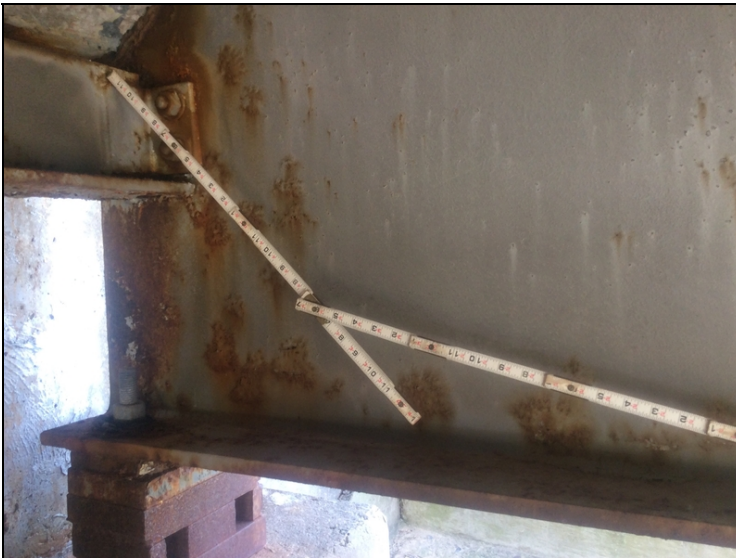
All beams have active rust with minor section loss in haunch area.

Span 1 beam 1 active rust with moderate pitting at upper web.

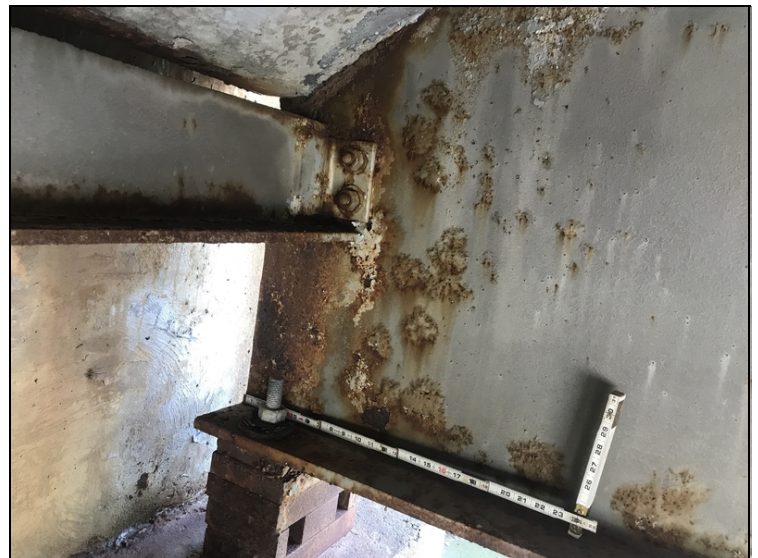
Span 1, girder 1: the beam end has flaking paint and active corrosion with areas of measurable section loss near the haunch

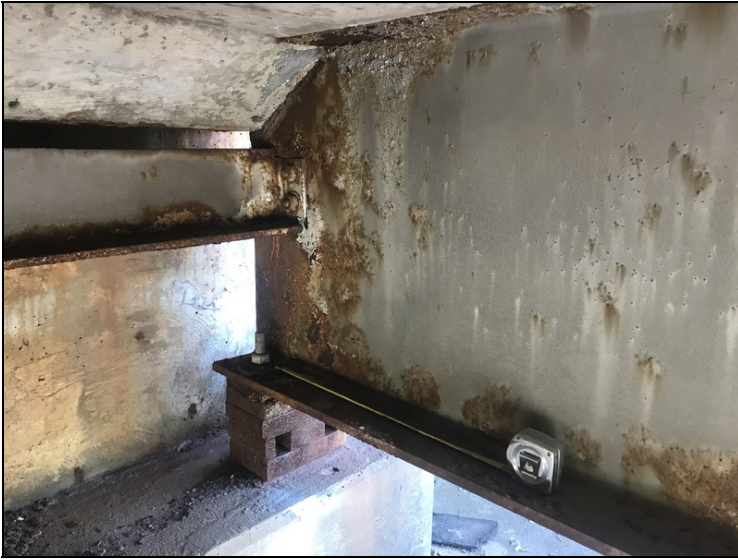
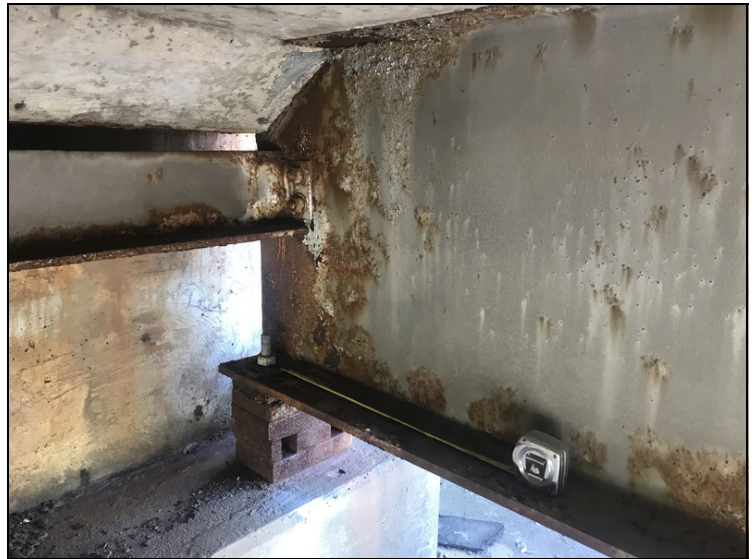
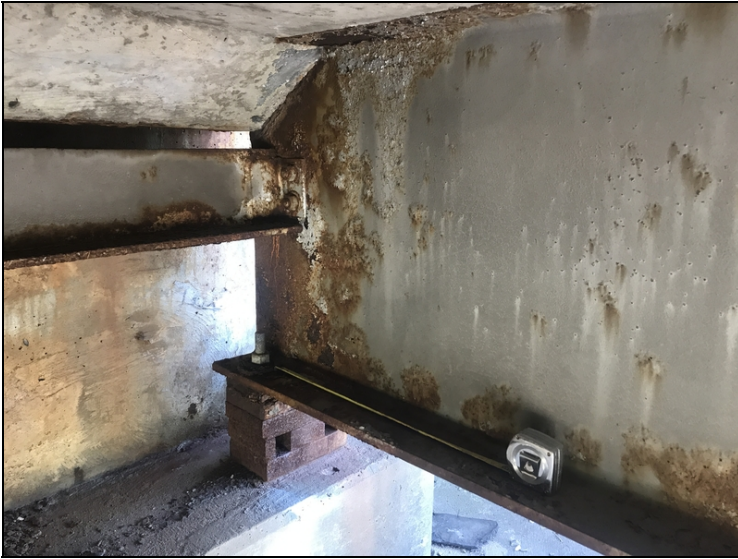
Span 1 beam 1 active corrosion

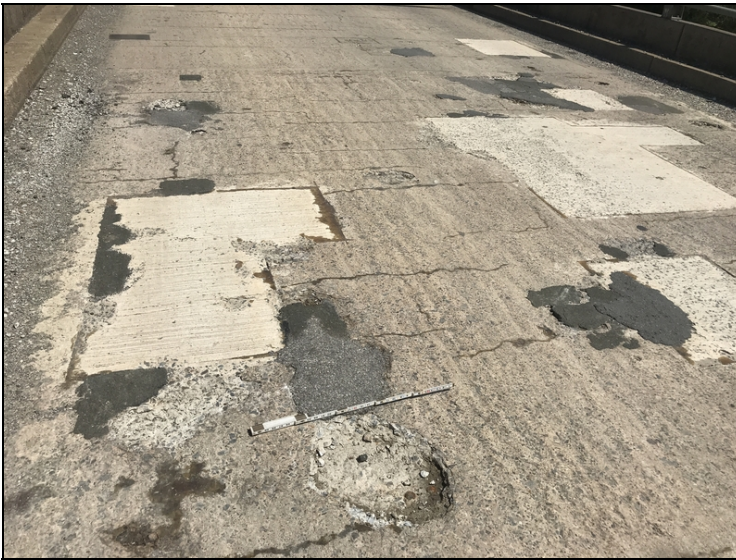
Deck spans 1, 2 & 3 have multiple open spalls with exposed rebar and spalls filled with asphalt.

Span 3: multiple large spalls with exposed rebar and spalls with asphalt patches

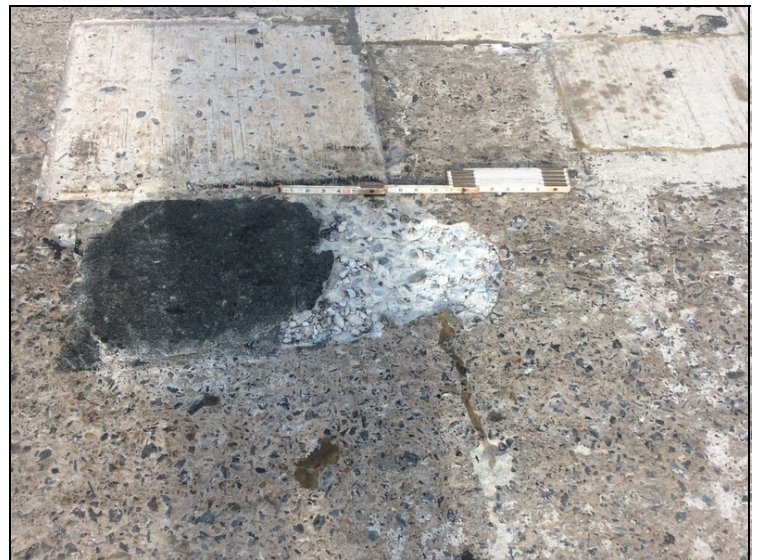
Span 2 has spall in deck.

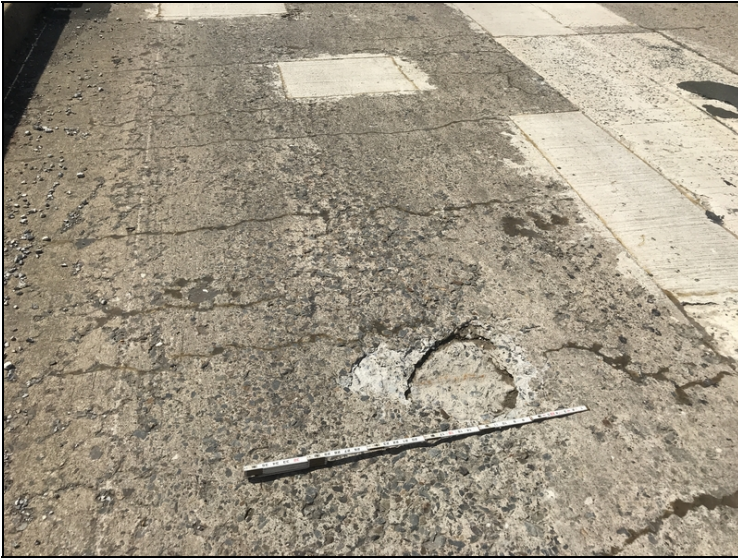
Span 1,northbound lane: large spall with exposed rebar

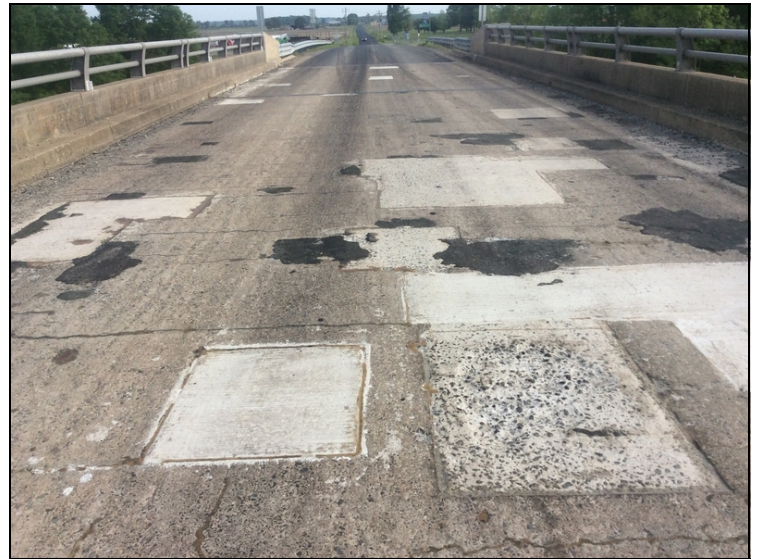
Span 3 has spalls and spalls filled with asphalt.

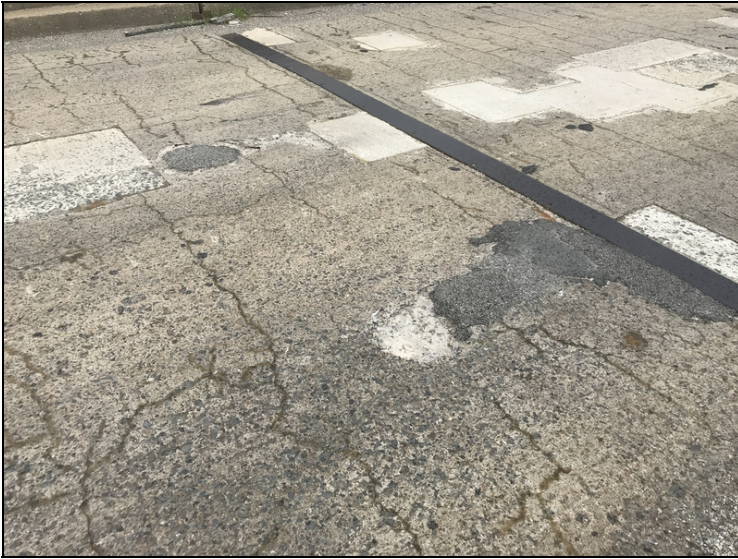
Span 1: large open spall and asphalt patches.

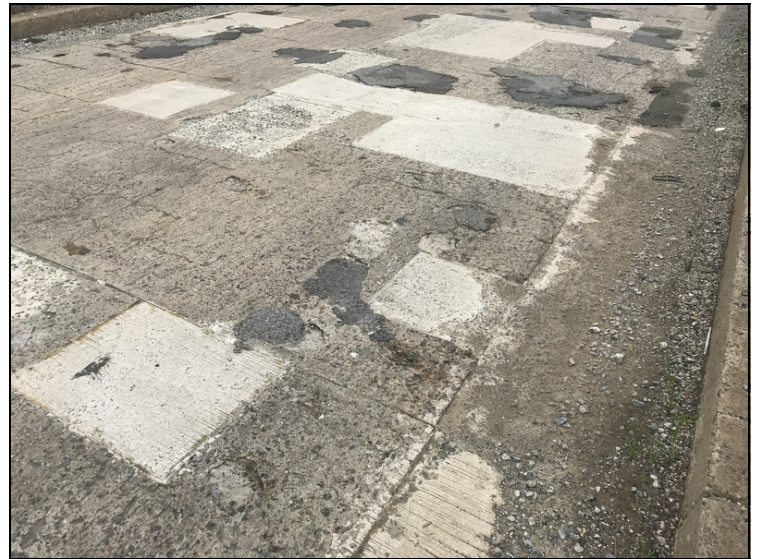
Span 3: numerous open spalls and asphalt patches.

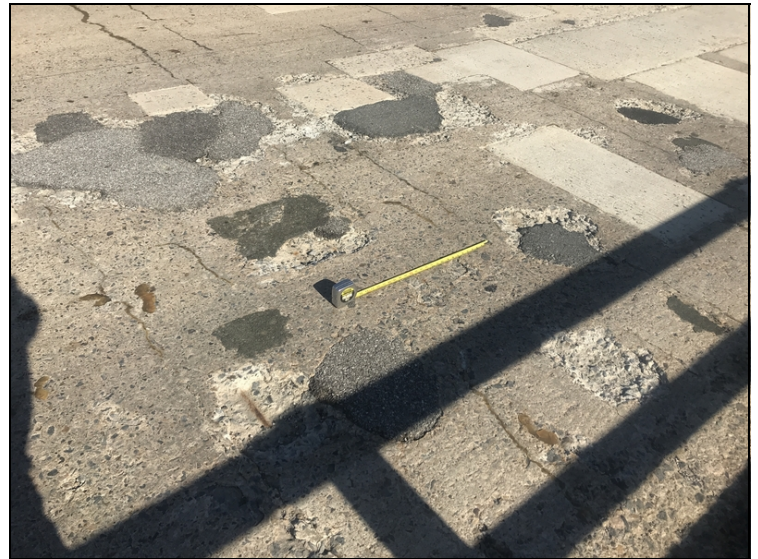
Span 2 multiple large spalls with exposed rebar  
and spalls with asphalt patches

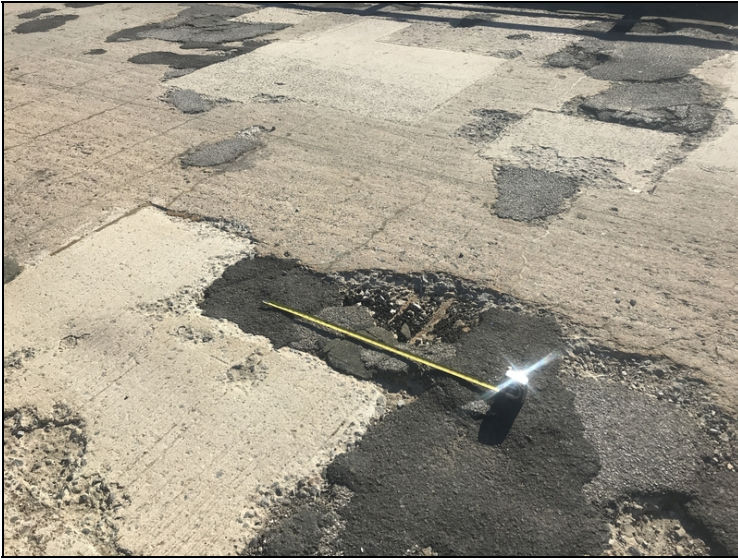
Span 3 multiple large spalls with exposed rebar  
and spalls with asphalt patches

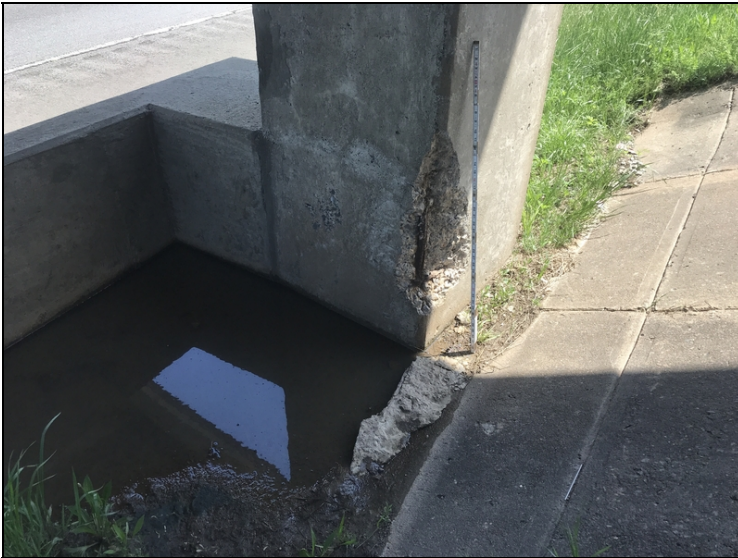
Bent 2, right column has a spall with exposed rebar at the bottom.  
Bent 3 left column has a spall with rebar near the top.  
Bent 4 right column has a spall on the east side.

Bent 2, column 2: spall with exposed rebar

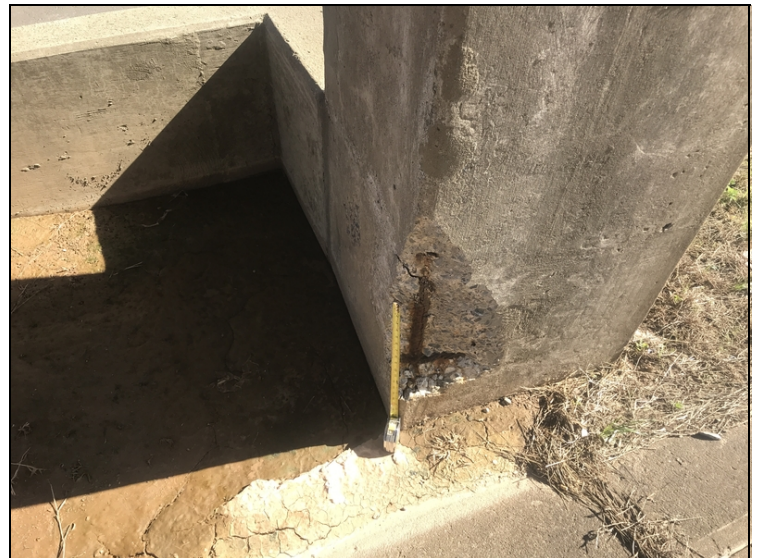
Large spall with exposed rebar on right column at bent 2

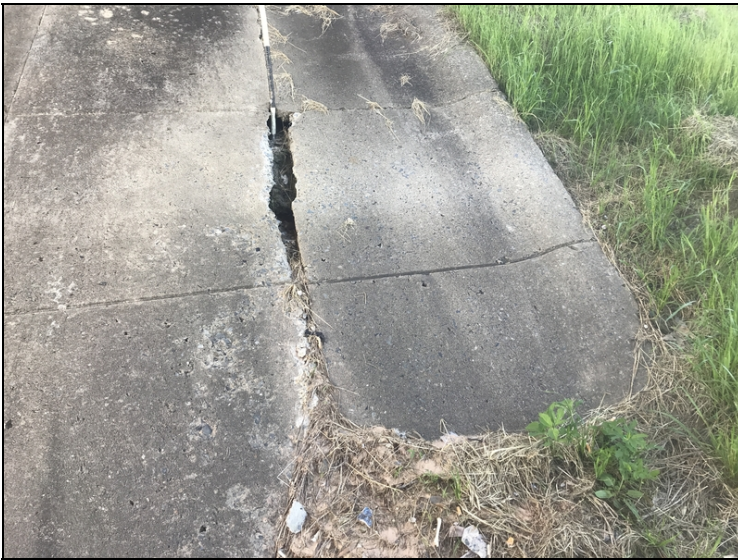
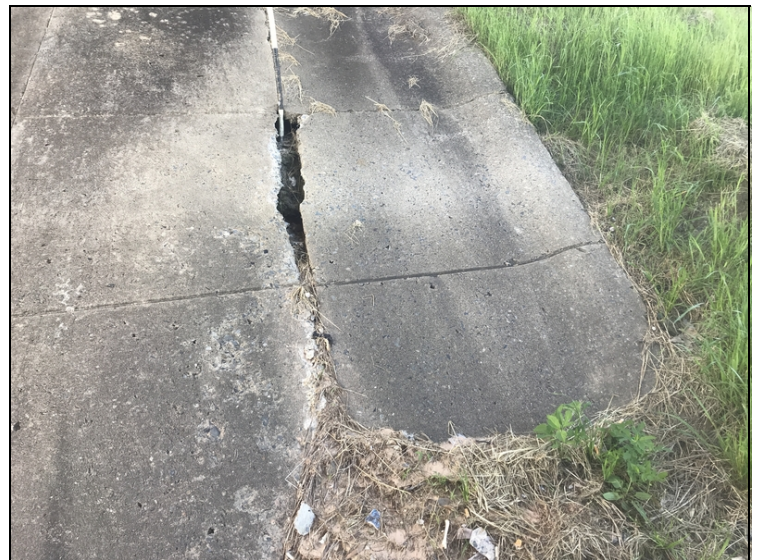
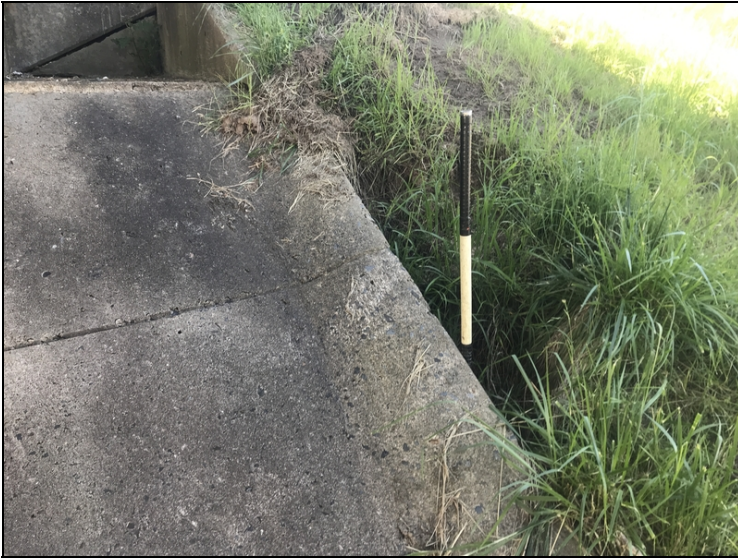
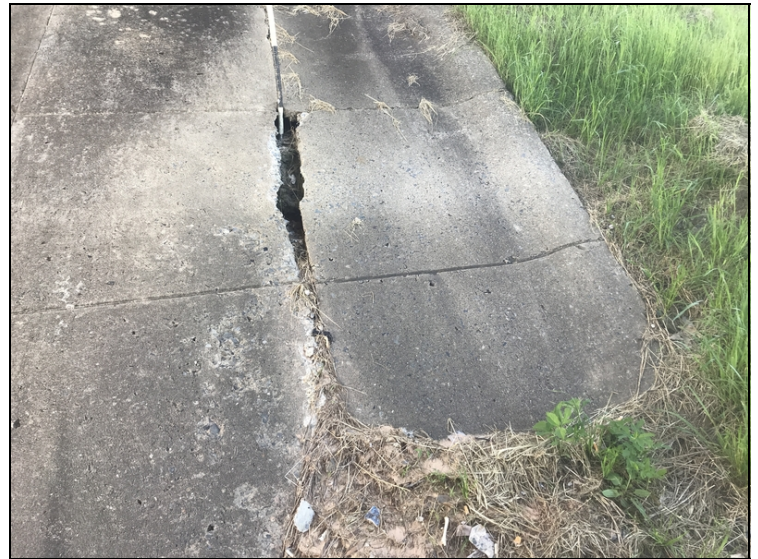
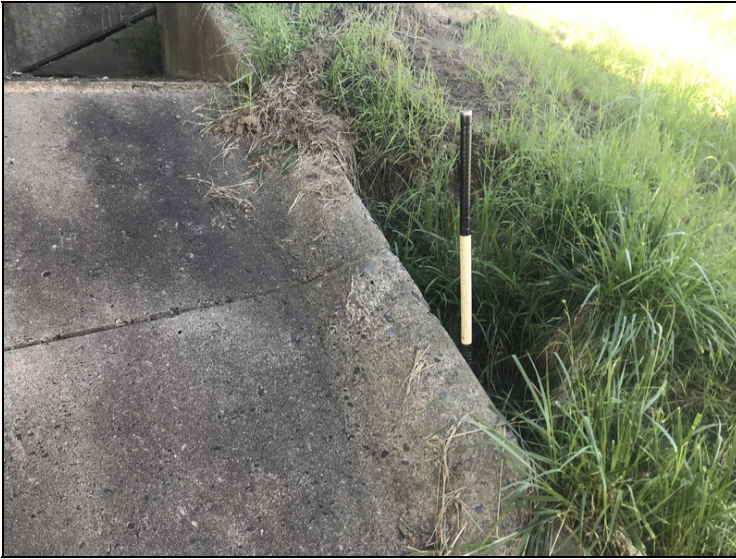
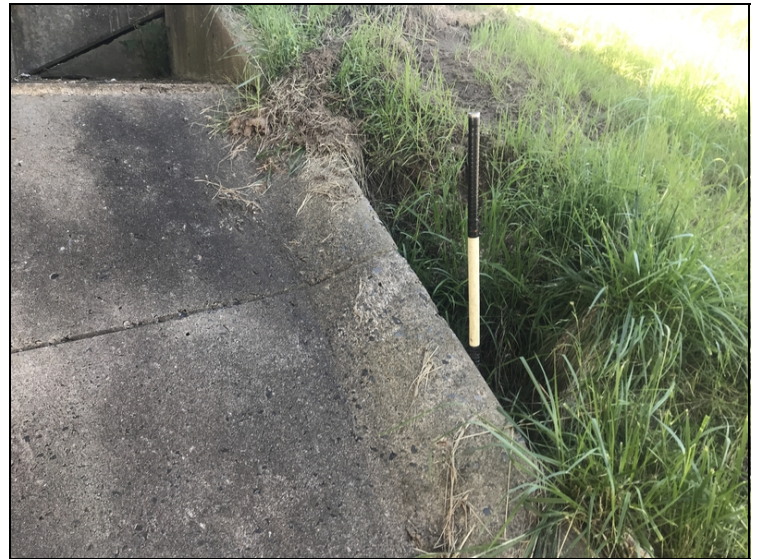
Slope paving under left side of span 1 is undermined from erosion.
