Bridge #03228(Routine)

SH 31 Overpass over I-40 LOG 174.58

Team Lead: Keith Harris Inspection Date: March 18, 2021

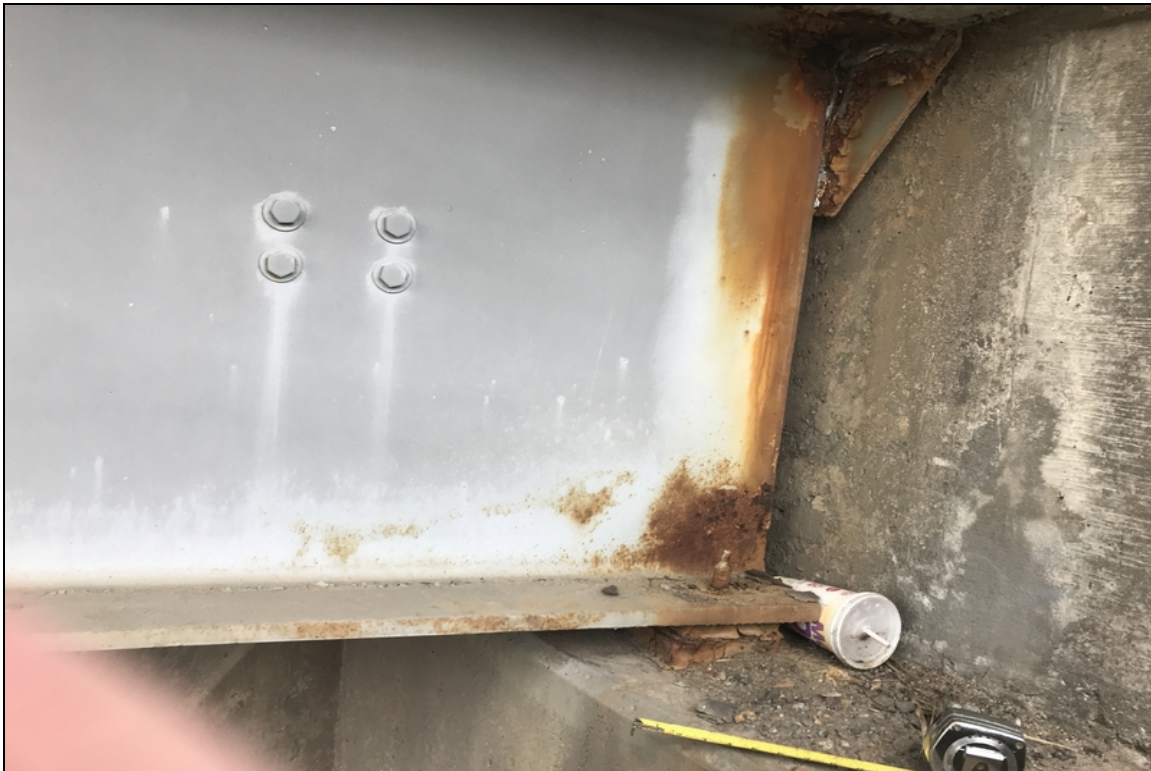
(107)	<p>Scattered areas of freckled rust on beams 1 and 5. All of the beam ends have some active rust with pitting up to 1/8 inch deep. Span 3 beam 1 thru 5 have active rust with moderate pitting.</p>						
205	Reinforced Concrete Column	EA	6	0	4	2	0
1080	Delamination/Spall/Patched Area	EA	4	0	4	0	0
1090	Exposed Rebar	EA	2	0	0	2	0

(303)	All joints are leaking causing corrosion to beam ends and bearings						
311	Movable Bearing	EA	20	0	0	20	0
1000	Corrosion	EA	20	0	0	20	0
(311)	All of the bearings have laminated rust.						
313	Fixed Bearing	EA	20	0	14	6	0
1000	Corrosion	EA	20	0	14	6	0

Bent 1 beam 1 typical beam end condition

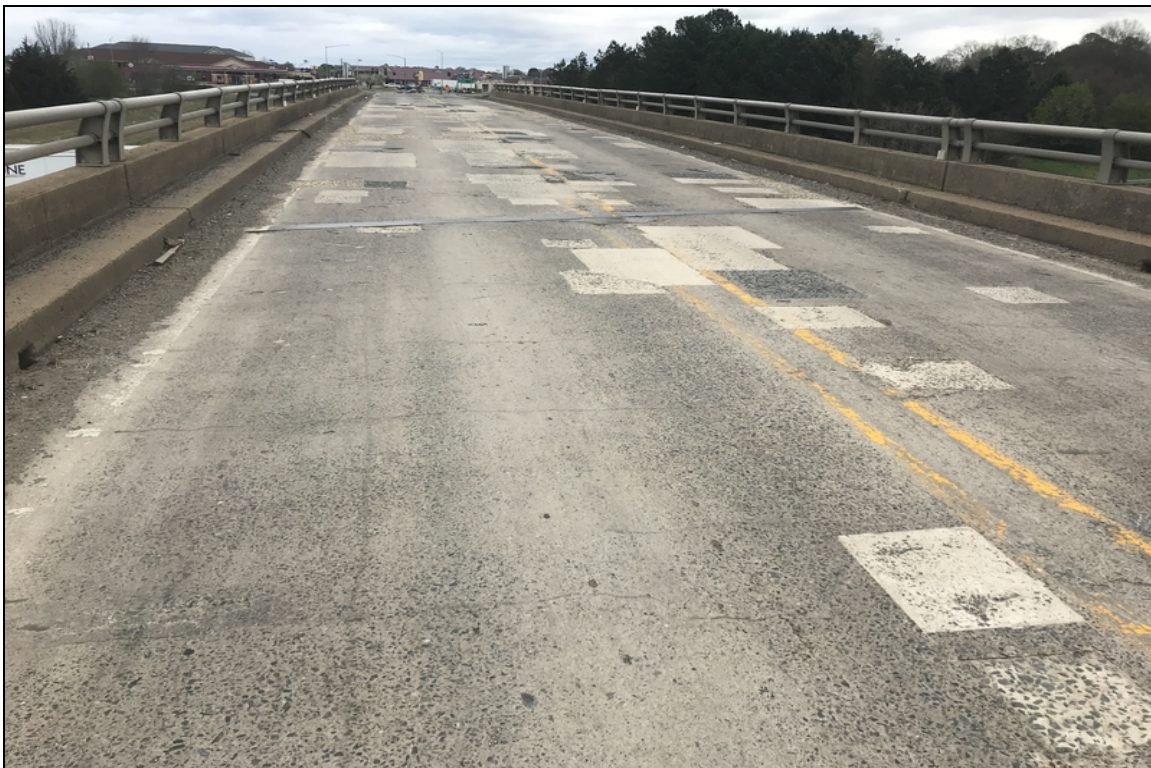
Deck overview

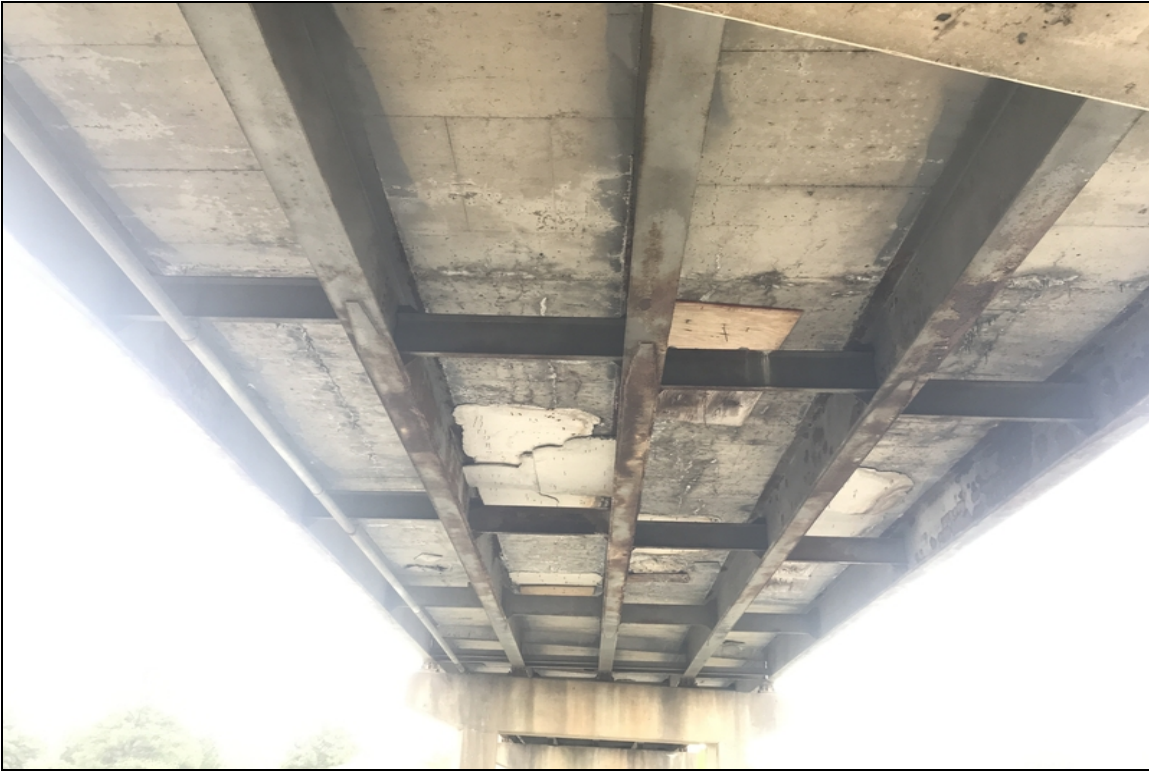
Span 3 under view

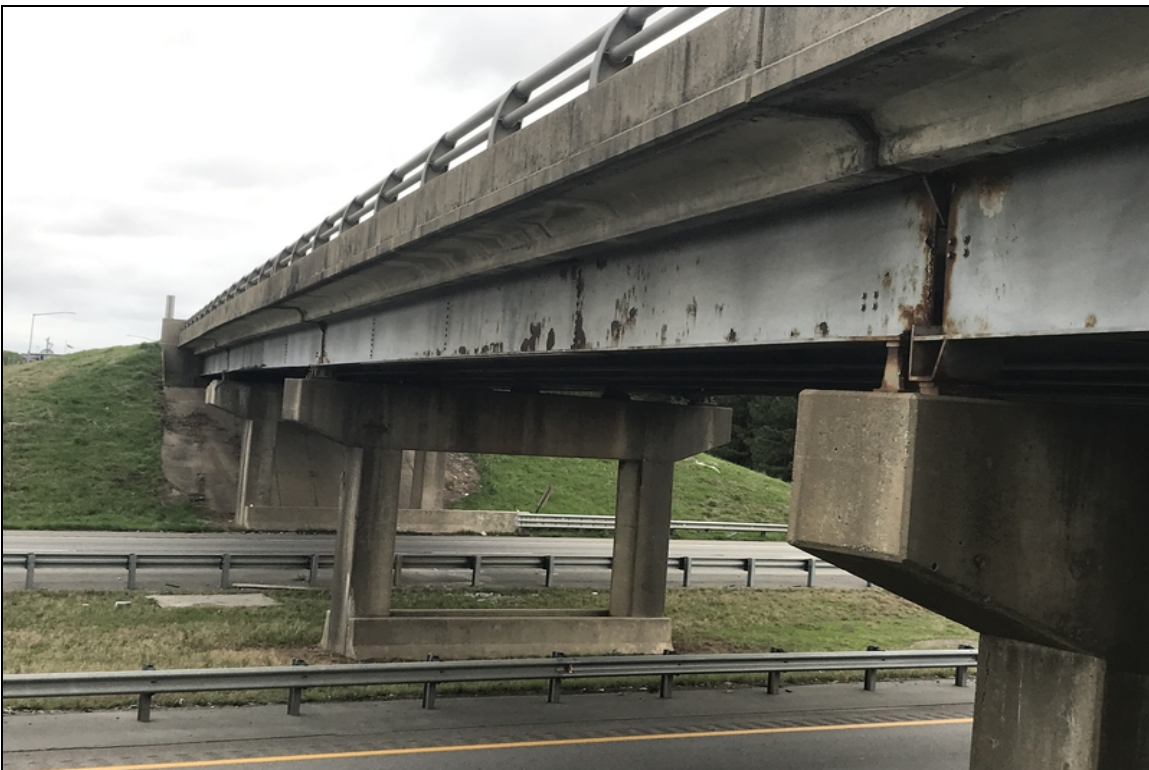
Typical paint condition

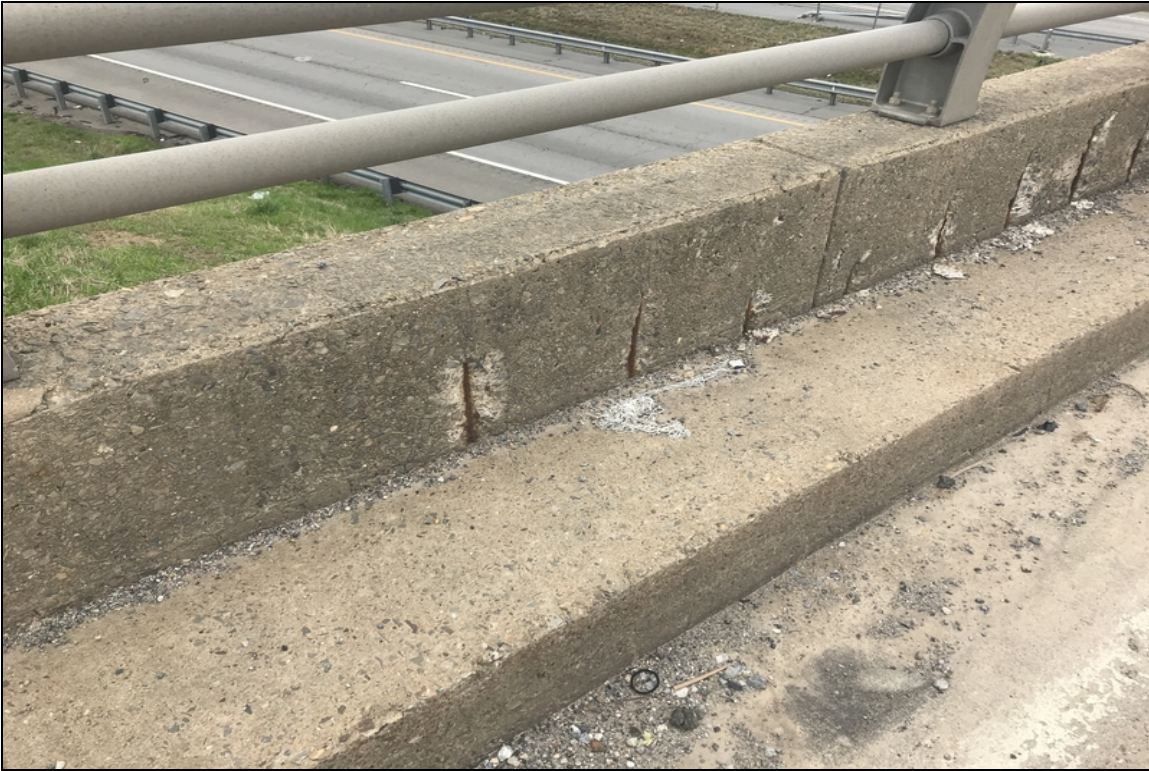
(331)	Scattered Spalls with exposed rebar along both rails.

Spalls with exposed rebar, Span 4 right bridge rail

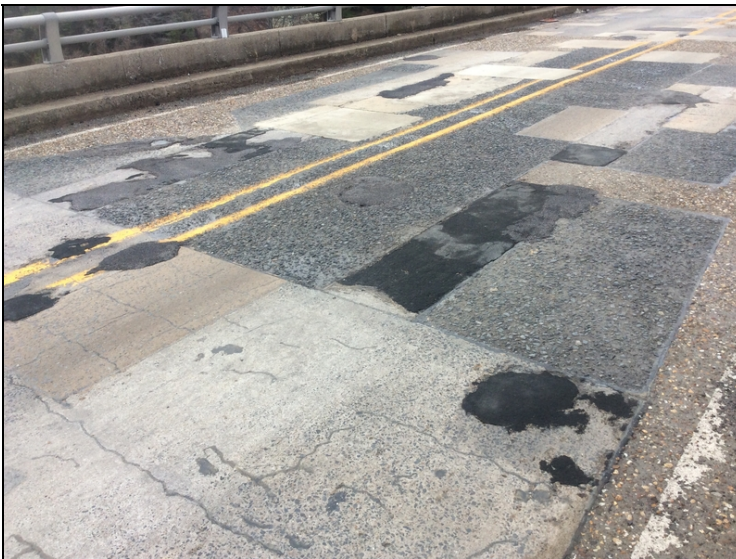
Top of deck on all spans have numerous patches, spalls, spalls filled with asphalt, rebar exposed and cracks that reflect through to bottom of the deck. Bottom of deck has numerous spalls and patches. Span 3: large open spall with exposed rebar.

Span 3 spalls filled with asphalt.

Date Reported: 03/28/2012
Priority: B - Pressing; 6 month completion goal
Type of Work: Repair
Status: Assigned
Component: 12 - Reinforced Concrete Deck

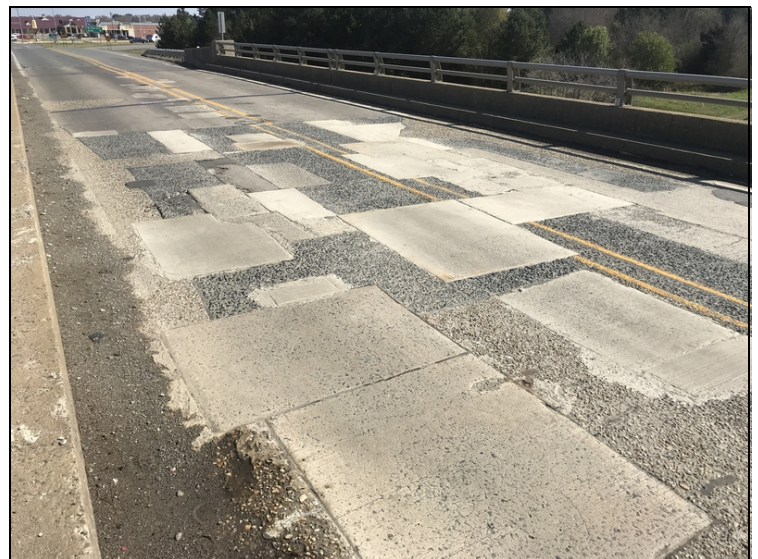
(12)	<p>The deck surface has numerous patched areas, span 3 is the worst with approx 1580 sf of patched areas. Some of the patched areas have exposed rebar and the overhangs have Spalls with exposed rebar at the deck drains and deck haunches.</p> <p>All spans have cracking with efflorescence and rust stains on the soffit.</p> <p>The deck surface has transverse cracks on approx. three foot centers, 0.030 to 0.040 width and these cracks have been sealed</p>						
107	Steel Open Girder/Beam	LF	1100	735	150	215	0
1000	Corrosion	LF	365	0	150	215	0
515	Steel Protective Coating	SF	8513	0	4500	1813	2200
3440	Effectiveness (Steel Protective Coatings)	SF	8513	0	4500	1813	2200

Span 3: majority of span is patched with most of the patches are beginning to deteriorate.

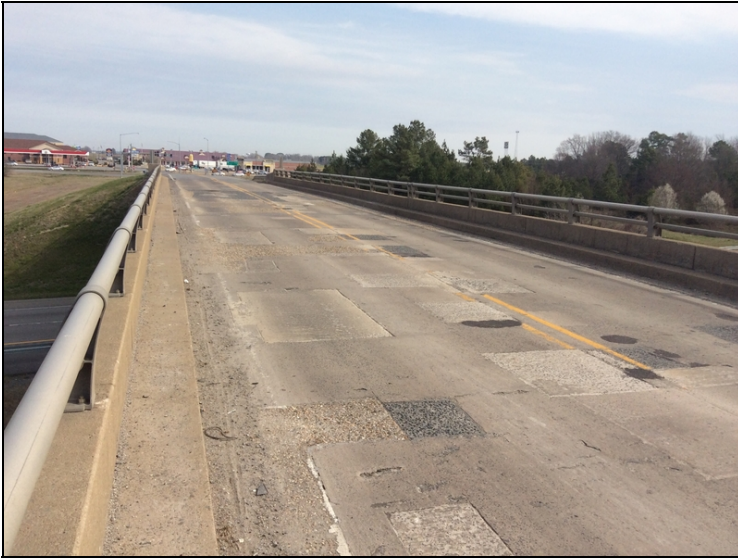
View of the deck with patched areas in all spans.

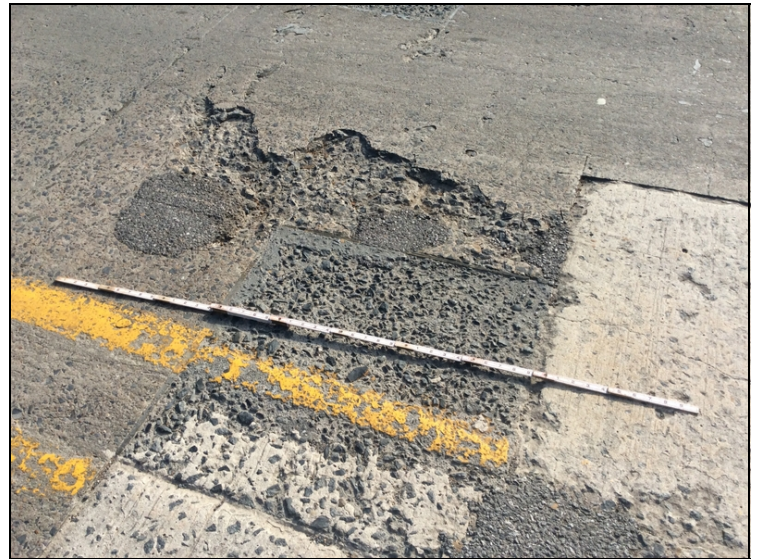
Span 2 spalls with exposed rebar.

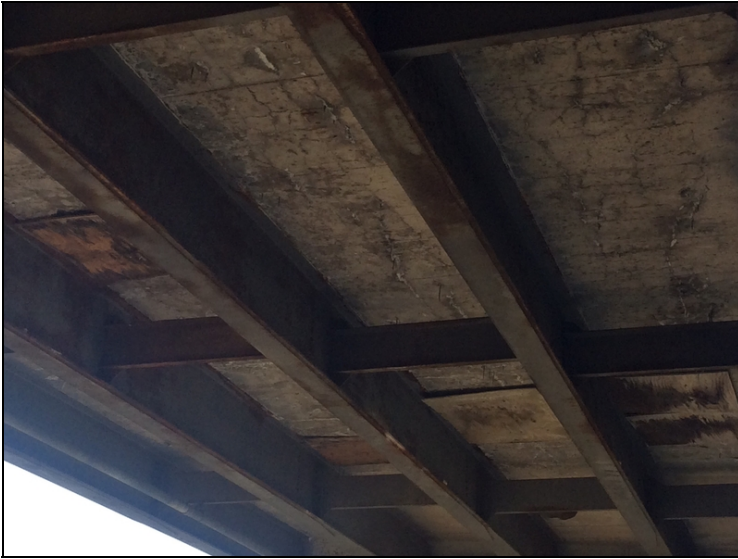
Span 3 soffit cracks with effloresces and rust stains.

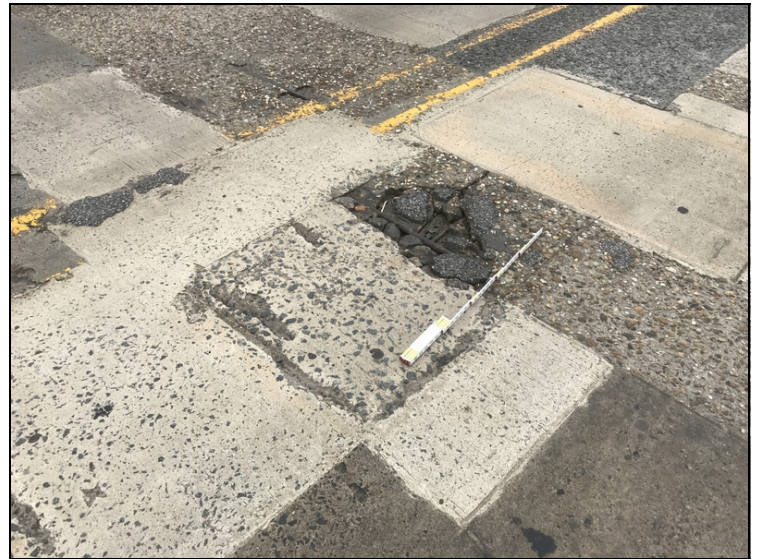
Span 3: large open spall with exposed rebar.

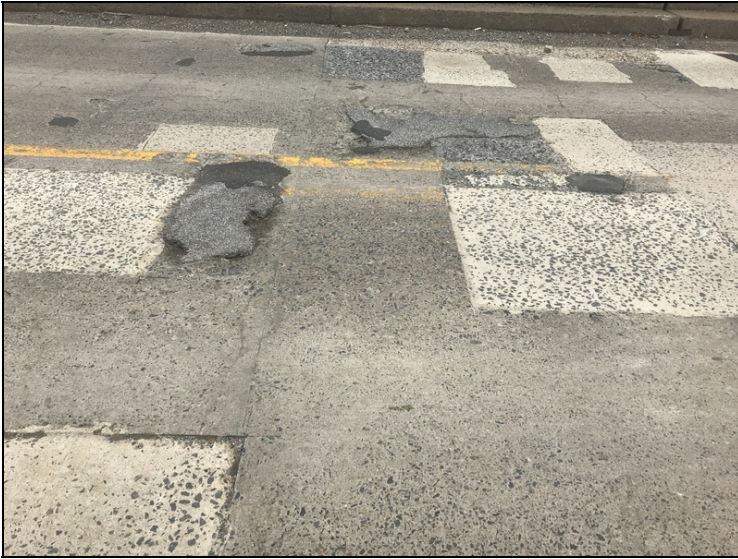
Span 2 spalls filled with asphalt

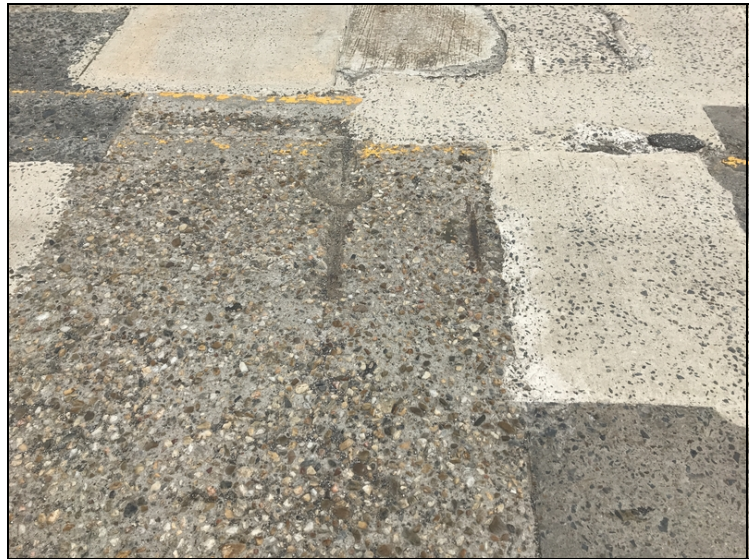
Span 3 spalls with exposed rebar

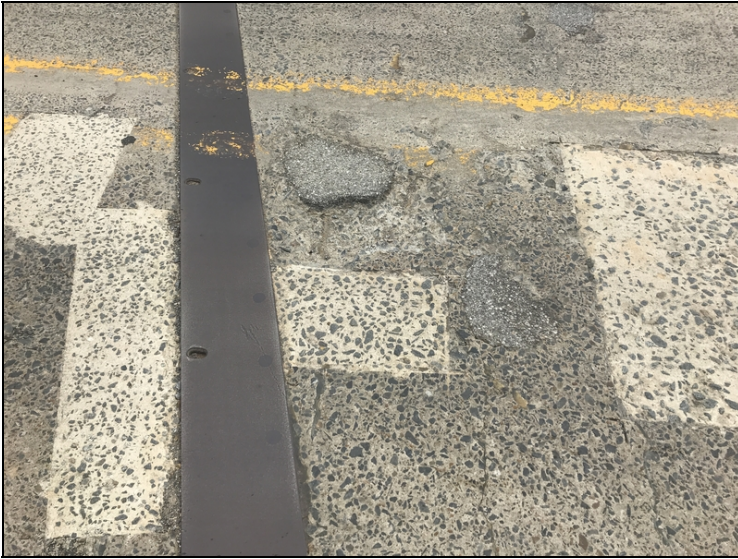
Span 3 spall with exposed rebar

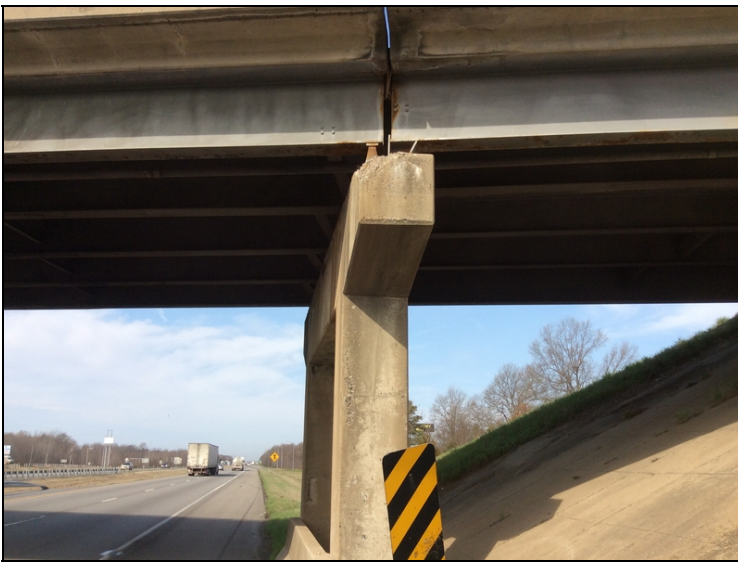
Caps of bents 3 and 4 have spalls with exposed rebar and delamination.
Bent 4: right end of cap with a large spall that is adjacent to girder 5 bearing.

The right end of the cap of bent 4 has a large spall.

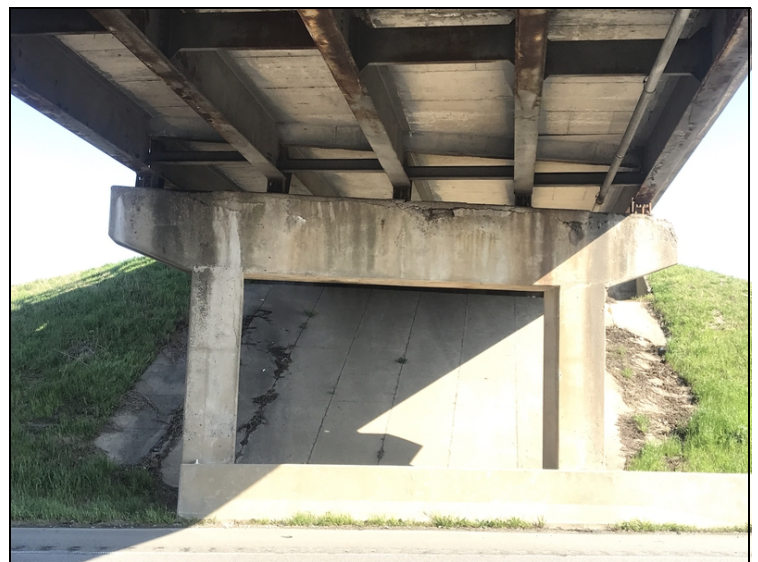
ELEM	DESCRIPTION	UNITS	TOTAL	CS1	CS2	CS3	CS4
1130	Cracking (RC and Other)	LF	18	0	18	0	0
(234)	All of the caps have Spalls with exposed rebar, cracking and efflorescence. Bent 4: top of cap is spalled and delaminated at the top. Approximately 15'.						
303	Assembly Joint with Seal	LF	146	0	0	146	0
2310	Leakage	LF	146	0	0	146	0

Bent 4, backside of cap is spalled and delaminated at the top.

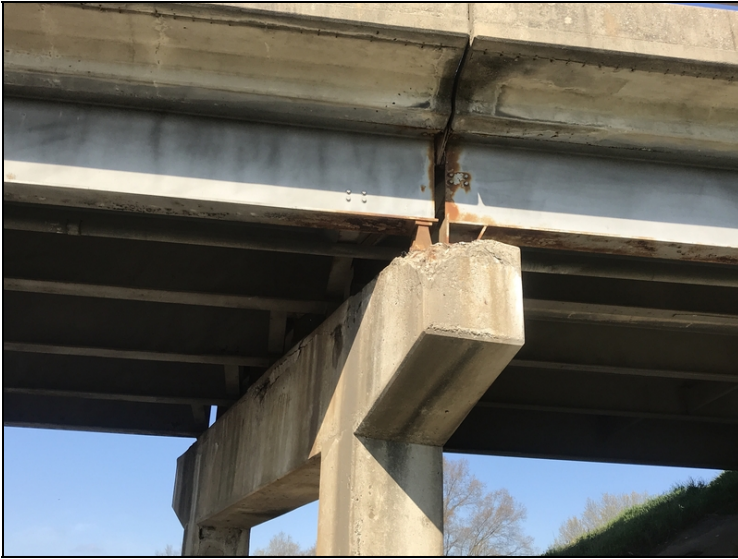
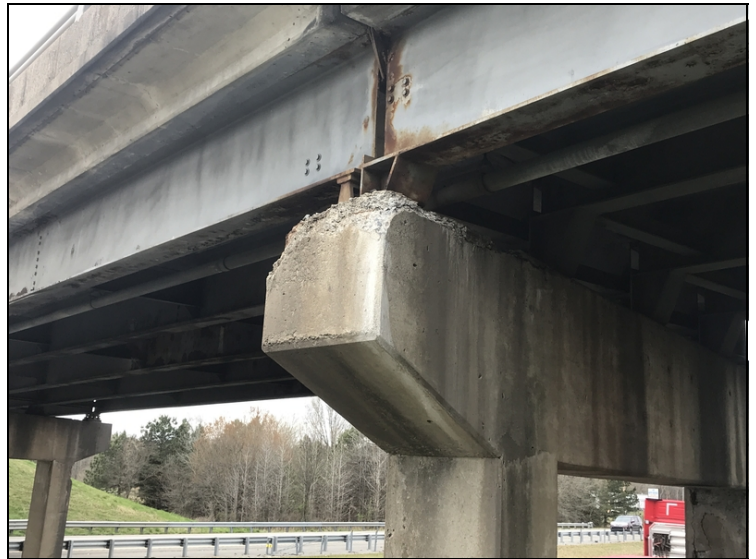
Bent 4: right end of cap with a large spall that is adjacent to girder 5 bearing.

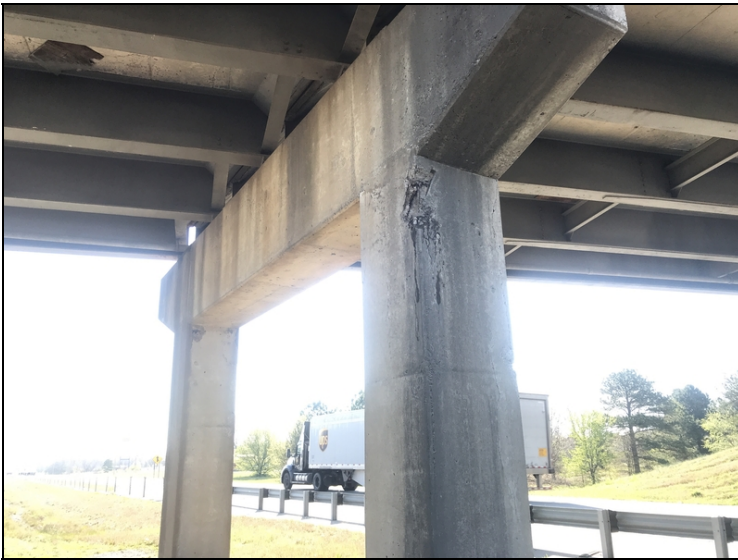
Columns of bents 2, 3 and 4 have spalls with exposed rebar and delamination.

Bent 3, column 1: large spall with exposed rebar.

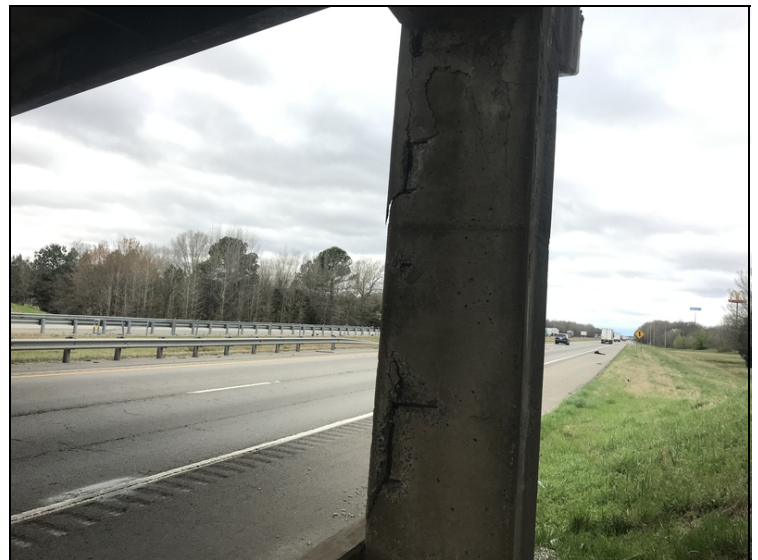
Bent 4 column 1 large spalls with exposed rebar

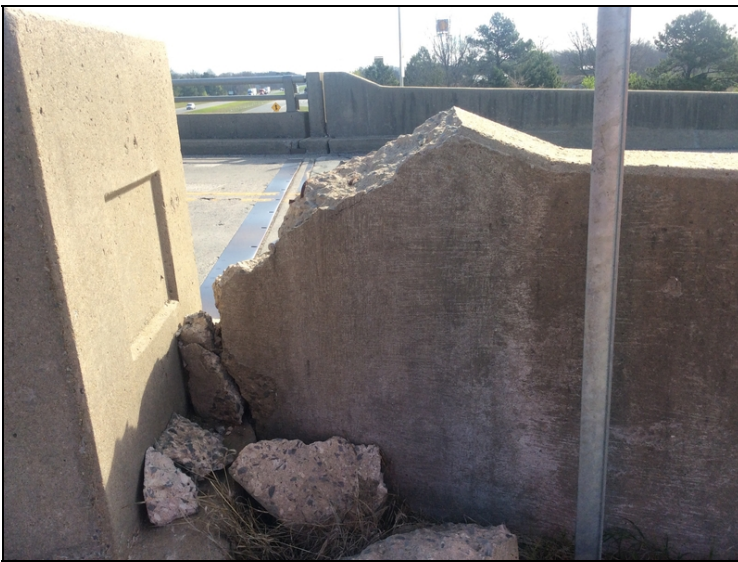
Left end post at bent 1.

Left approach rail at bent 1 has a large spall.

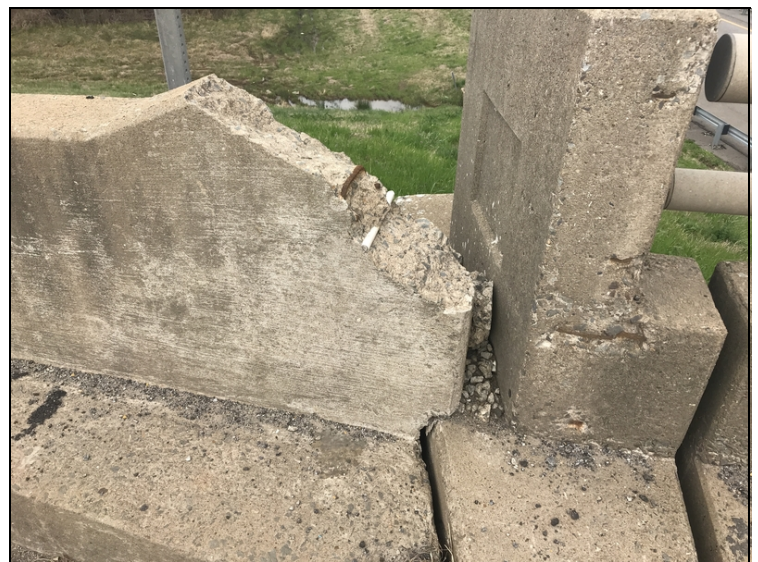
Left approach rail at bent 1 has a large spall.
