Bridge #05711(Routine)

SH 440 E-S Ramp over I-40 LOG 158.77

Location: 1.9MI W OF GALLOWAY

Team Lead: Chris Doggett Inspection Date: July 31, 2019

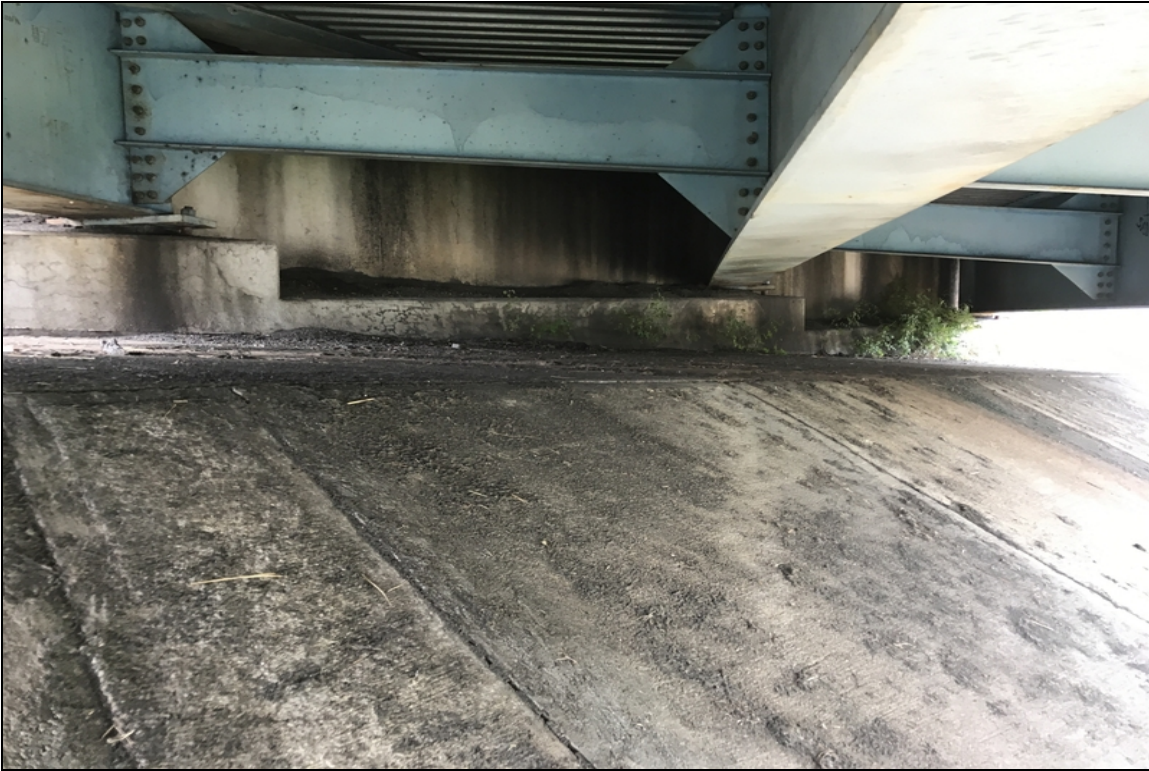
(215)							
Bent 1 & 6 has map cracking along the entire face. Both abutments have spalls in the top of back walls.							
234	Reinforced Concrete Pier Cap	LF	110	71	12	27	0
1130	Cracking (RC and Other)	LF	39	0	12	27	0

Bent 6: the beam seat has map cracking through the entire face. Also, the beam seat has a large amount of dirt and vegetation a top of it

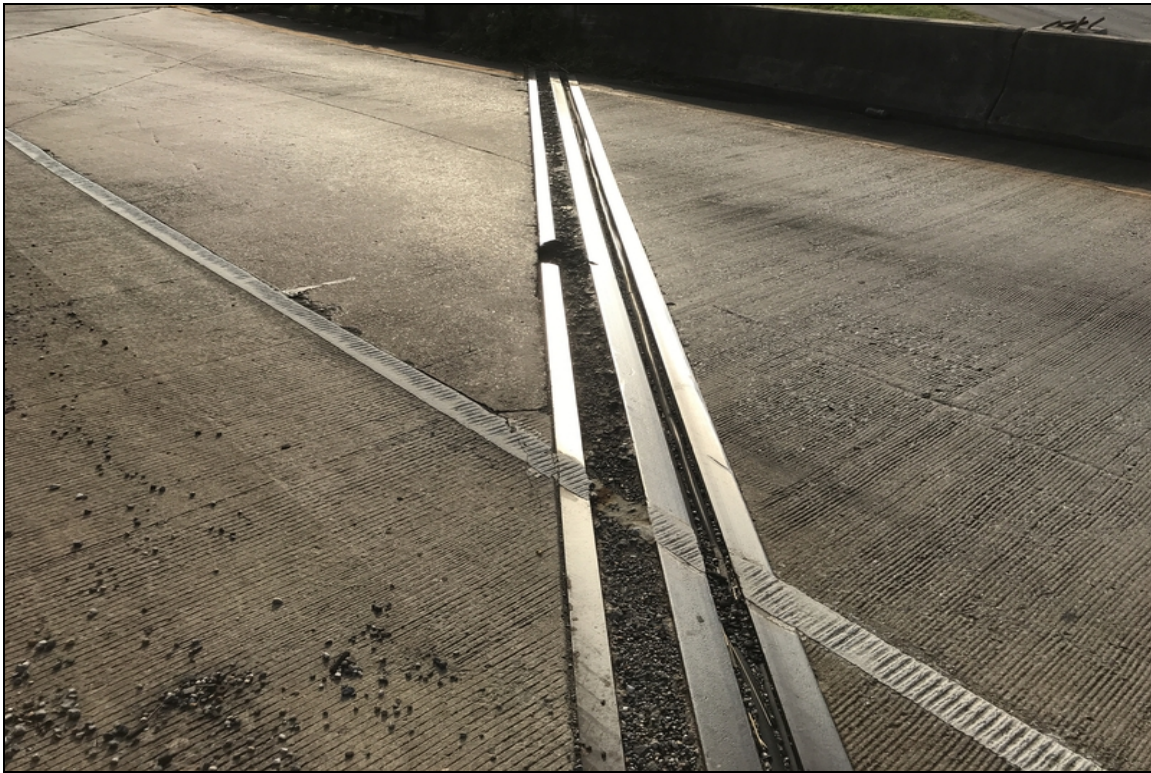
Top of back wall spalled

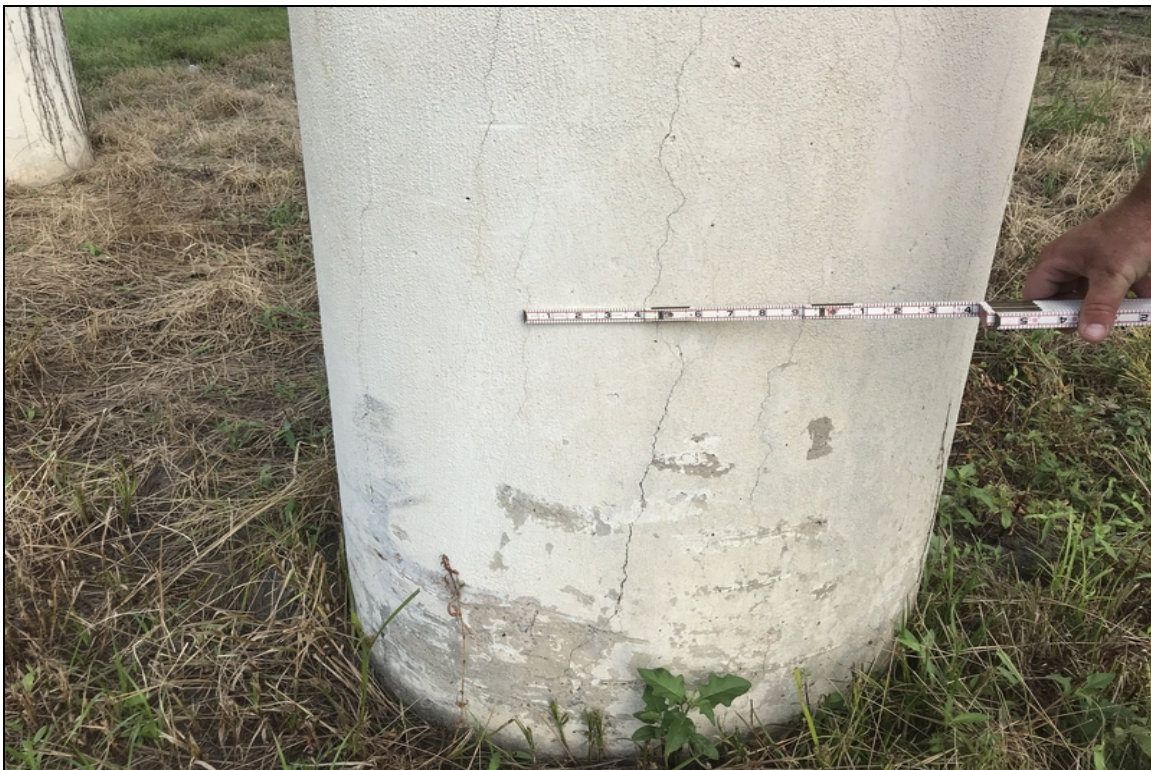
(205)							
All the columns have full height cracks on eight inch centers.							
215	Reinforced Concrete Abutment	LF	89	0	0	89	0
1080	Delamination/Spall/Patched Area	LF	28	0	0	28	0
1130	Cracking (RC and Other)	LF	61	0	0	61	0

Bent 3, column 1: the column has numerous full height vertical cracks on 6" centers. All columns are in similar condition

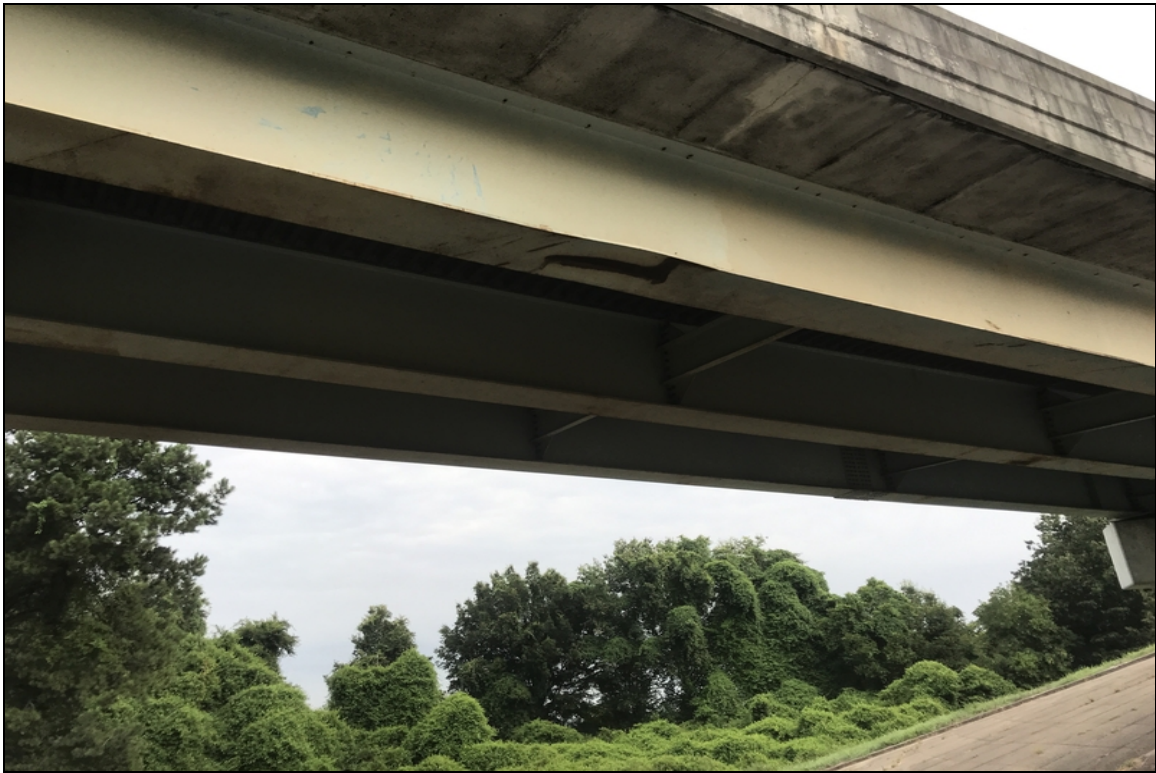
Span 4, girder 3: damage due to vehicle impact to the lower flange.

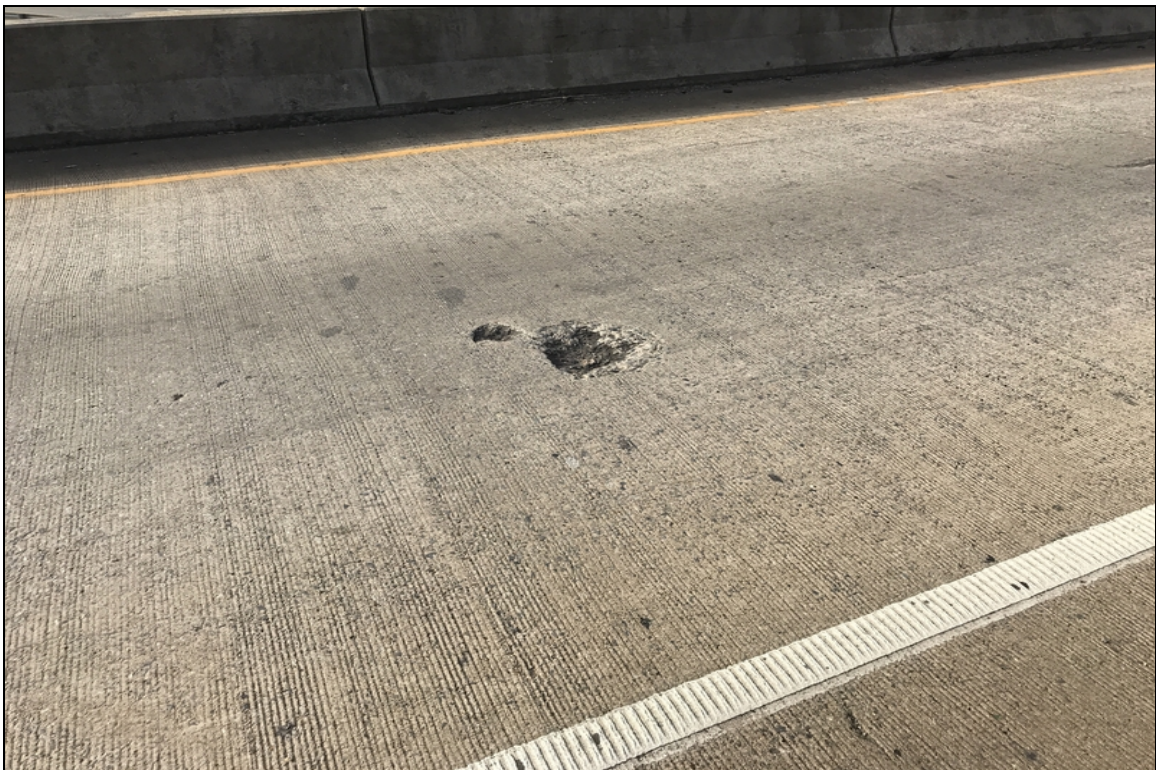
(12)							
Span 4 has a spall with exposed rebar. All spans have transverse and map cracks. 0.030 inch avg. Most of the travel lane has some surface abrasion.							
107	Steel Open Girder/Beam	LF	1347	1179	150	18	0
1000	Corrosion	LF	162	0	150	12	0
1010	Cracking	LF	3	0	0	3	0
7000	Damage	LF	3	0	0	3	0
515	Steel Protective Coating	SF	17391	0	12065	5171	155
3410	Chalking (Steel Protective Coatings)	SF	0	0	0	0	0
3440	Effectiveness (Steel Protective Coatings)	SF	17391	0	12065	5171	155

Span 4: spall in the deck surface

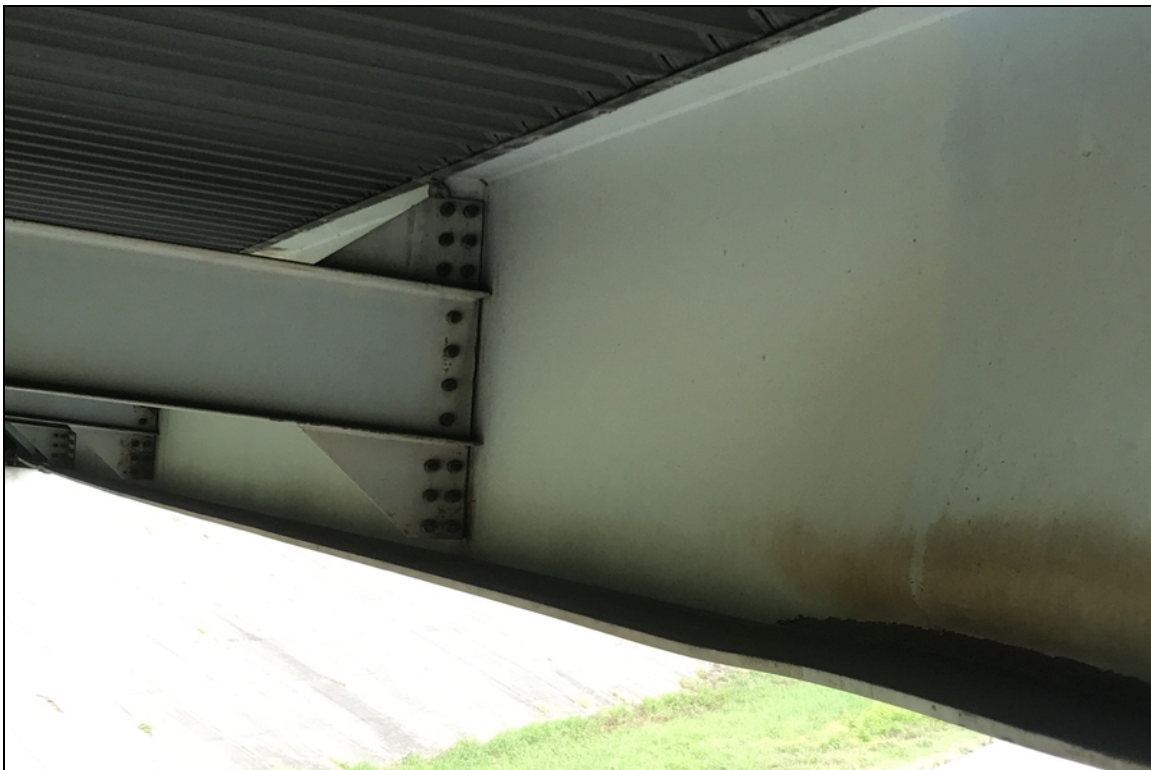
4th diaphragm

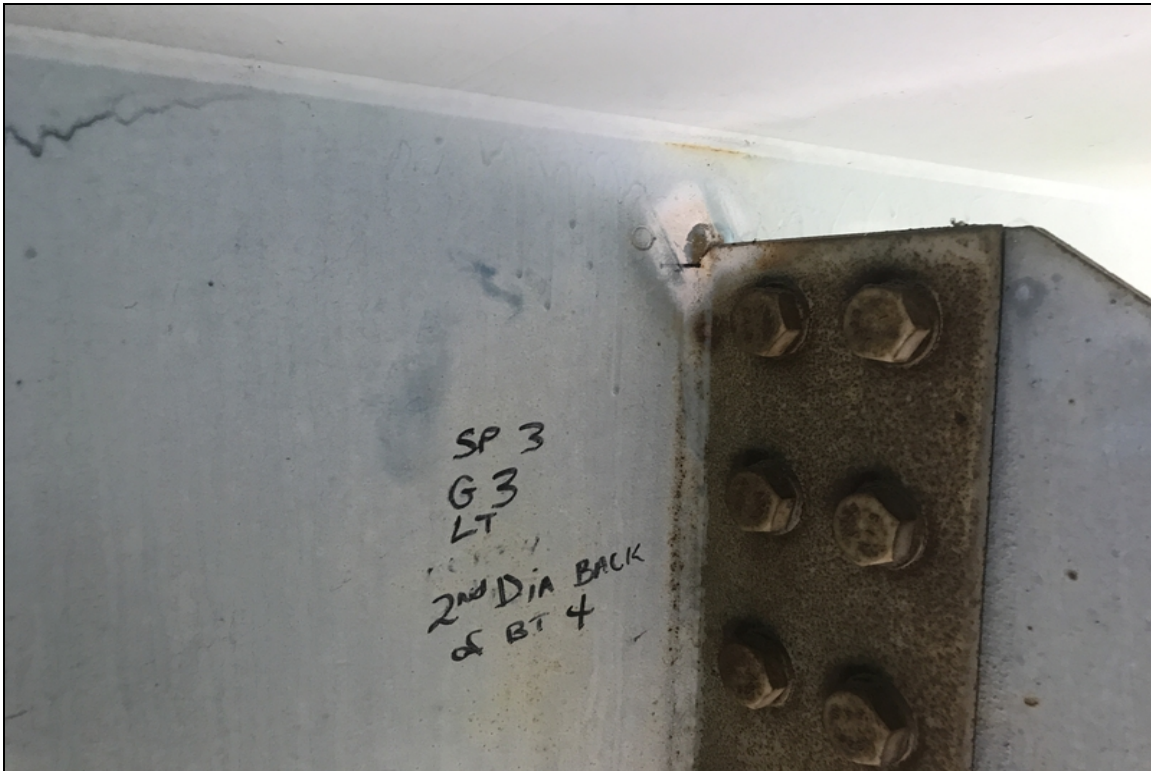
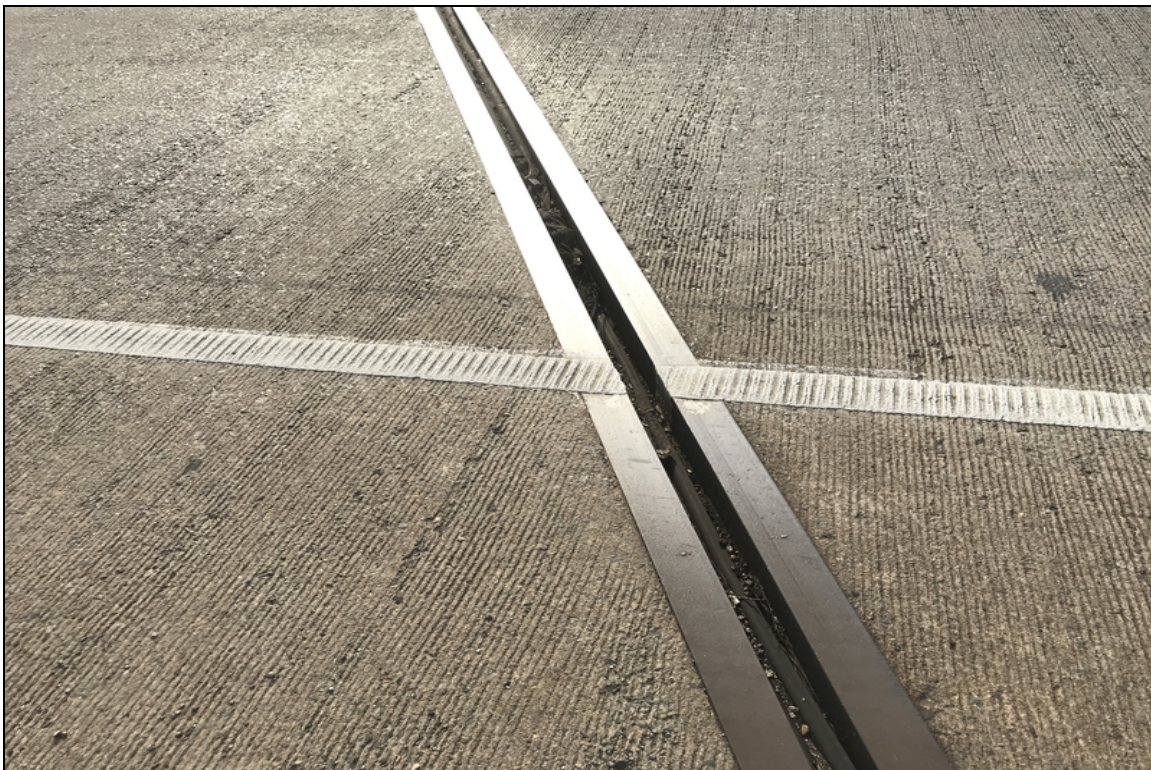
Bent 2: left side of the compression joint has lost bond allowing water to flow through

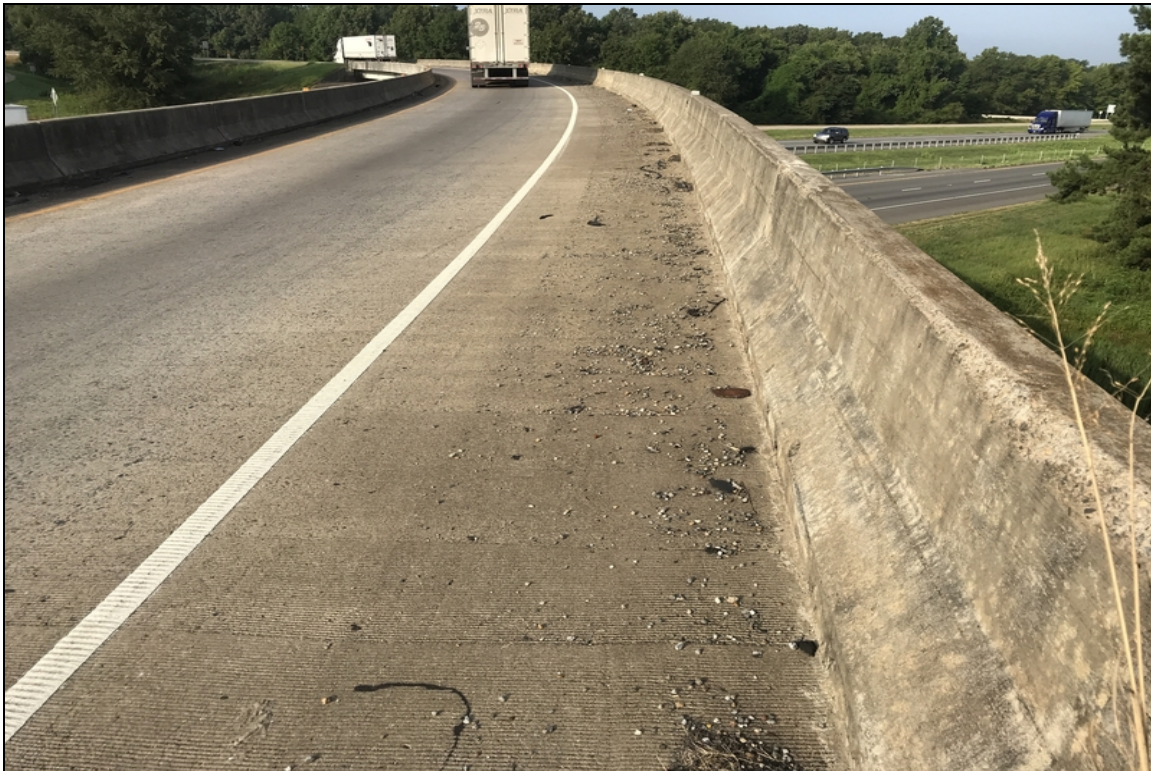
A large amount of debris accumulating on deck

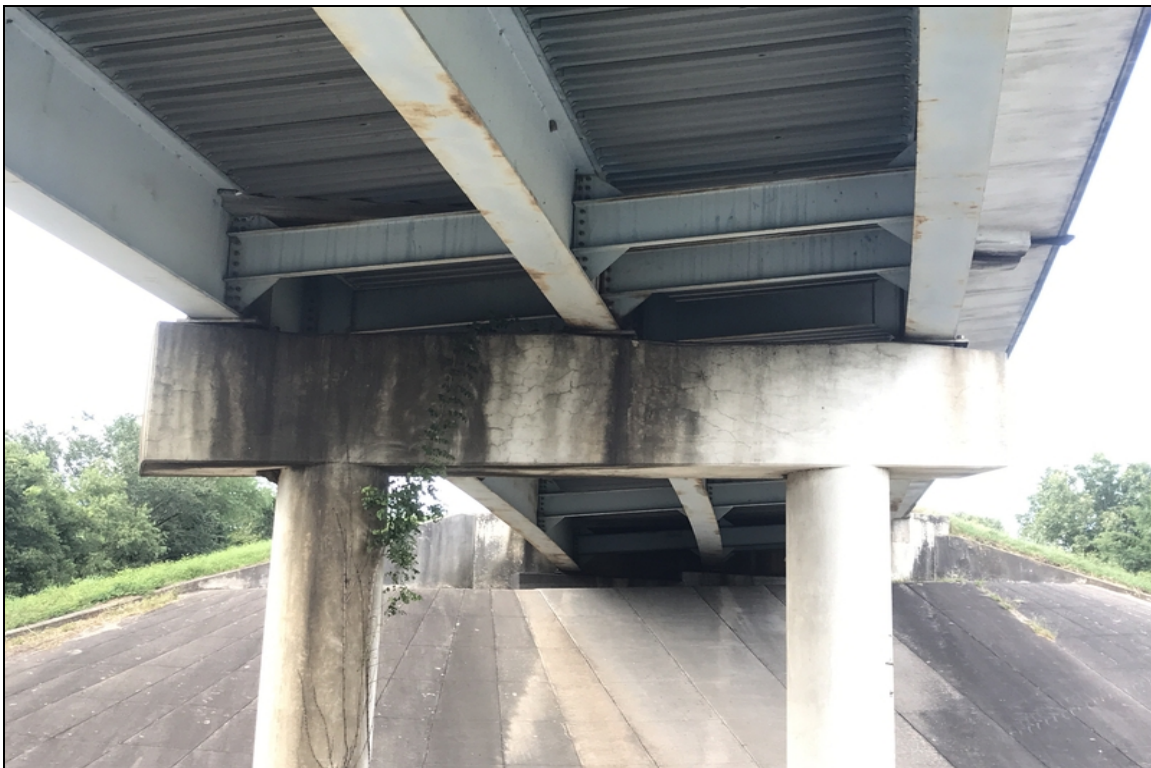
(234)							
Bent 2 cap has map cracking the entire length of ahead and back face.

Ahead side of bent 2: the entire face of cap is map cracked

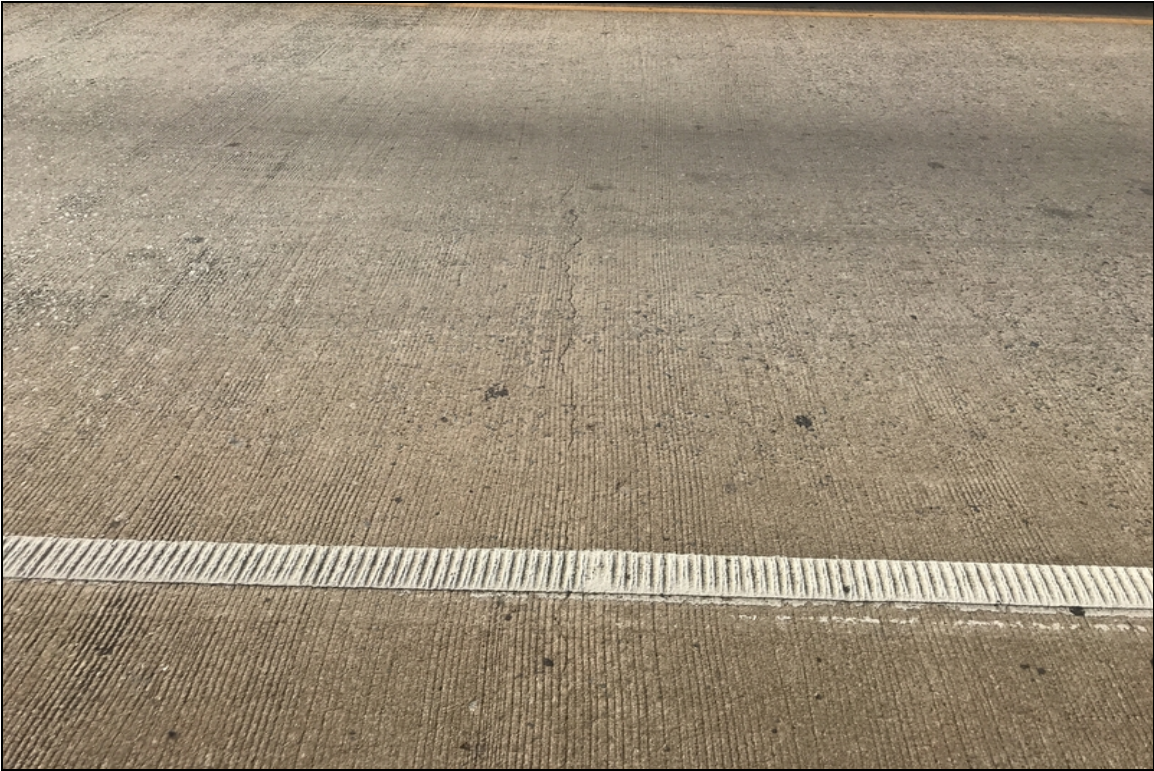
Span 5: large transverse crack

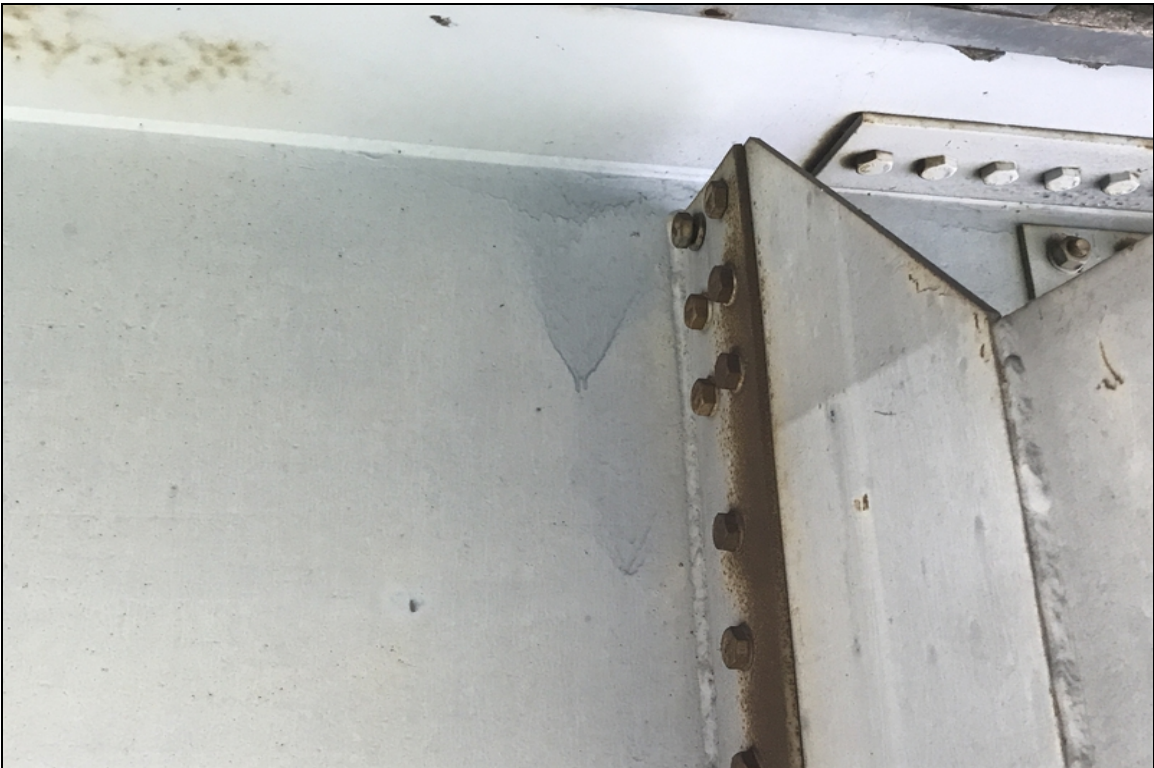
Span 4, girder 2, 2nd dia. Loose bolt at the top of diaphragm

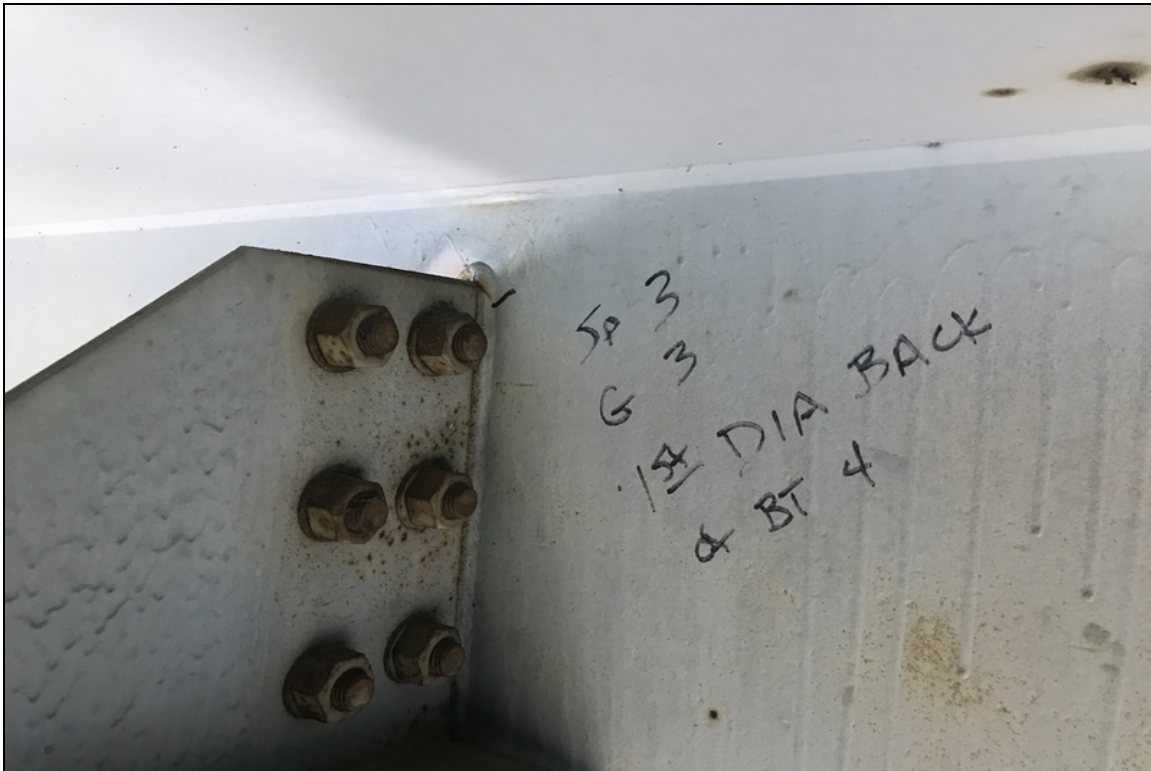
No movement since last inspection
