Bridge #05712(Routine)

SH 440 SW RAMP over I 40 Log 159.07

Team Lead: Chris Doggett Inspection Date: July 31, 2019

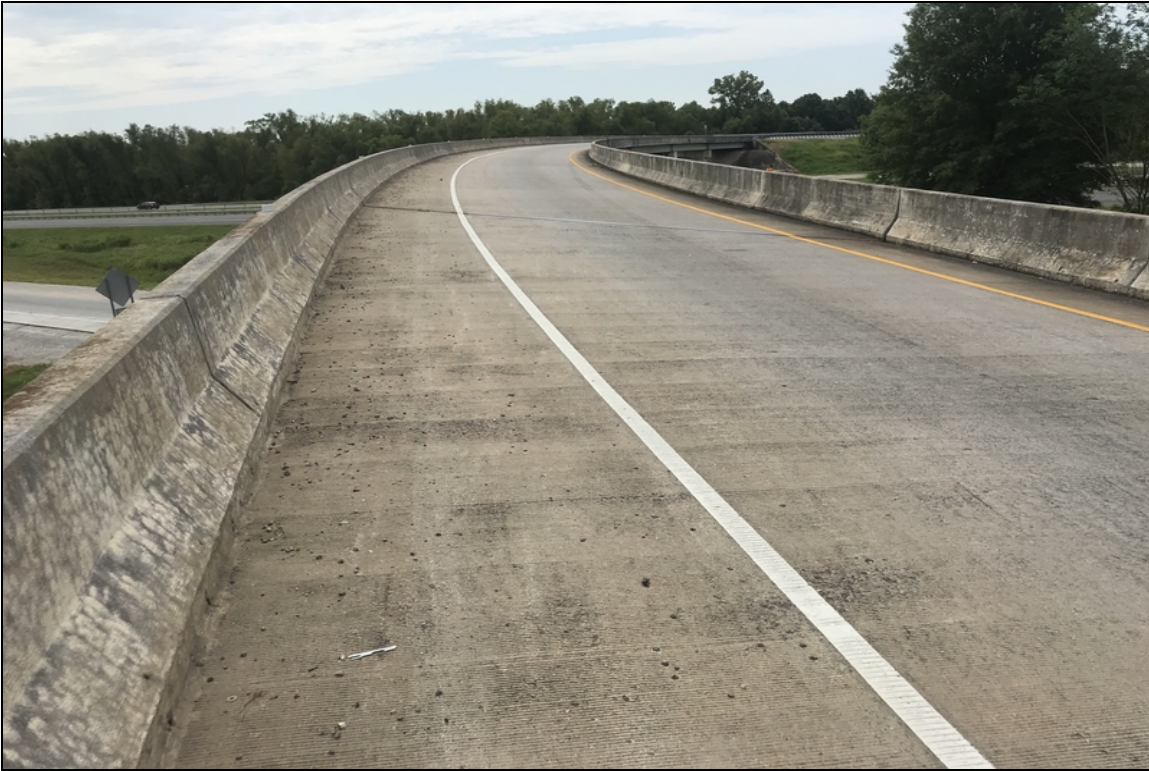
Deck view

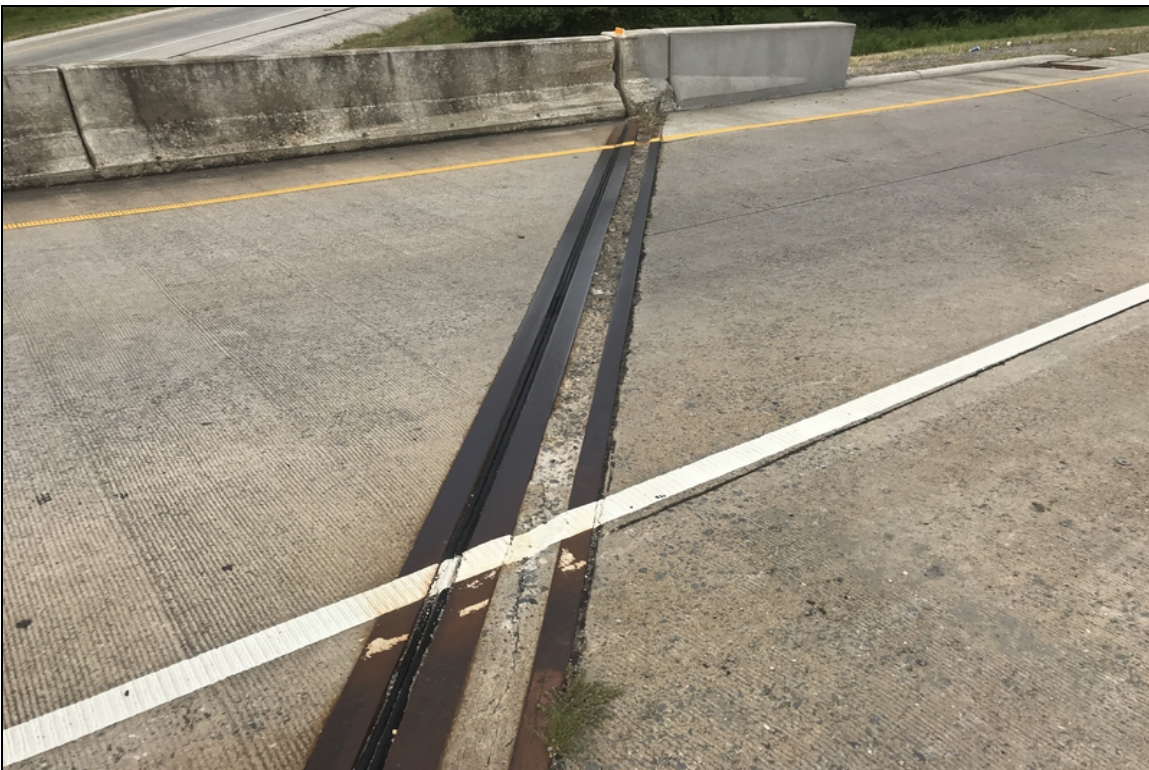
| ELEM | DESCRIPTION | UNITS | TOTAL | CS1 | CS2 | CS3 | CS4 |
|--|---|---|---|---|---|---|---|
| Spalls in the top of both back walls at road irons. | | | | | | | |

Bent 8: back wall spalled

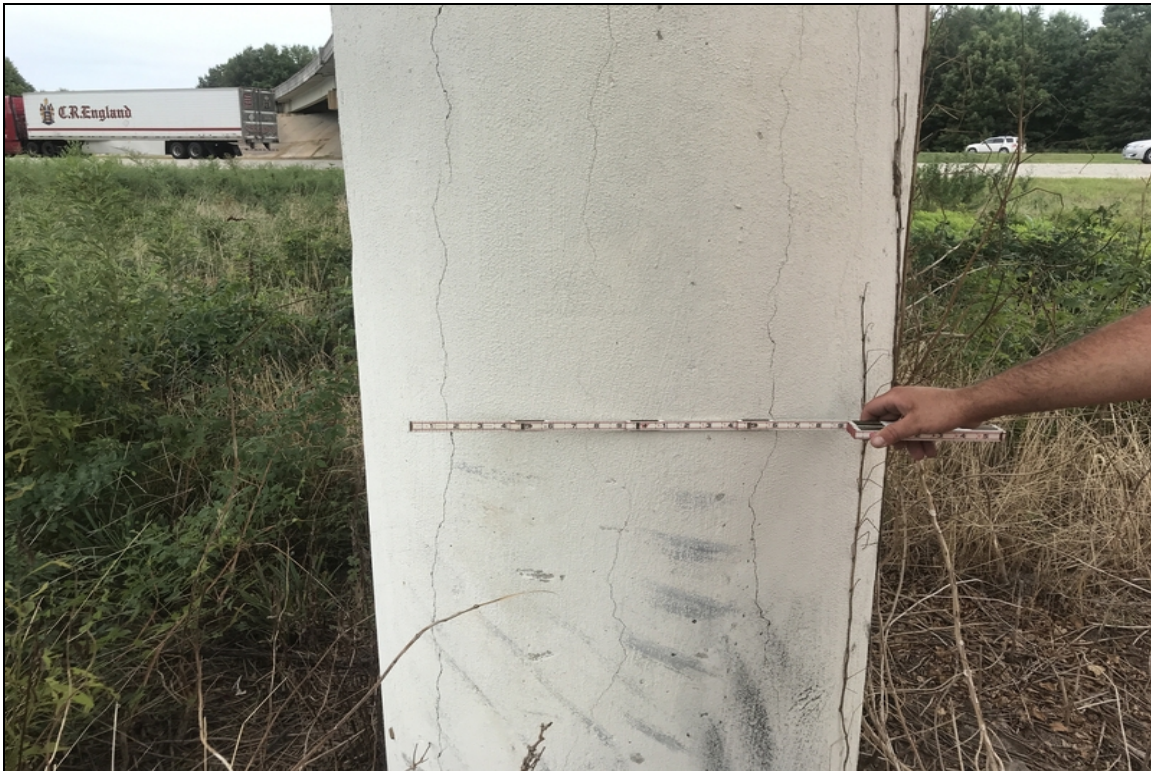
| ELEM | DESCRIPTION | UNITS | TOTAL | CS1 | CS2 | CS3 | CS4 |
|--|---|---|---|---|---|---|---|
| Bent 2 both column have cracks.<br>Bent 4, left column is cracked. 0.015 inch avg.<br>Bent 5, both columns have vertical cracks. 0.030 avg.<br>Bent 6, both columns have vertical cracks. 0.030 avg. | | | | | | | |

Bent 5, column 1: numerous full height vertical cracks on 6" centers. All columns on this structure are in similar condition

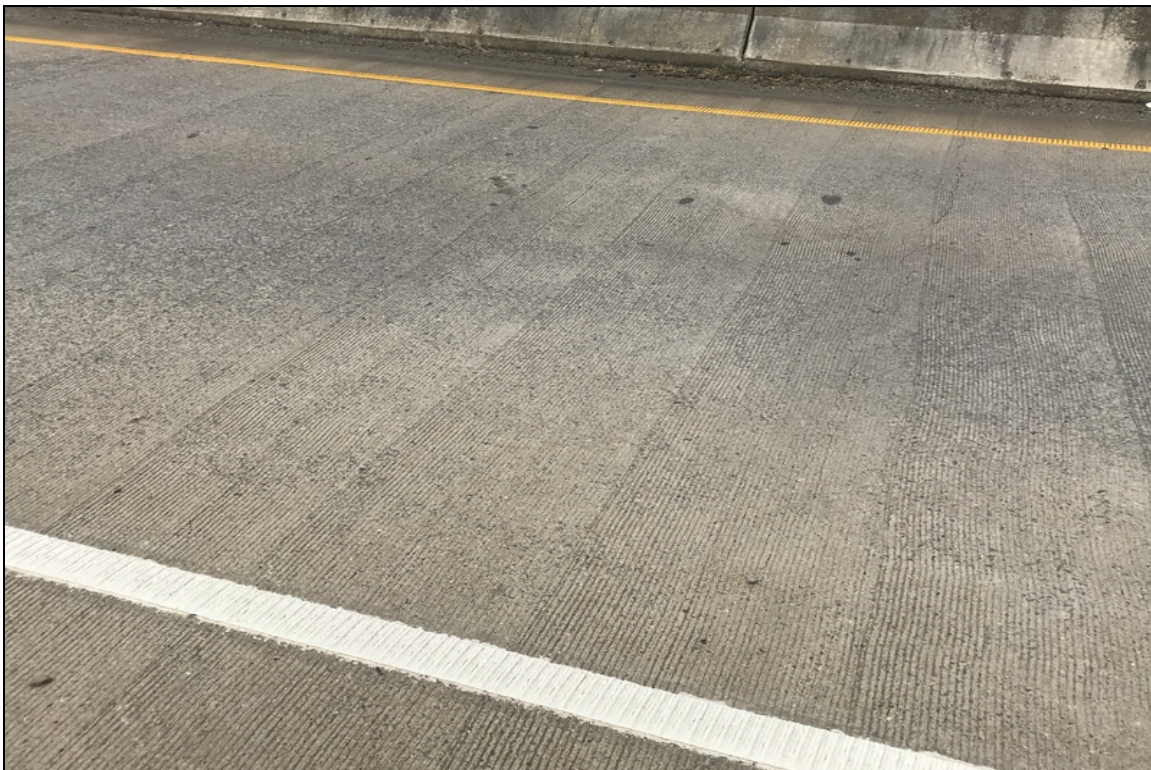
| ELEM | DESCRIPTION | UNITS | TOTAL | CS1 | CS2 | CS3 | CS4 |
|--|---|---|---|---|---|---|---|
| Transverse cracks are present in all spans on 6 to 8 foot spacing. 0.035 inch avg. Span 4 is the worst span. All spans have areas of map cracking. | | | | | | | |

Span 4: transverse cracks common at this span. (3' spacing)

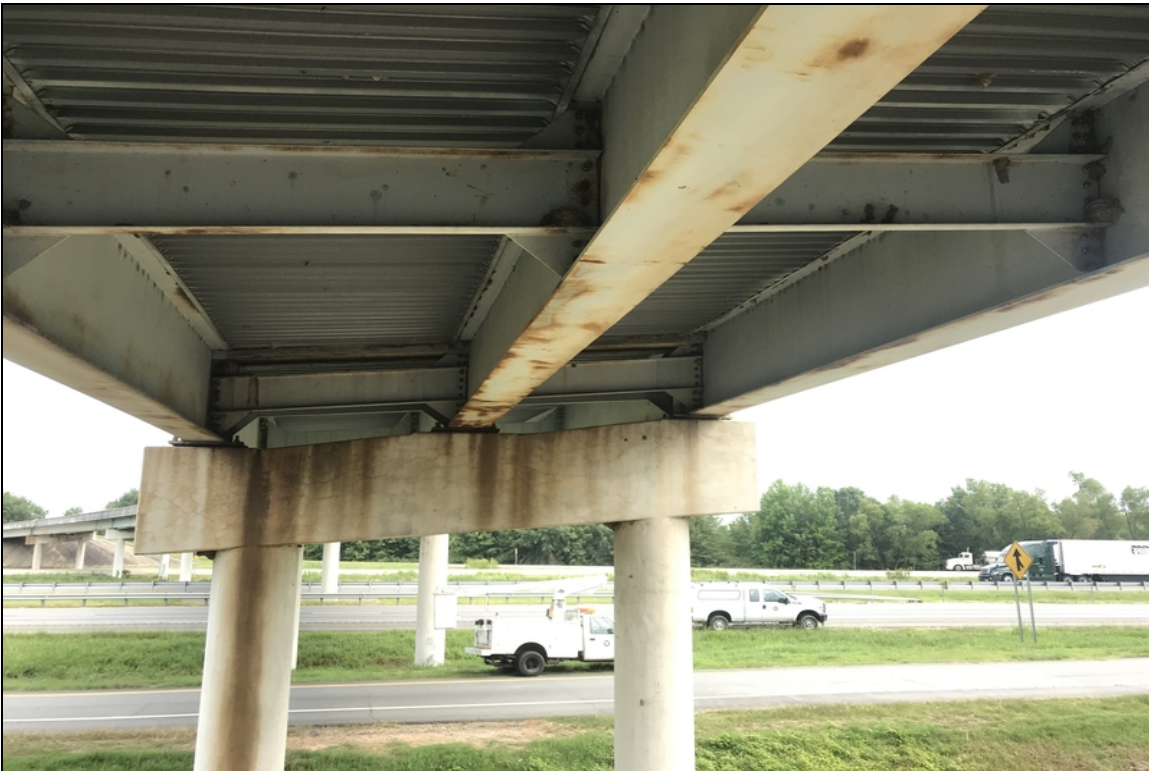
| ELEM | DESCRIPTION | UNITS | TOTAL | CS1 | CS2 | CS3 | CS4 |
|--|---|---|---|---|---|---|---|
| All beams have areas of freckling rust on the web and flanges with minor pitting. | | | | | | | |

Span 1: common paint condition of girders on this structure

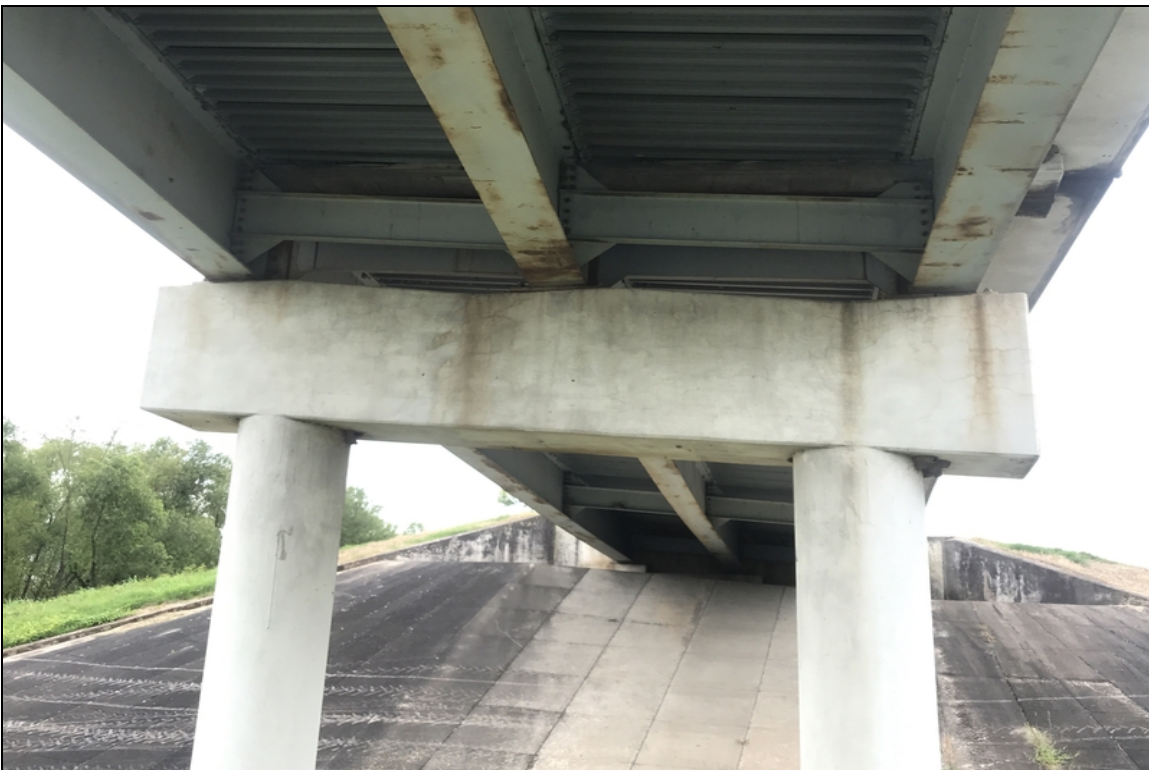
| ELEM | DESCRIPTION | UNITS | TOTAL | CS1 | CS2 | CS3 | CS4 |
|--|---|---|---|---|---|---|---|
| Bents 2 & 7 have map cracking the entire length of cap. Bent four has cracks on the bottom of cap. | | | | | | | |

Bent 2 ahead: entire length of cap is map cracked

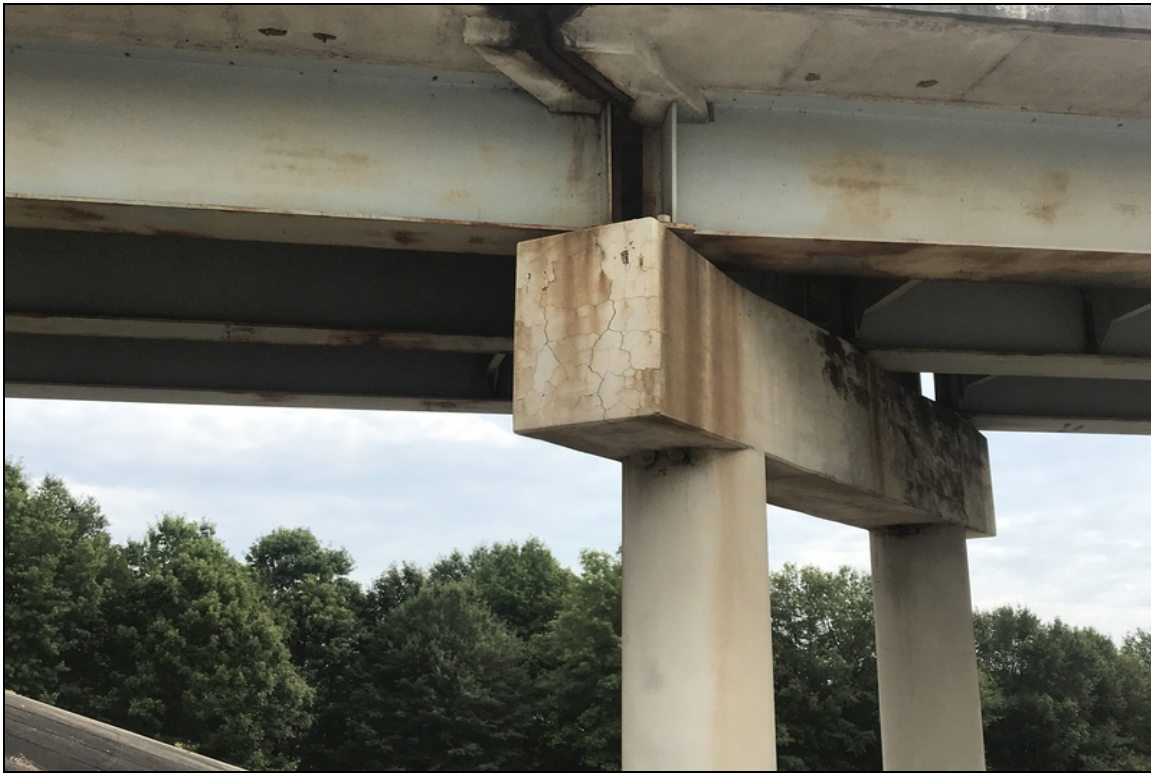
Bent 7, left end of cap is map cracked.
