Bridge #B6873(Routine)

I-40 EB Log 174.01 over Bayou Two Prairie

Team Lead: Chris Doggett Inspection Date: September 10, 2019

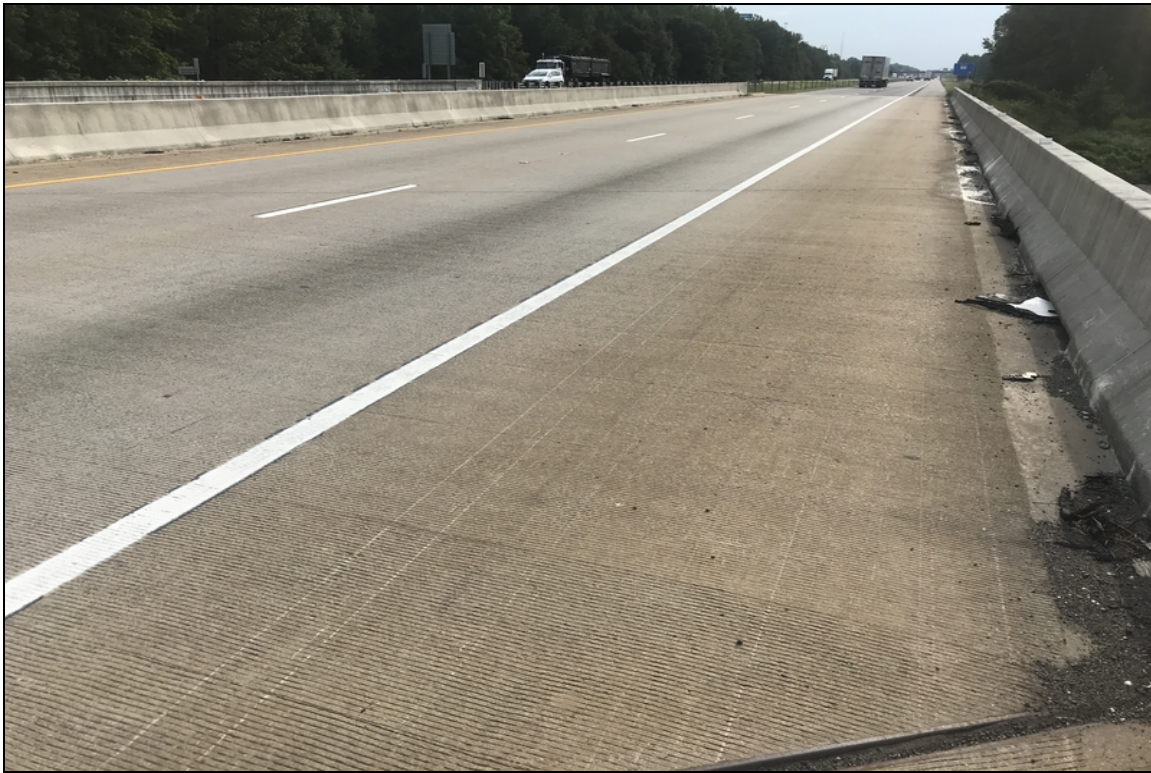
Deck view
