Bridge #A3224(Routine)

SH 15 over I-40 LOG 168.58

Location: 4.5 MI E PULASKI CO LN

Team Lead: Keith Harris Inspection Date: May 12, 2021

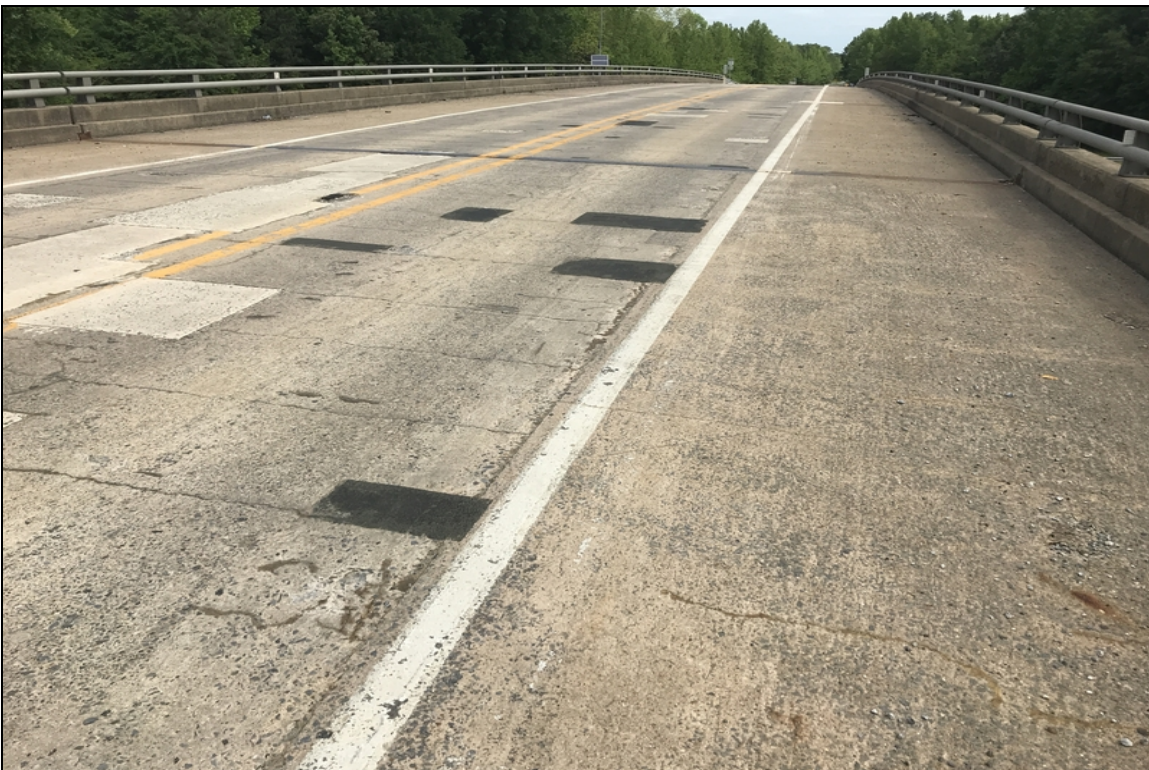
Deck overview

(12)							
The deck has approx. 328 sf of concrete patching, 254 foot of spalls, 89 foot of spalls with exposed rebar. The surface of the deck has sealed and unsealed transverse cracks on three foot centers and are up to 1/8 inch wide. Some cracks reflect thru to the soffit with effloresces							
107	Steel Open Girder/Beam	LF	2448	990	1215	243	0
1000	Corrosion	LF	1458	0	1215	243	0
515	Steel Protective Coating	SF	16694	0	12519	3275	900
3420	Peeling/Bubbling/Cracking	SF	400	0	400	0	0
3440	Effectiveness (Steel Protective Coatings)	SF	16294	0	12119	3275	900

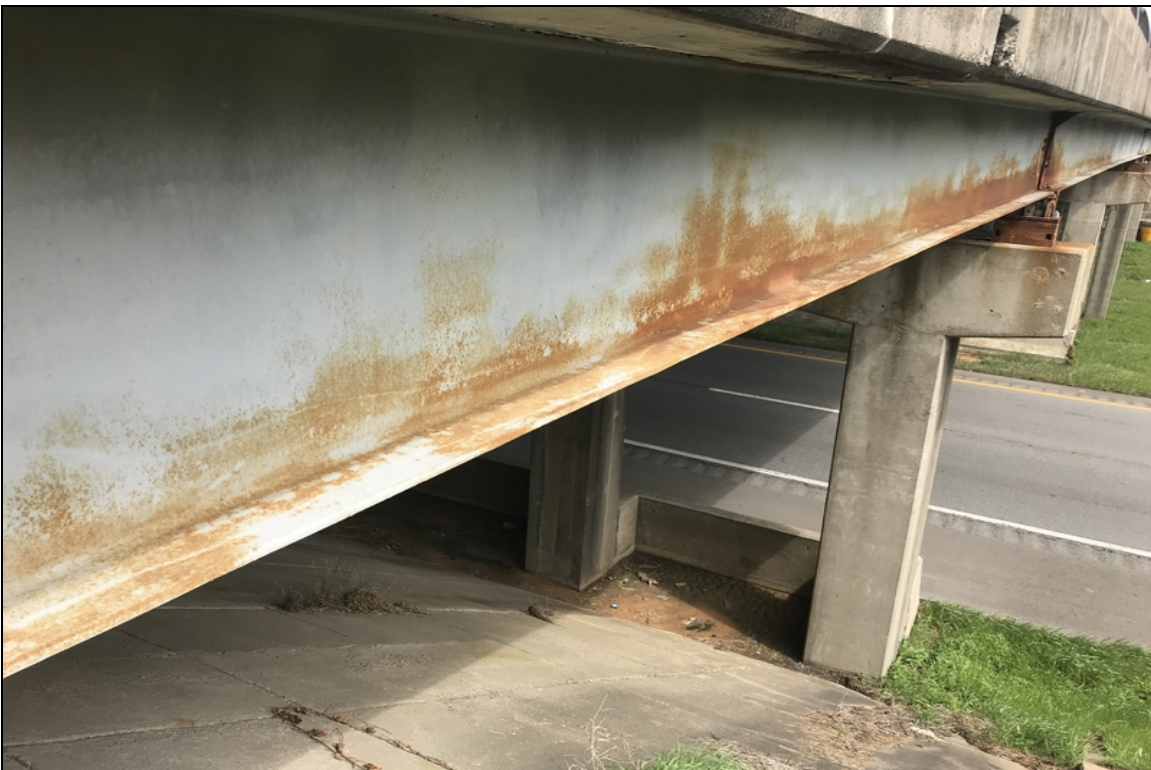
(107)							
The beam ends and scattered areas along the top and bottom flanges have active rust with moderate pitting. This is most common on the original beams before the bridge was widened.							
205	Reinforced Concrete Column	EA	20	7	9	4	0
1080	Delamination/Spall/Patched Area	EA	2	0	1	1	0
1090	Exposed Rebar	EA	6	0	3	3	0
1130	Cracking (RC and Other)	EA	5	0	5	0	0

Typical paint condition

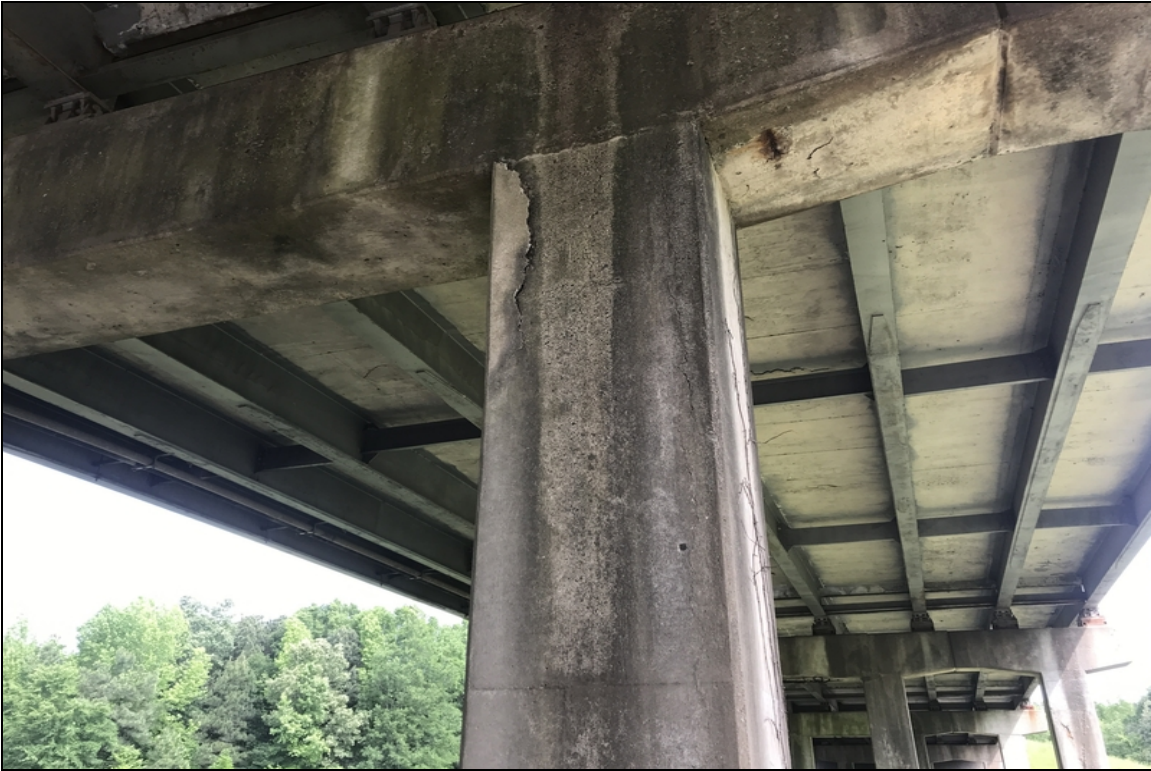
(205)							
Bent 2, columns 2&3: both cracked and have delamns. Bent 4 columns 1,2,3&4 have exposed rebar or spalls Bent 6, columns 2,3,4 are cracked.							
215	Reinforced Concrete Abutment	LF	96	75	21	0	0
1080	Delamination/Spall/Patched Area	LF	13	0	13	0	0
1090	Exposed Rebar	LF	5	0	5	0	0
1130	Cracking (RC and Other)	LF	3	0	3	0	0

Bent 3 column 3 large delam

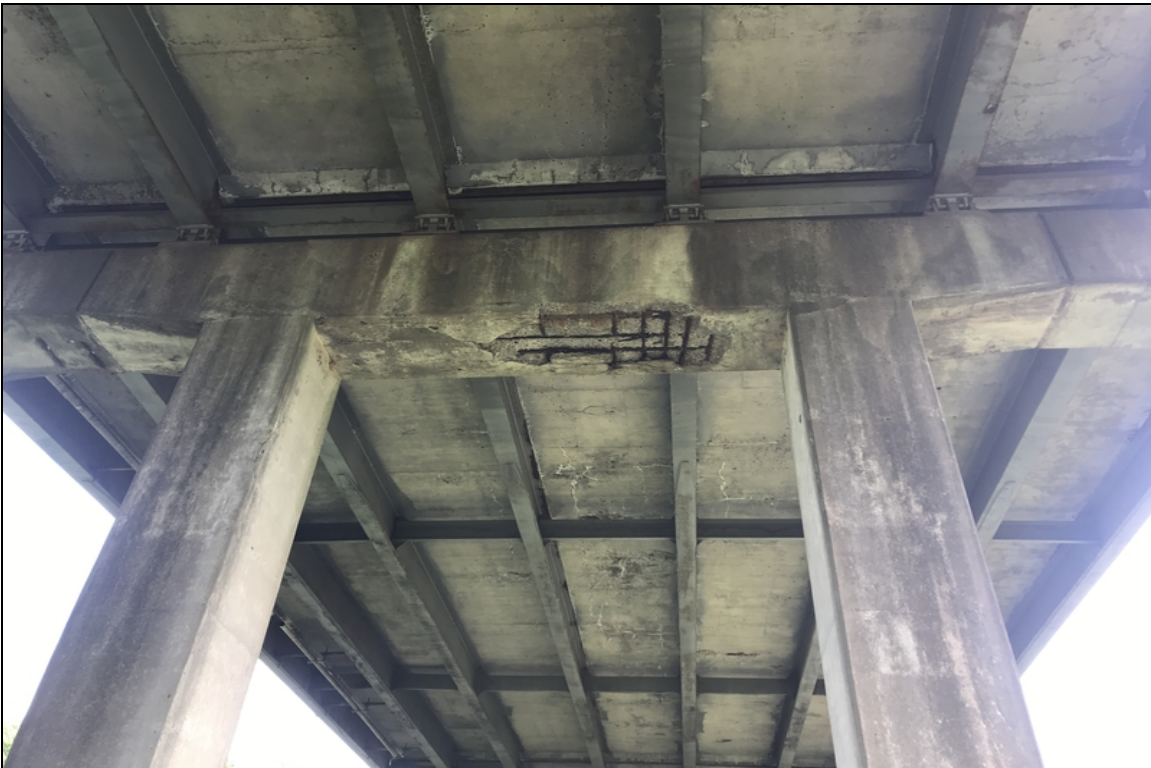
Bent 4 cap

ELEM	DESCRIPTION	UNITS	TOTAL	CS1	CS2	CS3	CS4
234	Reinforced Concrete Pier Cap	LF	210	175	13	22	0
1080	Delamination/Spall/Patched Area	LF	11	0	10	1	0
1090	Exposed Rebar	LF	24	0	3	21	0
(234)							
Small delaminations are present on the faces of all the caps. The caps of bents 2,3,4 & 5 have Spalls with exposed rebar on the sides and bottom.							
305	Assembly Joint without Seal	LF	280	130	150	0	0
2360	Adjacent Deck or Header	LF	150	0	150	0	0
(305)							
Several areas of the deck at the joints are cracked, spalled and patched.							
311	Movable Bearing	EA	48	0	48	0	0
1000	Corrosion	EA	48	0	48	0	0
313	Fixed Bearing	EA	48	0	48	0	0
1000	Corrosion	EA	48	0	48	0	0
330	Metal Bridge Railing	LF	612	612	0	0	0
331	Reinforced Concrete Bridge Railing	LF	612	548	64	0	0
1080	Delamination/Spall/Patched Area	LF	6	0	6	0	0
1090	Exposed Rebar	LF	6	0	6	0	0
1130	Cracking (RC and Other)	LF	52	0	52	0	0

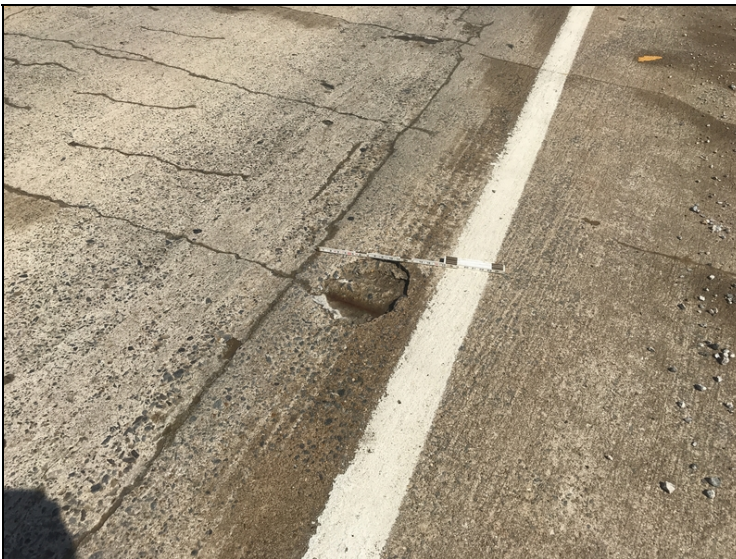
Deck has spalls and spalls filled with asphalt

Span 6 with an open spall in northbound lane

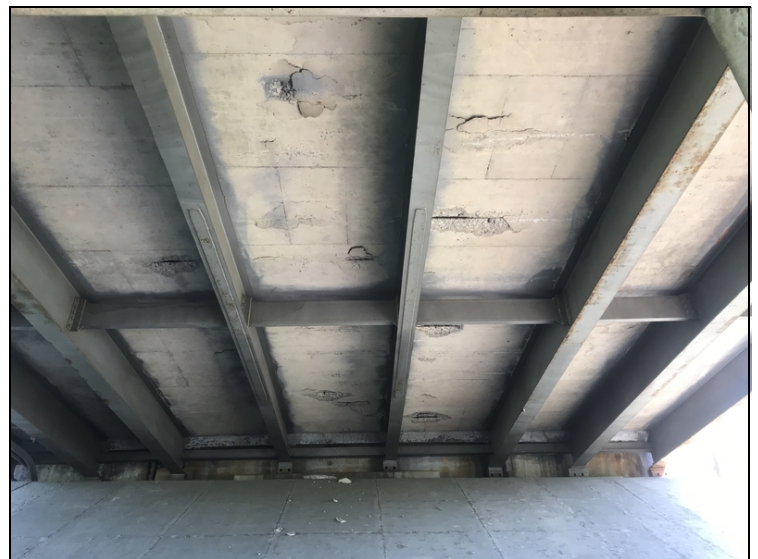
Soffit has numerous open spalls, open spalls with rebar exposed, delamination and large cracks with efflorescence and rust stain.

Soffit view of span 6: (worst case)

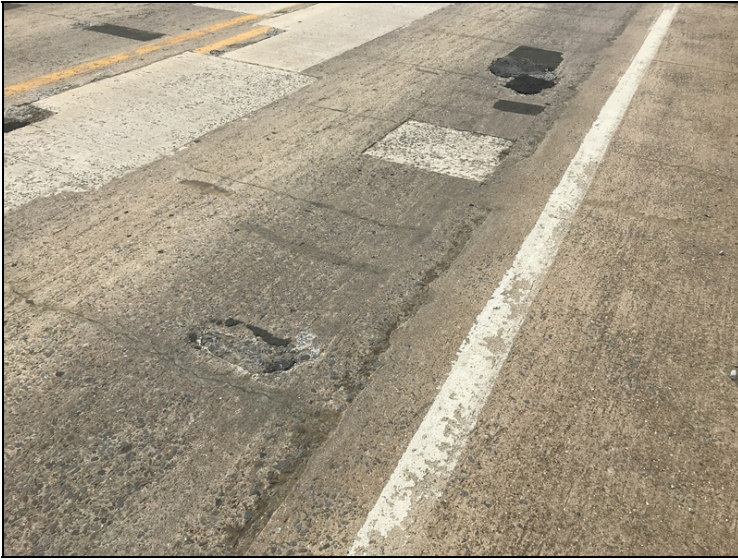
Span 1 spalls and spall# filled with asphalt

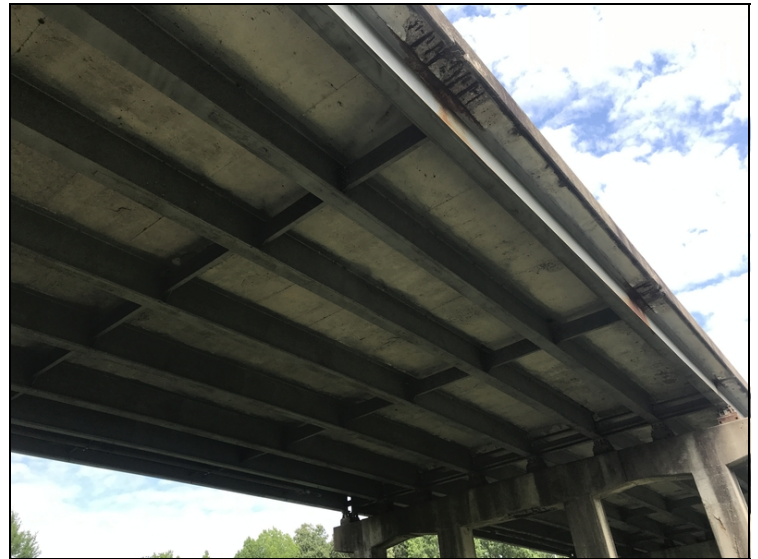
Spalls with exposed rebar on the right side of span

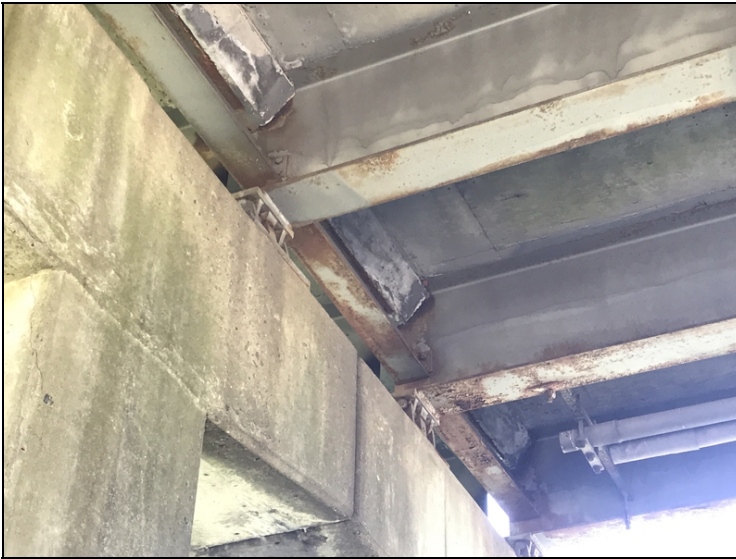
Beam ends at bents 2,3,4,5 & 6 have active rust with moderate pitting at the upper web at deck haunch.  
Added 5-2021 span 1 beam 6 at bent 2 has a 1/2" hole in haunch area

Span 6, bent 5, girder 5 and 6: measurable section loss to the girder at the haunch. Similar condition at girders 1, 5,6, and 7

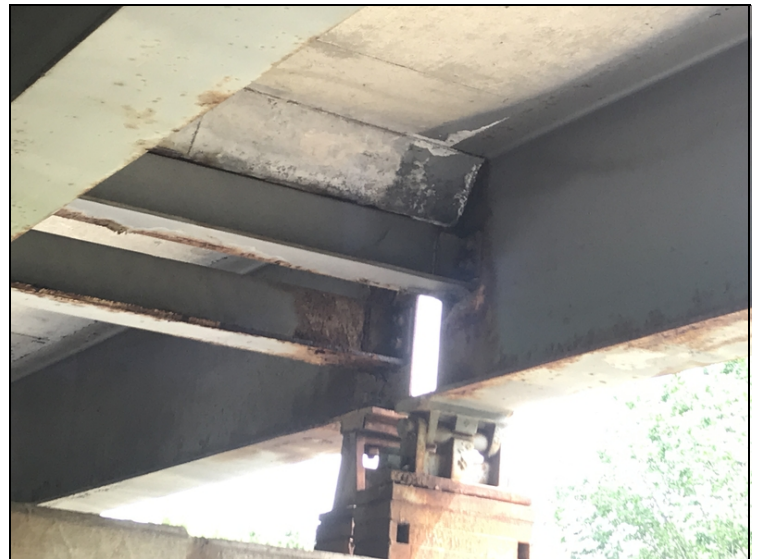
span 1 beam 6 at bent 2 has a 1/2" in haunch area
