Bridge #03652(Routine)

CR 313 Lilly Rd over I-40 LOG 177.29

Team Lead: Keith Harris Inspection Date: April 27, 2022

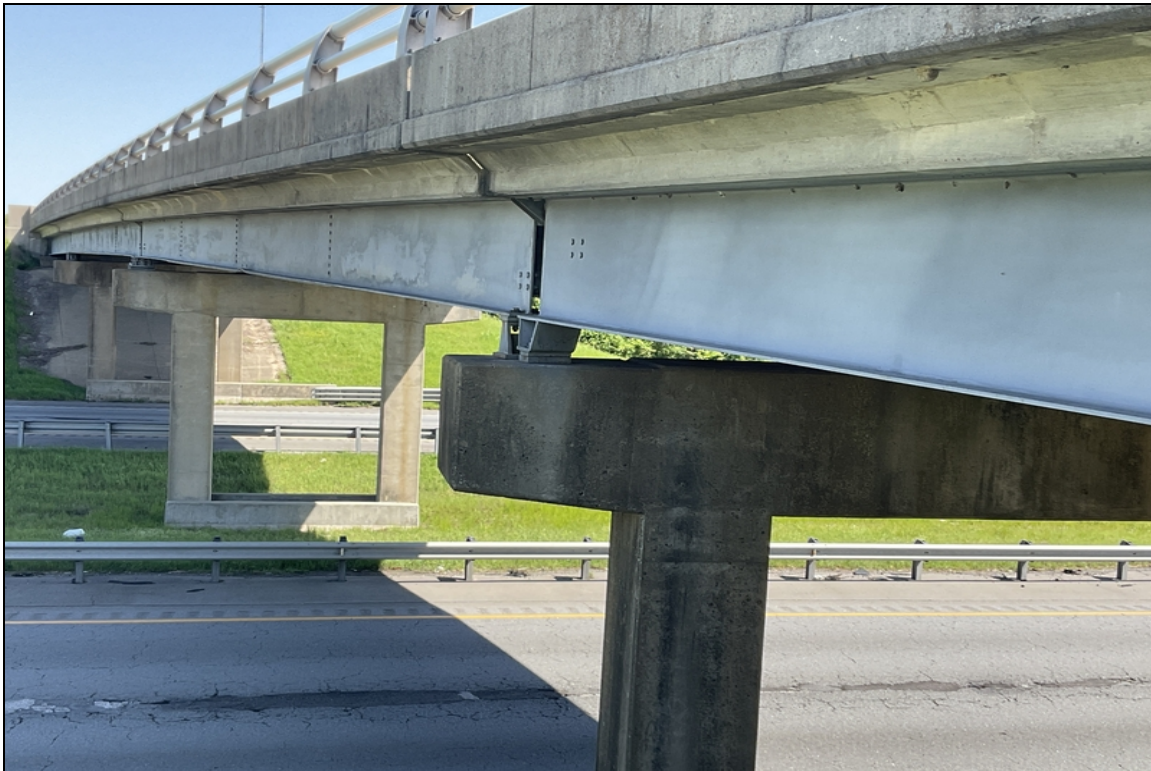
(107)	HBM repainted the beams in 2007. Small areas of active rust on the top flange of beams 1 & 4. Small areas of peeling paint at the beam ends. Span 2, beams 1& 4 have impact damage to the bottom flange.						
205	Reinforced Concrete Column	EA	6	2	4	0	0
1090	Exposed Rebar	EA	4	0	4	0	0

Typical paint condition

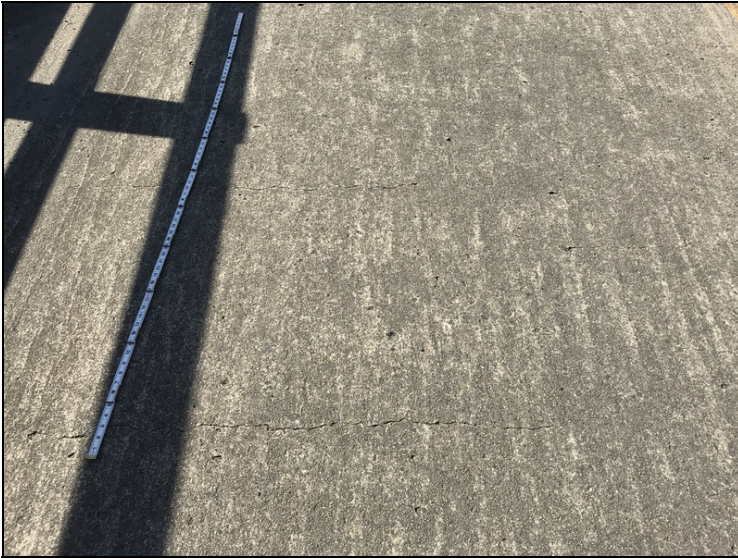
Deck has unsealed cracks up to 0.040 inch wide.

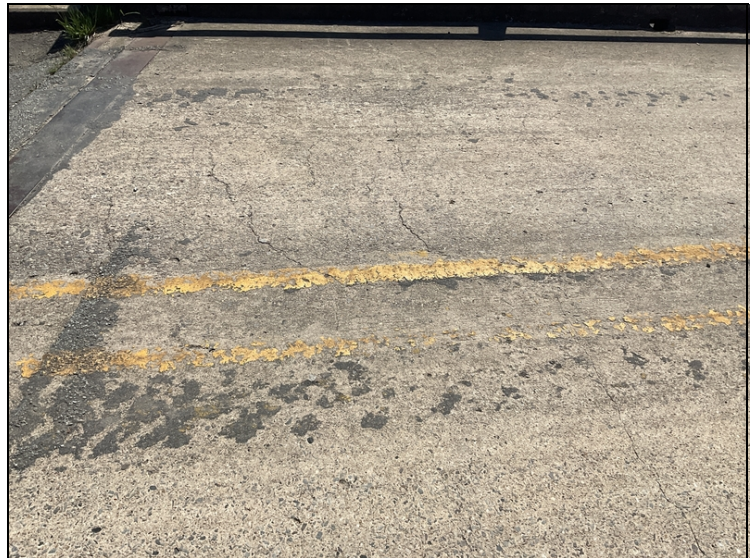
(12)	Unsealed transverse cracks on 3 to 5 foot centers. 0.035 inch avg. Areas of light abrasion/wear in all spans Scattered small spalls along top flanges						
107	Steel Open Girder/Beam	LF	852	715	137	0	0
1000	Corrosion	LF	135	0	135	0	0
7000	Damage	LF	2	0	2	0	0
515	Steel Protective Coating	SF	6313	0	6132	46	135
3420	Peeling/Bubbling/Cracking	SF	46	0	0	46	0
3440	Effectiveness (Steel Protective Coatings)	SF	6267	0	6132	0	135

Span 4 deck cracking up to .040"

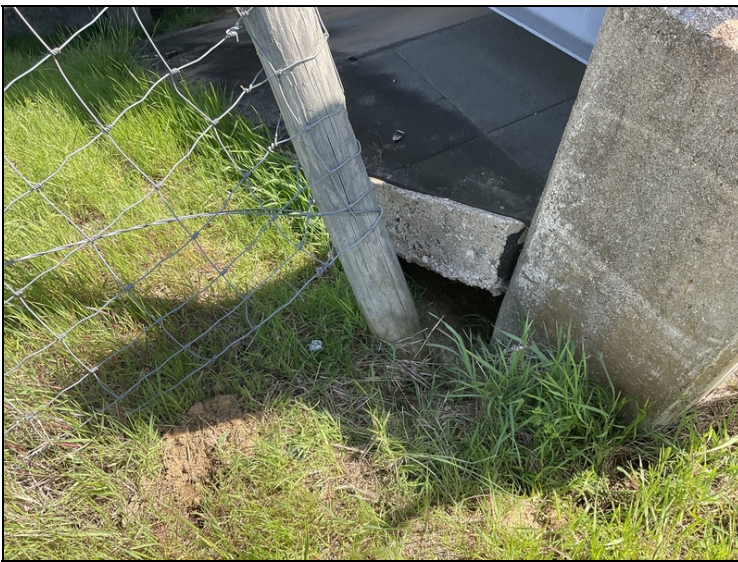
Large voids under Slope pavement at both abutments.

Void under slope paving on south abutment

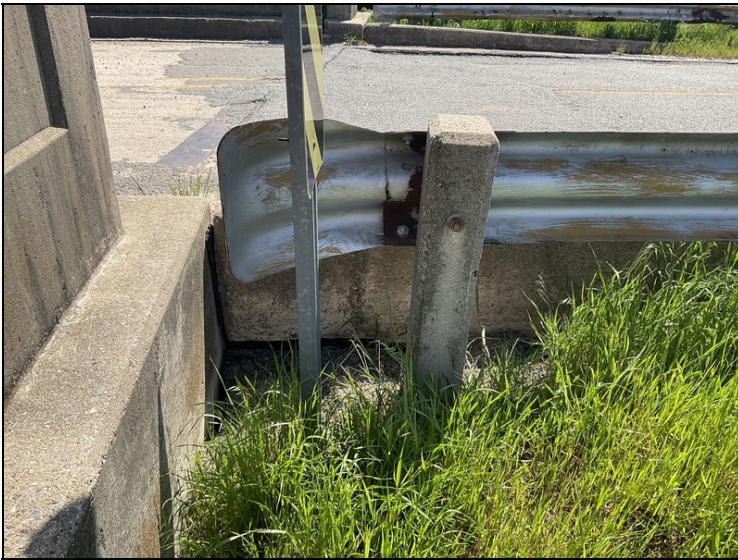
Large Void under approach roadway at south abutment causing the approach roadway to settle
