Bridge #03653(Routine)

CR308-K Northcutt over I-40 LOG 179.34

Location: 1.4 M N US 70

Team Lead: Keith Harris Inspection Date: April 21, 2022

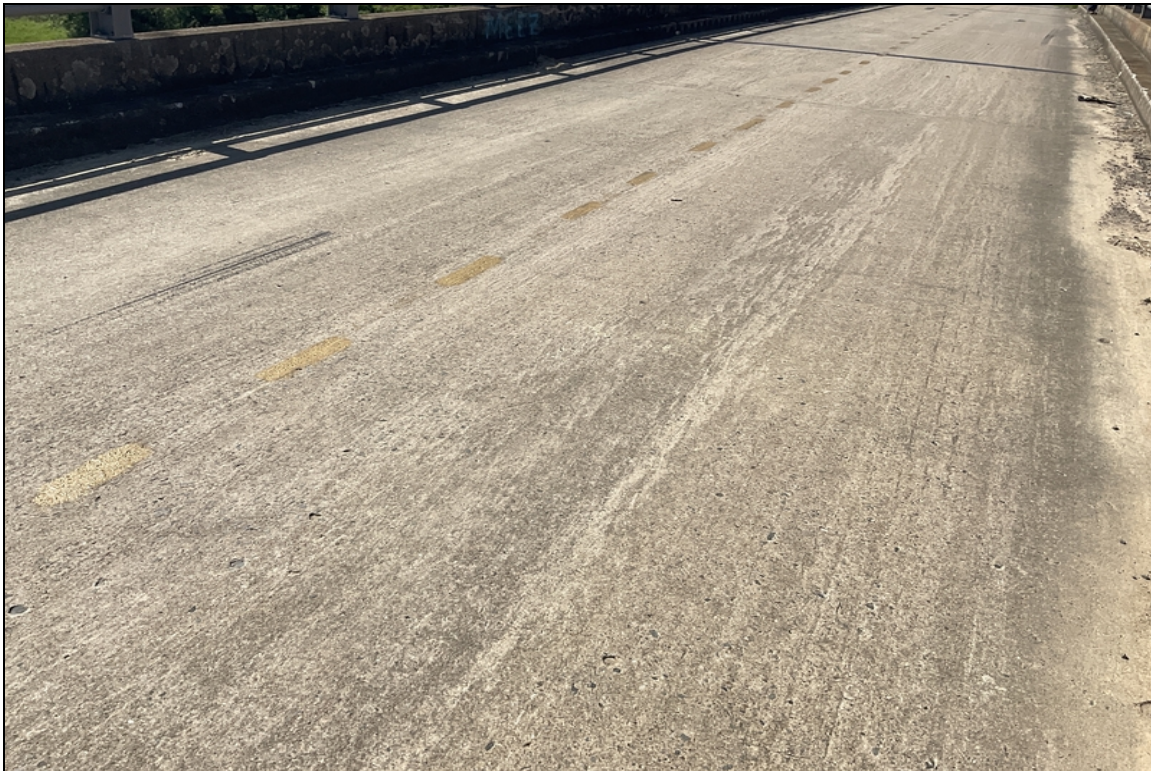
(12)							
Unsealed transverse cracks on 4 foot centers. 0.030 inch avg. some reflect through to the bottom of the deck with stains and light efflorescence. All spans have light abrasion/wear Span 1 small spalls on right side of beam 4							
107	Steel Open Girder/Beam	LF	840	252	588	0	0
1000	Corrosion	LF	588	0	588	0	0
515	Steel Protective Coating	SF	6225	0	4430	1045	750
3440	Effectiveness (Steel Protective Coatings)	SF	6225	0	4430	1045	750

Deck overview

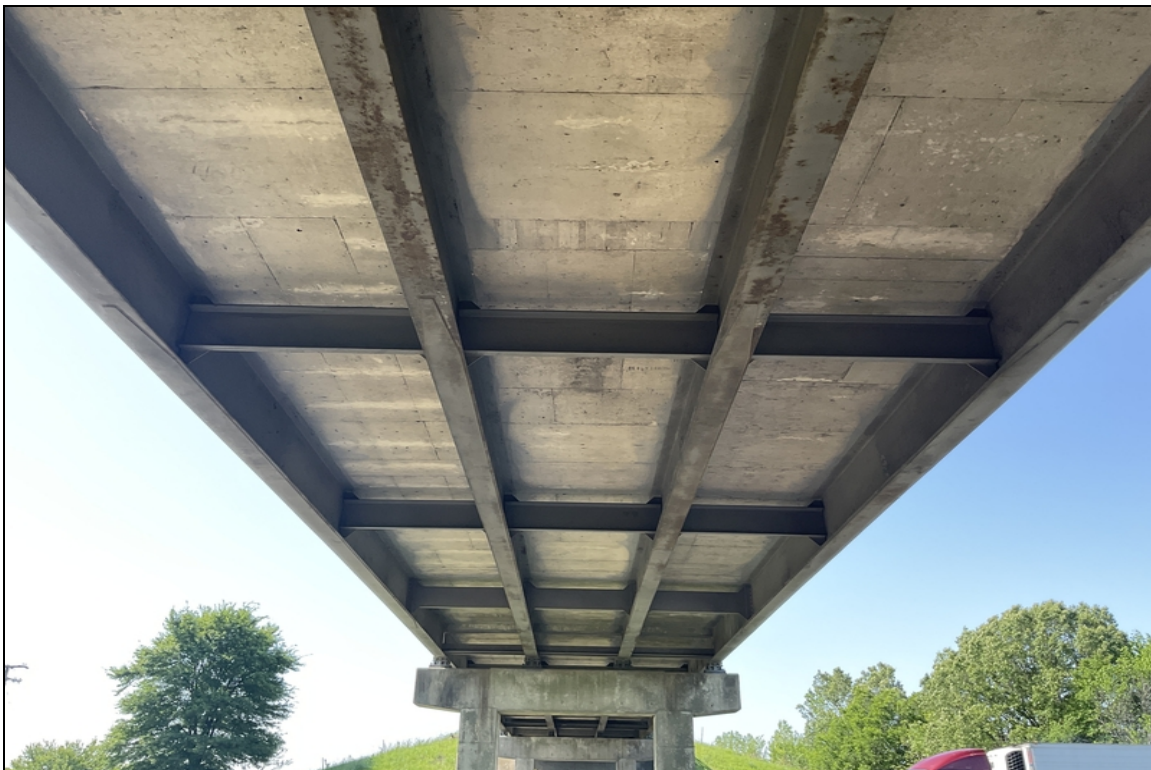
Span 3 soffit view

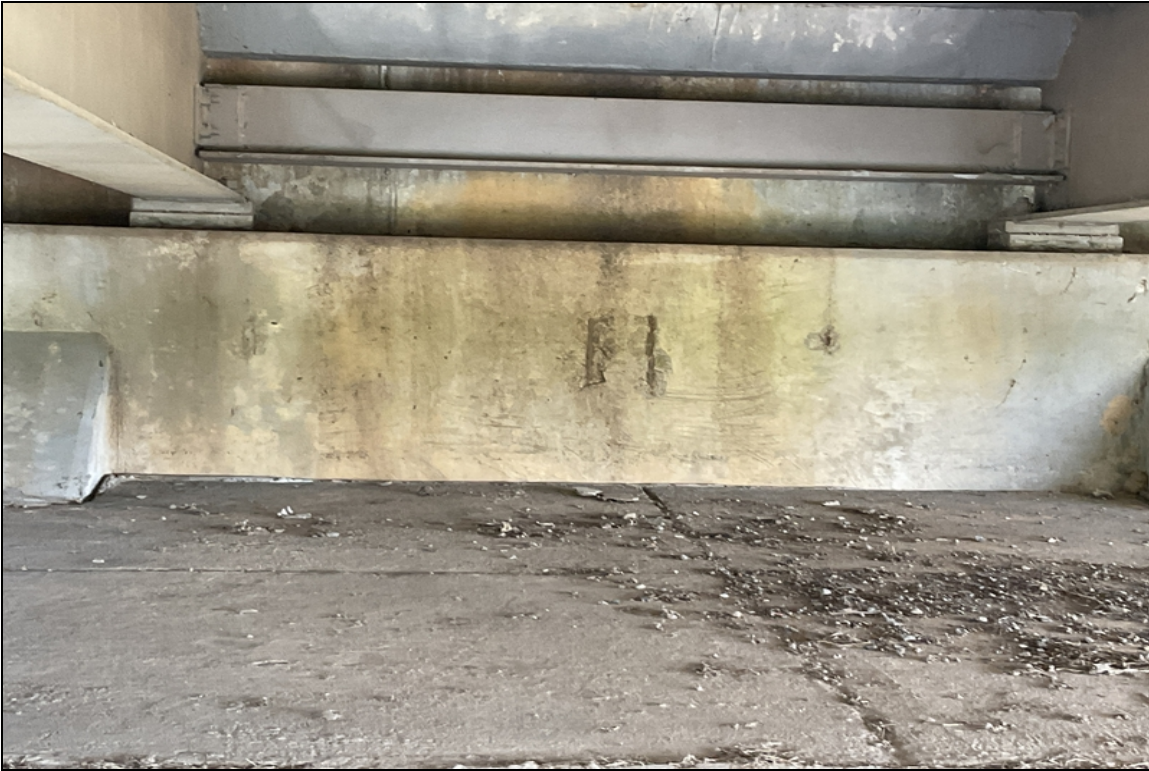
(215)							
Bent 5 has 2 exposed rebar and 1 delam.							
234	Reinforced Concrete Pier Cap	LF	60	57	3	0	0
1080	Delamination/Spall/Patched Area	LF	2	0	2	0	0
1090	Exposed Rebar	LF	1	0	1	0	0

Bent 5 exposed rebar

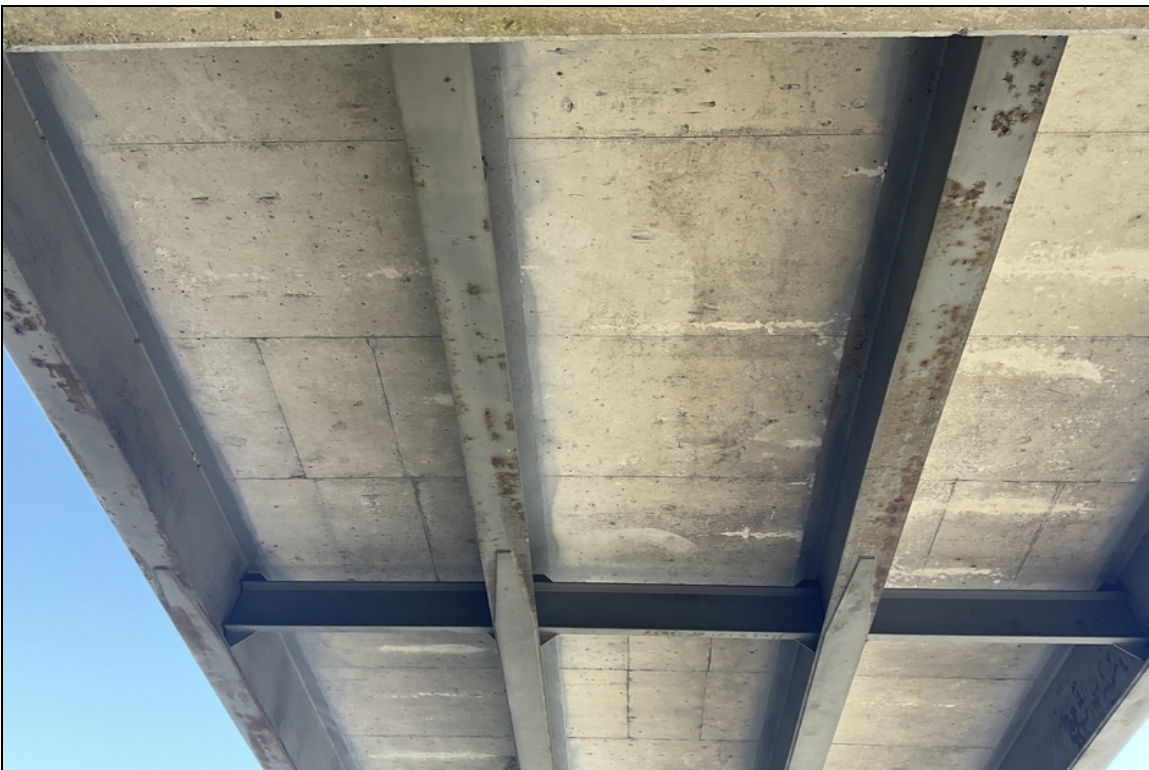
(107)							
HBM repainted the beams 5-1-2007. Scattered areas of freckled rust and small areas of peeling paint on all beams.							
205	Reinforced Concrete Column	EA	6	3	1	2	0
1080	Delamination/Spall/Patched Area	EA	1	0	1	0	0
1090	Exposed Rebar	EA	2	0	0	2	0

Span 2 freckled rust on bottom flanges

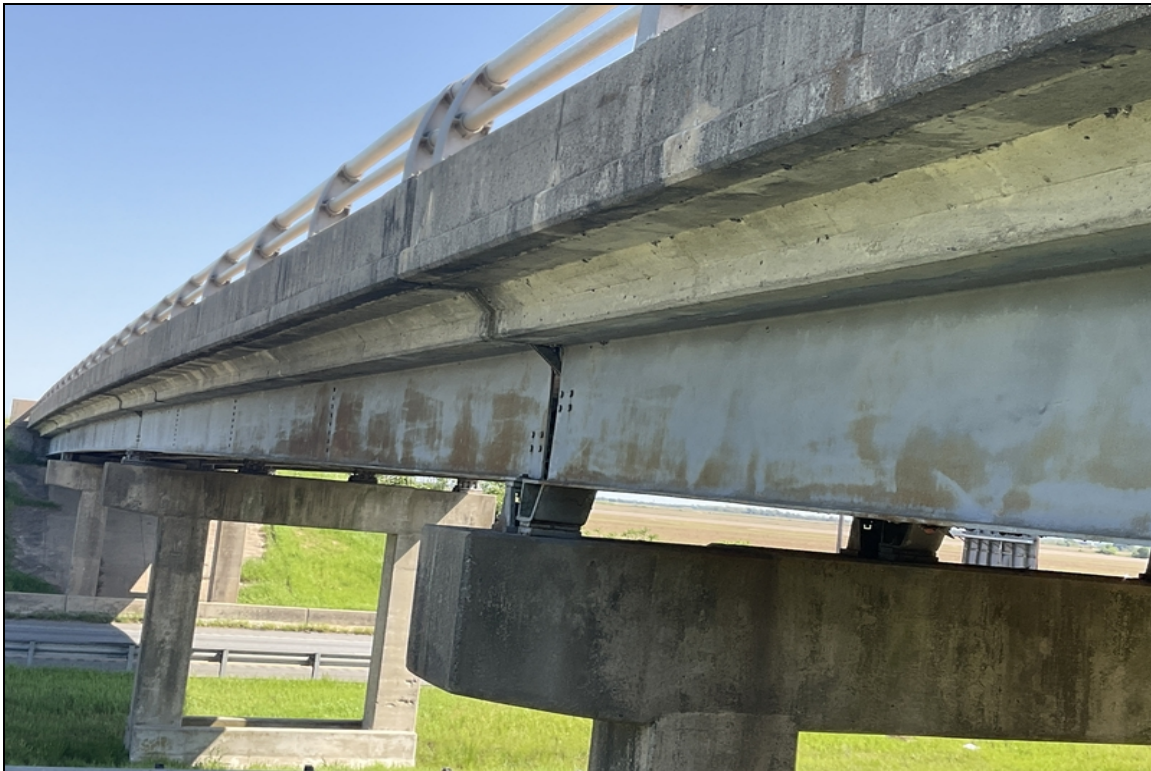
Typical paint condition

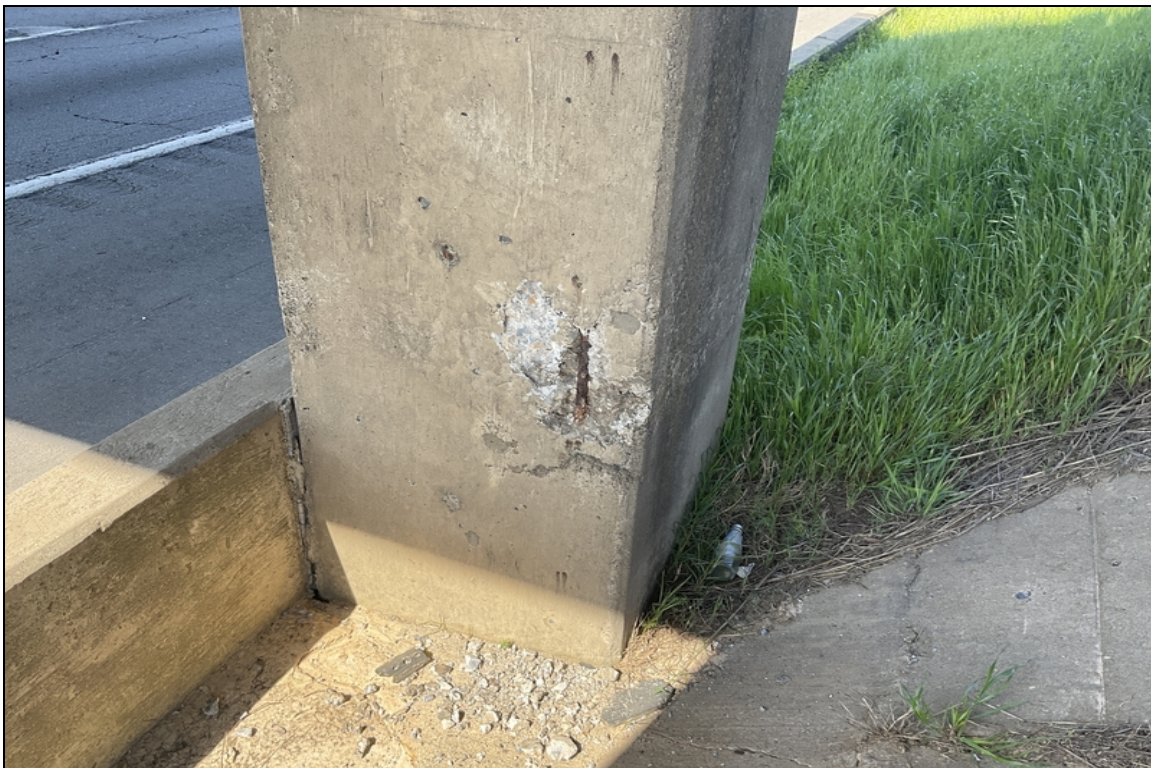
(205)							
Bent 3 left column has a small spall Bent 3, right column, spalls exposed rebar. Bent 4 Left column has spall with exposed rebar							
215	Reinforced Concrete Abutment	LF	57	54	3	0	0
1080	Delamination/Spall/Patched Area	LF	1	0	1	0	0
1090	Exposed Rebar	LF	2	0	2	0	0

Bent 4 Left column has spall with exposed rebar

Bent 3 column 2 and bent 4 column 1 have spalls with exposed rebar.

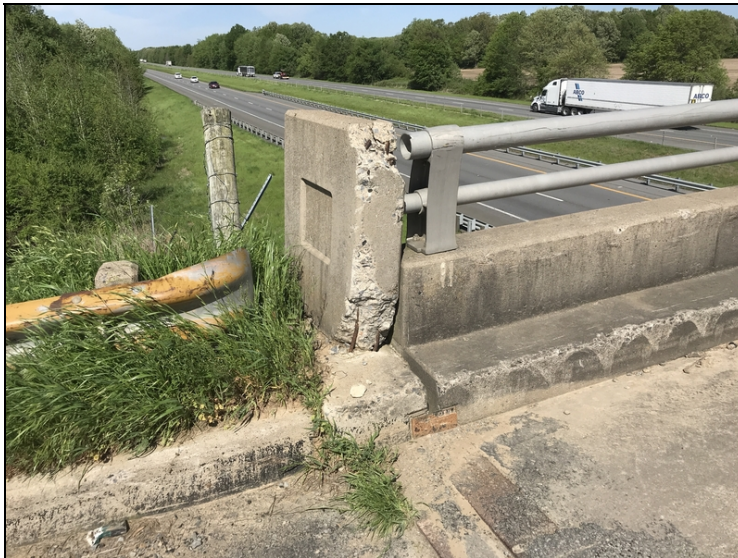
Left concrete end post at both abutment and both Bridge rails on spans 1 and 2 have traffic damage.  
Span 2 at bent 2 left rail is spalled from traffic impact

Left end post span 1 has spalls with exposed rebar.

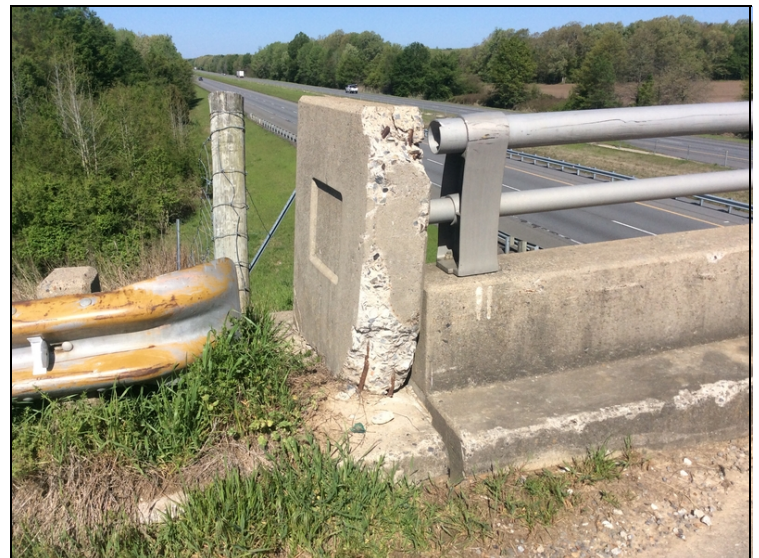
Left end post span 1 has spalls with exposed rebar.

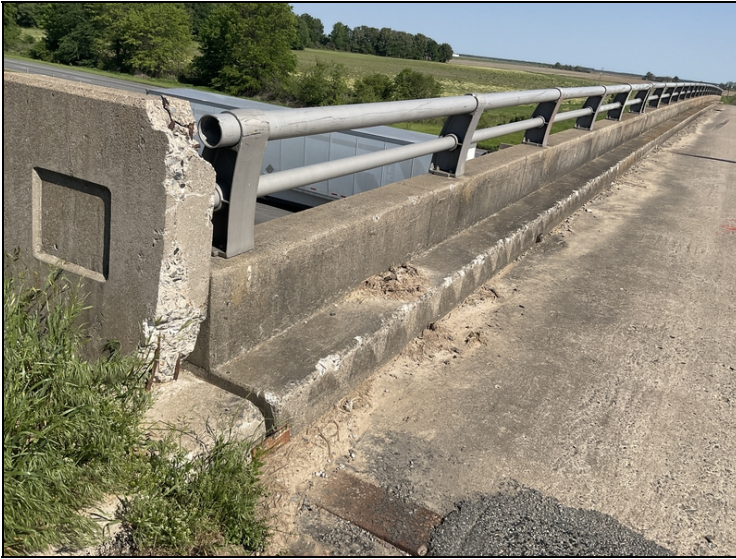
Left concrete end post at South abutment and both Bridge rails on spans 1 and 2 have traffic damage.

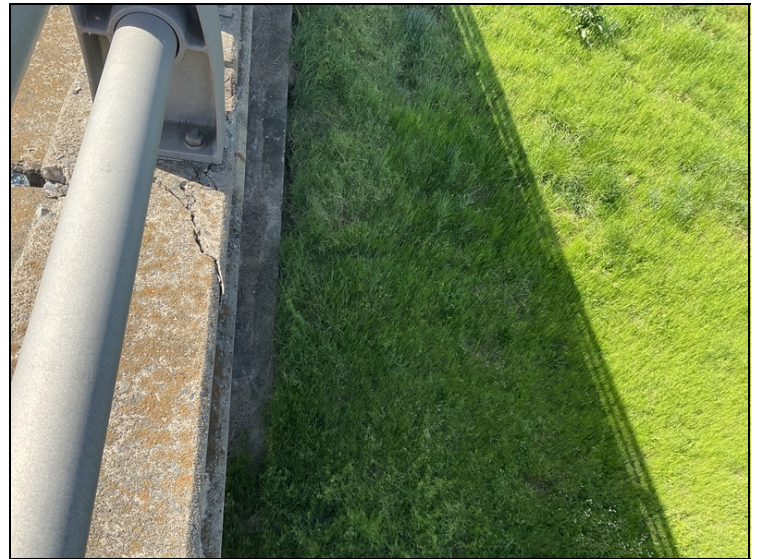
Span 2 at bent 2 left rail is spalled from traffic impact

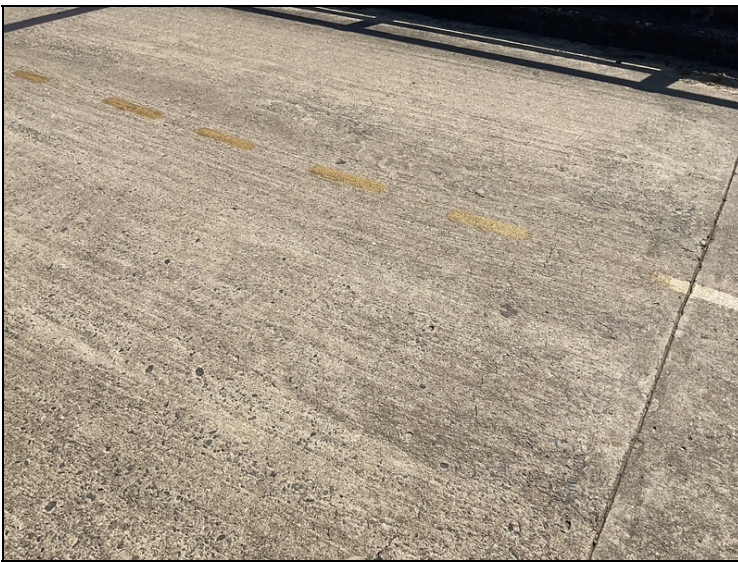
Deck has large unsealed up to 0.030 inch wide.

Span 3 unsealed cracks up to 0.030"

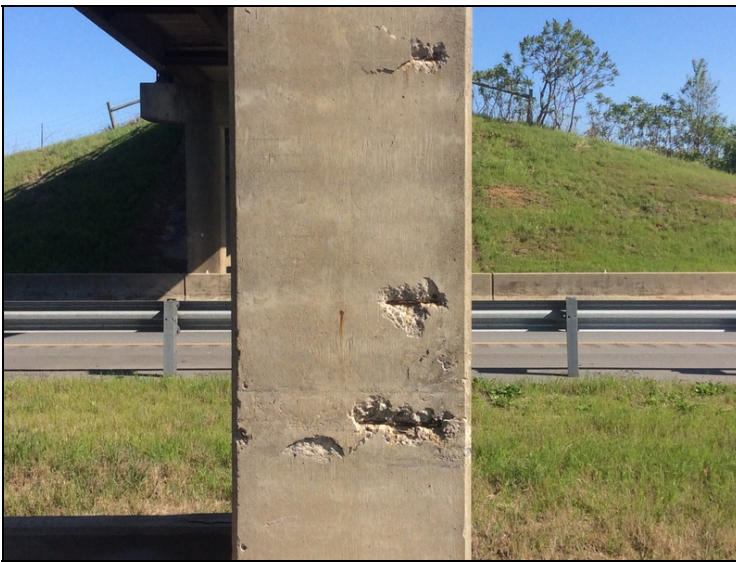
Bent 3 right column has spalls with exposed rebar.

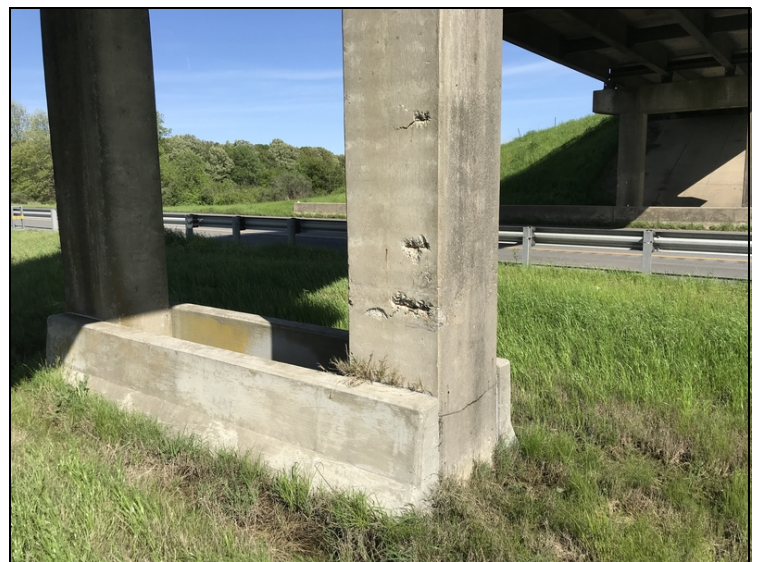
Bent 3, right column has spalls with exposed rebar
