Bridge #03656(Routine)

CR46-K Pauschert over I 40-SEC 41LOG 183.54

Team Lead: Bryan Saunders Inspection Date: July 19, 2022

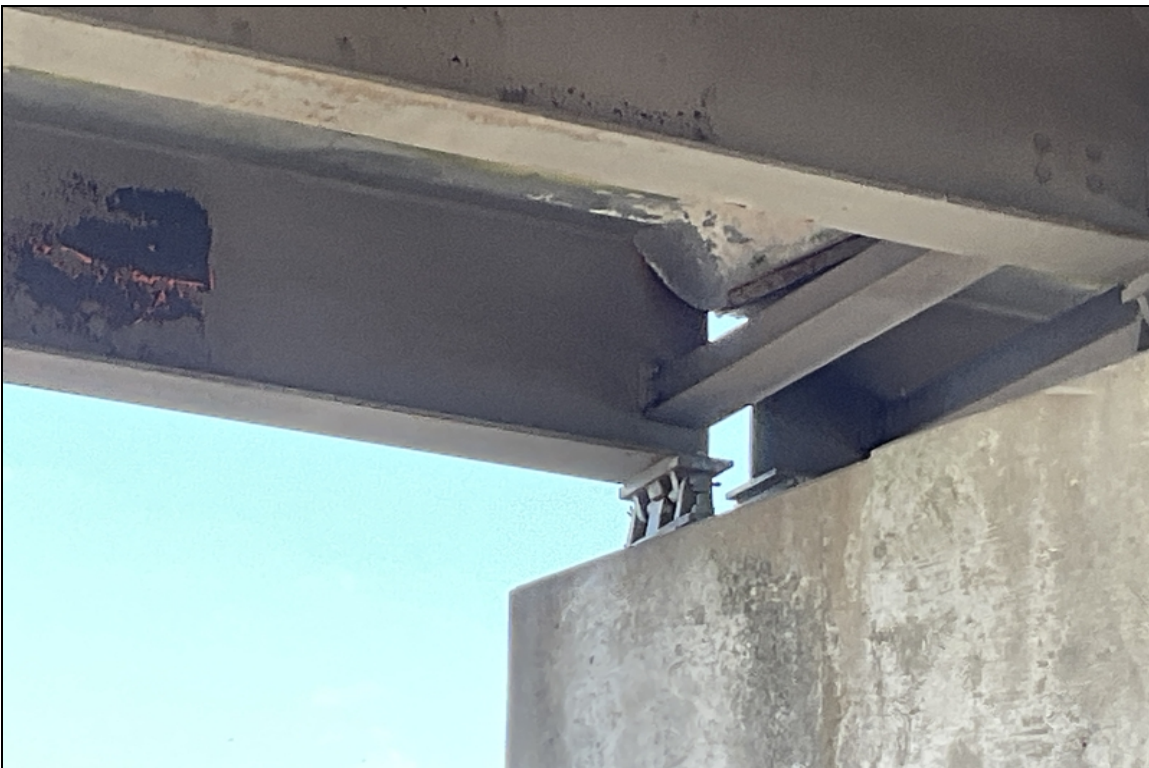
(107)	All beams have areas of scattered surface rust on web and flanges. Bent 3 beam 1 laminated rust in the haunch (107-515) Protective coating has peeling bubbling and cracking in all spans						
205	Reinforced Concrete Column	EA	6	3	3	0	0
1080	Delamination/Spall/Patched Area	EA	1	0	1	0	0
1090	Exposed Rebar	EA	2	0	2	0	0

Bent 3 beam 1

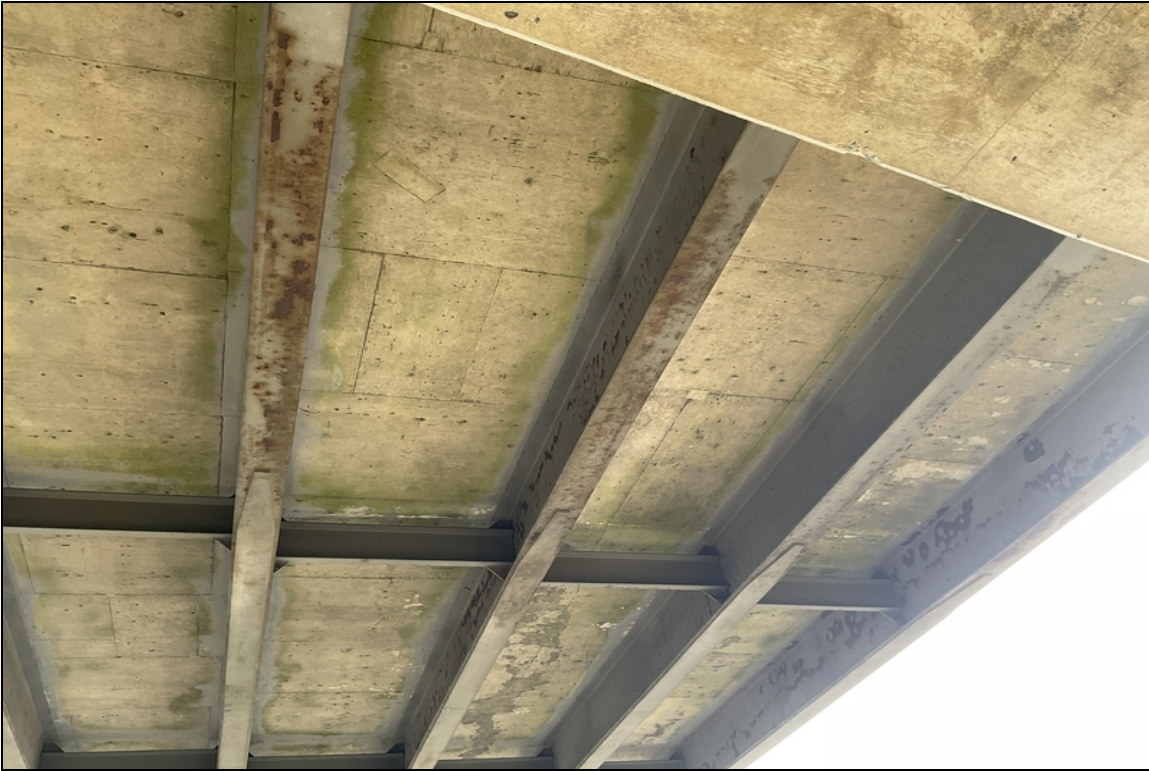
Protective coatings span Span 2 scattered areas of surface rust to webs and bottom flanges

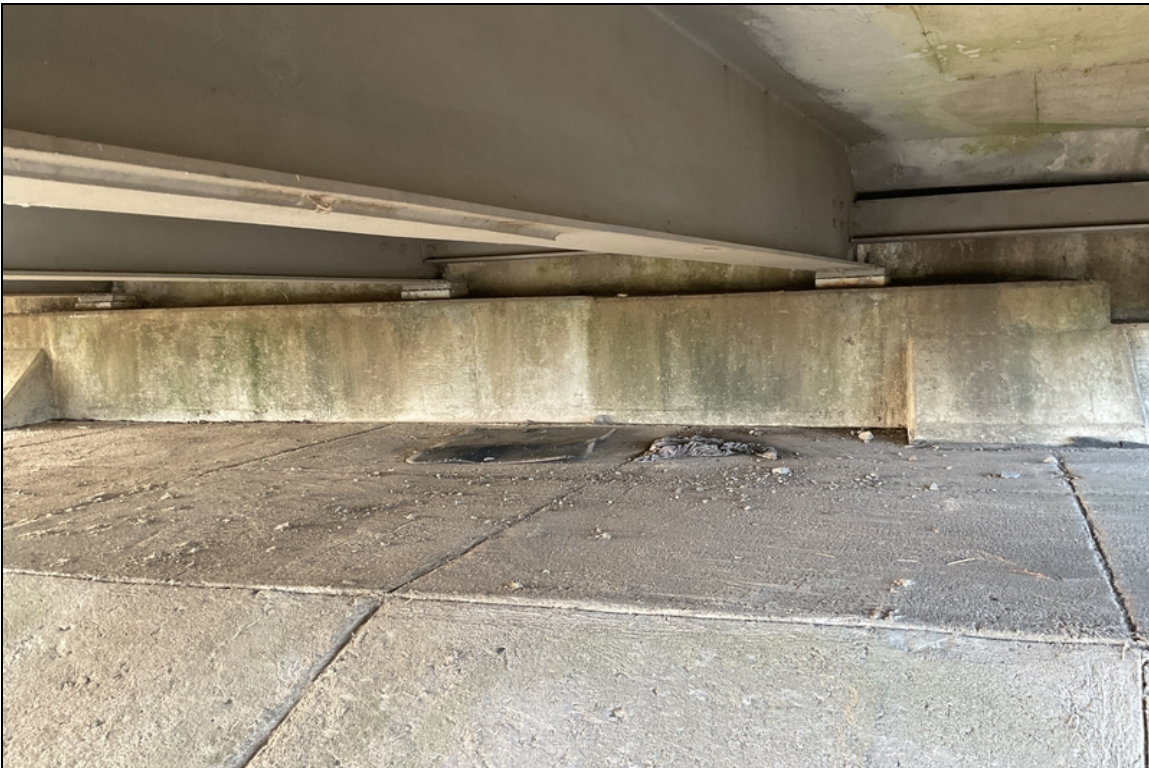
Bearings at bent 1 typical condition of most

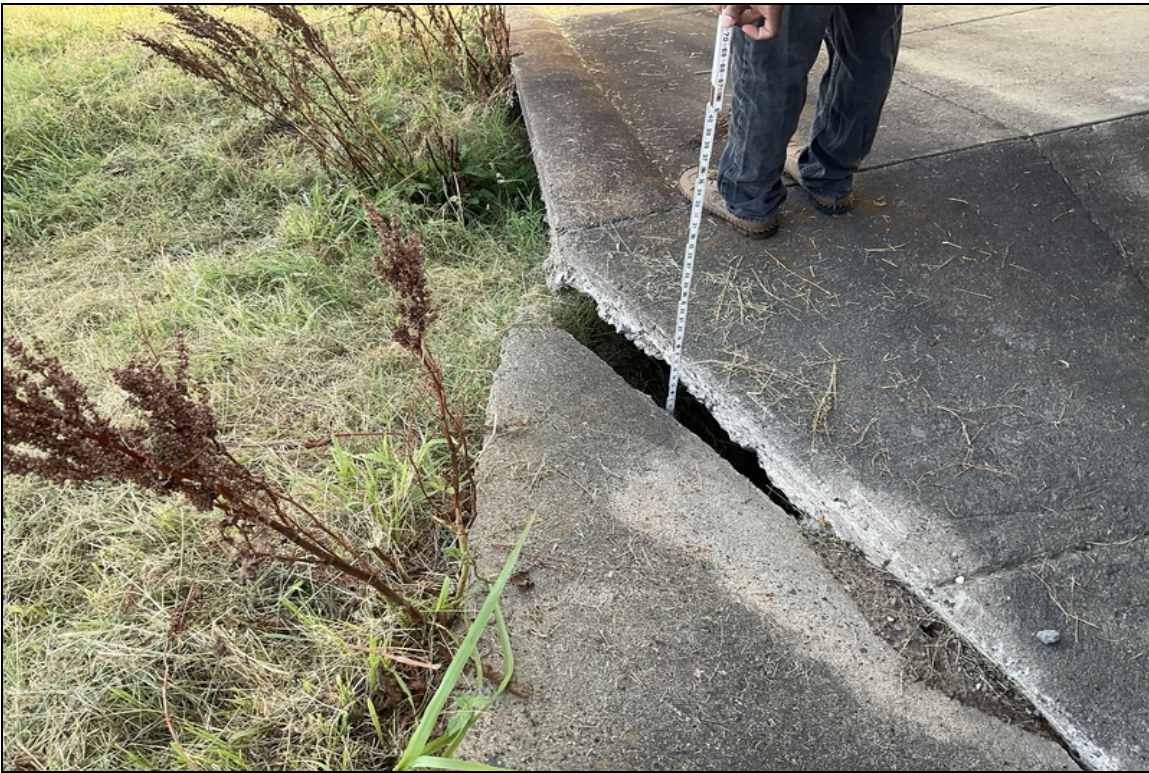
Void under slope pavement at bent 1

Bent 1, right side: erosion action creating a small void under slope pavement and large hole beside the slope pavement

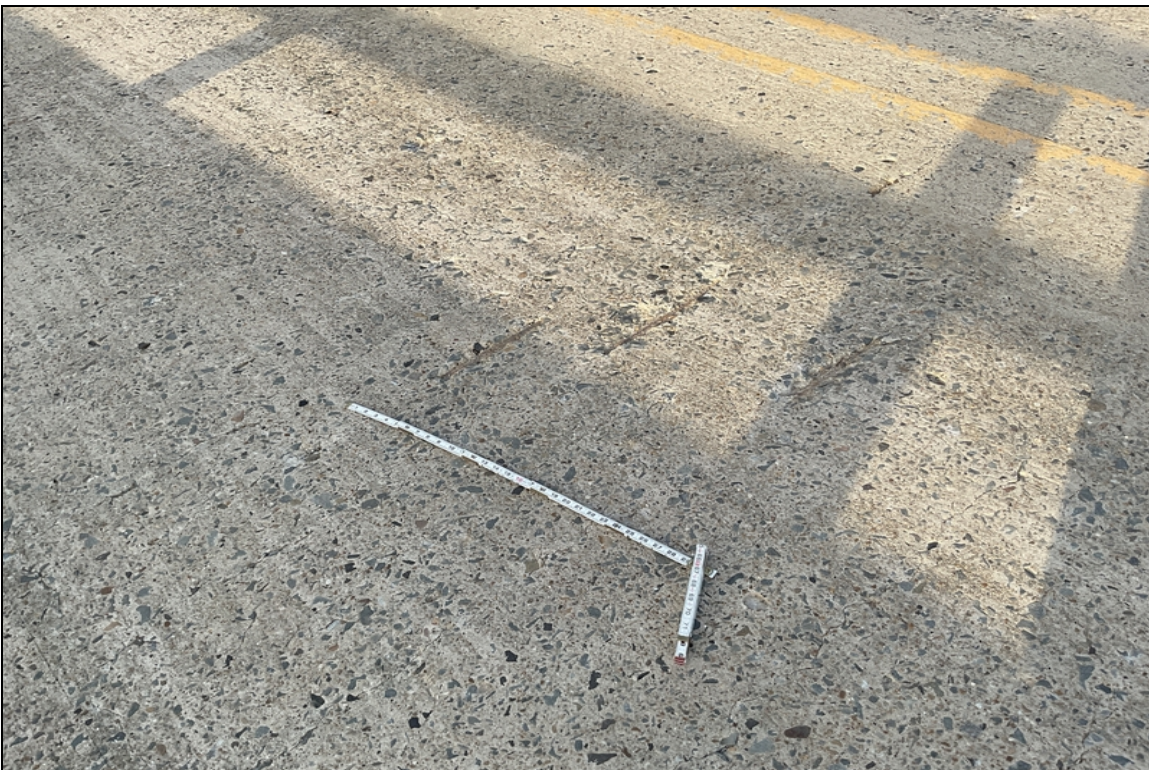
Rebar exposed in span 2

Deck has transverse and longitudinal unsealed cracks. Spaced 12 to 18 inches apart. Width 0.040 to 0.060 inches. Span 2 Deck has small spalls with rebar exposed.

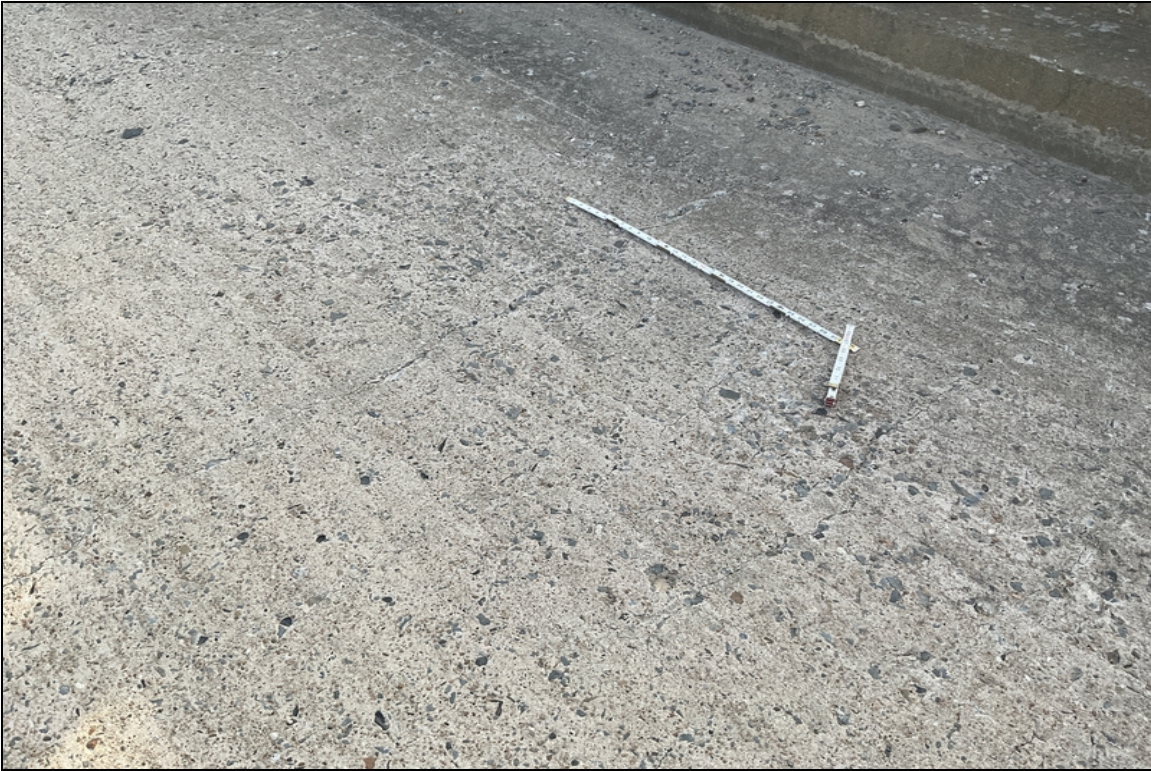
(12)	Deck has transverse and longitudinal unsealed cracks. Spaced 12 to 18 inches apart. Width 0.040 to 0.060 inches. Deck has small spalls with rebar exposed top and sides.						
107	Steel Open Girder/Beam	LF	1070	986	84	0	0
1000	Corrosion	LF	84	0	84	0	0
515	Steel Protective Coating	SF	8721	1	8000	720	0
3440	Effectiveness (Steel Protective Coatings)	SF	8000	0	8000	0	0
3420	Peeling/Bubbling/Cracking	SF	720	0	0	720	0

Large cracks in span 2

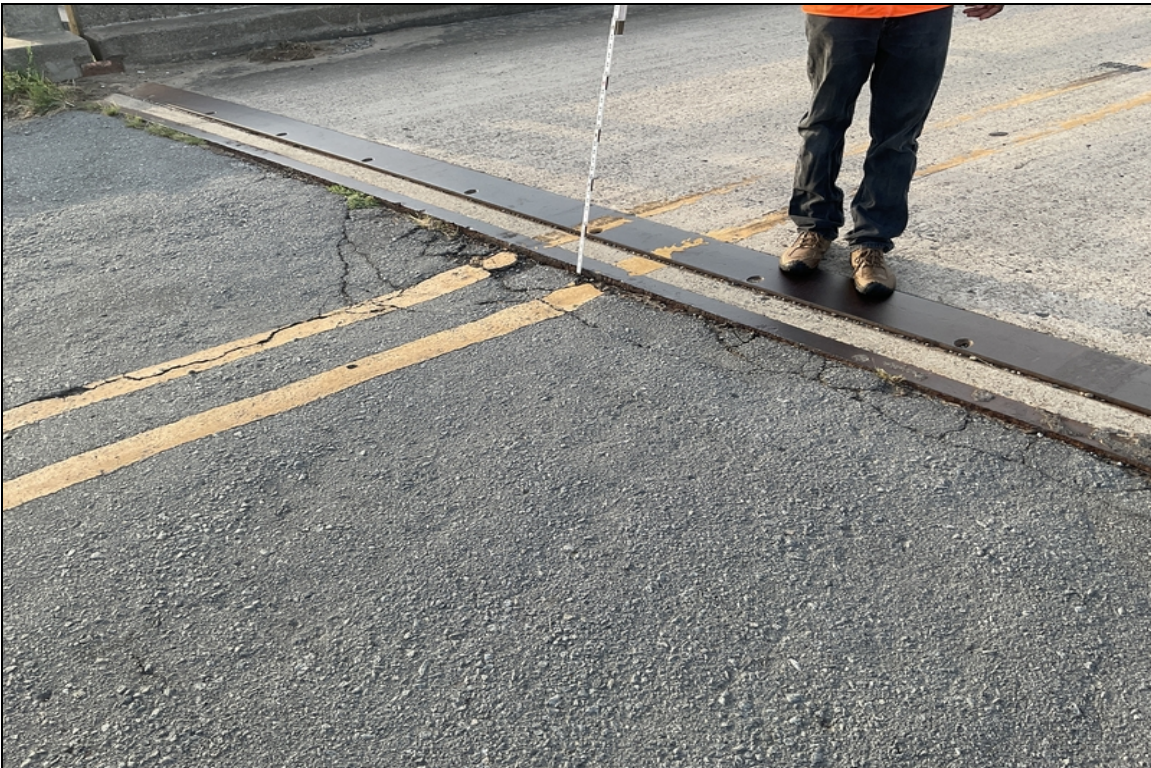
Approach roadway has settled

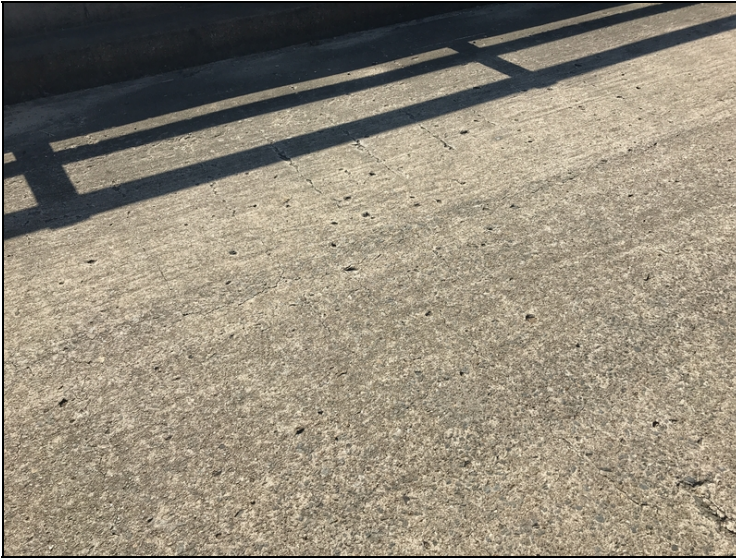
Span 4 transverse and longitudinal cracks up to 0.040"

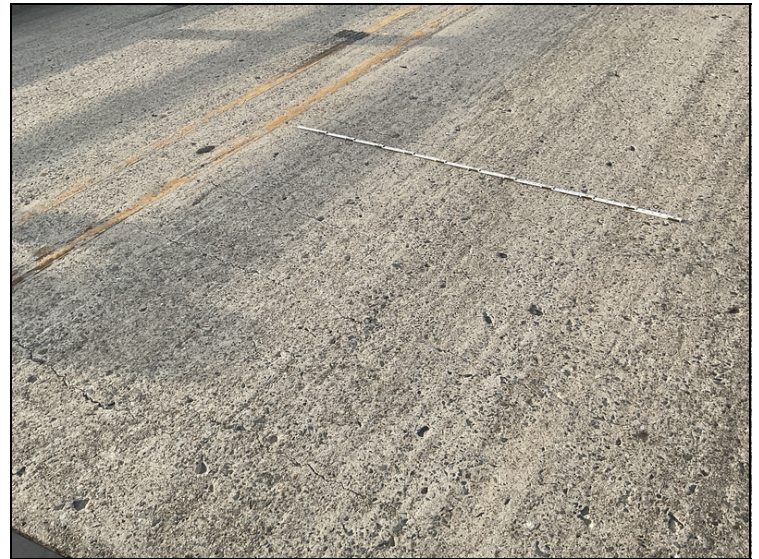
Deck cracks in span 4

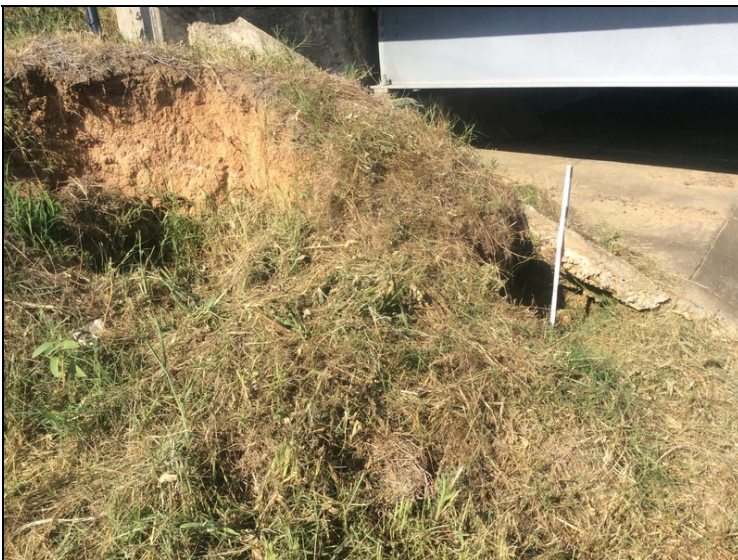
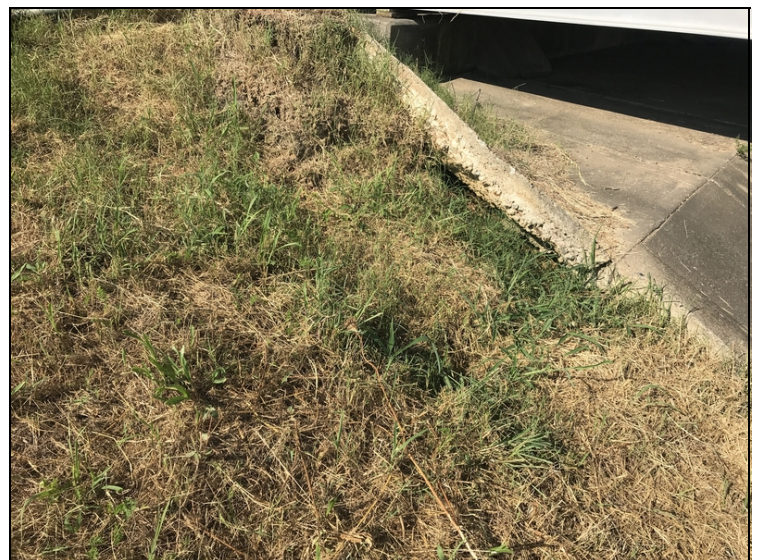
Bent 1, right side: erosion action creating a small void under slope pavement and large hole beside the slope pavement
