Bridge #03670(Routine)
CR12E Halijan Rd over I-40 Log 186.94
Location: 1.40 MI E LONOKE CO.LIN
Team Lead: Keith Harris Inspection Date: April 19, 2022

IDENTIFICATION	
(1) State Names	Arkansas
(8) Structure Number	03670
(5) Inventory Route	12
(2) Highway Agency District	06
(3) County Code	117-Prairie County, Arkansas

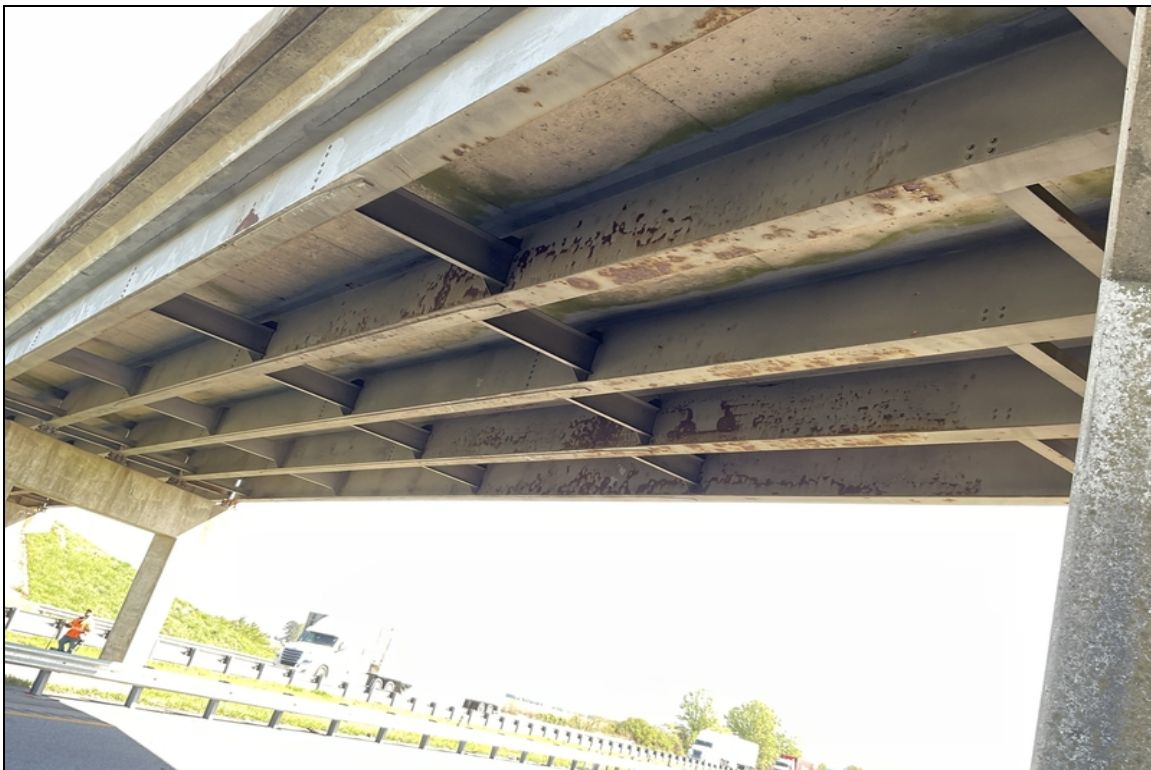
(107)	HBM repainted the beams 5-31-2007! Both of the outside beams are chalky, there are scattered areas of peeling paint on all beams and the bottom flanges and lower webs of all span shave freckled rust and some exposed metal with active rust.						
205	Reinforced Concrete Column	EA	6	6	0	0	0
215	Reinforced Concrete Abutment	LF	78	29	1	48	0
1080	Delamination/Spall/Patched Area	LF	49	0	1	48	0

Span 2 typical paint condition

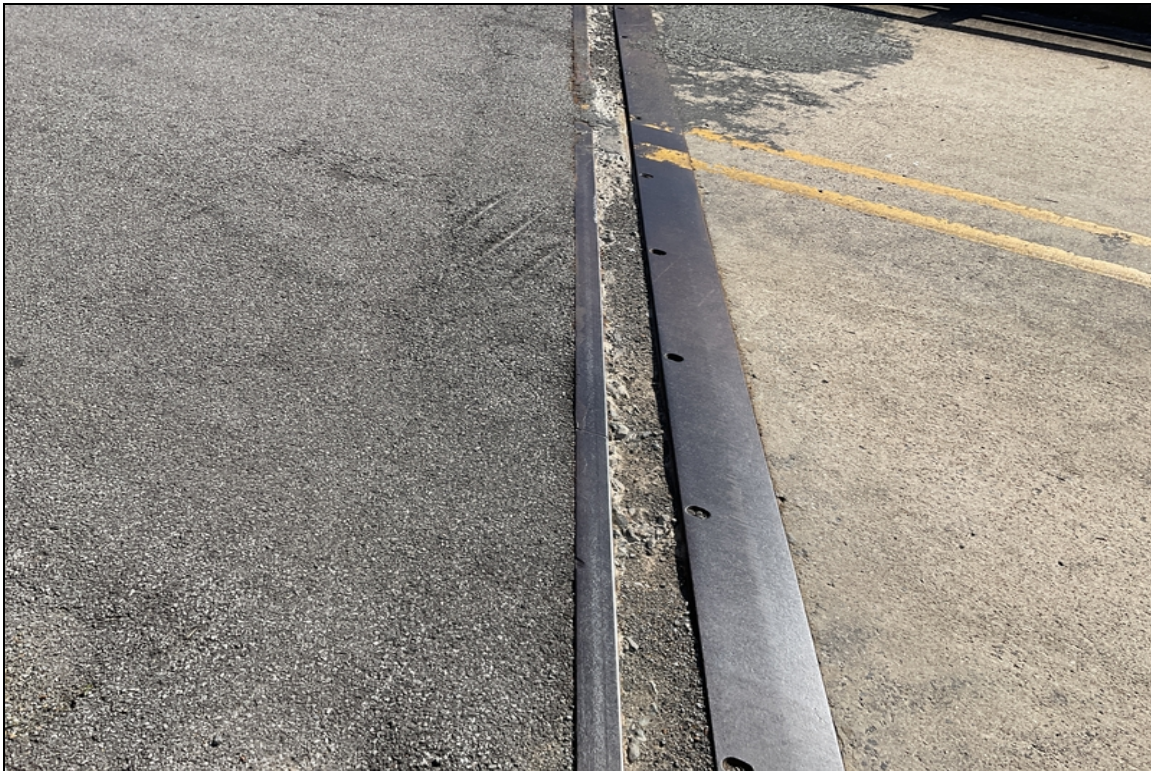
(215)	The top of back walls at both abutments are spalled. Bent 5 abutment has spall with exposed rebar.						
234	Reinforced Concrete Pier Cap	LF	90	89	1	0	0
1080	Delamination/Spall/Patched Area	LF	1	0	1	0	0

Bent 5 top of backwall is spalled

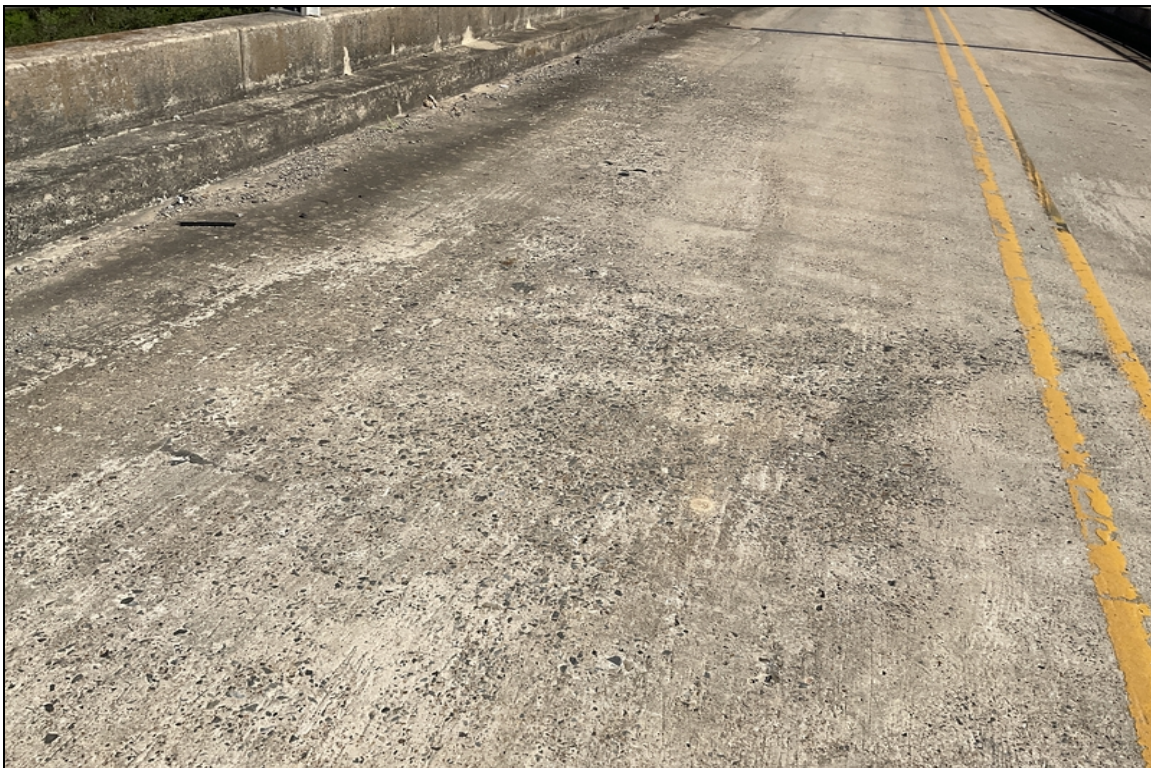
Span 3 abrasion/wear in left lane

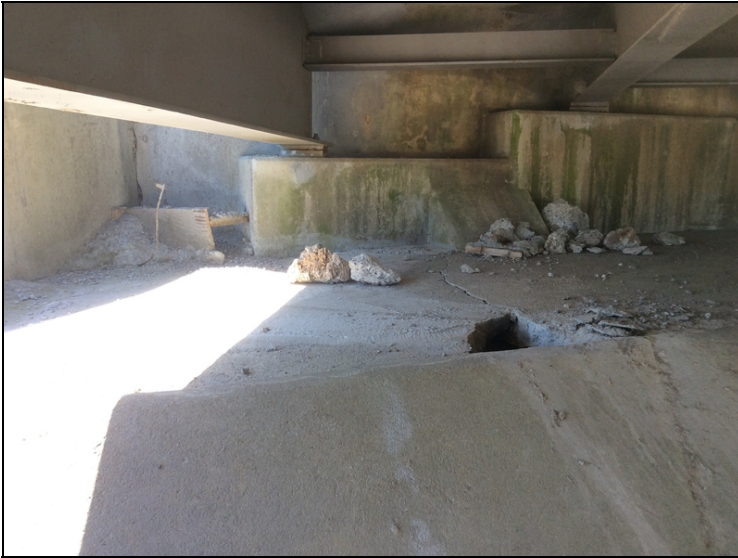
Broken pieces of concrete under the bridge at the south abutment.

Broken pieces of concrete at bent 5, south abutment.

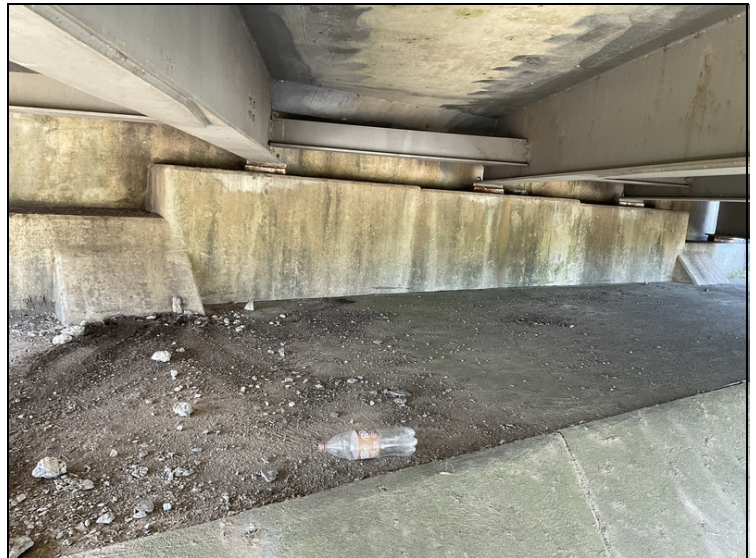
Most of the broken concrete has been removed

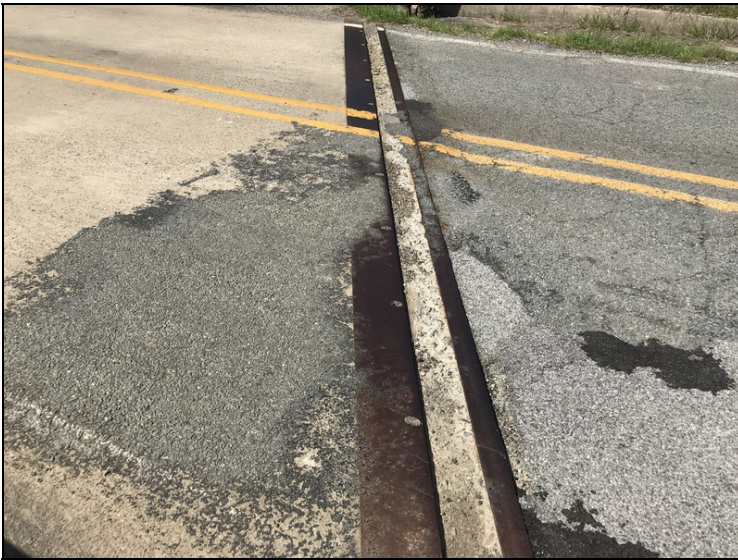
Spalls on top of back wall at bents 1 & 5 abutments.

Bent 5: top of back wall is spalled

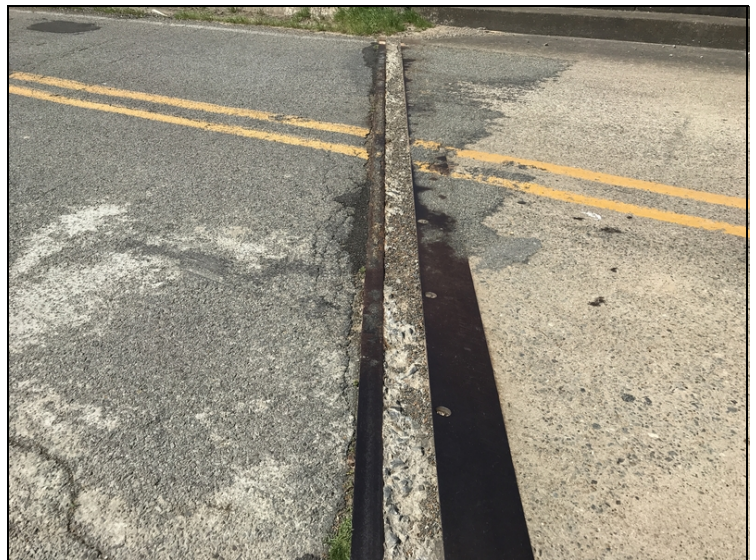
Bent 1 top of back wall has spalled

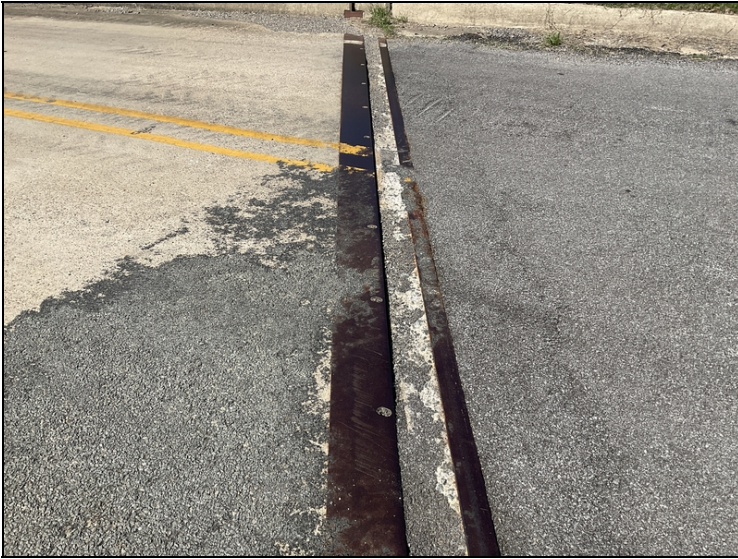
Bent 5 spalls on top on back wall.

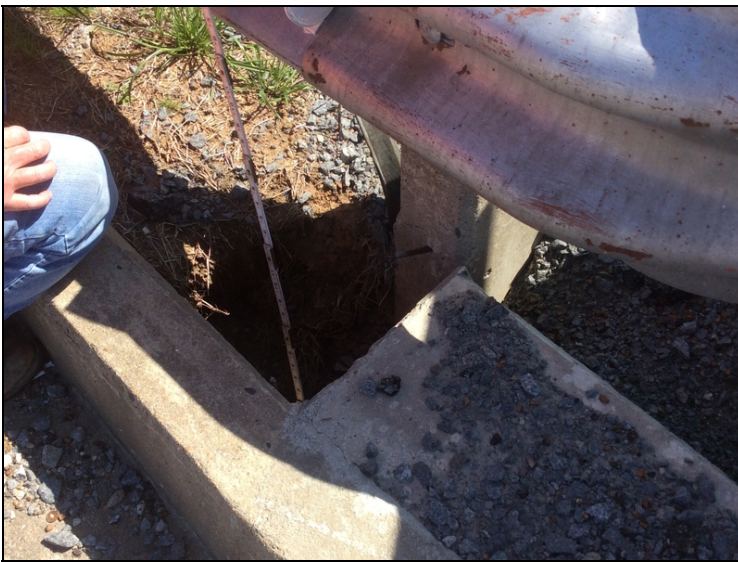
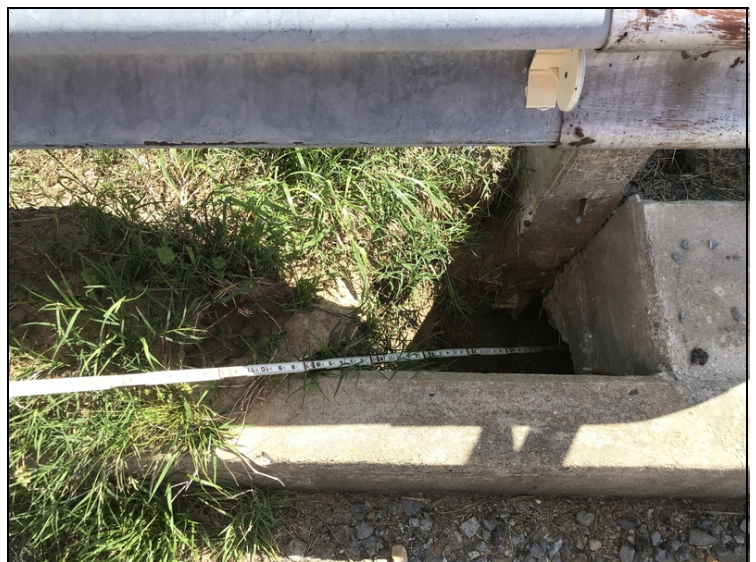
North abutment right approach gutter void.

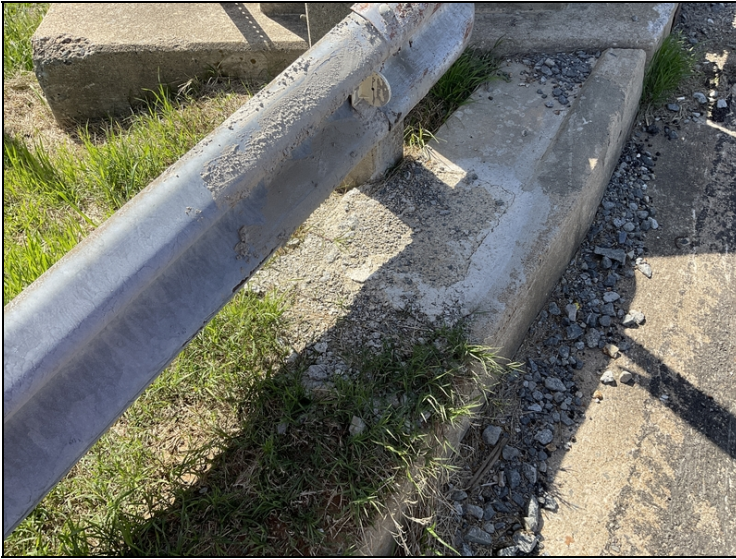
State forces have poured concrete in void

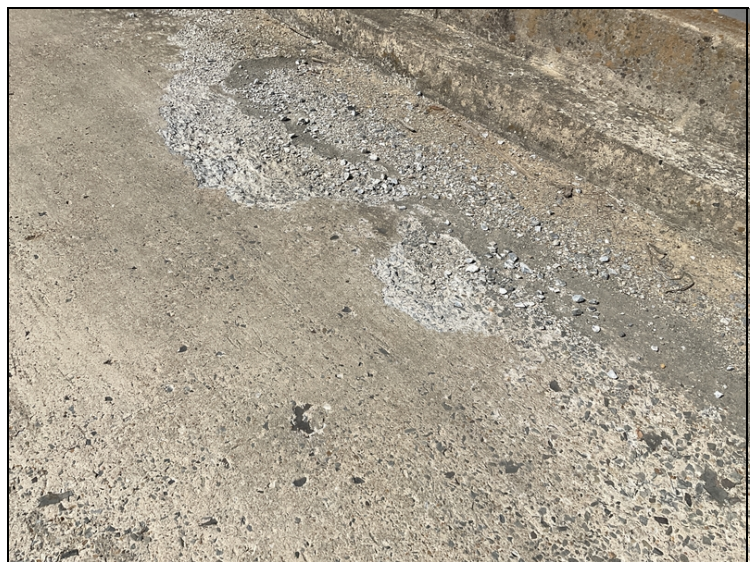
Span 3 spalls in left lane

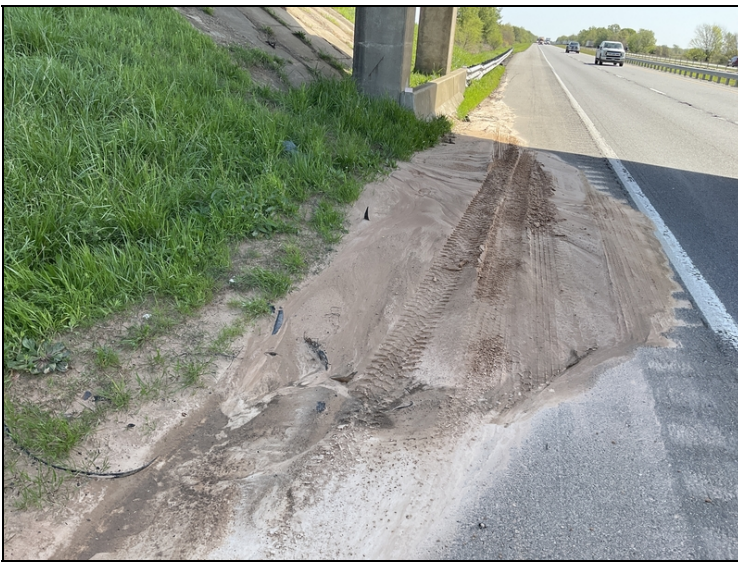
North side of bridge, erosion has caused a pile of dirt to accumulate on interstate shoulder.
