Bridge #03671(Routine)

CR 11-E Anderson over I-40 LOG 189.10

Team Lead: Keith Harris Inspection Date: April 19, 2022

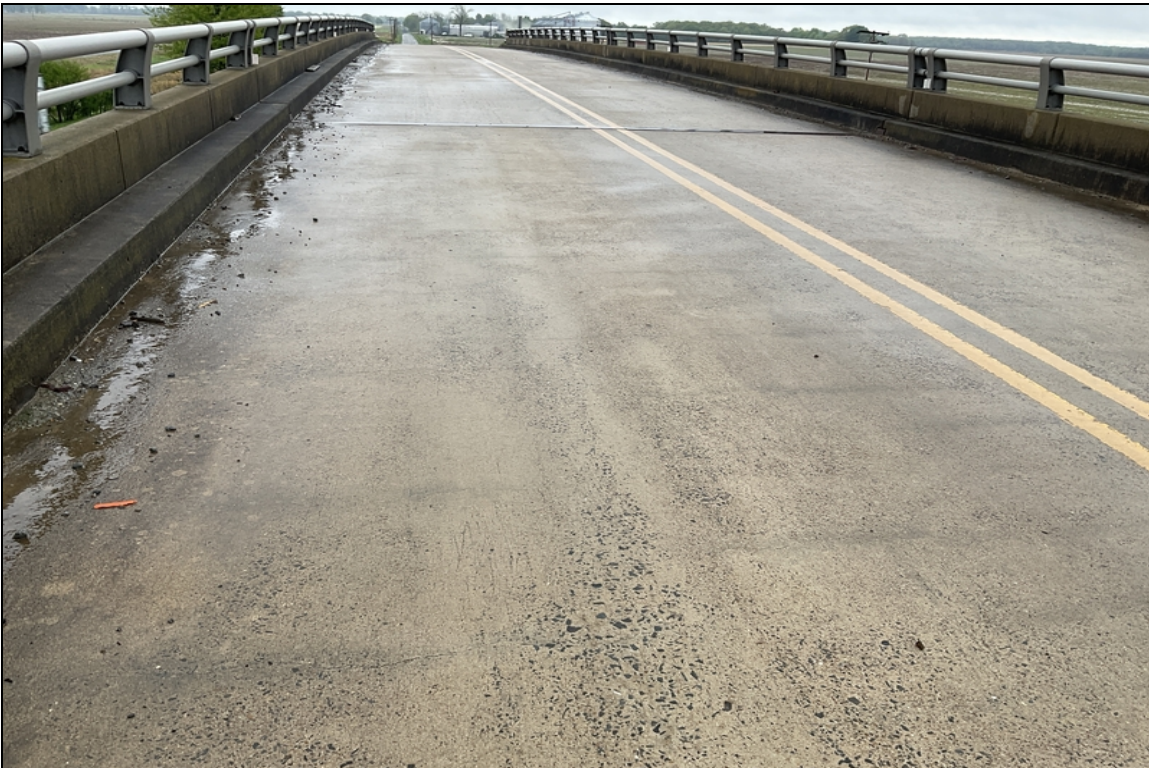
Deck overview

(12)	Unsealed transverse cracks on 1 to 3 foot centers. 0.030 to 0.060 inch width. Some reflect to the bottom of the deck with staining. Span 2 has small spall in the south bound lane. Scattered Small spalls on soffit of along top flange.						
107	Steel Open Girder/Beam	LF	1050	585	465	0	0
1000	Corrosion	LF	465	0	465	0	0
515	Steel Protective Coating	SF	7161	4506	1790	865	0
3440	Effectiveness (Steel Protective Coatings)	SF	2655	0	1790	865	0

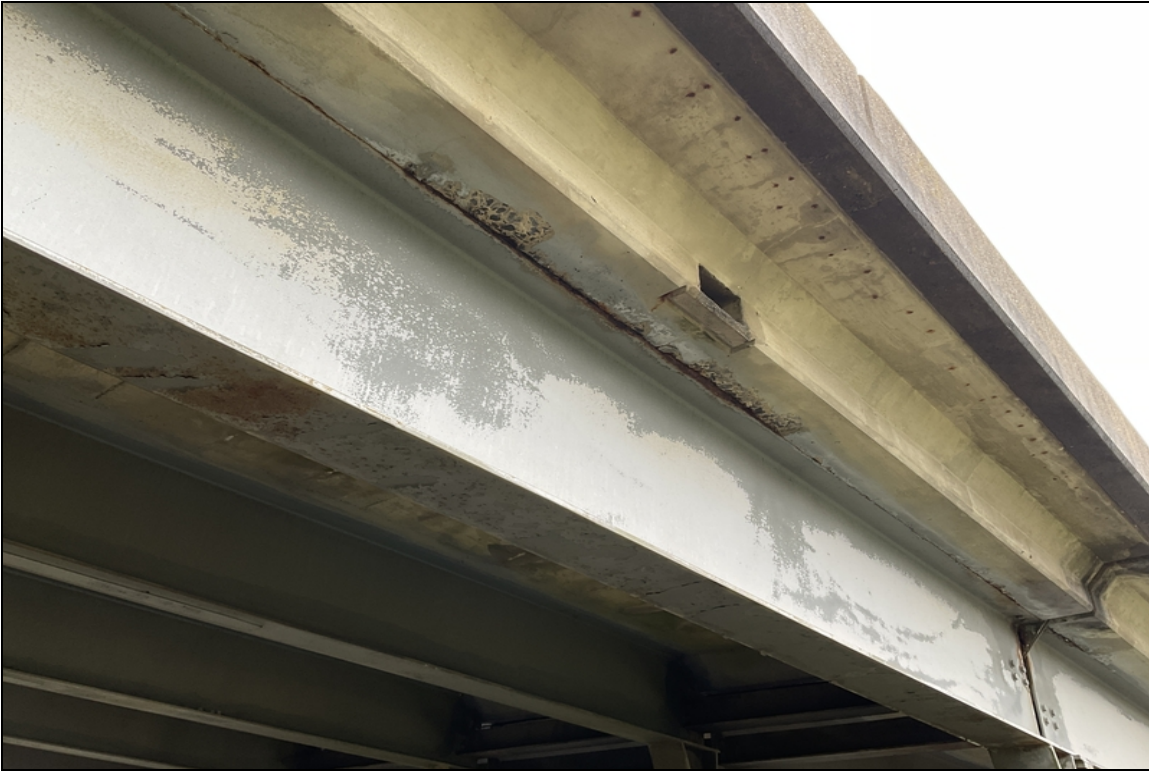
Span 1 small spalls along top flange

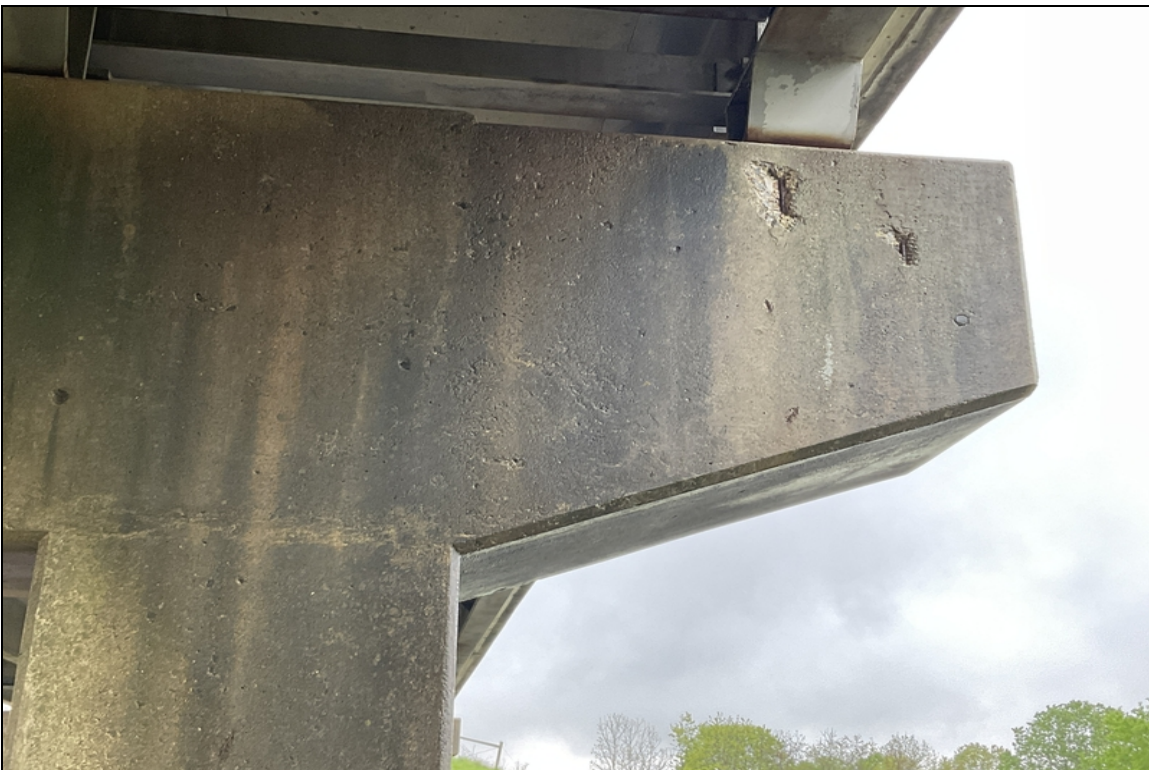
(234)	Exposed rebar at Bent 3, back side and ahead side. Bent 3 cap back side delam. Exposed rebar at Bent 4, ahead side left end. Bent 4 exposed rebar on cap left end. Bent 4 cap delam on ahead face.						
303	Assembly Joint with Seal	LF	143	143	0	0	0
311	Movable Bearing	EA	20	10	10	0	0
1000	Corrosion	EA	10	0	10	0	0
313	Fixed Bearing	EA	20	20	0	0	0
330	Metal Bridge Railing	LF	424	424	0	0	0

Bent 4 exposed rebar on ahead face

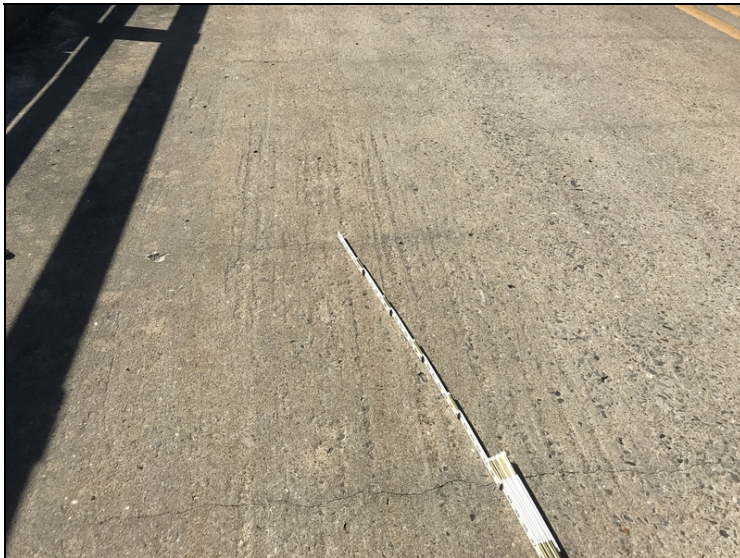
Deck: entire deck surface has multiple unsealed transverse deck cracks. Also, the deck surface has significant amount of wear.

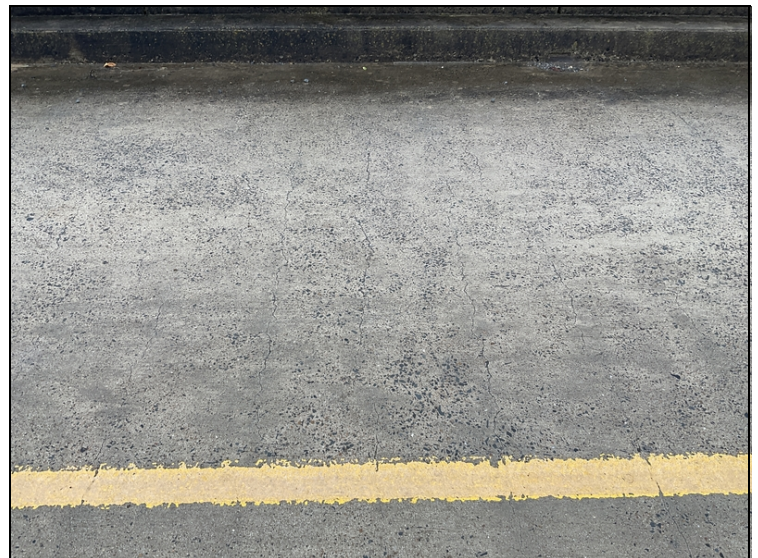
Deck has large unsealed cracks up to 0.060 inch wide at 1 foot intervals.

Span 1 Deck has large unsealed cracks up to 0.060 inch wide at 1 foot intervals.

**Date Reported:** 05/15/2012  
**Priority:** C - Important  
**Type of Work:** None  
**Status:** Monitor  
**Inspection Direction** S to N  
**Component:** Deck
