Bridge #03672(Routine)

SH 249 Log 3.52 over I-40 LOG 191.13

Location: INTER SH 249 & I 40

Team Lead: Keith Harris Inspection Date: April 18, 2022

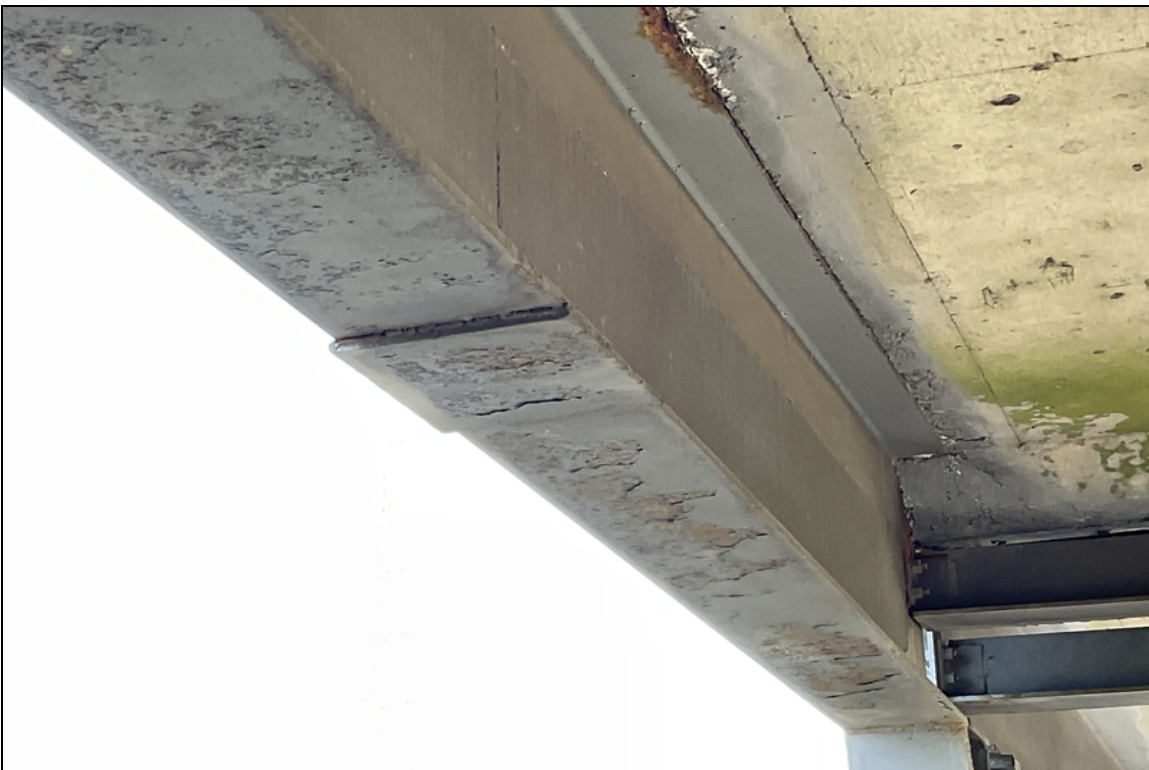
(107)							
HBM has repainted the beams in the past, date unknown.							
Span 1, beam 1 has been damaged and repaired in the past. The repair was a "tee" section repair with an additional plate welded to the bottom flange. The welds at the plate are cracked transversely. Beam ends at bents 2,3 & 4 have freckling and areas of surface rust in the upper web.							
All spans have areas of freckling rust on the bottom flanges							
205	Reinforced Concrete Column	EA	6	5	1	0	0
1080	Delamination/Spall/Patched Area	EA	1	0	1	0	0

Span 1 beam 1 repair, weld is cracked on added bottom plate. No change since last inspection.

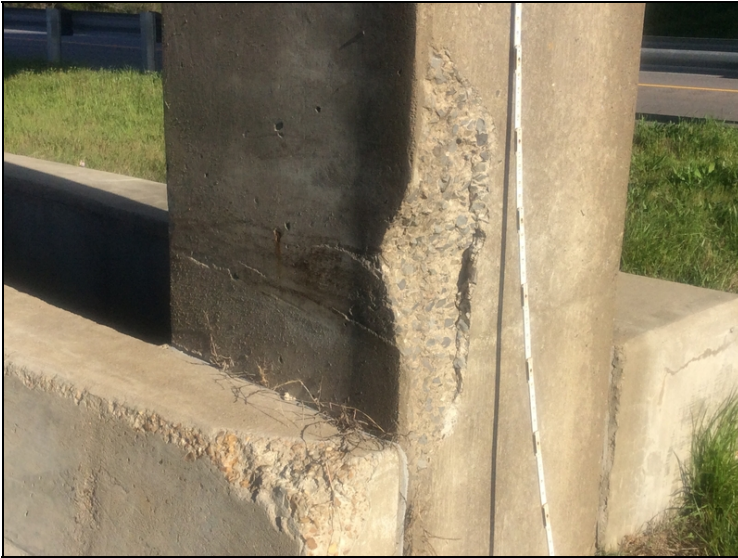
(205)							
Bent 3, right column has a spall.							
215	Reinforced Concrete Abutment	LF	90	87	3	0	0
1130	Cracking (RC and Other)	LF	3	0	3	0	0
(215)							
Bent 5 abutment has scattered cracks in the back wall.							
234	Reinforced Concrete Pier Cap	LF	85	72	13	0	0
1080	Delamination/Spall/Patched Area	LF	3	0	3	0	0
1090	Exposed Rebar	LF	6	0	6	0	0
1130	Cracking (RC and Other)	LF	4	0	4	0	0

Bent 3 column 2 has large spall due to traffic impact

Bent 3 column 2 has spall due to traffic impact.

**Date Reported:** 05/14/2012  
**Priority:** D- Routine  
**Type of Work:** Repair  
**Status:** Monitor  
**Inspection Direction** S to N  
**Component:** 205 - Reinforced Concrete Column

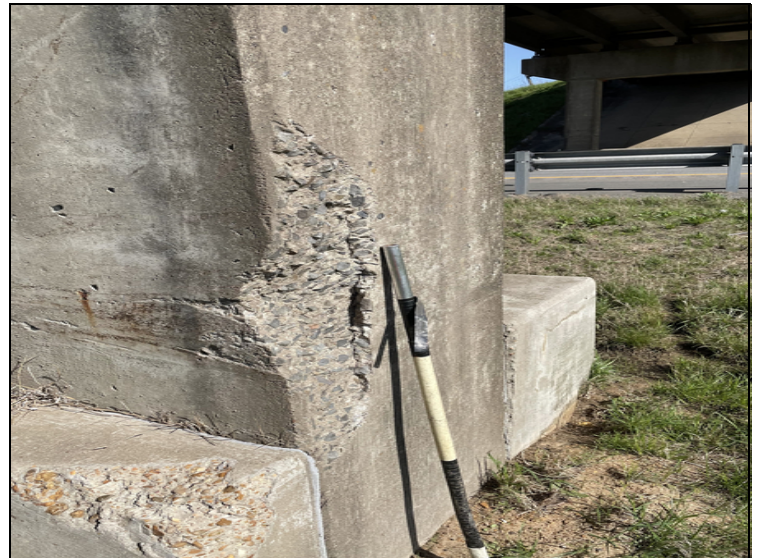
Bent 3 column 2 large spall

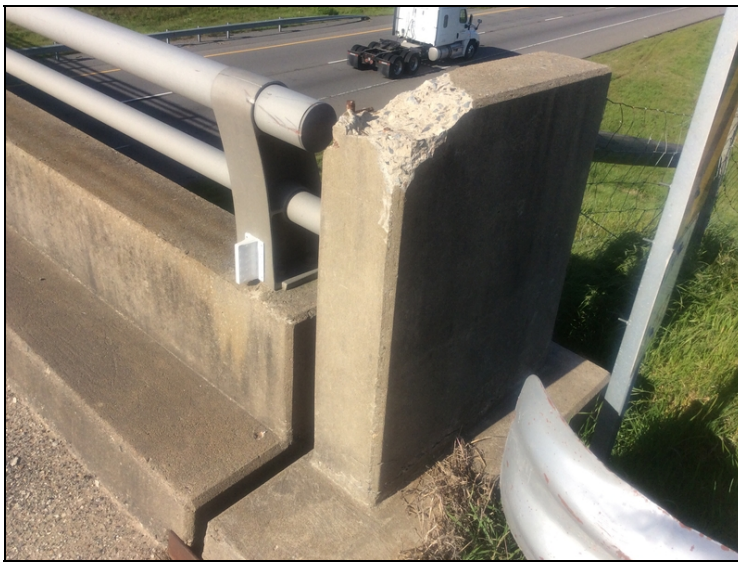
The left end post at bent 1 is spalled and the left end post at bent 5 is spalled. Both end post at bent 5 are cracked at the bottom.

Left end post at bent 5 has spall with exposed rebar and is cracked at the bottom. Common left end post bent 1.

**Date Reported:** 04/13/2016  
**Priority:** D- Routine  
**Type of Work:** Repair  
**Status:** Monitor  
**Inspection Direction** S to N  
**Component:** 331 - Reinforced Concrete Bridge Railing

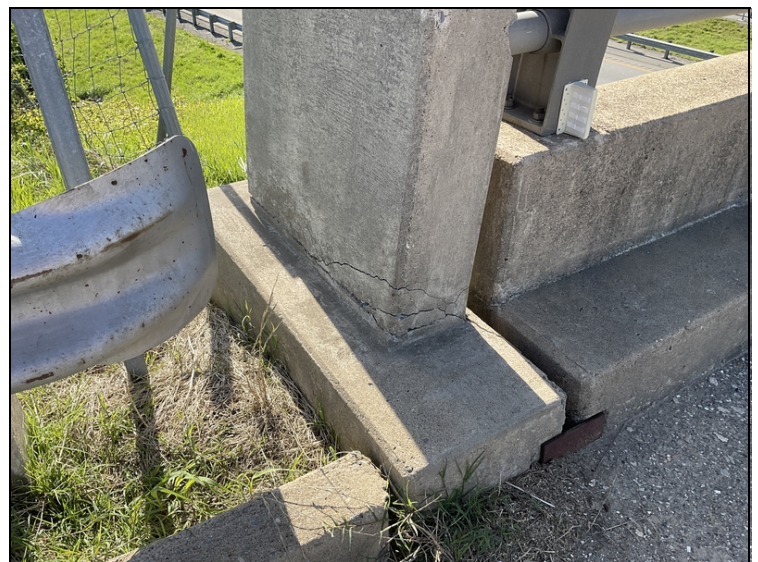
Bent 5 right end post cracked at bottom.
