Bridge #03708(Routine)
US HWY 63,SEC 11 over I 40-SEC 42 LOG 193.22

Location: 2.66 MI N US 70

Team Lead: Keith Harris Inspection Date: September 23, 2021

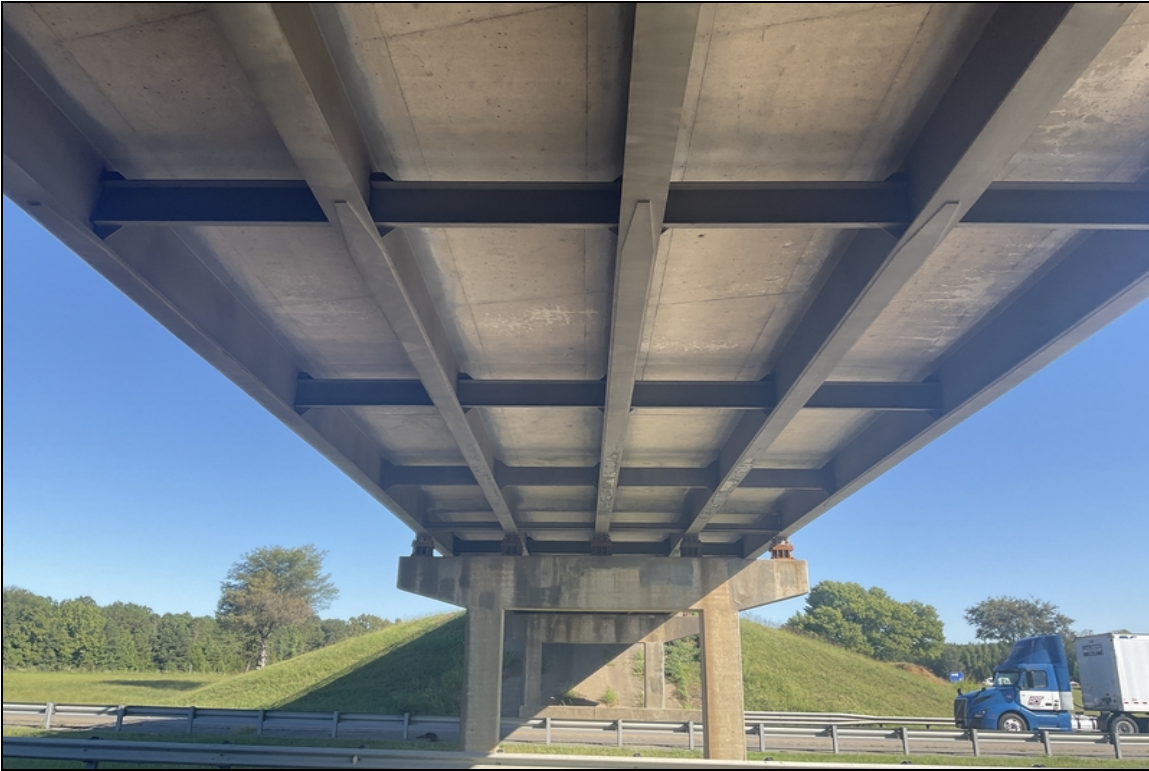
Span 3 under view

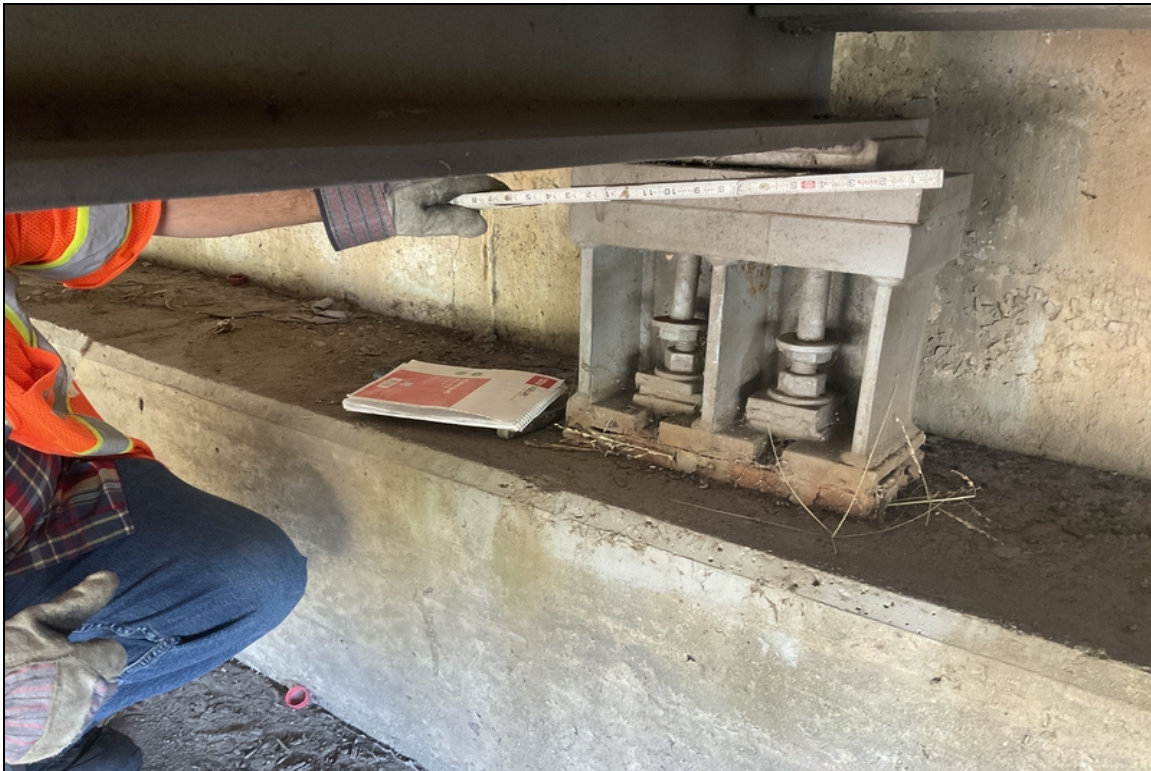
Bent 5 bearing 4 has 2 missing anchor nuts

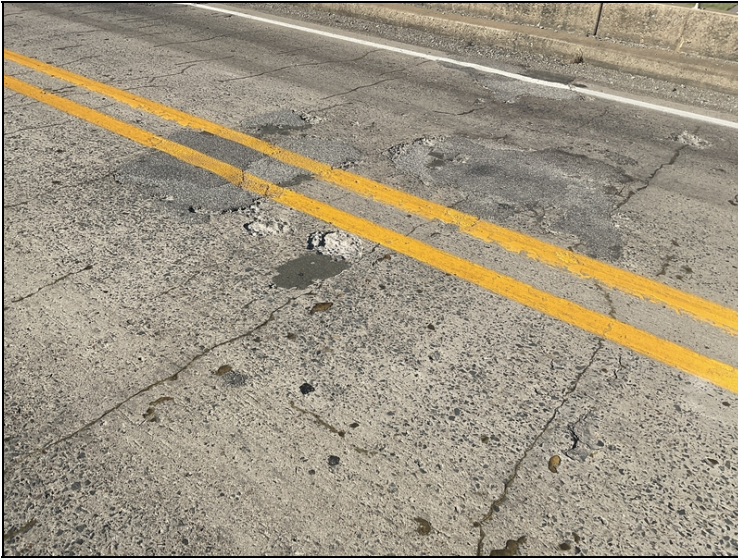
All spans have spall and spalls filled with asphalt

Span 2 spalls and spalls filled with asphalt

Date Reported: 09/17/2019
Priority: C - Important
Type of Work: Repair
Status: Monitor
Inspection Direction N to S
Component:

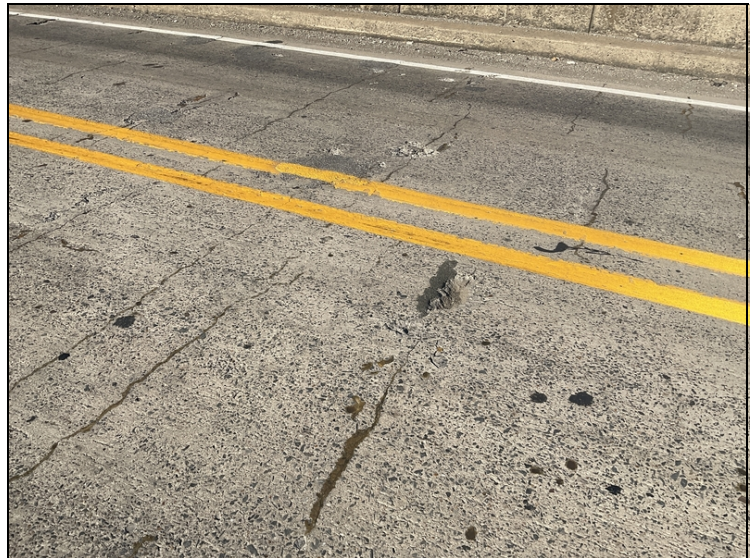
Span 3 spalls and spalls filled with asphalt

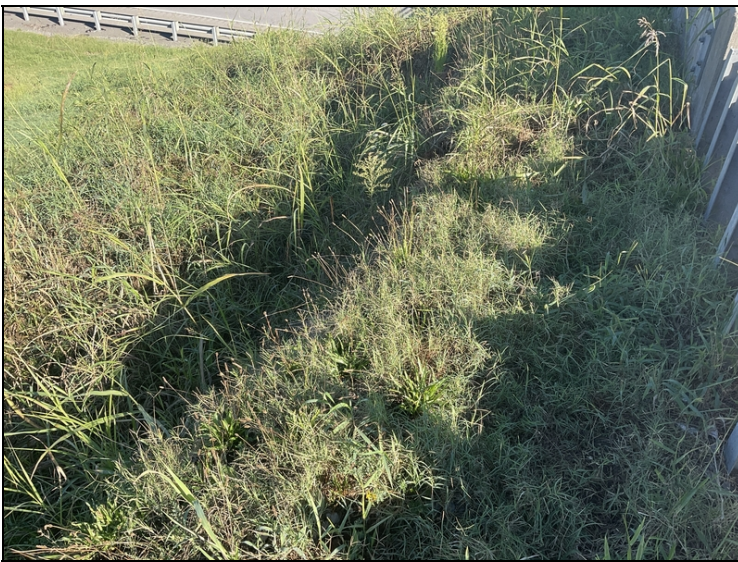
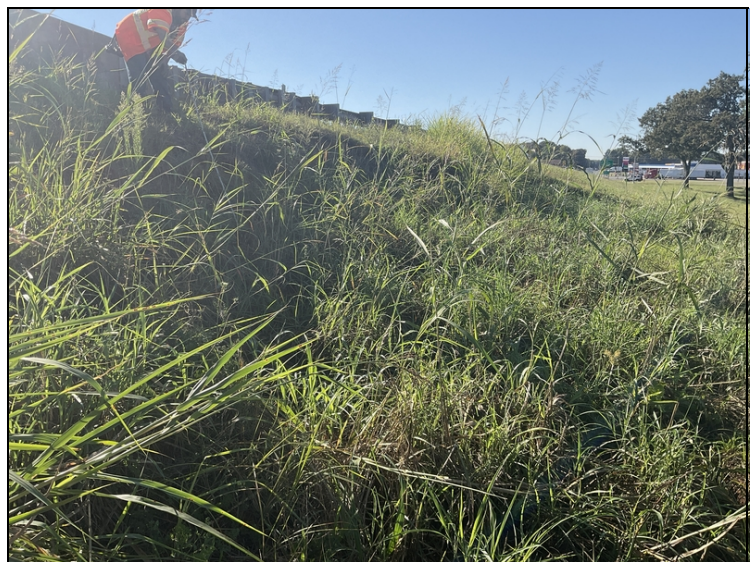
Southwest side of approach roadway embankment has a large sink hole 4' behind guardrail.

Date Reported: 09/23/2021
Priority: C - Important
Type of Work: Repair
Status: Open
Inspection Direction N to S
Component:

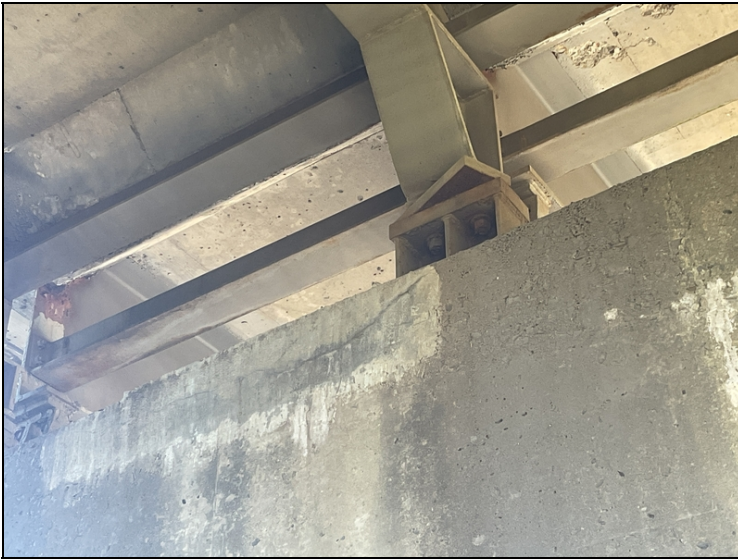
Span 4 at Bent 4 bearing 4 left side of bearing has moved out approximately 3"

Date Reported: 09/23/2021
Priority: B - Pressing; 6 month completion goal
Type of Work: Repair
Status: Open
Inspection Direction N to S
Component:

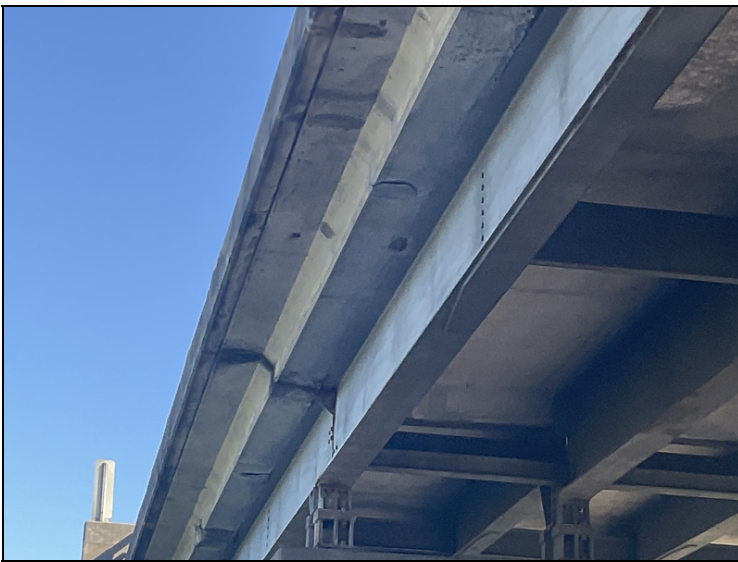
Delam on right side of beam 1 over westbound slow lane traffic.

Delam on right side of beam 1 over westbound
slow lane traffic.

Date Reported: 09/23/2021
Priority: A - Safety deficiency; requires prompt action
Type of Work: Repair
Status: Open
Inspection Direction N to S
Component:
