Bridge #03710(Routine)

CR705G Wattensaw over I -40 LOG 196.32

Team Lead: Keith Harris Inspection Date: April 18, 2022

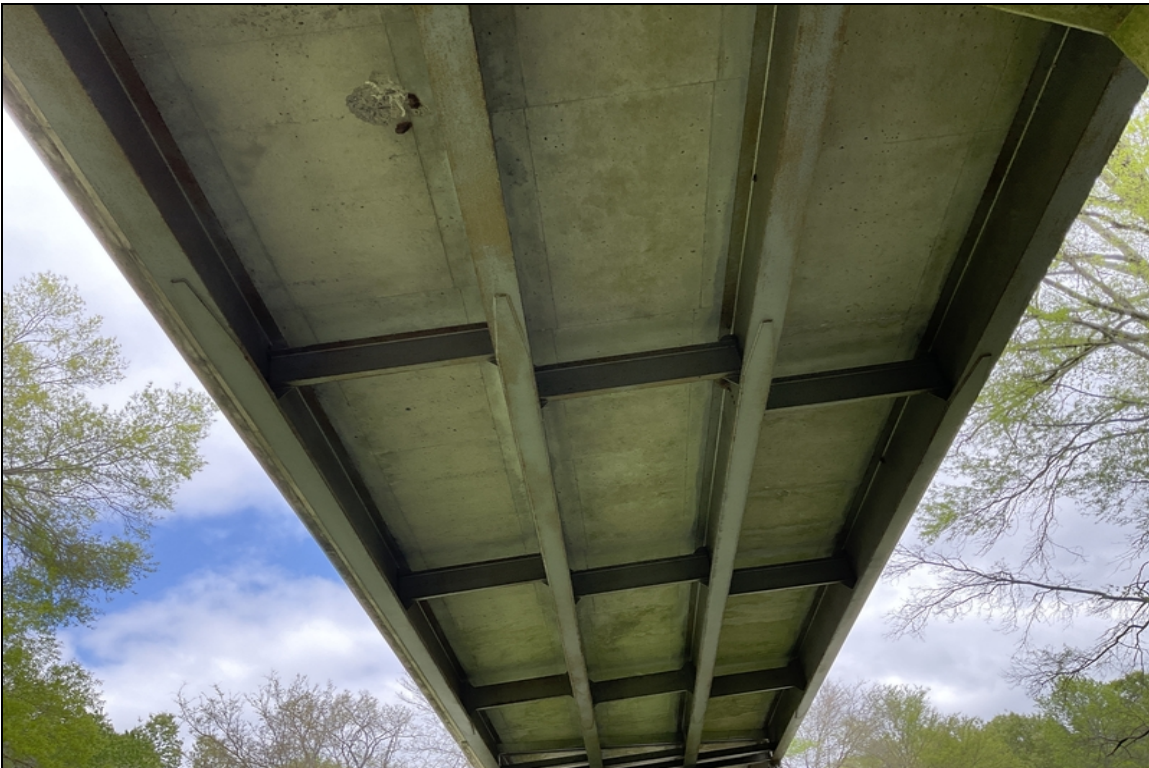
(12)	State forces have patched spalls in the deck and sealed cracks. Span 3& 4 soffit spall with rebar. Span 3: small area of honey combing with exposed rebar adjacent to girder 3						
107	Steel Open Girder/Beam	LF	1384	742	642	0	0
1000	Corrosion	LF	642	0	642	0	0
515	Steel Protective Coating	SF	10255	0	2752	2752	4751
3440	Effectiveness (Steel Protective Coatings)	SF	10255	0	2752	2752	4751

Span 4 soffit view

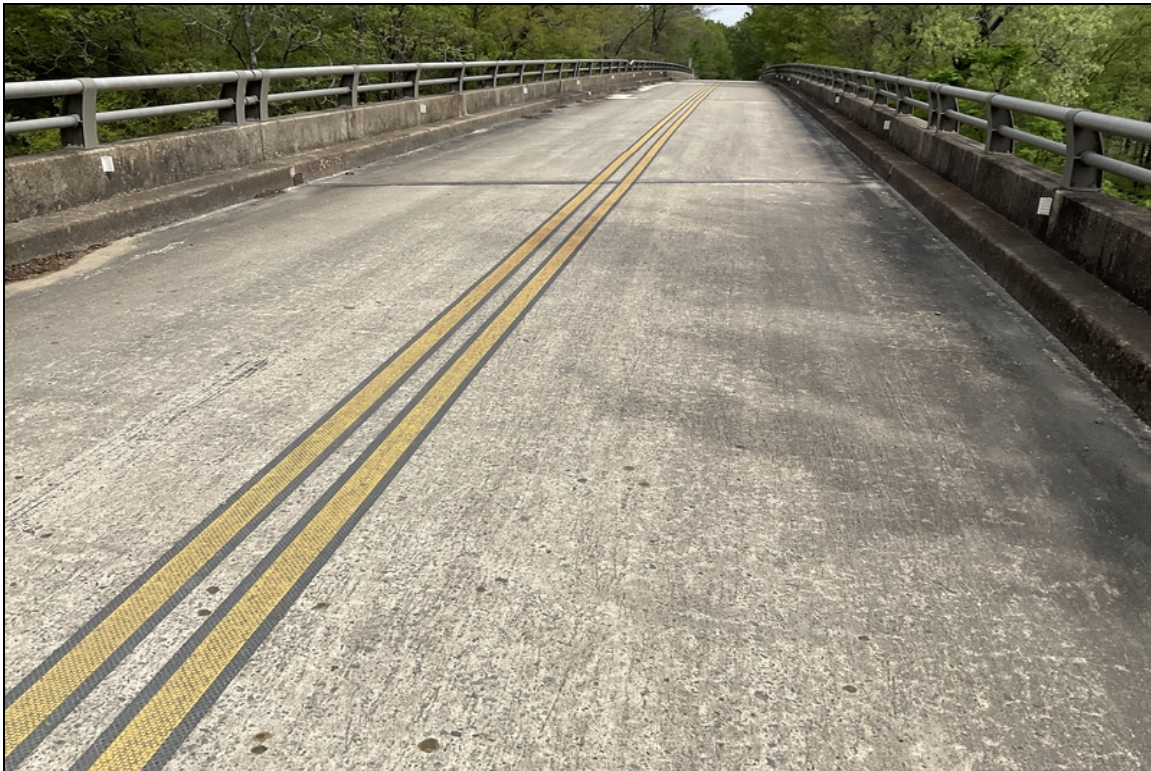
Deck overview

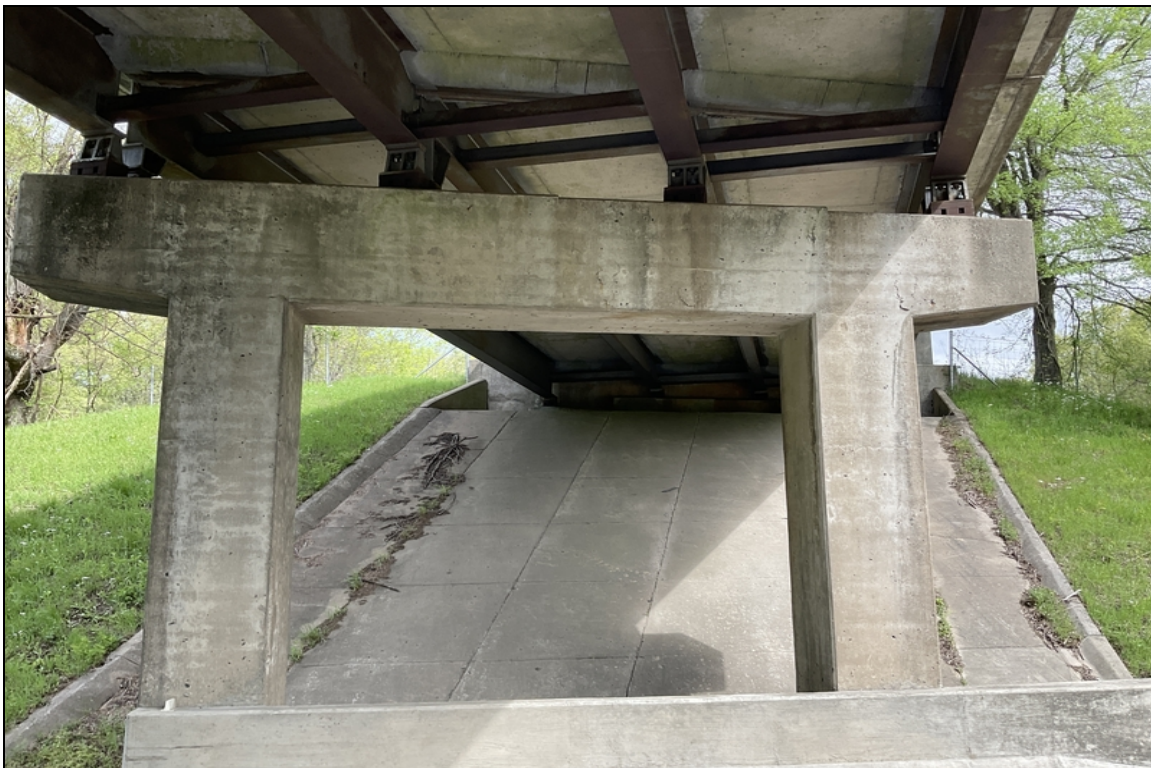
(234)	Bent 2 cap back face has delam. Bent 3, left end ,ahead face, exposed rebar. Bent 5, right end bottom, exposed rebar. Bent 5 cap ahead face has delam. Bent 6 cap back face right end, delam and exposed rebar.						
303	Assembly Joint with Seal	LF	172	172	0	0	0
311	Movable Bearing	EA	24	0	20	4	0
1000	Corrosion	EA	16	0	16	0	0

Bent 6 delams on back face

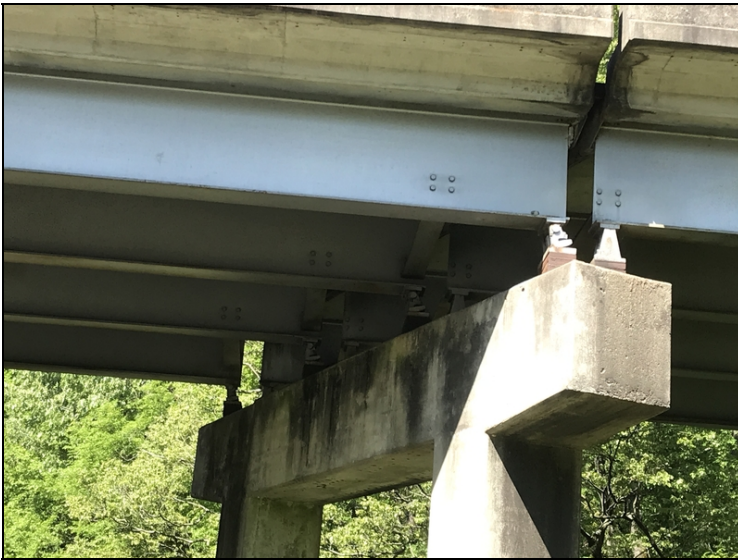
ELEM	DESCRIPTION	UNITS	TOTAL	CS1	CS2	CS3	CS4
2220 (311)	Alignment	EA	8	0	4	4	0
The bearings at bent 3 are rotated to the stop blocks. The bearings at bent 4 are rotated.							
313 1000 (313)	Fixed Bearing Corrosion	EA EA	24 24	0 0	24 24	0 0	0 0
All bearings have light corrosion							
330 7000 (330)	Metal Bridge Railing Damage	LF LF	697 7	690 0	0 0	7 7	0 0
Span 3, left metal guard rail damaged.							
331 1080 1090 1130 (331)	Reinforced Concrete Bridge Railing Delamination/Spall/Patched Area Exposed Rebar Cracking (RC and Other)	LF LF LF	697 2 1 35	659 0 0 0	38 2 1 35	0 0 0 0	0 0 0 0
Concrete bridge railing has scattered cracks and 2 small spalls with exposed rebar.

Bearings are fully rotate at bent 3 on span 2 and joint is open up to 4 ½ inches.

Span 2, bent 3: all bearings are rotated fully to their max inwards.

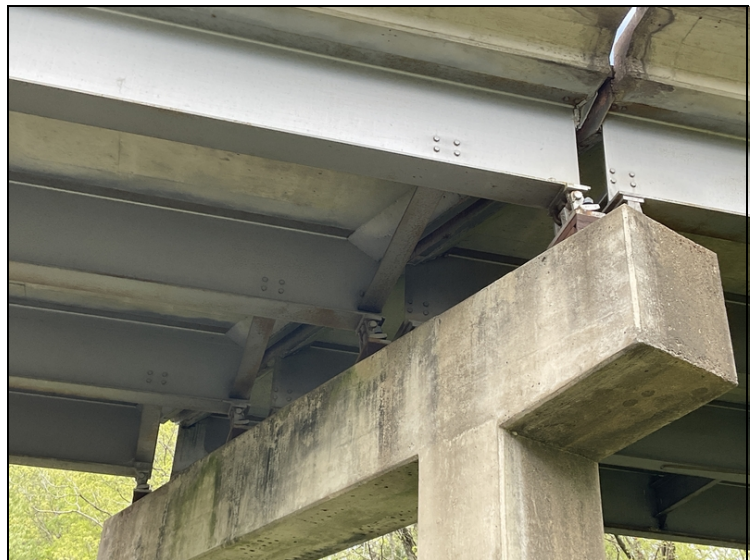
Bearings are fully rotate at bent 3 on span 2 and joint is open up to 4 ½ inches.

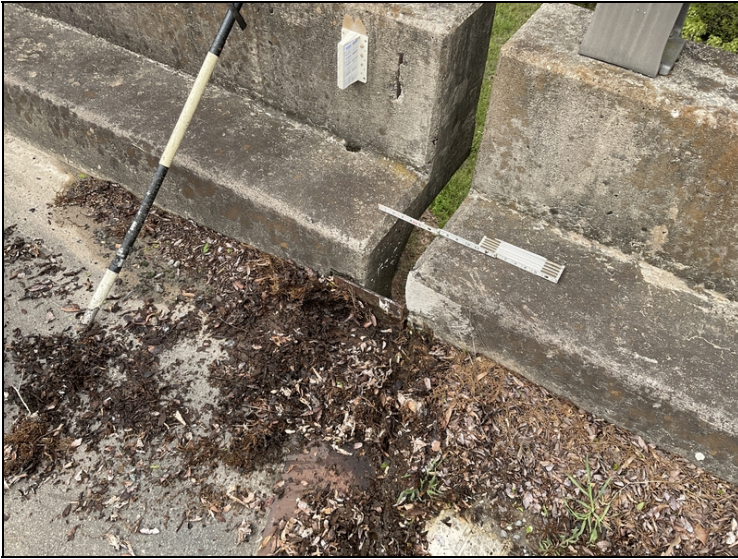
Bearings are fully rotate at bent 3 on span 2 and joint is open up to 4 ½ inches.

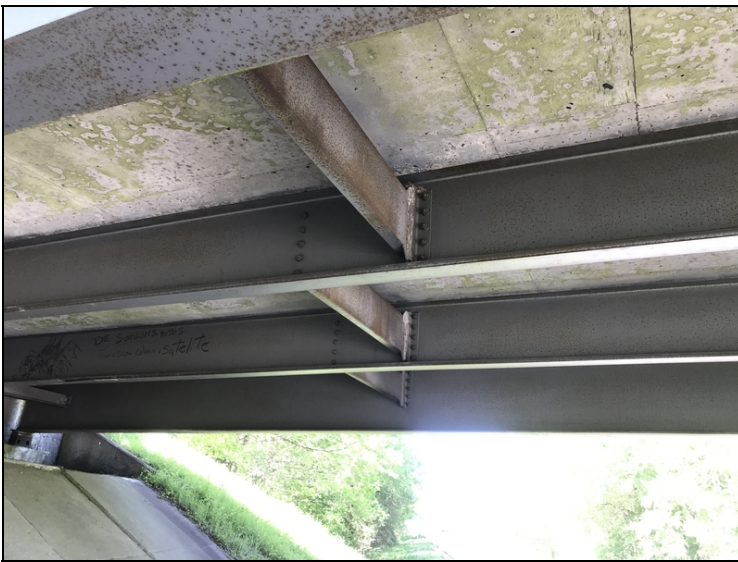
(107)	Moderate to heavy freckled rust is common on spans 2&5 where traffic is present under the bridge. Beams at spans 1,3,4 & 6 have moderate freckling rust. Paint system is failing.						
205	Reinforced Concrete Column	EA	10	8	2	0	0
1080	Delamination/Spall/Patched Area	EA	2	0	2	0	0

All spans beams have moderate to heavy freckling rust. Paint system is starting to fail.

Span 1: majority of the painted steel has freckled rust, the remainder has dulled paint

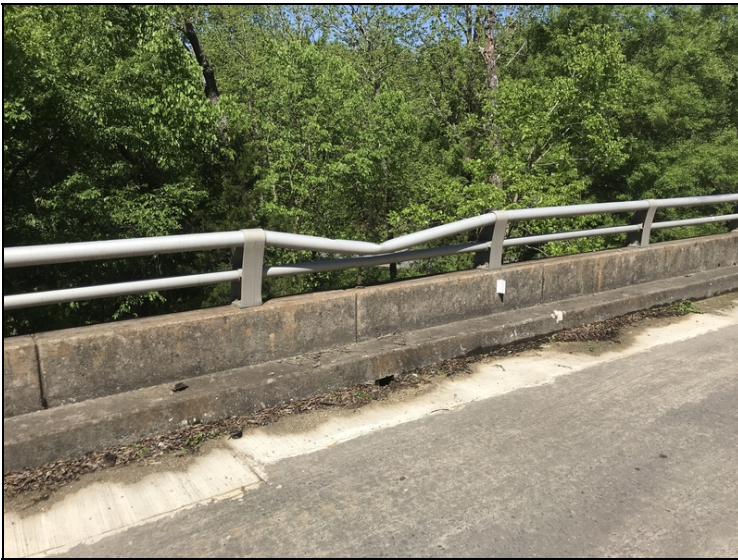
Span 3, left metal guard rail damaged.

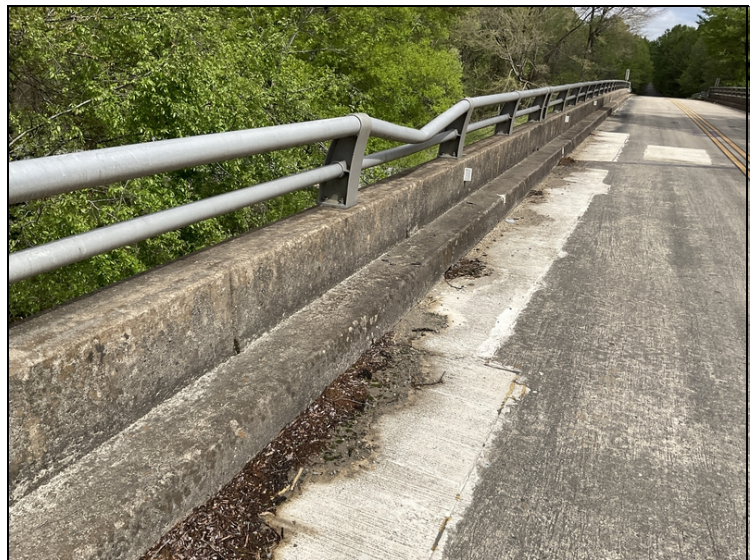
Span 3, left metal guard rail damaged.
