Bridge #06893(Under Record Clearance)
I-40 Log 199.12 over White Rvr Rlf & Park Rd
Location: .30 MI W OF WHITE RIVER
Team Lead: Bryan Saunders **Inspection Date:** July 12, 2022

IDENTIFICATION	
(1) State Names	Arkansas
(8) Structure Number	06893
(5) Inventory Route	40
(2) Highway Agency District	06
(3) County Code	117-Prairie County, Arkansas

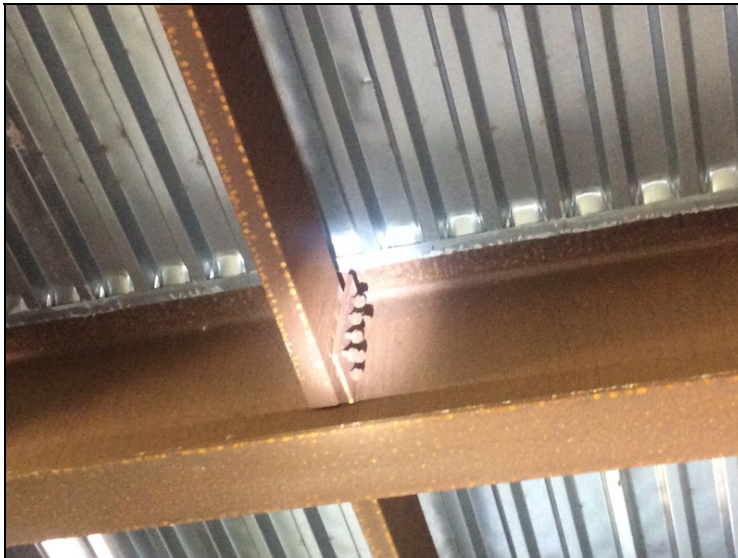
Span 5 beam 4 right side first diaphragm, 6 bolts loose. 2 missing

Span 5 beam 4 right side first diaphragm, bolts loose.

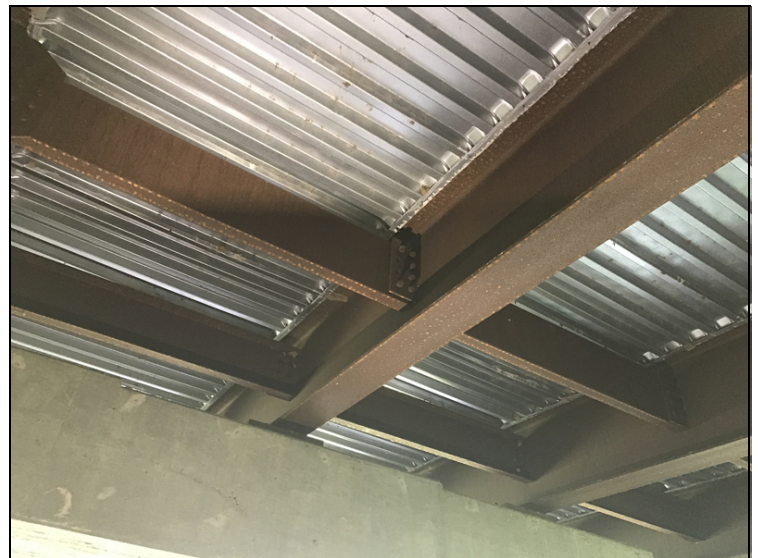
(107)	Span 2, beams 1,2,3,4,5,7,8,9 11 have been damaged by an over sized vehicle Span 5 beam 4 right side first diaphragm, 6 bolts loose, 2 missing						
205	Reinforced Concrete Column	EA	8	8	0	0	0
215	Reinforced Concrete Abutment	LF	156	132	24	0	0
1080	Delamination/Spall/Patched Area	LF	1	0	1	0	0
1120	Efflorescence/Rust Staining	LF	23	0	23	0	0

Span 5 beam 4 right side first diaphragm, 6 bolts loose. 2 missing

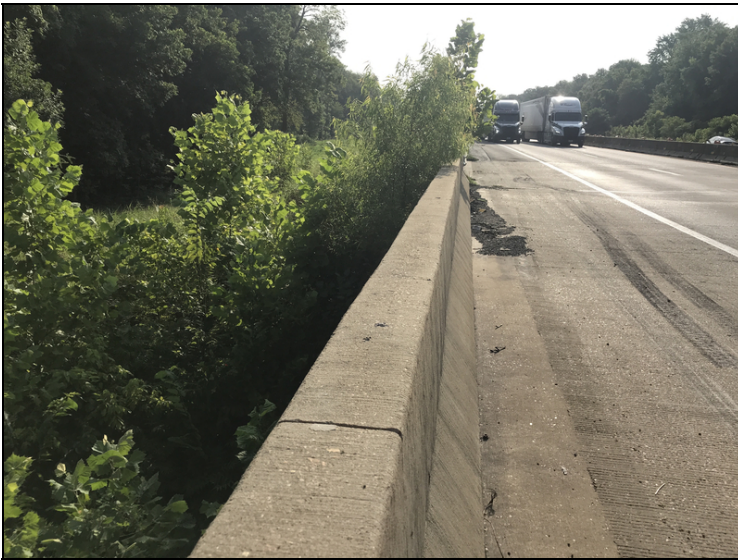
East end of bridge has vines and trees growing against bridge.

Trees growing against bridge

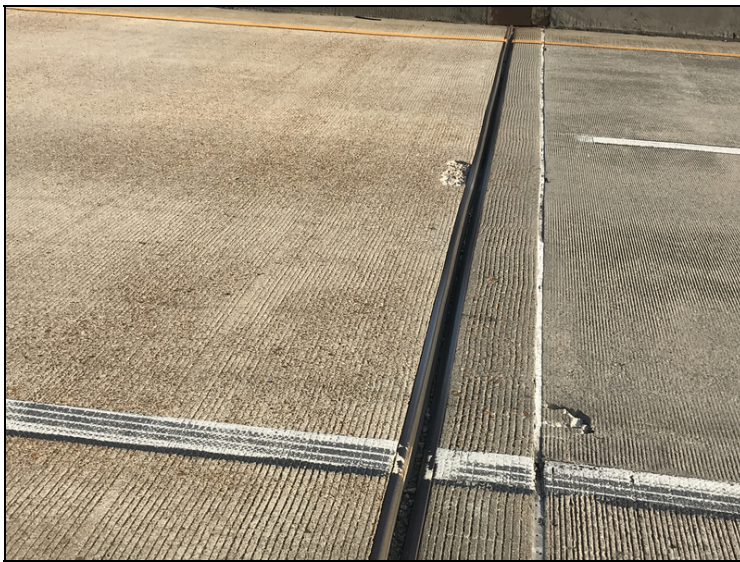
All spans have unsealed cracks in deck up to .025".
Span 4 east bound lane has small spall at bent 5.

Span 4 at bent 5 small spall

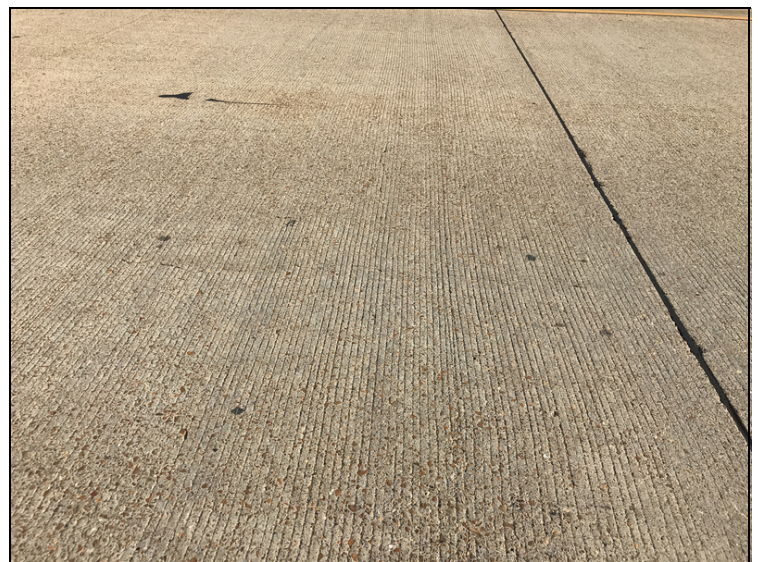
(12)	Unsealed longitudinal and transverse cracks in all spans. 0.030 inch avg. width.						
107	Steel Open Girder/Beam	LF	2772	2755	17	0	0
1020	Connection	LF	1	0	1	0	0
7000	Damage	LF	16	0	16	0	0
515	Steel Protective Coating	SF	20430	0	20430	0	0
3430	Oxide Film Degradation Color/Texture Adherence(Steel Protective Coatings)	SF	20430	0	20430	0	0

Span 3 unsealed deck cracks up to 0.025"
