Bridge #A3709(Routine, Underwater type 2)

I-40 WB Log194.39 over HURRICANE CREEK

Location: 1.2 MI EAST JCT SH 11

Team Lead: Keith Harris Inspection Date: August 25, 2021

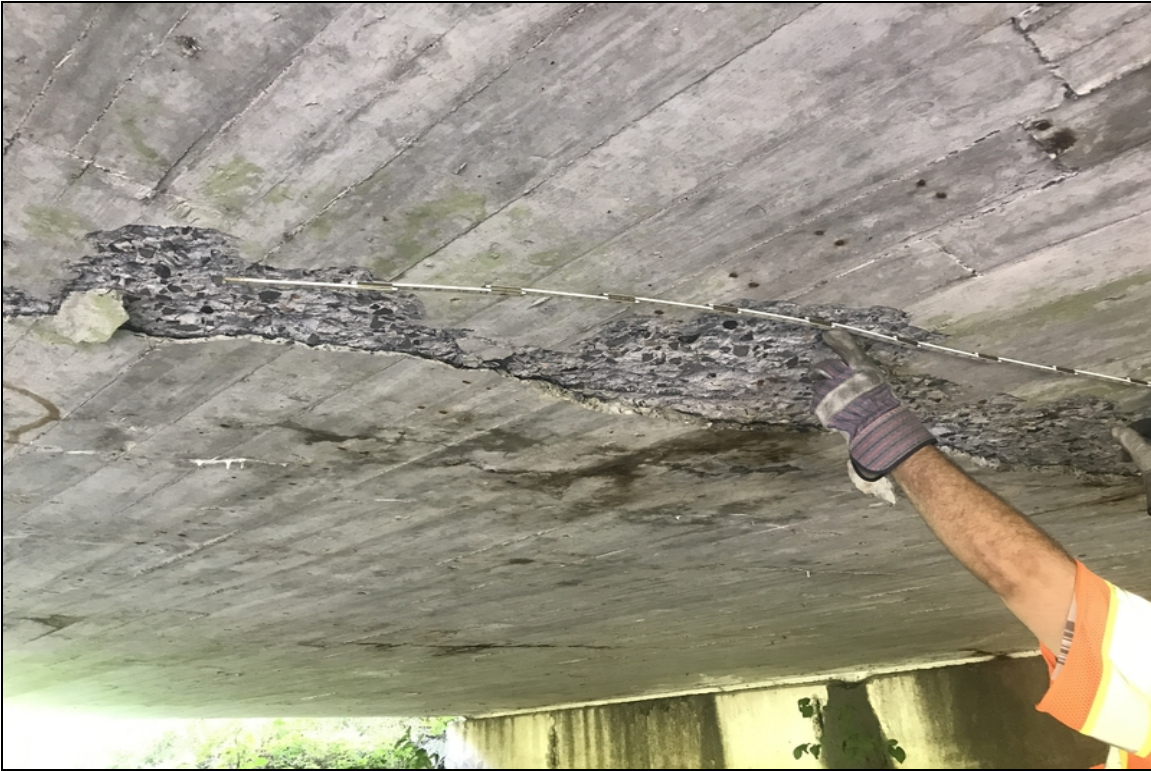
(38)							
All spans have patches filled with asphalt. Span 1 has on open spall in the outside lane, Span 3 has a large spall that was patched with asphalt but is deteriorating and is exposing steel. Span 2 has multiple spalls and spalls filled with asphalt that is deteriorating. Span 5 at bent 5 has a spall with exposed rebar in travel lane. All spans have large cracks, sealed and unsealed on the deck surface and all spans have longitudinal cracks with rust stains and efflorescence build up on the soffit. Scattered delams are present on the bottom of spans 2,3,4&5.							
215	Reinforced Concrete Abutment	LF	115	109	4	2	0
1090	Exposed Rebar	LF	2	0	0	2	0
1130	Cracking (RC and Other)	LF	4	0	4	0	0

Span 5 large spall with exposed rebar and delam

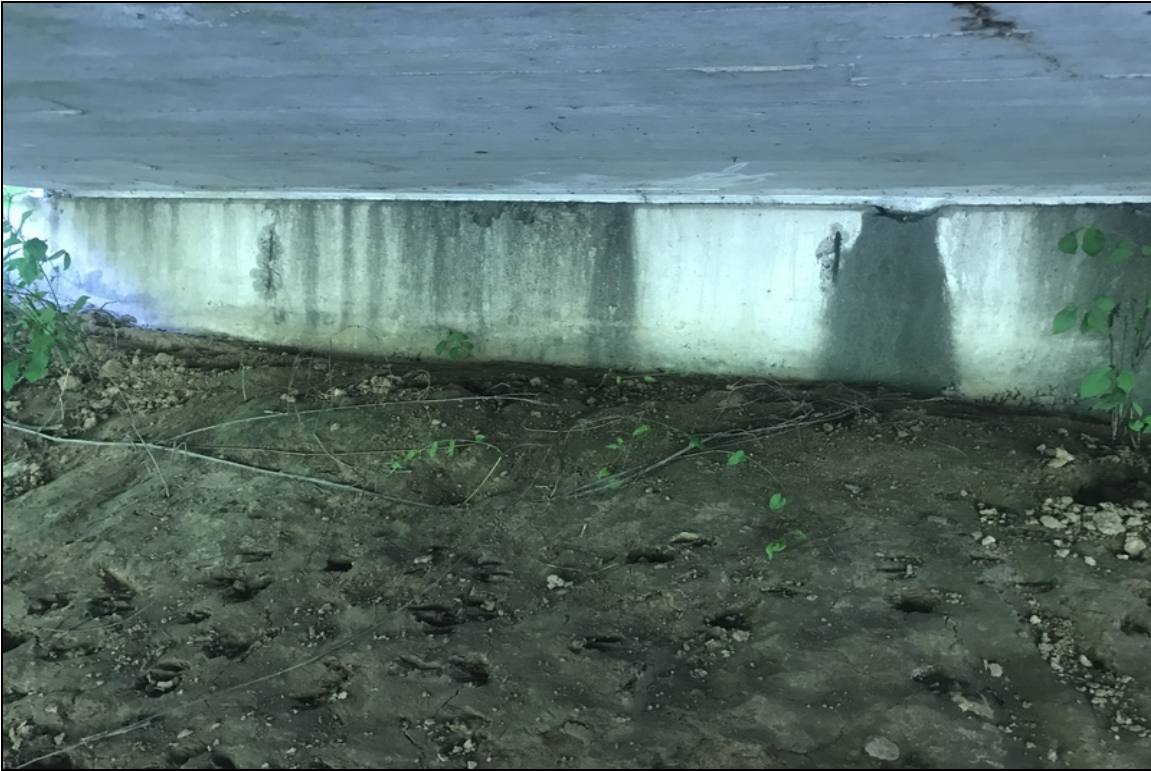
(215)							
Bent 6 has Spalls with exposed rebar and two vertical cracks.							
227	Reinforced Concrete Pile	EA	28	7	21	0	0
1190	Abrasion/Wear (PSC/RC)	EA	21	0	21	0	0

Bent 6 exposed rebar

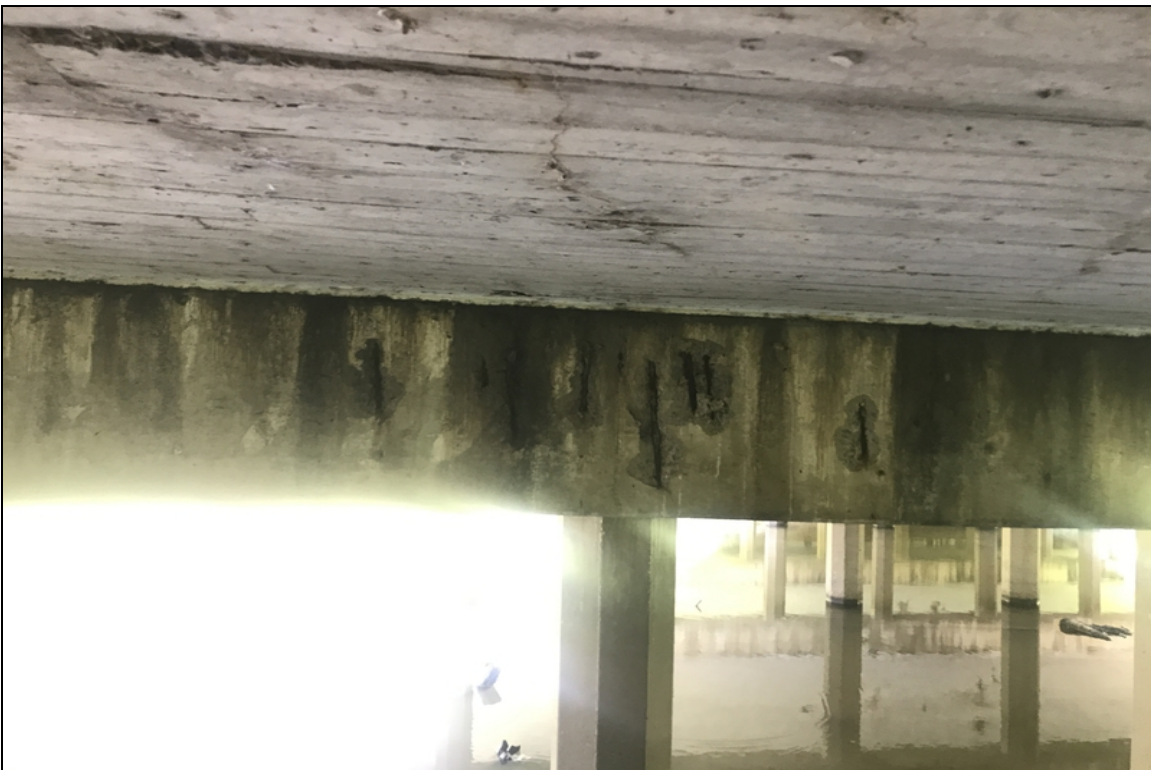
(234)							
Bent 2 at piles 2 and 3, Bent 2 at pile 5 on the bottom, exposed rebar and on the ahead face at pile 5 on cap. Bent 3, left end spalled with exposed rebar and efflorescence. Large spall on cap between piles 2 and 3. Bent 4 back side, left end and Bent 4 ahead face, spalls with exposed rebar. Bent 5 back side at pile 6, Bent 5, ahead face at pile 4, Spalls with exposed rebar.							
301	Pourable Joint Seal	LF	254	0	0	0	254
2350	Debris Impaction	LF	127	0	0	0	127

Bent 5 spalls with exposed rebar on ahead face

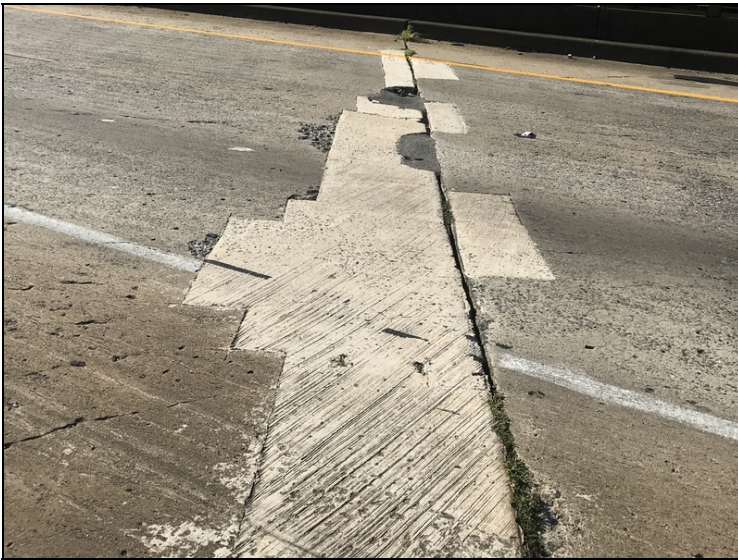
Span 3: large open spall that was patched with asphalt has deteriorated exposing steel

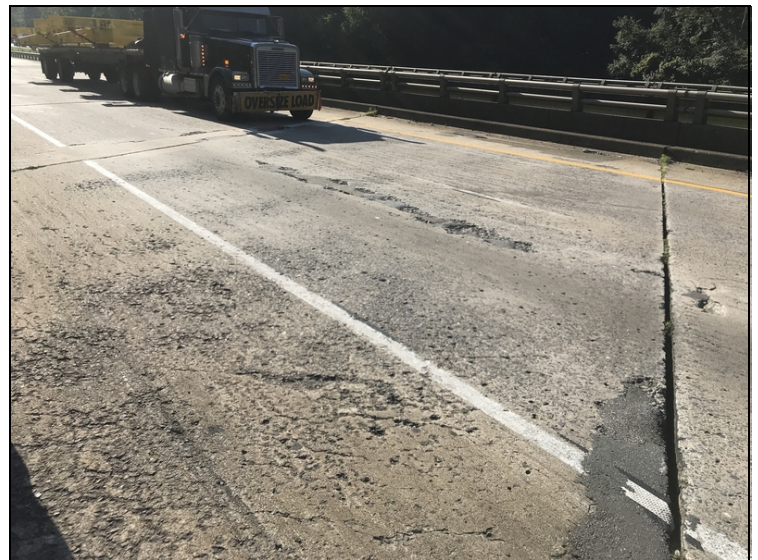
Span 2: Multiple spalls and spalls filled with asphalt that is deteriorating

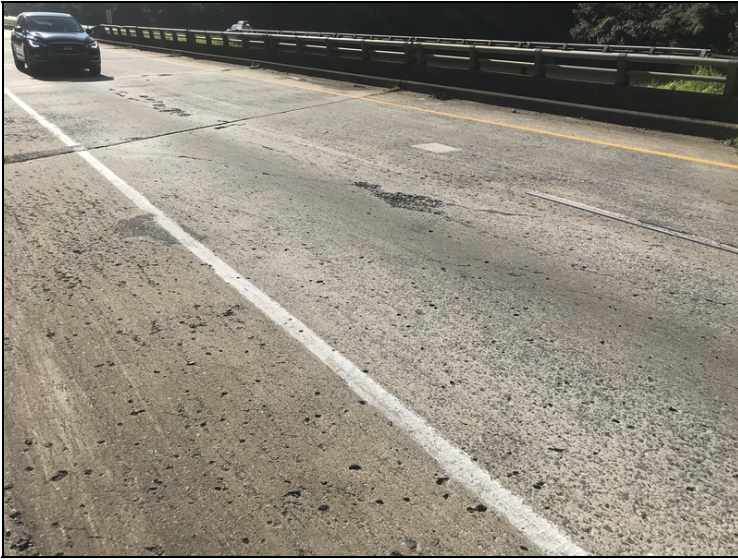
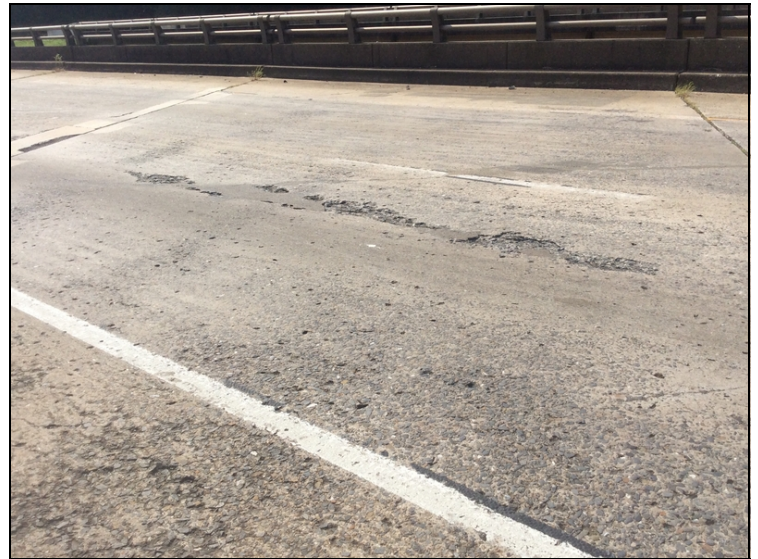
Span 1: open spall in outside lane

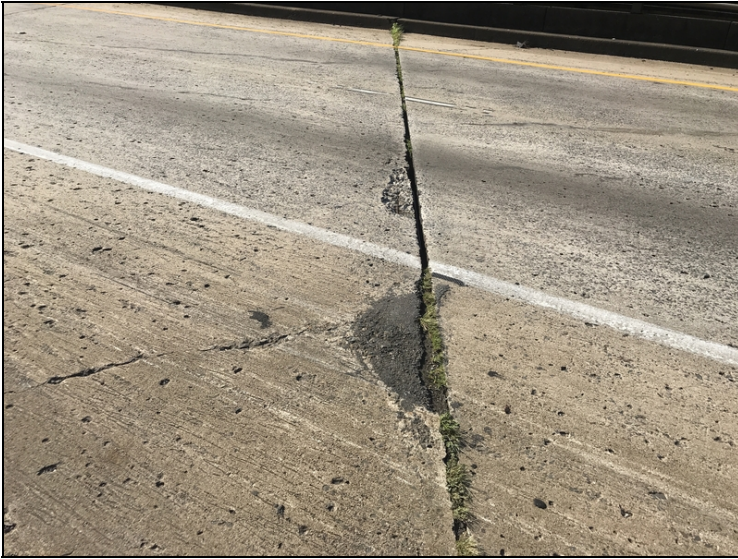
Span 5 at bent 5: spall with exposed rebar in travel lane

Spalls have been filled with asphalt

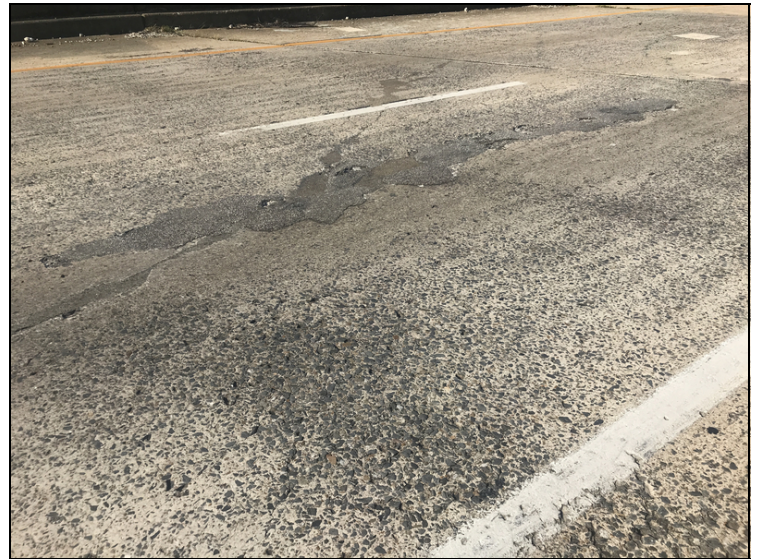
Span 2 spalls and spalls filled with asphalt

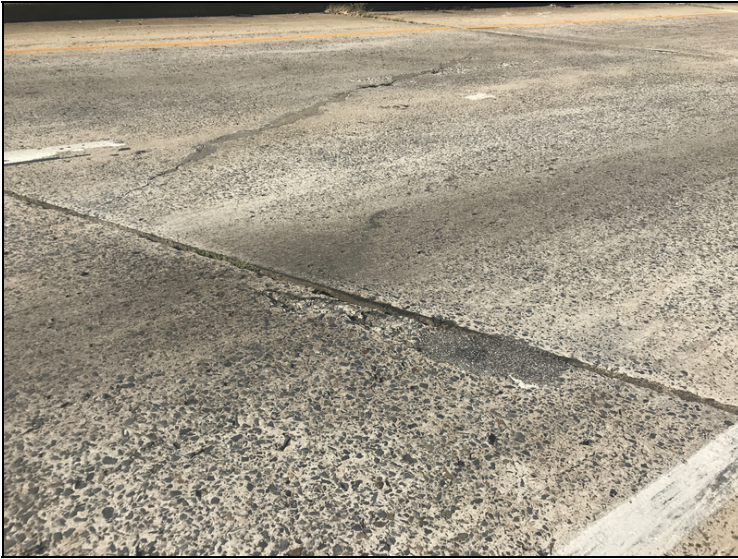
Span 4&5 spalls

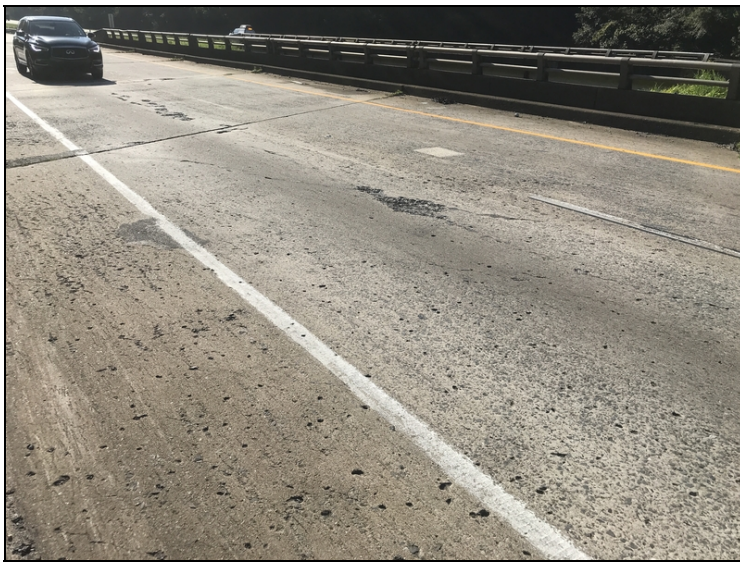
Span 5 at bent 5: spall with exposed rebar in the inside travel lane.
Span 1: open spall in outside lane

Span 1: open spall in outside lane

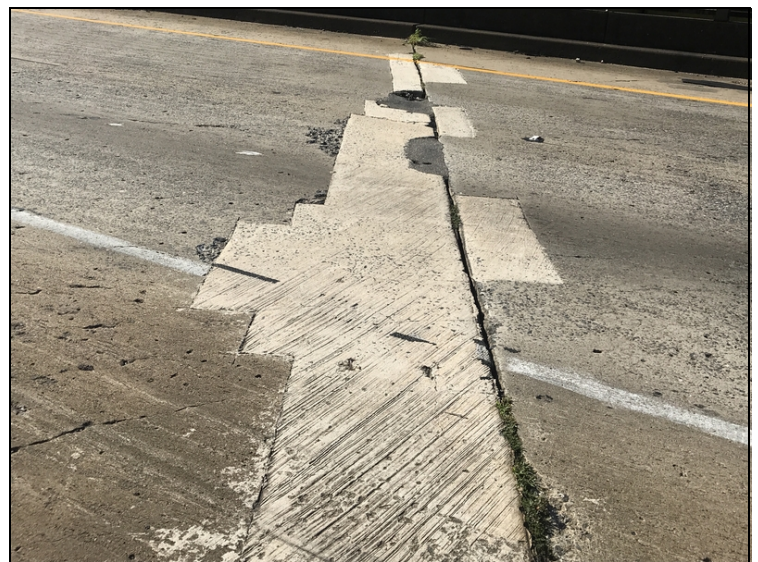
Span 3: large open spall that was patched with asphalt has deteriorated exposing steel

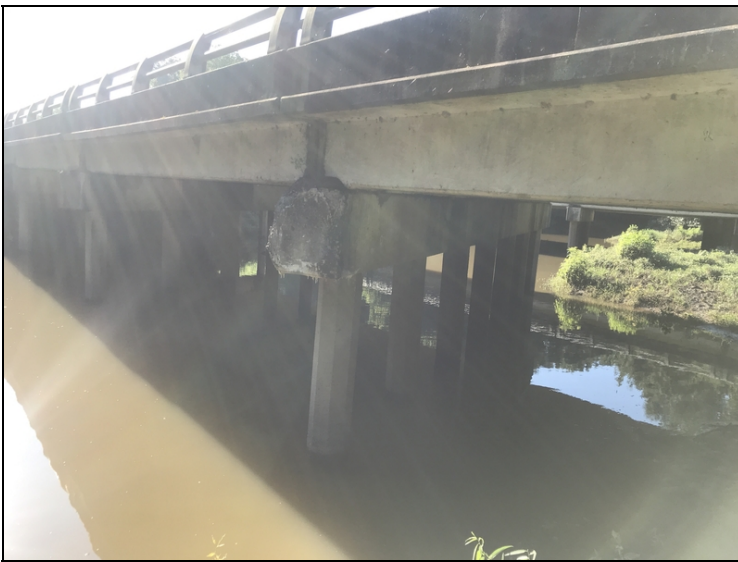
Left side of bent 2 is spalled and cracked with efflorescence build up

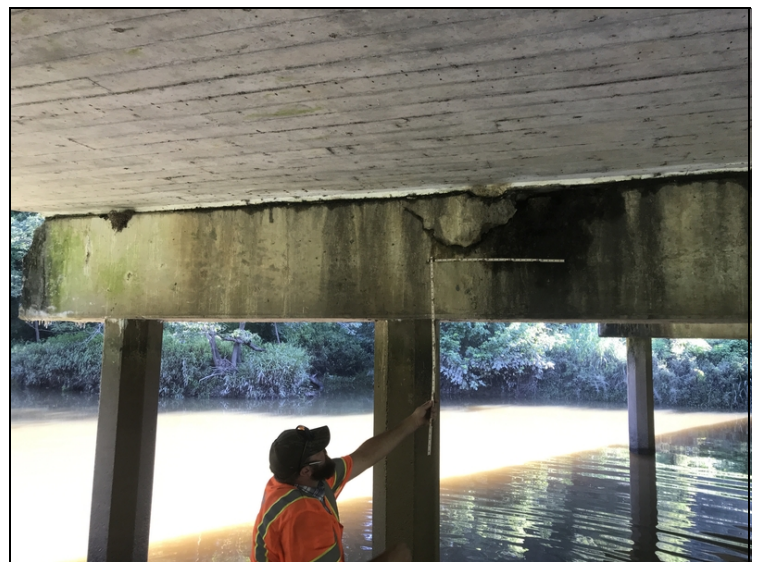
Bent 3: Large spall with exposed rebar and large delam above pile 2 at the key way

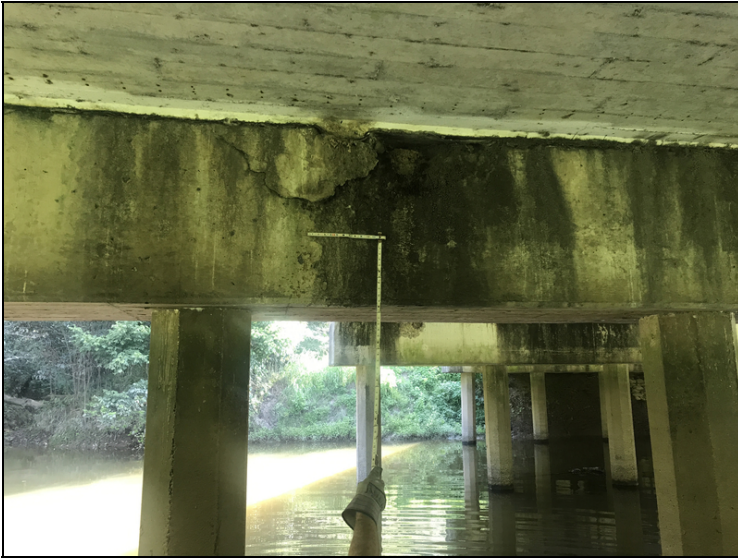
Bent 3: Large spall with exposed rebar and large delam above pile 2 at the key way

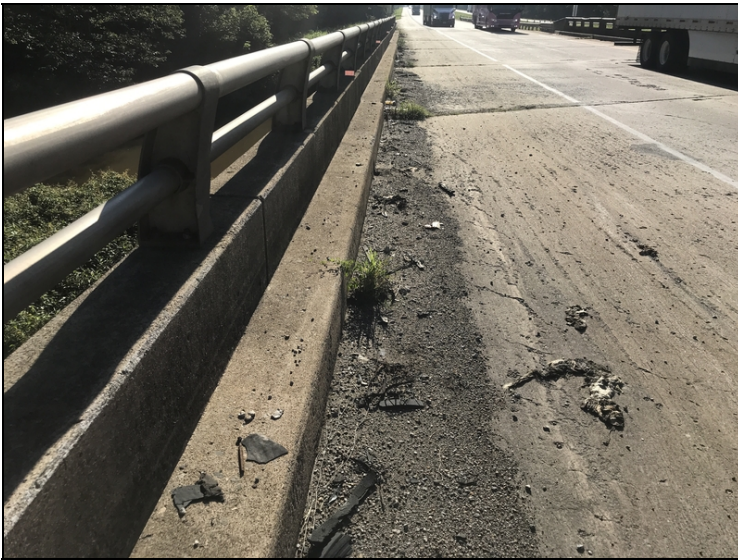
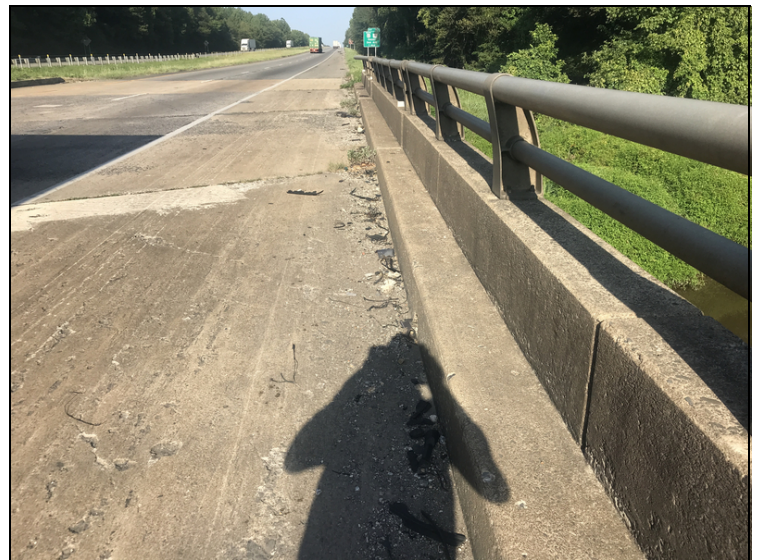
Left gutter line full of debris

Assigned Prairie 06591 10/8/19

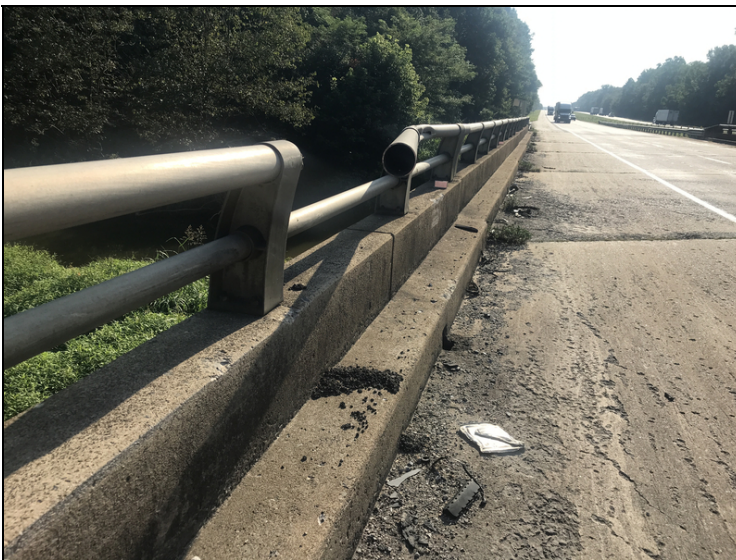
Span 1 left bridge rail has damaged from traffic impact
