Bridge #B3709(Routine, Underwater type 2)

I 40 EB Log 194.39 over HURRICANE CREEK

Team Lead: Keith Harris Inspection Date: August 25, 2021

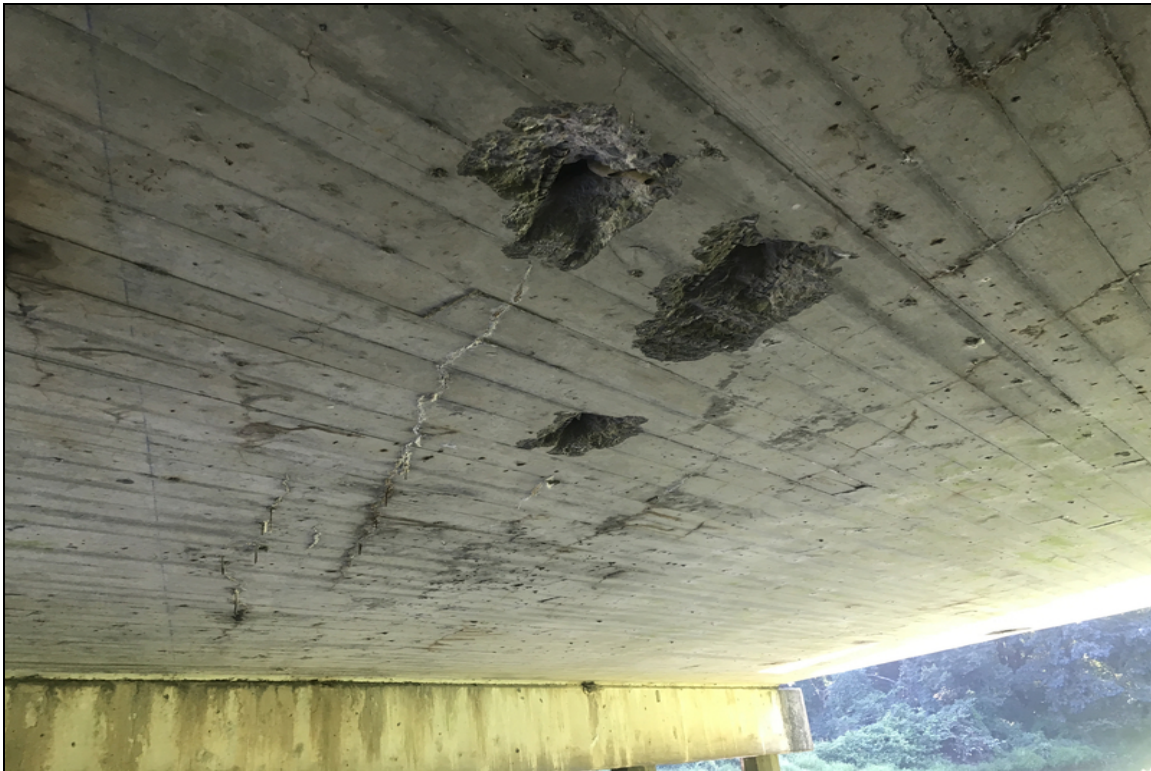
(38)							
Span 2 on the bottom has Spalls with exposed rebar. The right end of the span at bent 2 is spalled with exposed rebar. Span 2: right lane has large spall almost the entire length of span. Also spall with asphalt patch Span 4 is similar on both ends of the right side and the ahead end of the left side.							
All spans have Spalls filled with asphalt and span 2 & 3 have some concrete patches.							
All spans have cracking in the deck surface and cracking with efflorescence and rust stains on the bottom.							
The right gutter line of all spans have severe abrasion.							
215	Reinforced Concrete Abutment	LF	115	105	10	0	0
1080	Delamination/Spall/Patched Area	LF	2	0	2	0	0
1090	Exposed Rebar	LF	8	0	8	0	0

Span 2 spalls with exposed rebar on soffit

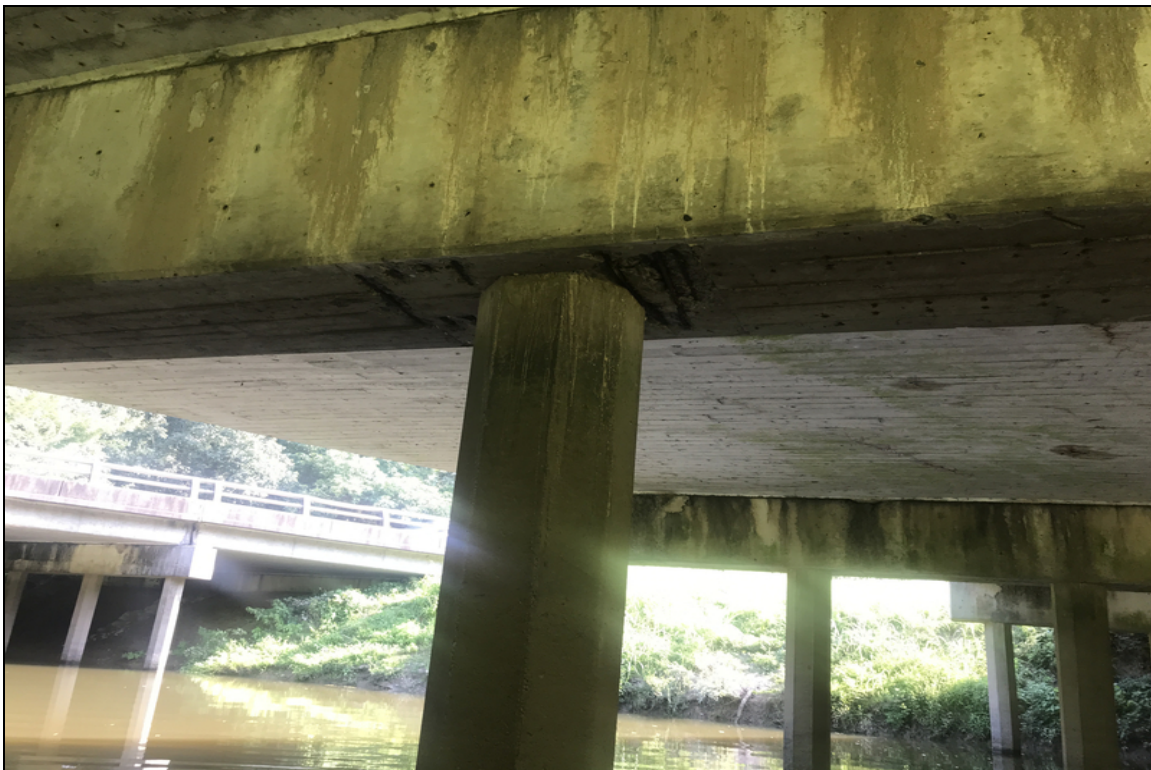
(234)							
Bent 2 has small Spalls with exposed rebar on both sides.							
Bent 3 has a delamination on the back side at pile 2 and cracking with efflorescence between piles 5 and 6, Spalls with exposed rebar on the bottom of the cap at pile 4.							
Bent 4 back side, has a spall at pile 1 and a large delam. Cracking on the ahead side at pile 4.							
Bent 5 cap back spall with exposed rebar above pile 1.

Bent 3 exposed rebar around pile 4

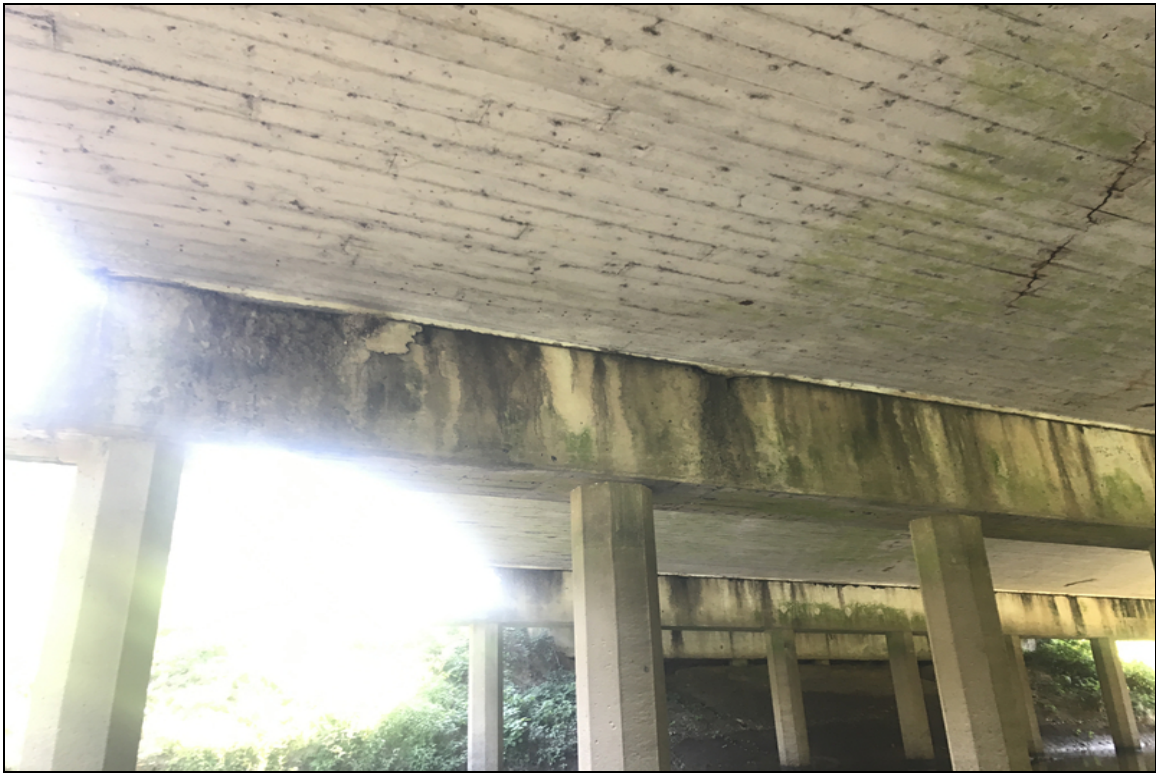
Bent 4 cap large spalls

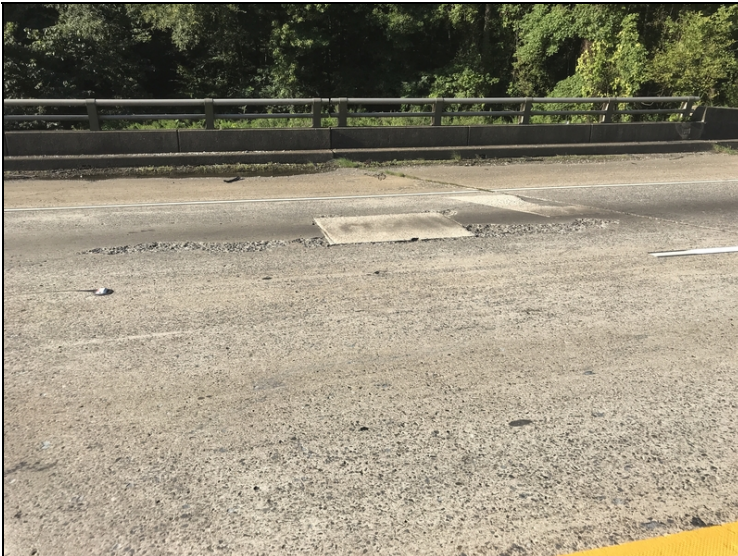
Span 2: right lane has large spall almost the entire length of span. Also spall with asphalt patch

Date Reported: 08/17/2015
Priority: B - Pressing; 6 month completion goal
Type of Work: Repair
Status: Open
Inspection Direction
Component:

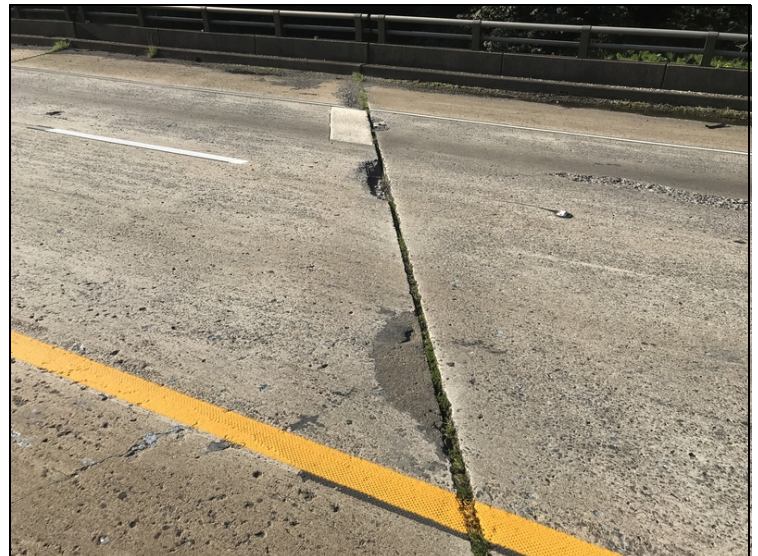
Added 8/14/2019: Most asphalt patches have deteriorated or have been reopened. Large open spall with exposed rebar at bent 2, span 3

Large open spall with exposed rebar at bent 2, span 3

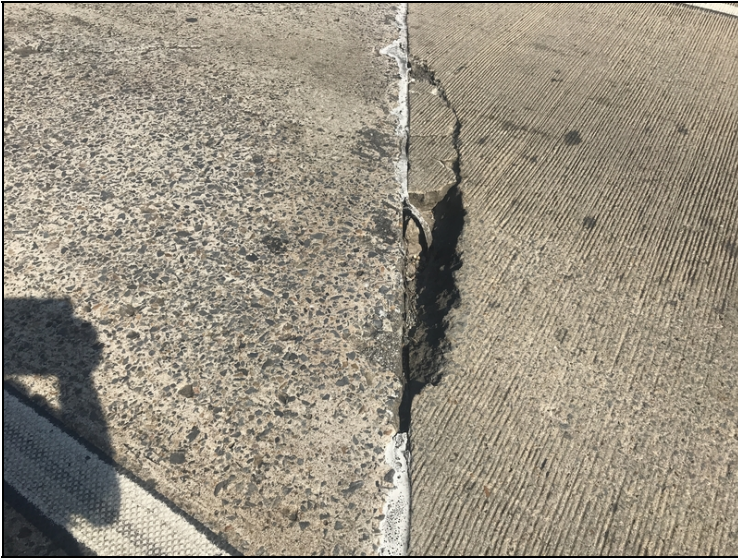
large spall at bent 6 in approach slab

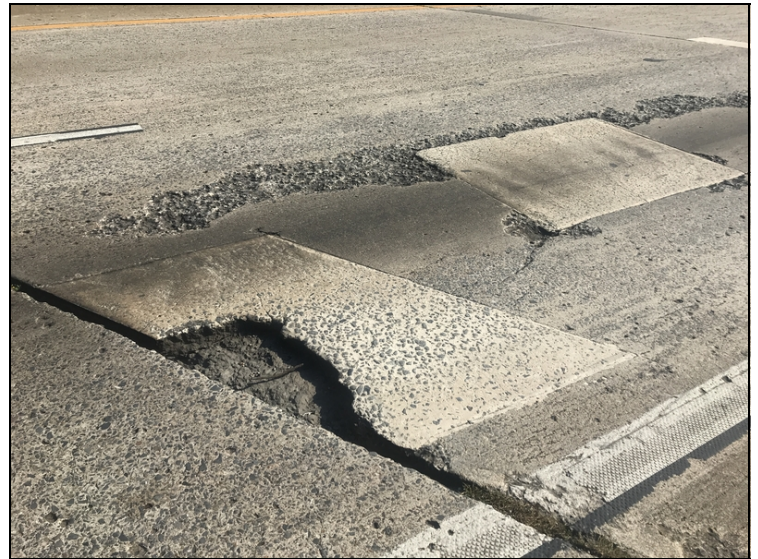
Span 2 large open spall in wheel path

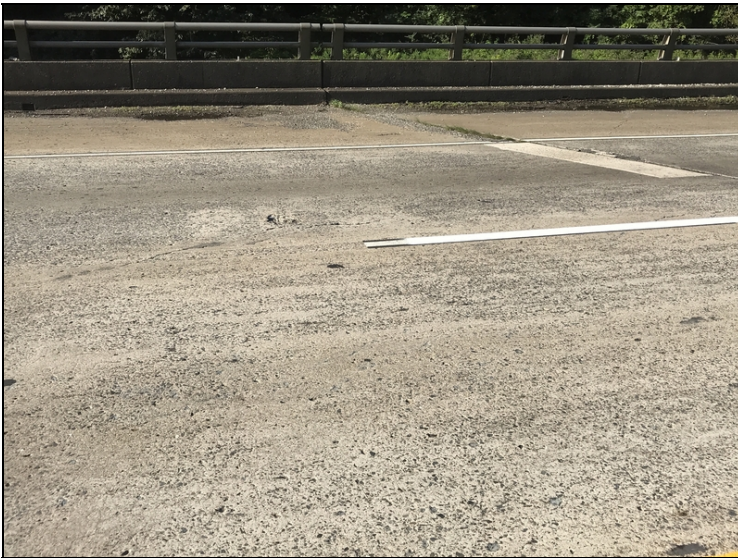
Span 3: large crack at the center line with an open spall.

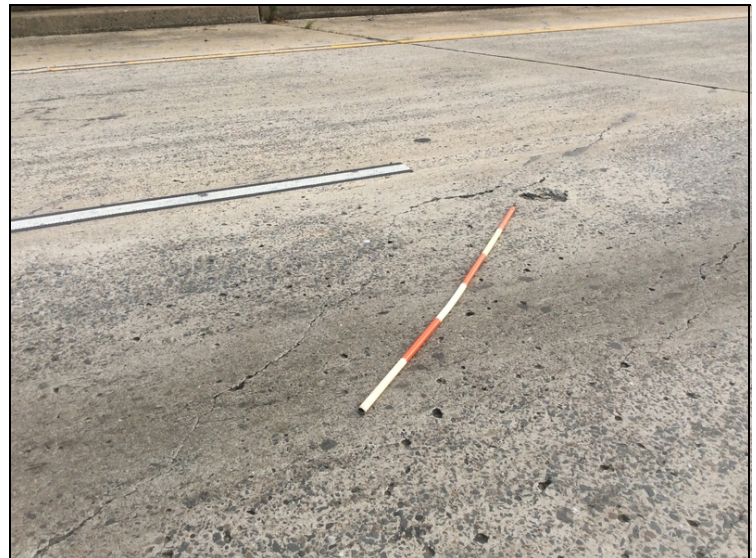
Deck all spans have large unsealed cracks.

Span 3 large unsealed cracks. Common in all spans.

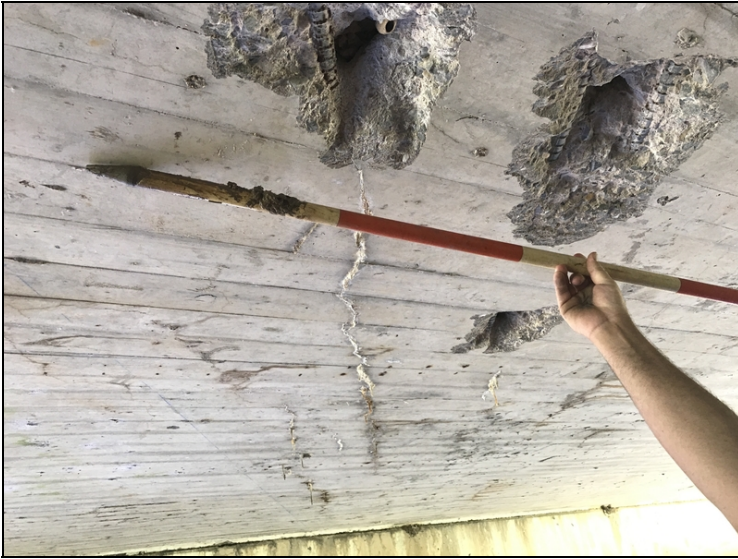
Span 2: spalls with exposed rebar in the soffit. Also multiple cracks with efflorescence staining

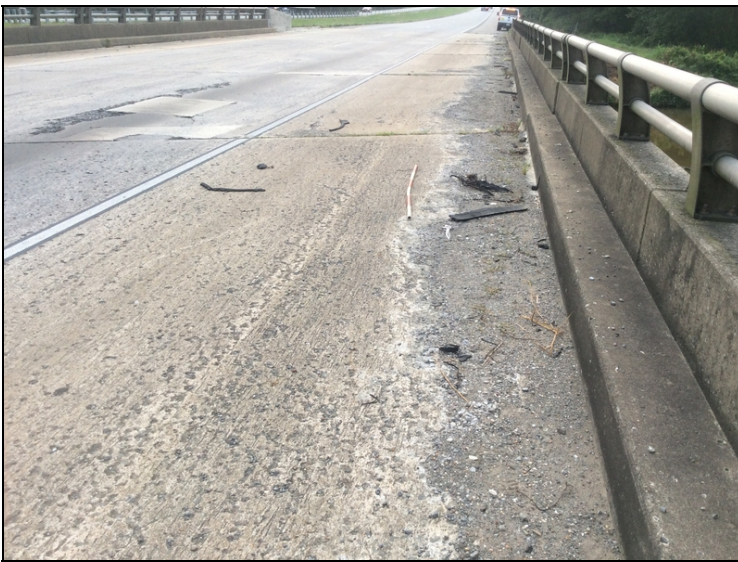
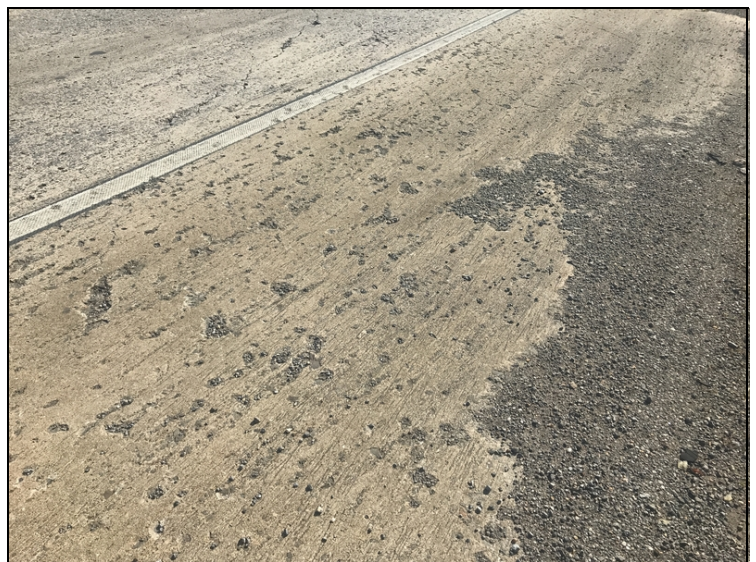
Right shoulder of all spans severe abrasion.

Spans 1,2,&3 right gutter line has severe abrasion.

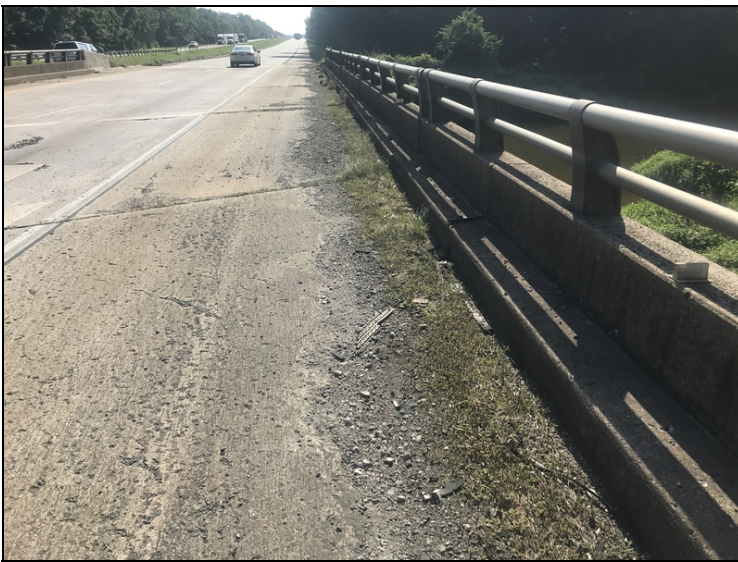
Right gutter line is full of debris and gravel

Type of Work: Clean
