## Bridge 13213 Inspection Report

**Sentinel Rd over Creek**

**Location: .11 MI E SH 227**

**Team Lead: Keith Harris Inspection Date: 03/03/2026**

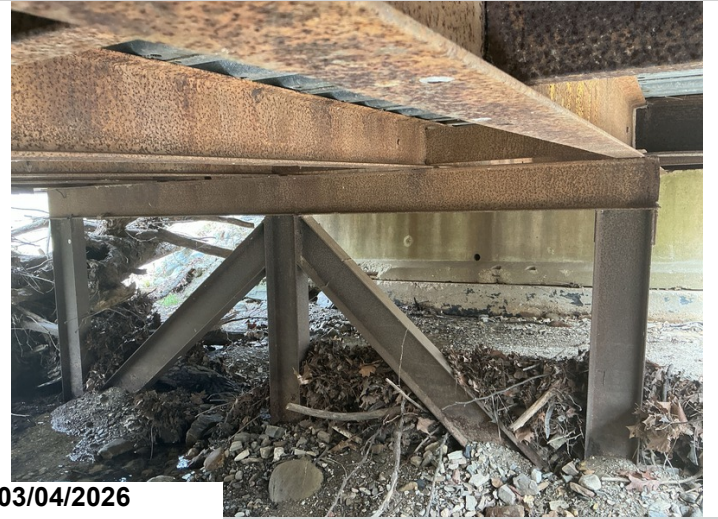
NSTM view

Steel cap has minor corrosion throughout.

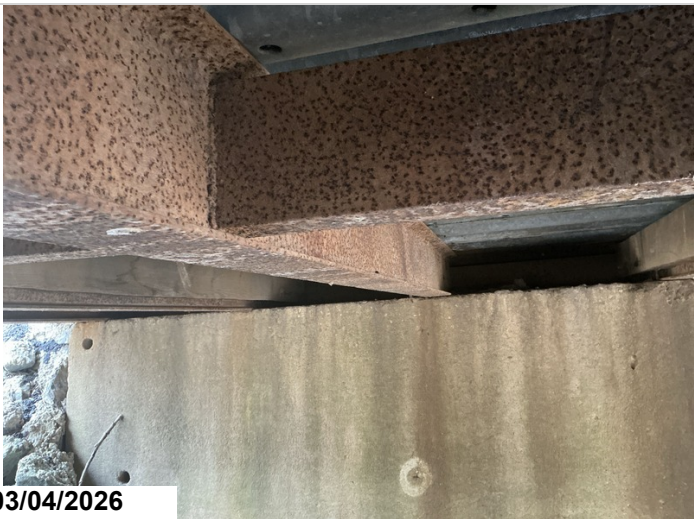
All of the steel girders have active corrosion with pitting up to 1/16".

Span 2 girder 3: girder has active corrosion with moderate pitting. All girders in both spans are in similar condition.

**A-60 - Full Girder Painting Needed (Yes)**

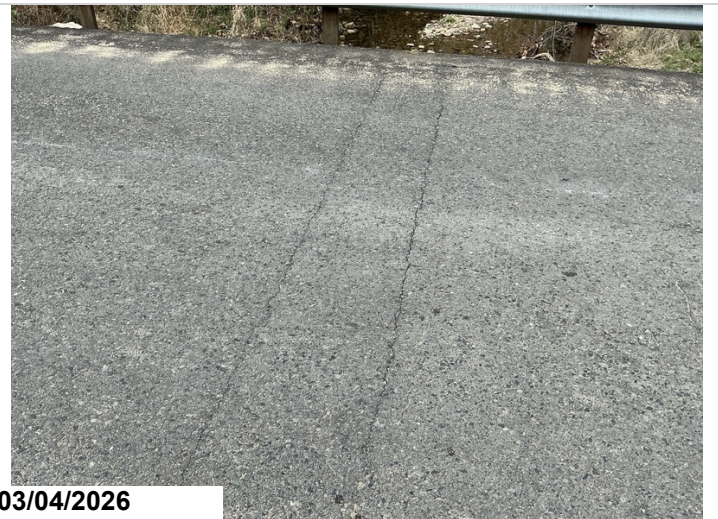
The deck is a 3 1/2" x 6" x 3/16" thick corrugated galvanized steel with 5" edge dams and an asphalt wearing surface. Transverse cracks in the asphalt wearing surface.

Transverse cracks in the asphalt wearing surface.

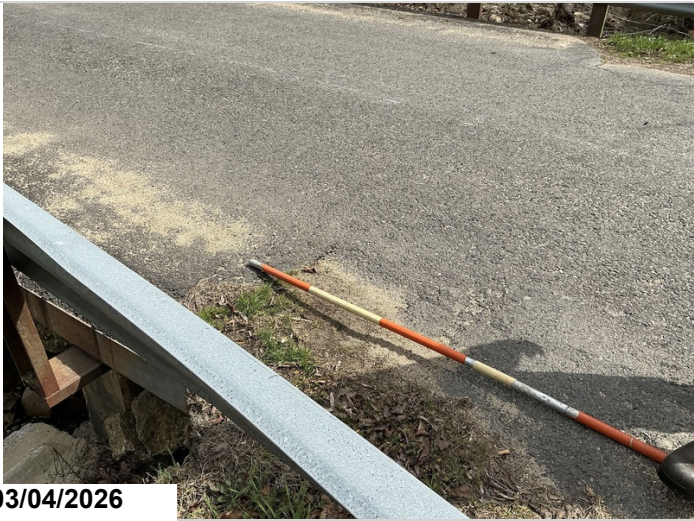
Bent 1, left side, up to 8' void behind abutment.

Bent 1, left side, up to 8' void behind abutment causing approach roadway to settle.

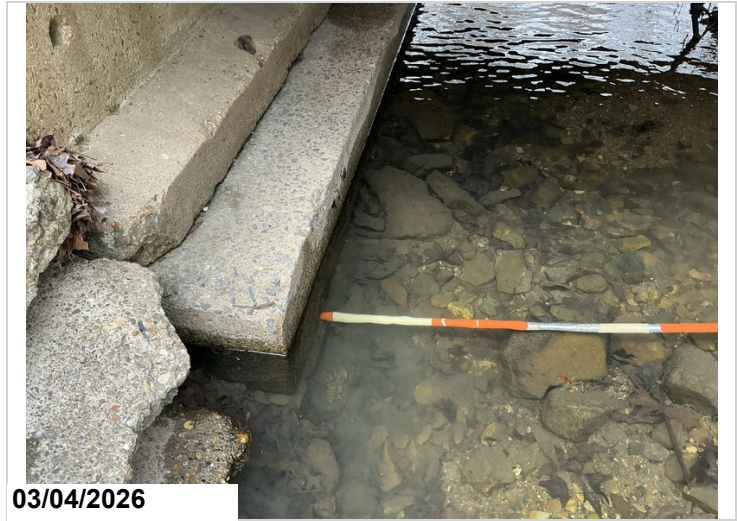
Bent 1 downstream footing is undermined up to 2'.

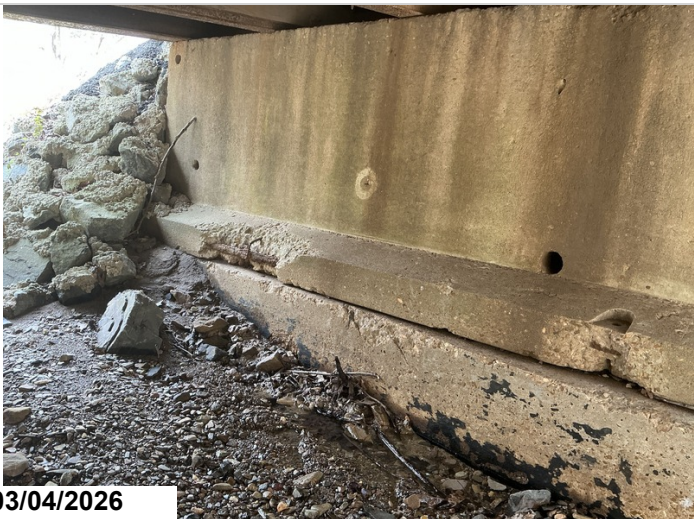
Bent 3 has two spalls in the curb area of the unit.

Bent 3 footing has a couple spalls with exposed rebar.

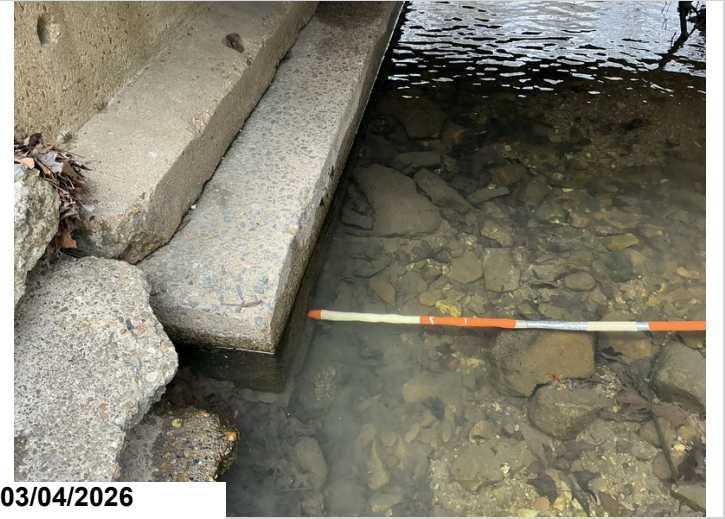
Bent 1 downstream footing is undermined up to 2'.

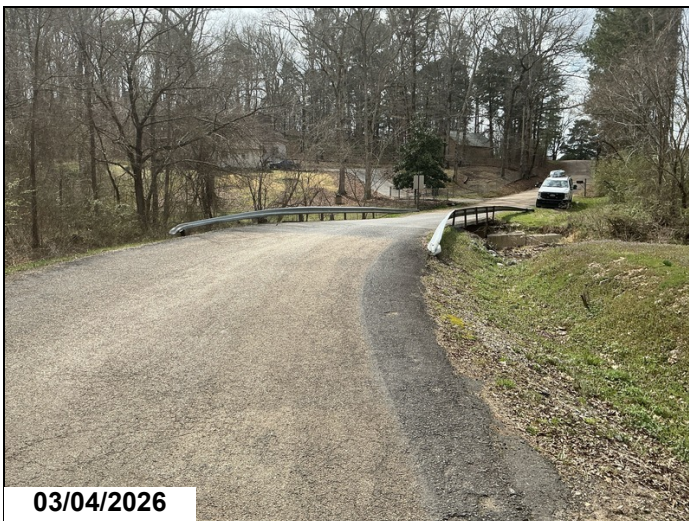
**Priority:** A - Safety deficiency; requires prompt action

Load posting sign on east end of bridge is missing.

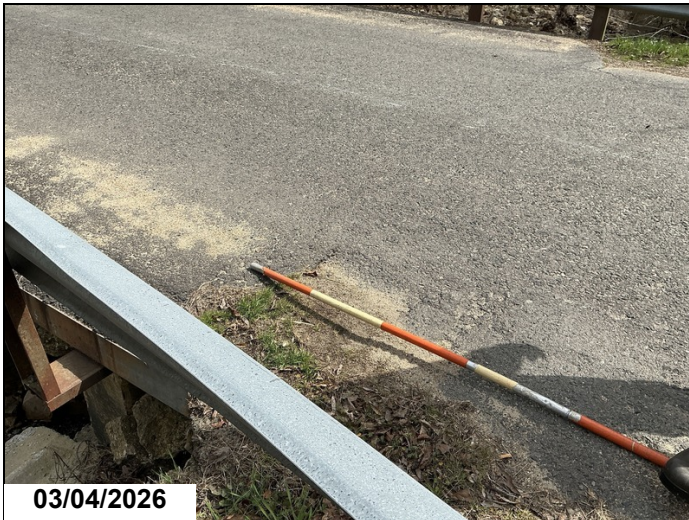
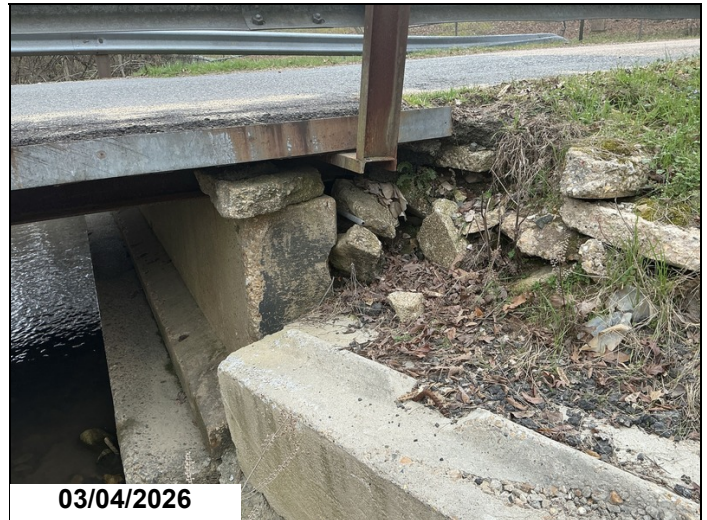
Bent 1, left side: up to 8' void behind abutment causing approach roadway to settle.

Bent 1, left side, up to 8' void behind abutment causing approach roadway to settle.

Type of Work: Substructure Repair

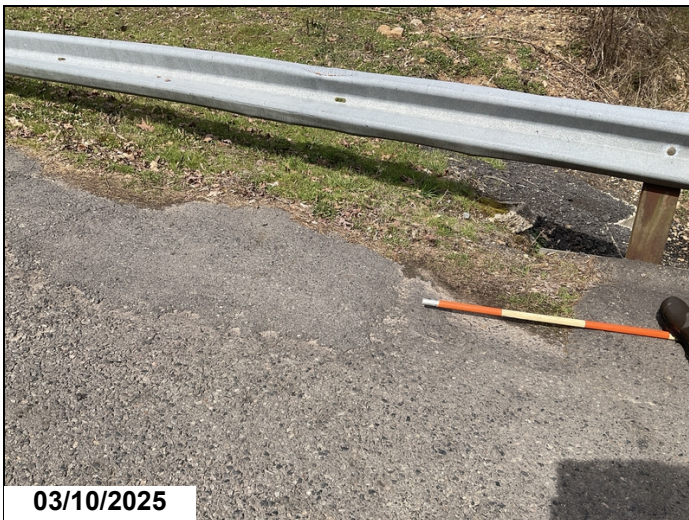
Bent 1, right side: up to 2' void behind abutment causing approach roadway to settle.

Bent 1, right side, up to 5' void behind abutment causing approach roadway to settle.

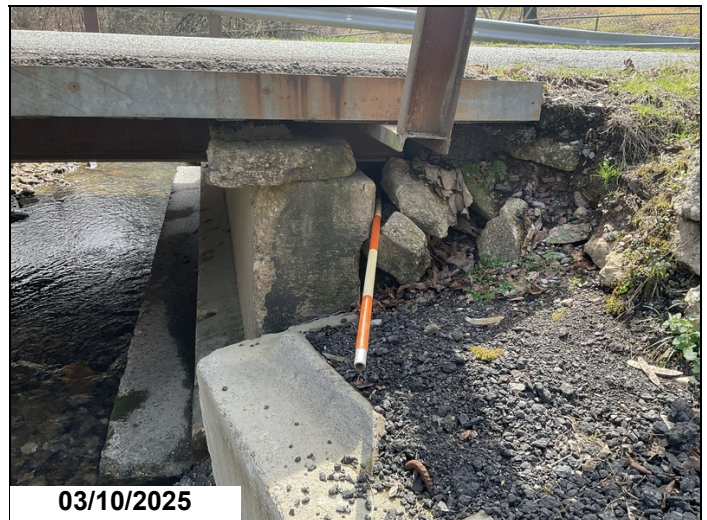
Bent 1 left side, 5' void behind abutment.

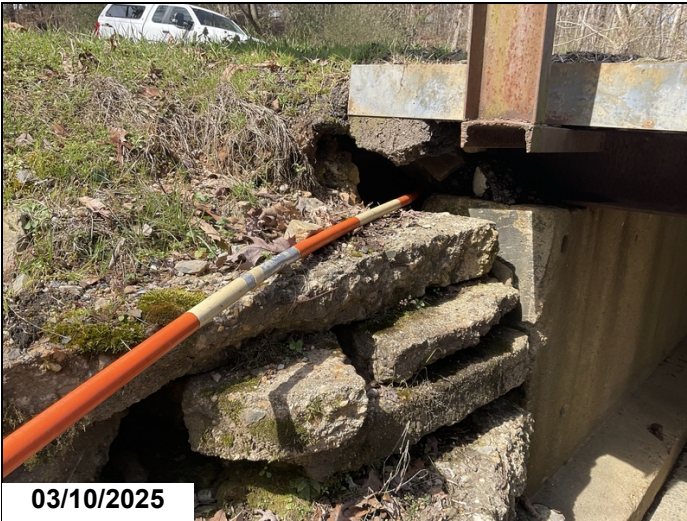
Bent 1, right side: up to 2' void behind abutment.

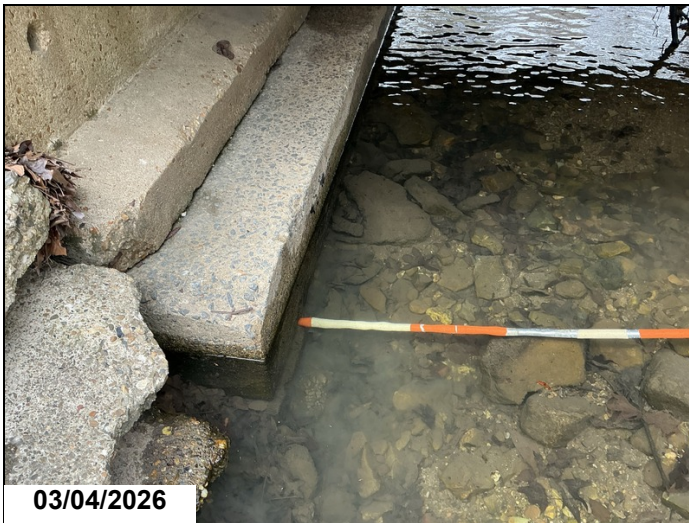
Bent 1 downstream footing is undermined up to 2'.

**Type of Work:** Substructure Repair

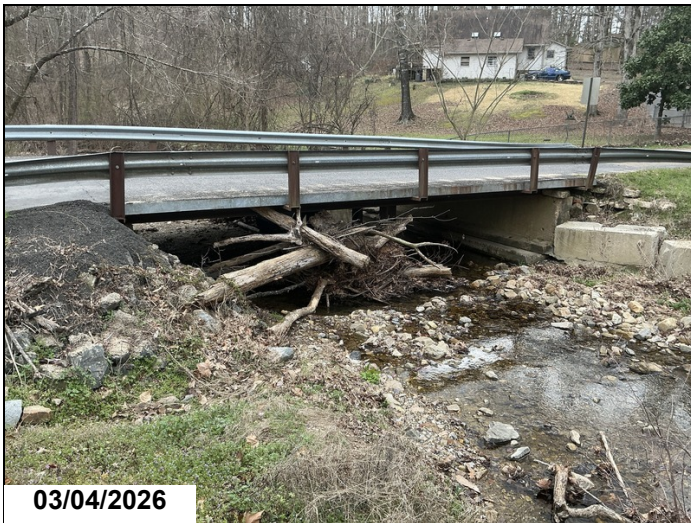
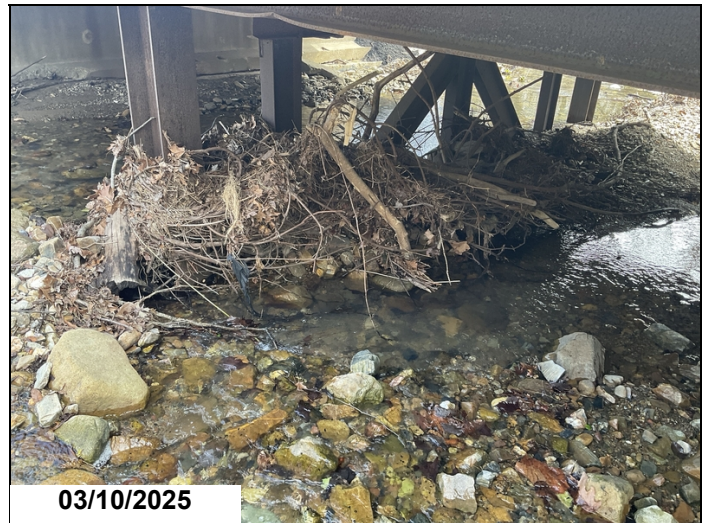
Drift and debris has accumulated at bent 2.

**Type of Work:** Channel Work/Drift Removal

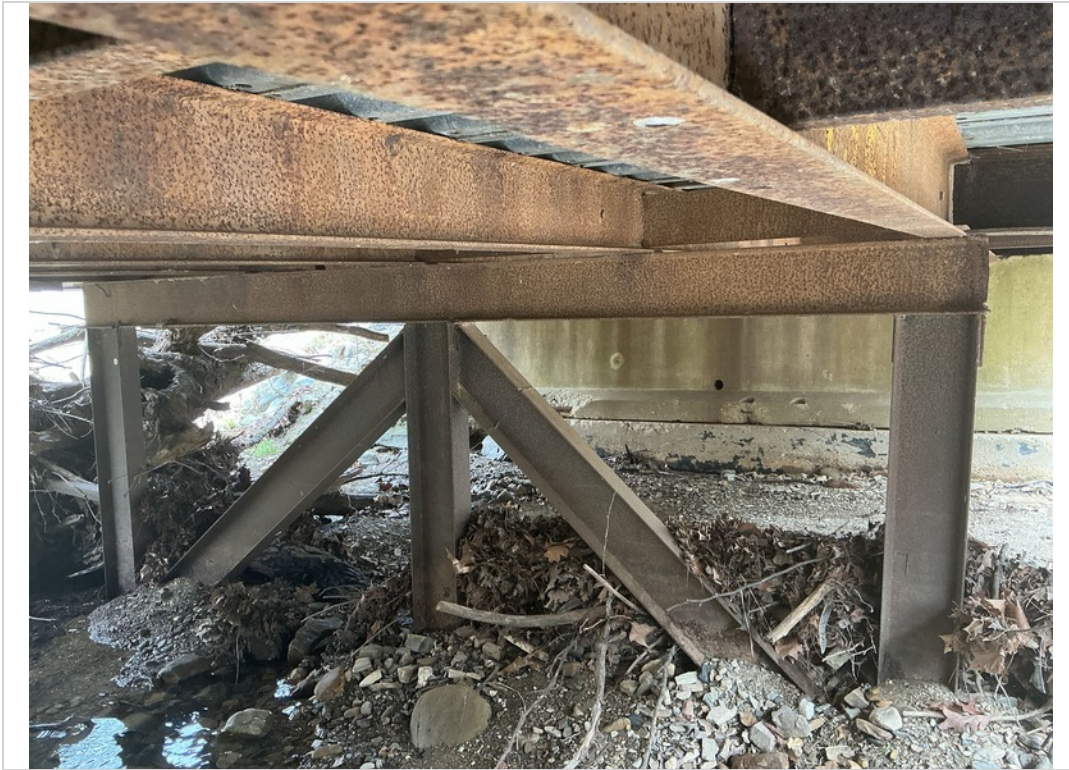
NSTM view

Steel cap has minor corrosion throughout.

Bridge #13213 NSTM Member Inspection Log			
Member or Element (NSTM)	Access Equipment	Condition Rating	General Condition Notes
Steel cap	Waders	6	Steel cap has active corrosion due to no protective coating.

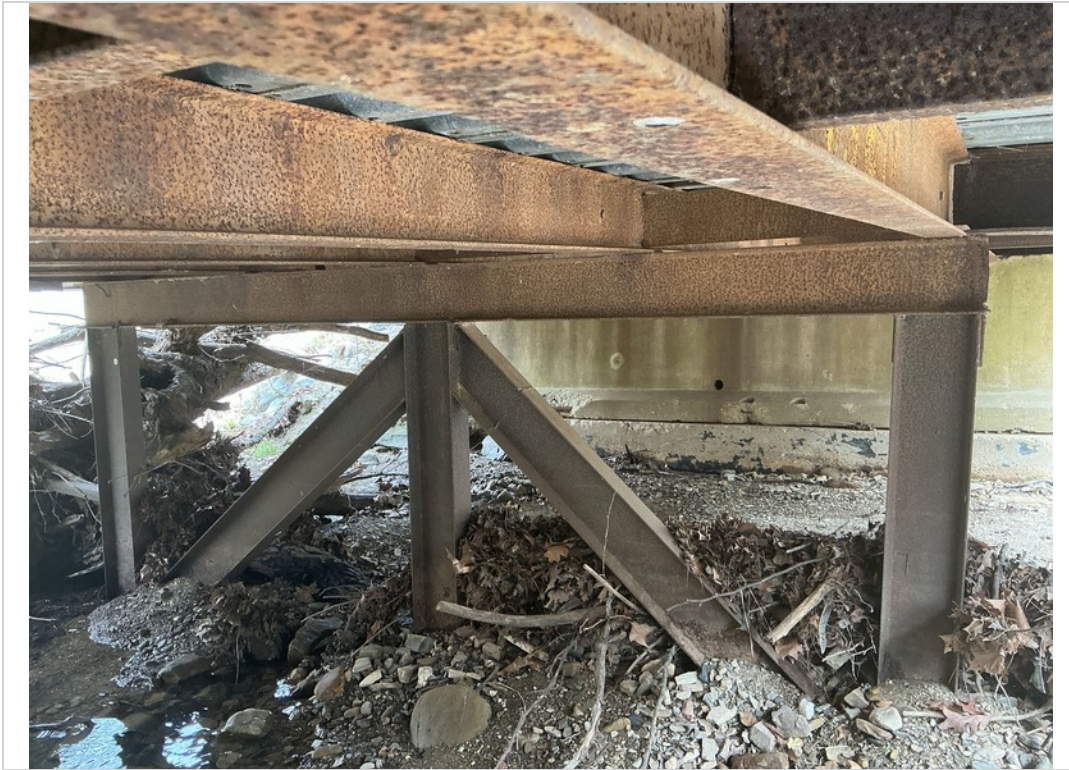
NSTM view

Steel cap has minor corrosion throughout.

Bridge #13213 NSTM Member Inspection Log			
Member or Element (NSTM)	Access Equipment	Condition Rating	General Condition Notes
Steel cap	Waders	6	Steel cap has active corrosion due to no protective coating.
