Bridge 19840 Inspection Report

SH 600 -21 Log 0.5 over Mill Creek 3 Sisters

Location: 1 MI E JCT SH 227

Team Lead: Chris Doggett Inspection Date: 11/20/2025

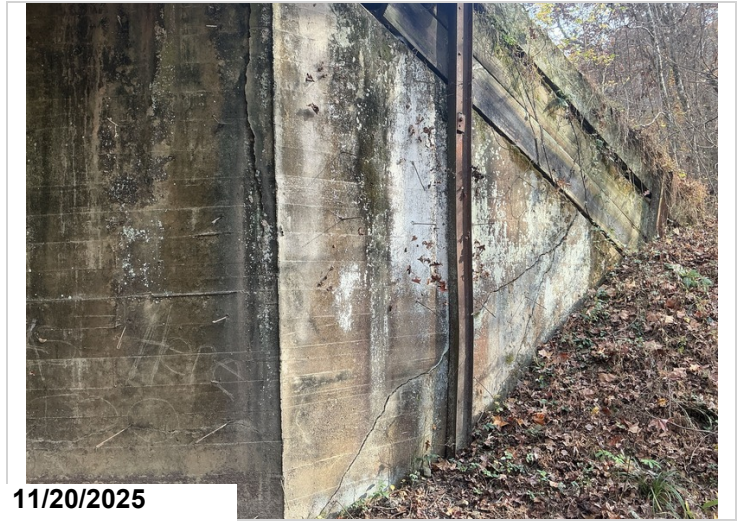
Overall, the substructure is in poor condition. Wing walls have large open cracks and are separating from the abutment. Steel channels appear to have been added to stabilize wing walls. Bents 2&3 scour action has exposed the footings with minor undermining at bent 2.

Bent 4: cracking in the wingwall.

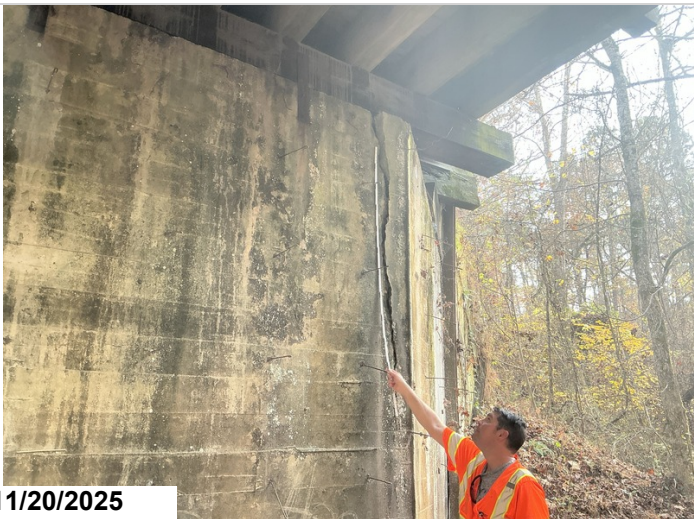
(205) No notable defects at this inspection							
215	Reinforced Concrete Abutment	LF	80	18	20	42	0
1130	Cracking (RC and Other)	LF	62	0	20	42	0
(215) Bent 1 has diagonal and horizontal cracks in the breast wall and large diagonal cracks in the wing walls. CS3							
Bent 4 has a large 2" wide vertical crack on the right side and large horizontal and diagonal cracks in the breast wall and wing walls. CS3							
216	Timber Abutment	LF	80	42	2	36	0
1140	Decay/Section Loss	LF	36	0	0	36	0
1170	Split/Delamination (Timber)	LF	2	0	2	0	0

Bent 4: Large vertical crack on the right side of the abutment that is separating.

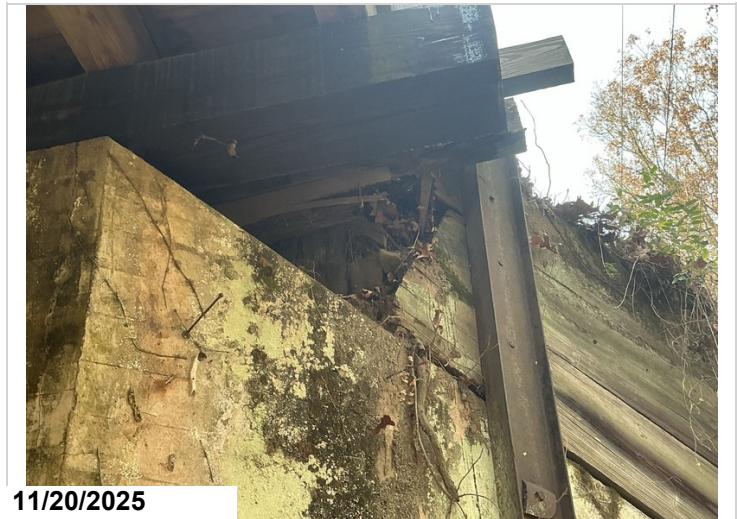
(216) The cribbing at both abutments have heavy decay. CS3							
220	Reinforced Concrete Pile Cap/Footing	LF	32	0	30	2	0
6000	Scour	LF	32	0	30	2	0
(220) The footings at bents 2 and 3 are exposed. CS2							
Bent 2 upstream end is undermined up to 4". CS3							
234	Reinforced Concrete Pier Cap	LF	28	28	0	0	0

Cribbing decay in timber abutment at bent 1 left side. 2025

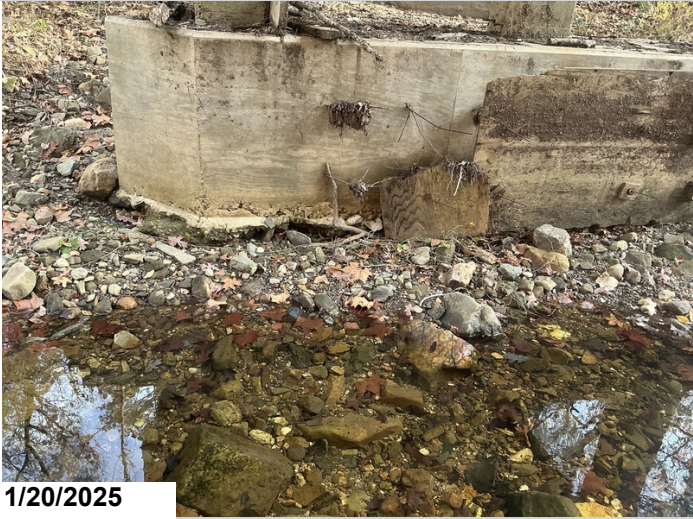
The footings at bents 2 and 3 are exposed.
Bent 2 upstream end is undermined up to 4".

Bent 3: footing is exposed.

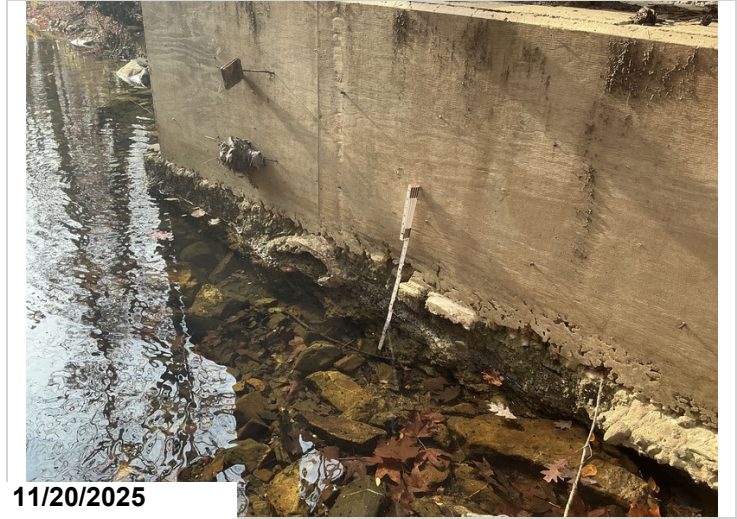
Ahead side of bent 2: footing is exposed.

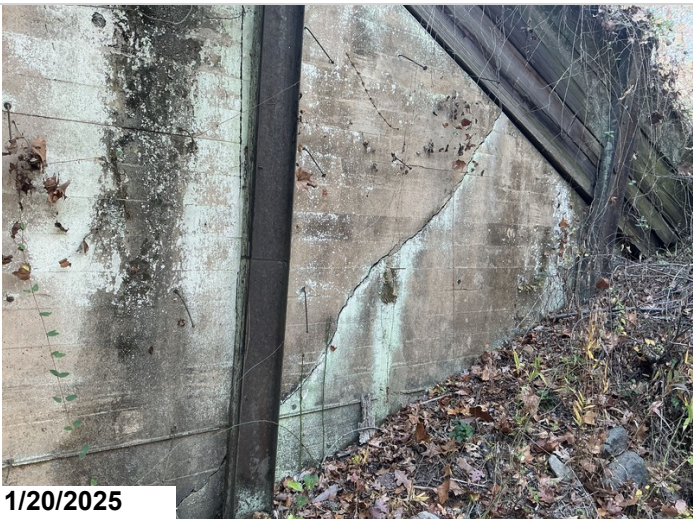
Bent 1: left side of abutment the wingwall with large diagonal cracking

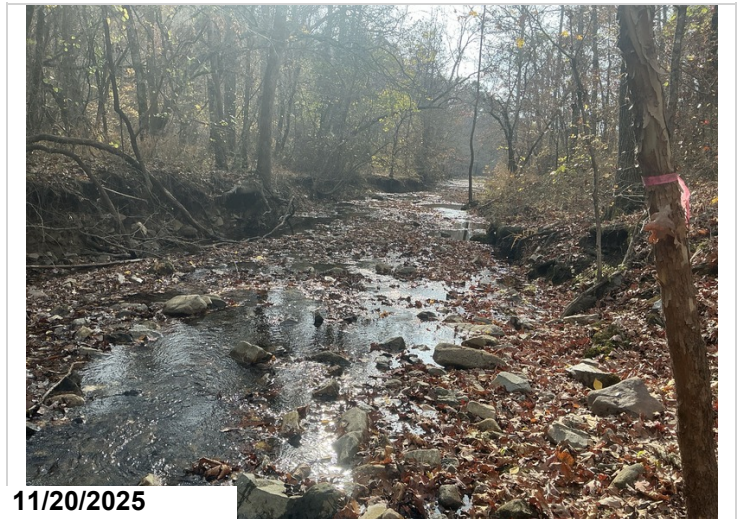
The channel shows some signs of the bank eroding and slumping.

Channel looking down stream

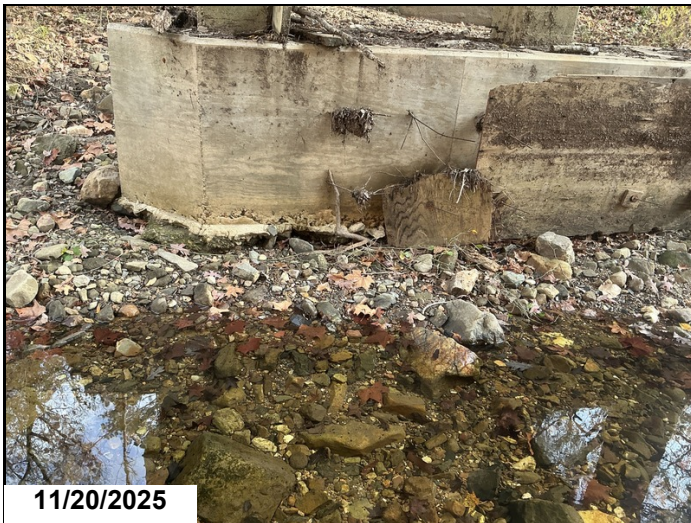
Bents 2 & 3 bottom of footing exposed on channel side of bents. See photos

Bent 3: footing is exposed.

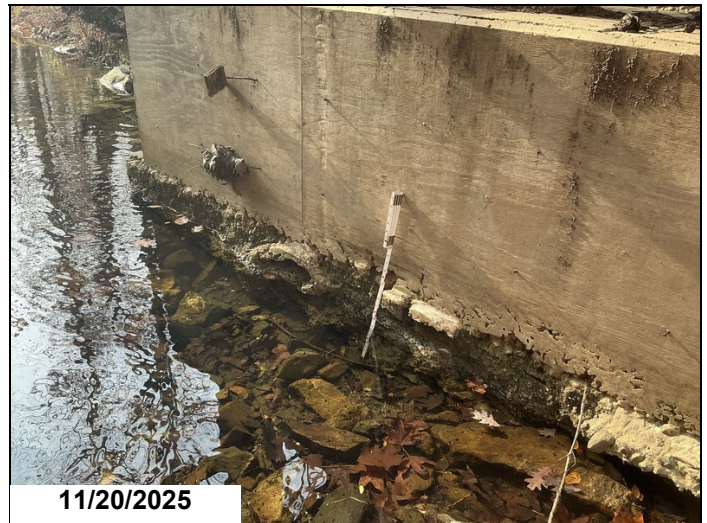
Ahead side of bent 2: footing is exposed.

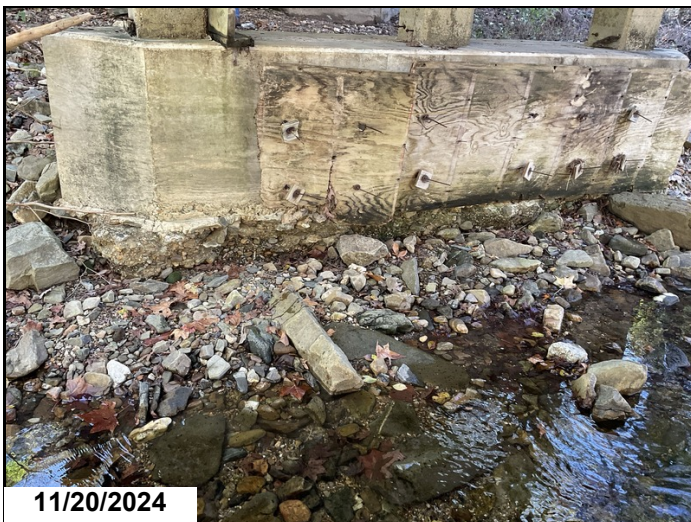
Bent 3: Scour action has exposed the footing. 2024

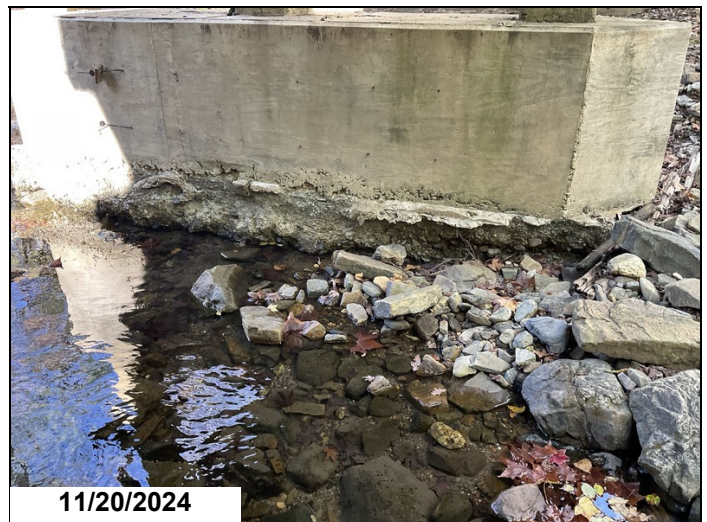
Bent 2: Scour action has exposed the footing. 2024

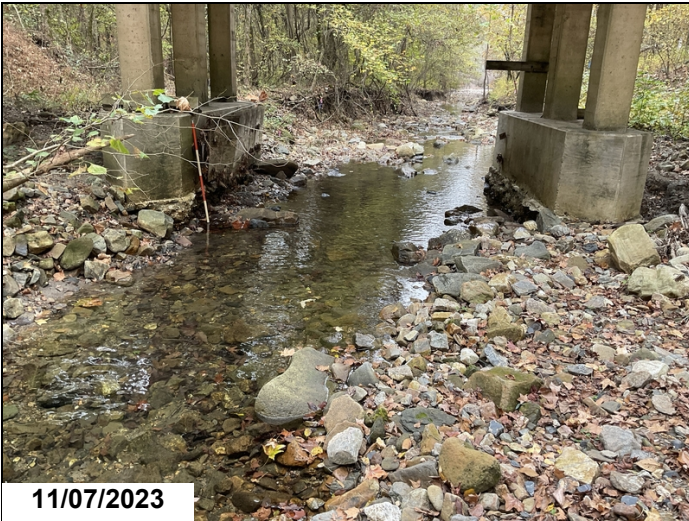
Bents 2&3: both footings are exposed due to scour action. 2023

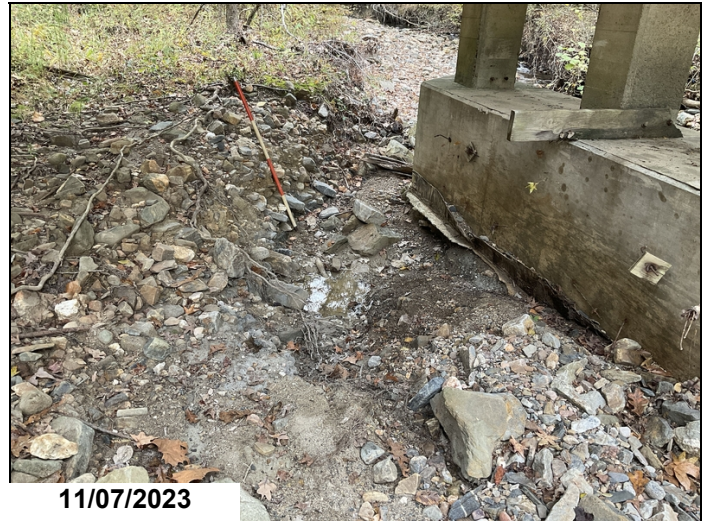
Bent 2: backside of footing is exposed due to local scour action. 2023

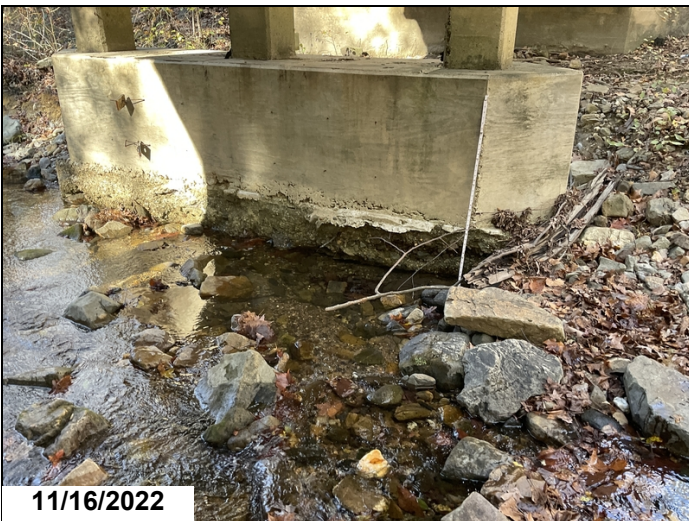
Bent 2: Scour action has exposed the footing and has some undermining. 2022

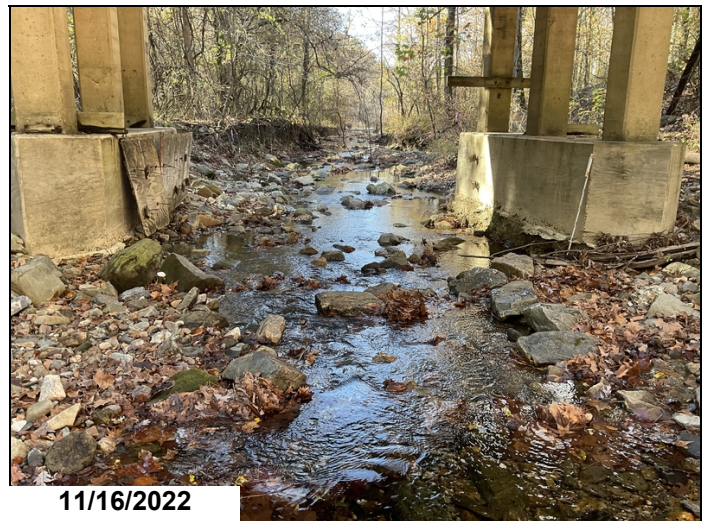
Looking at both bents 2 and 3: both bottom of their footings are exposed. 2022

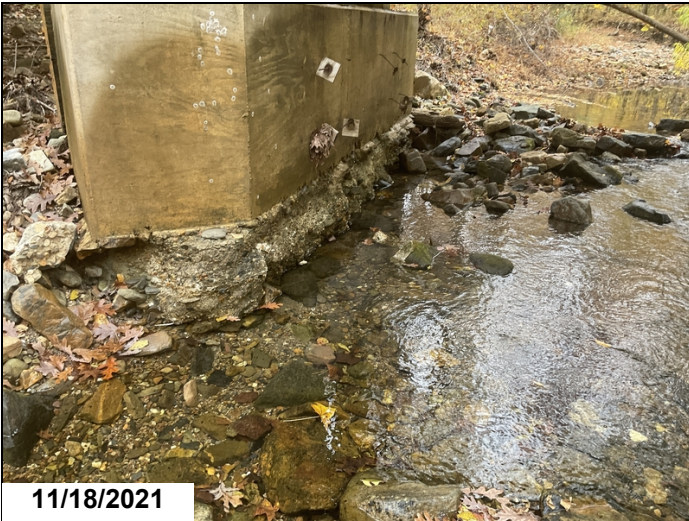
Bent 2 footing ahead bottom of footing exposed.

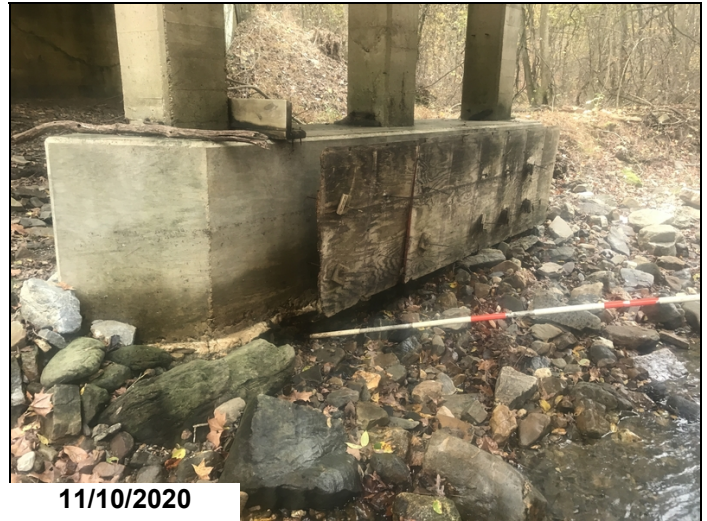
Back side bent 3 footing is exposed.

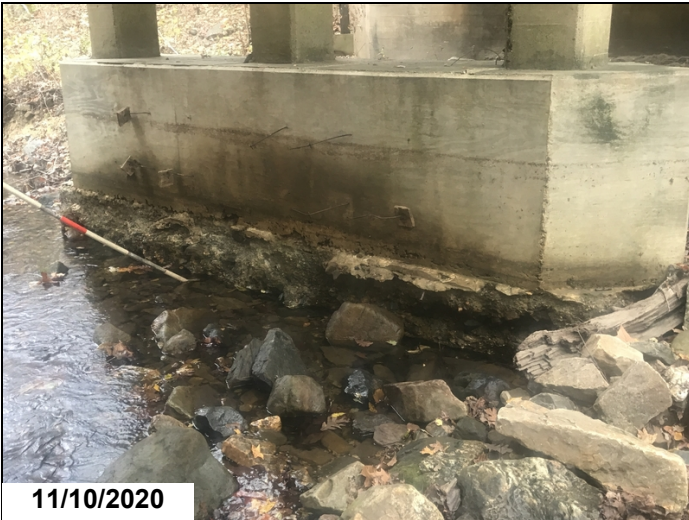
Bent 2 ahead side of footing is exposed due to scour.

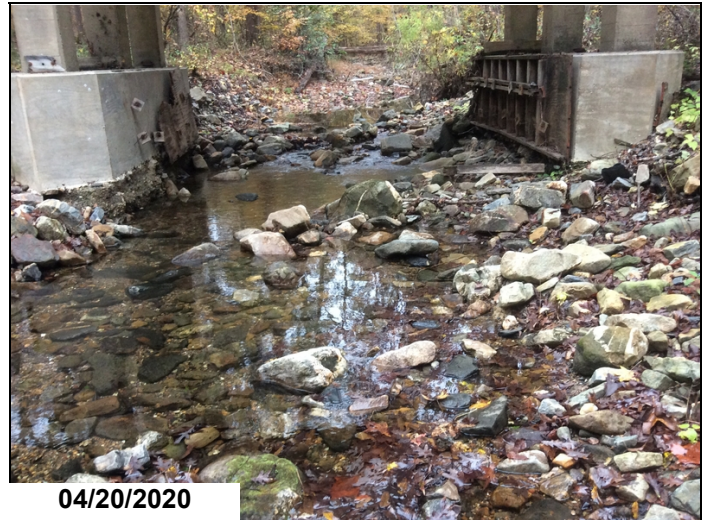
Bents 2 & 3 bottom of footing exposed on channel side of bents.

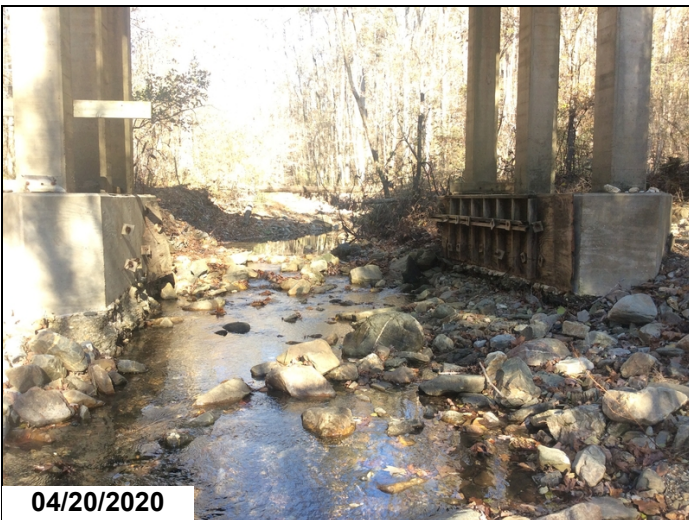
Bents 2 and 3 footings exposed.

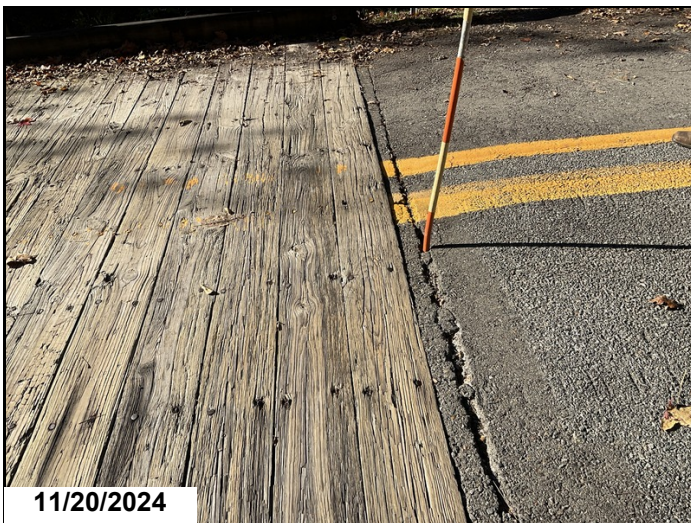
Approach roadway north end of bridge small void in the road at bridge end due to cribbing decay. 2024

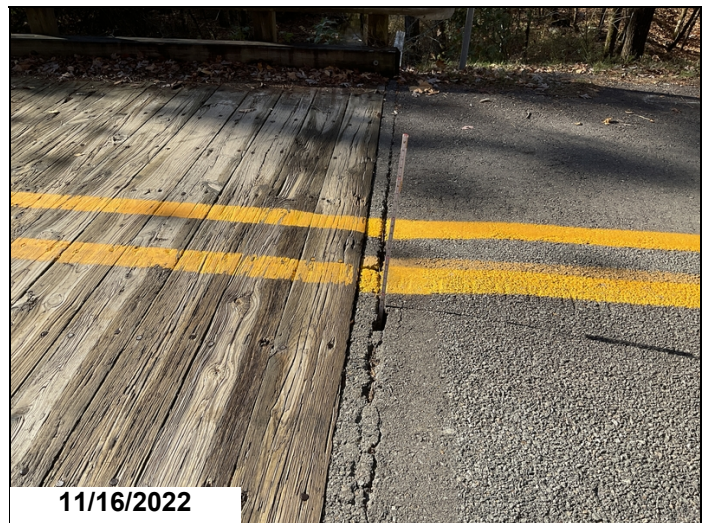
2022

Approach roadway north end of bridge small void in the road at bridge end due to cribbing decay.

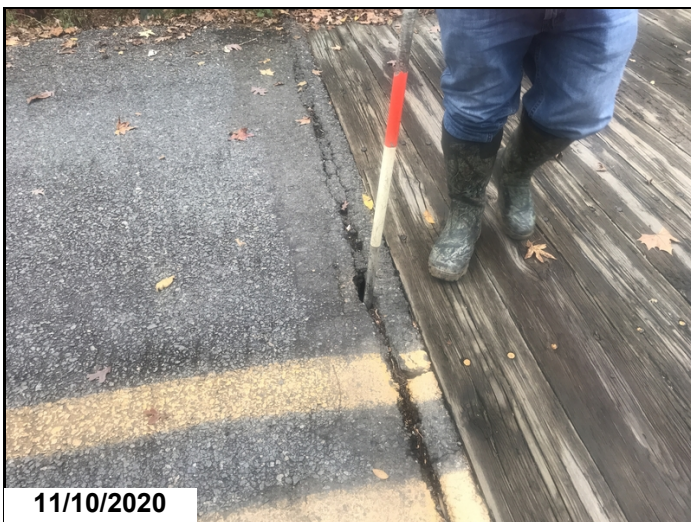
Approach roadway north end of bridge small void in the road at bridge end due to cribbing decay.

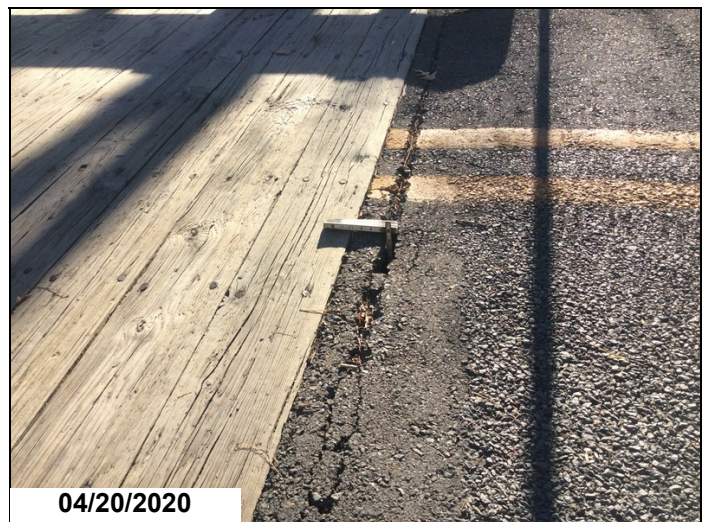
Bent 1, void in the approach.

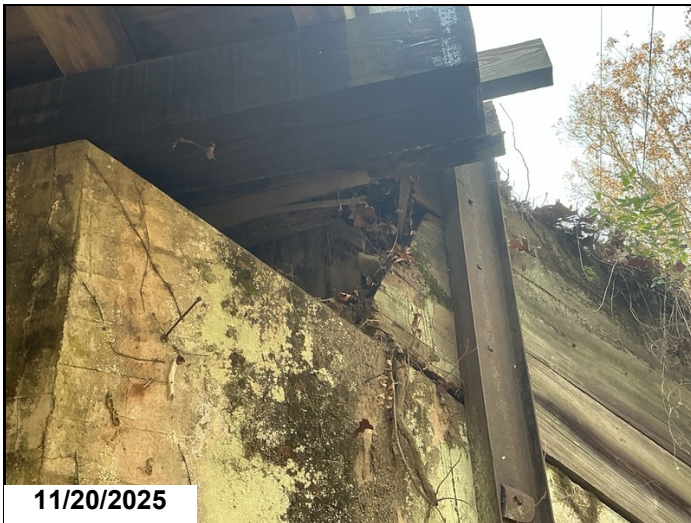
Cribbing decay in timber abutment at bent 1 left side.
2025

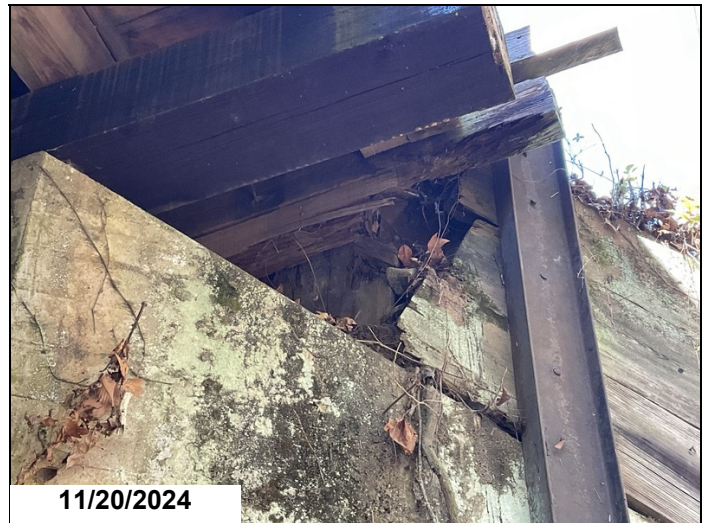
Cribbing decay in timber abutment at bent 1 left side.
2024

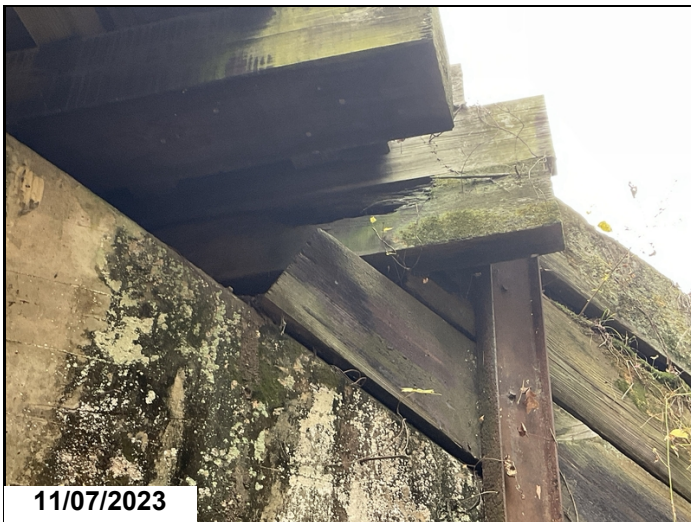
Cribbing decay in timber abutment at bent 4 right side.
2023

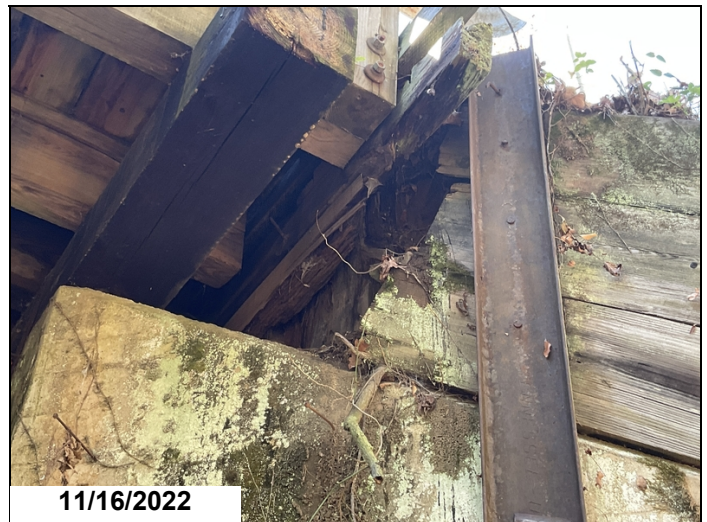
Bent 1, right end

Wooden cribbing at both abutments have decay.

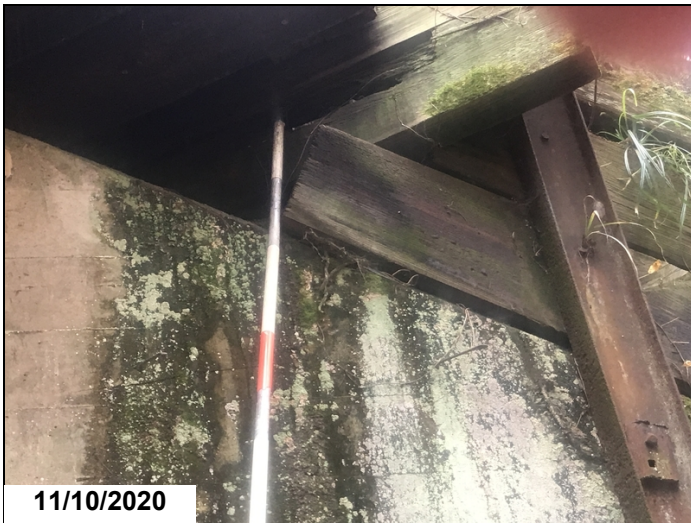
Cribbing decay in timber abutment at bent 4 right side.

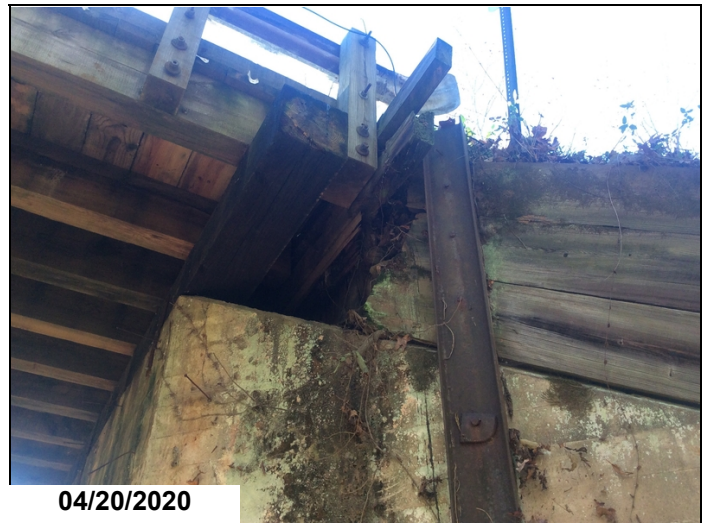
Bent 1, decayed timber cribbing.

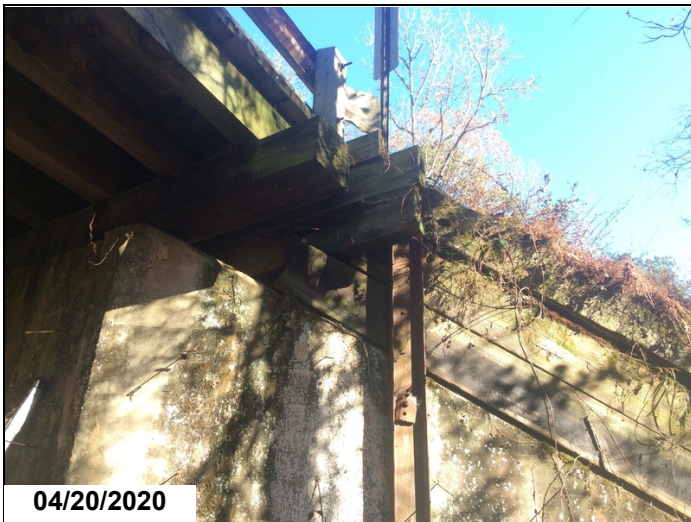
Right side of bent 4 cribbing decayed.

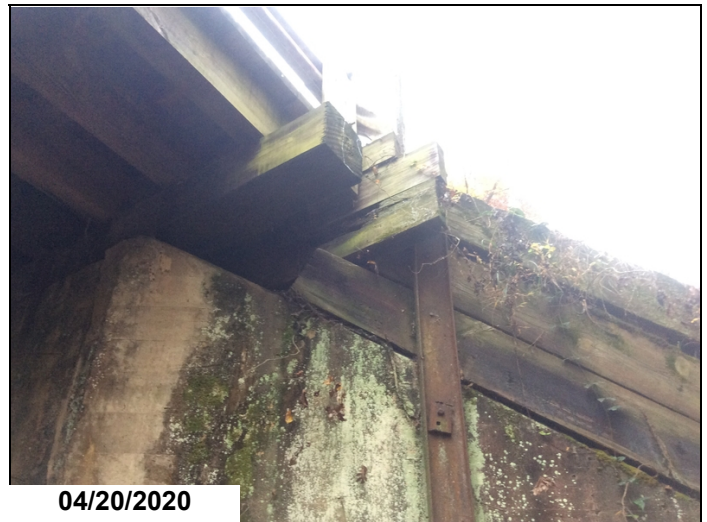
Bt. 4 timber cribbing has decay.

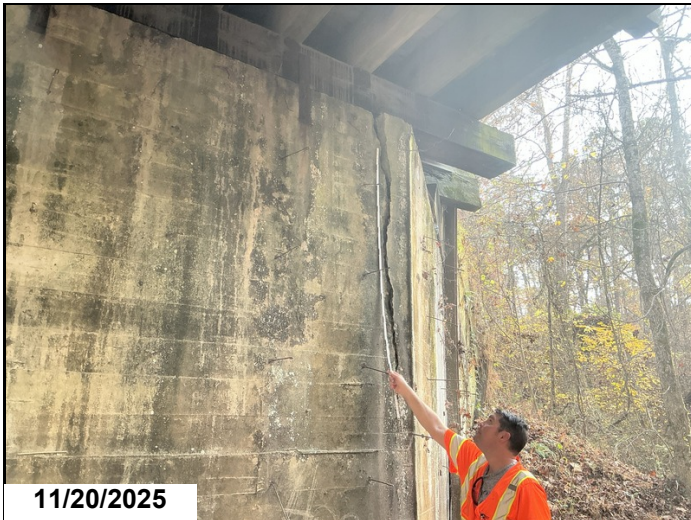
Bent 4: Large vertical crack on the right side of the abutment that is separating. Steel channels appear to have been added to stabilize wing walls.

Bent 4: Large vertical crack on the right side of the abutment that is separating.
