Asset #A3245(Routine)

I-30 WB Log 105.28 over TEN MILE CREEK

Location: 7.3 MI NO JCT I-30 & 270

Team Lead: Shane Byrd, Inspection Date: 08/25/2021

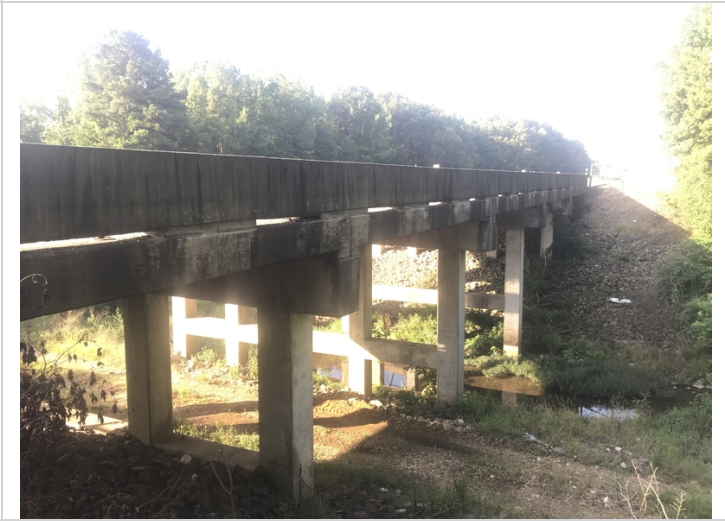
Elevation.

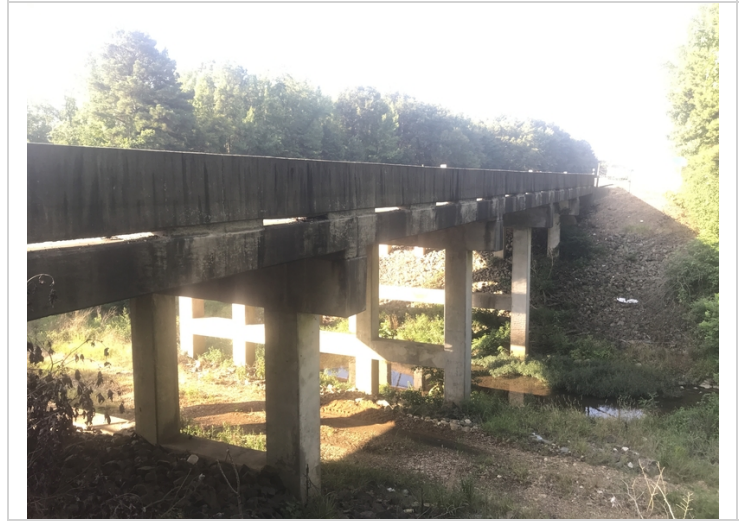
Elevation.

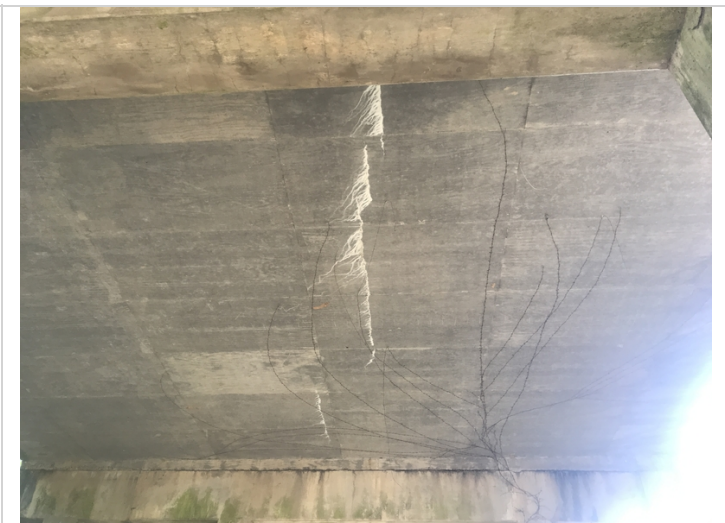
Span 3 soffit overview.

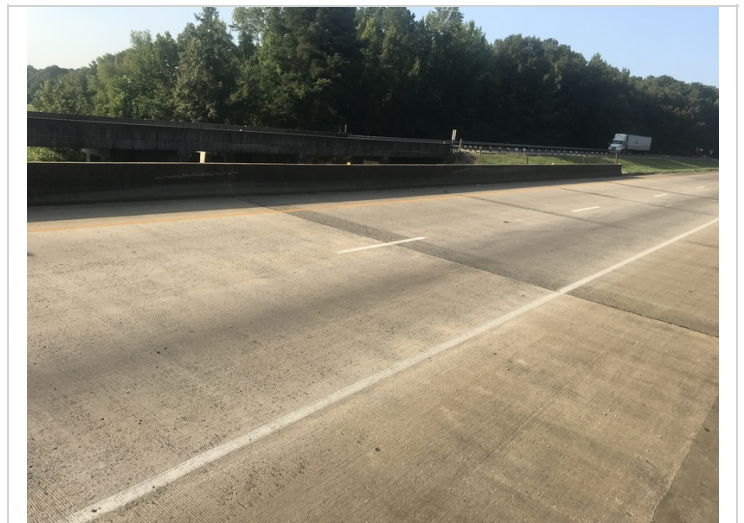
Deck overview.

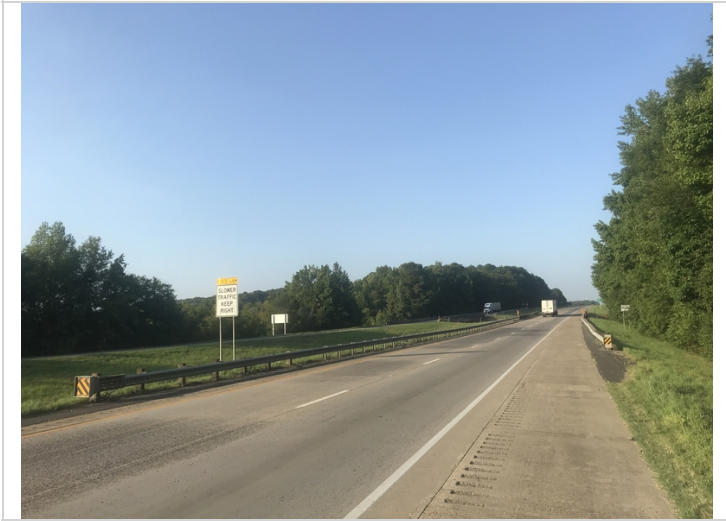
Approach Westbound

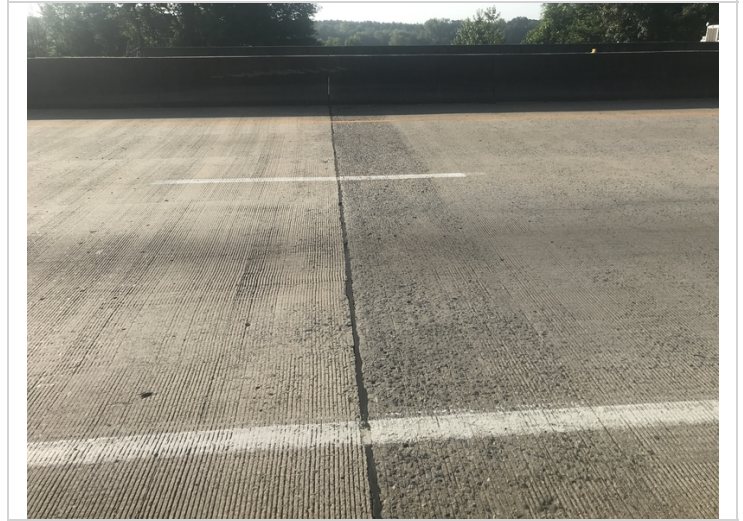
Span 4 at bent 5 deck has abrasion common bent 2.

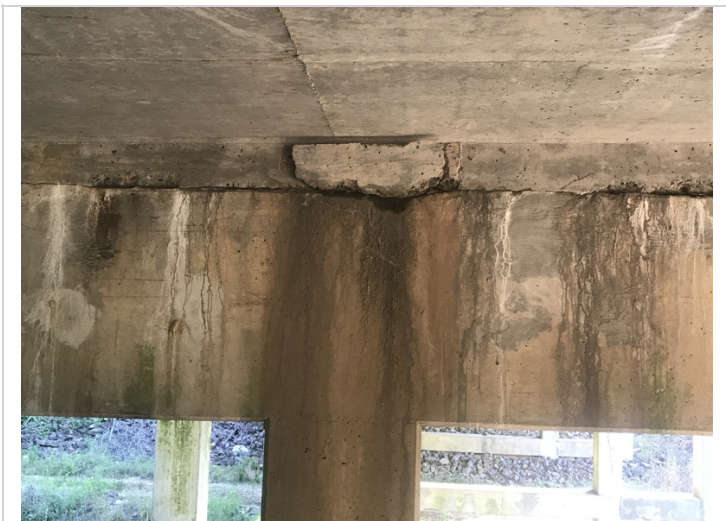
Bent 2 above cap haunch of deck has delam.

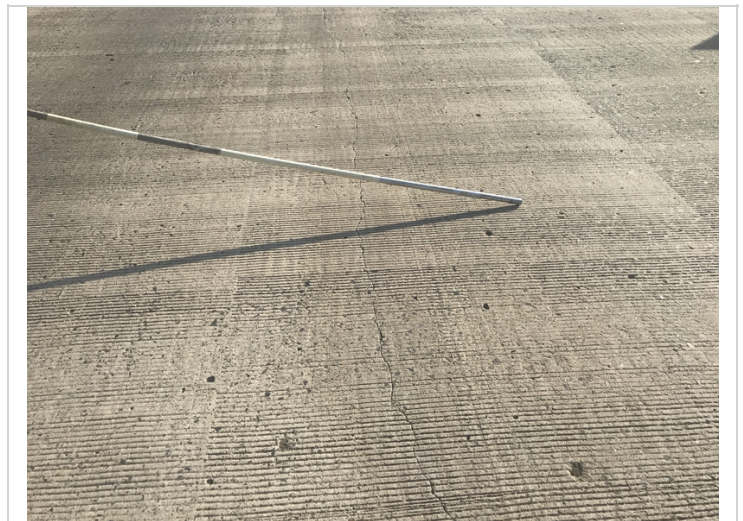
Span 5 deck has longitudinal crack that reflects through to the soffit at centerline.

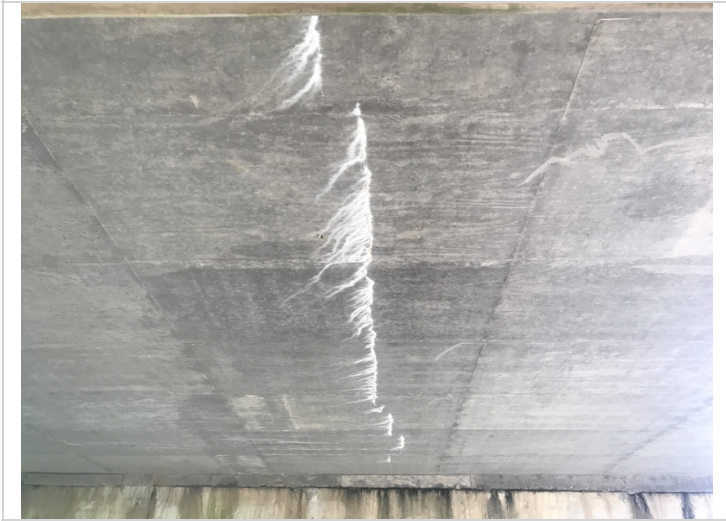
(38) Bottom of deck has cracks with efflorescence. The top of deck has large unsealed cracks. Bent 2,3,4, 5,6 spalls, exposed rebar and delamination in the haunch area. Abrasion at the joints bents 2-5.							
205	Reinforced Concrete Column	EA	16	9	4	3	0
1080	Delamination/Spall/Patched Area	EA	4	0	4	0	0
1090	Exposed Rebar	EA	2	0	0	2	0
1130	Cracking (RC and Other)	EA	1	0	0	1	0

Span 2 soffit has cracks with efflorescence at centerline, common all spans.

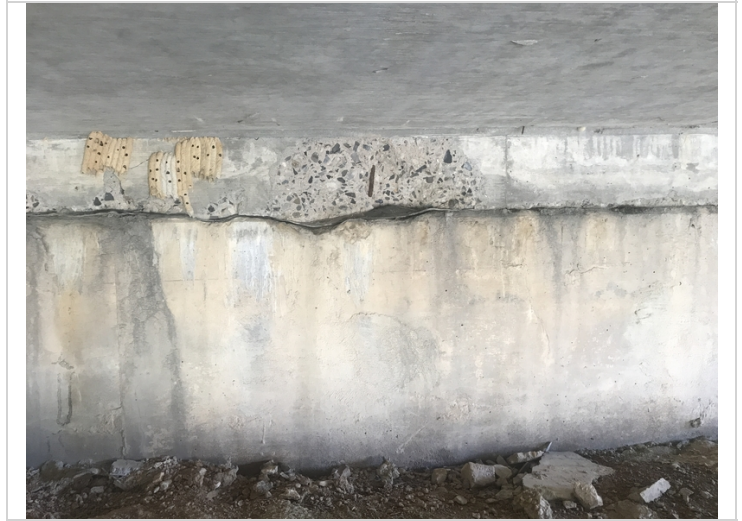
Deck haunch above bent 6 has spall with exposed rebar.

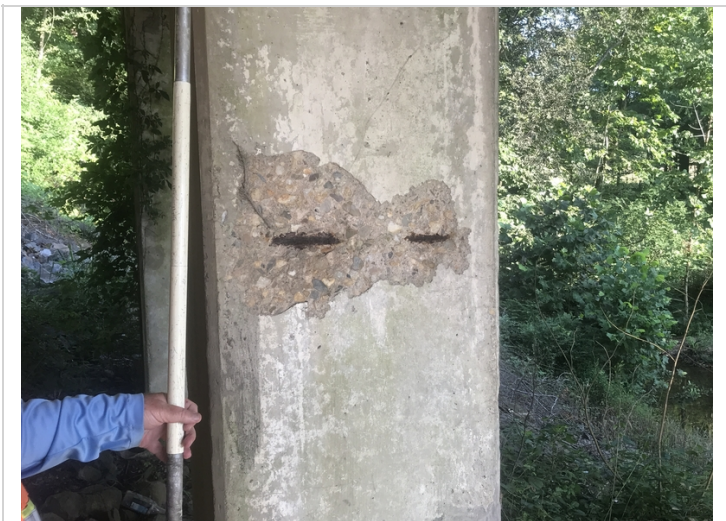
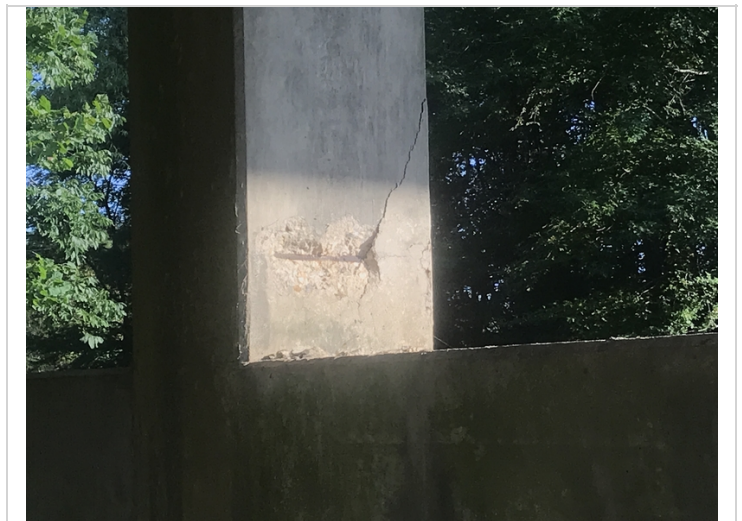
(205) Bent 2 column 2 exposed rebar. Bent 3 column 2 exposed rebar, column 3 delamination. Bent 4 column 2 has delamination and column 3 has a large crack. Bent 5 columns 2 and 3 have delamination.							
210	Reinforced Concrete Pier Wall	LF	180	180	0	0	0

Bent 2 column 2 has spall with exposed rebar.

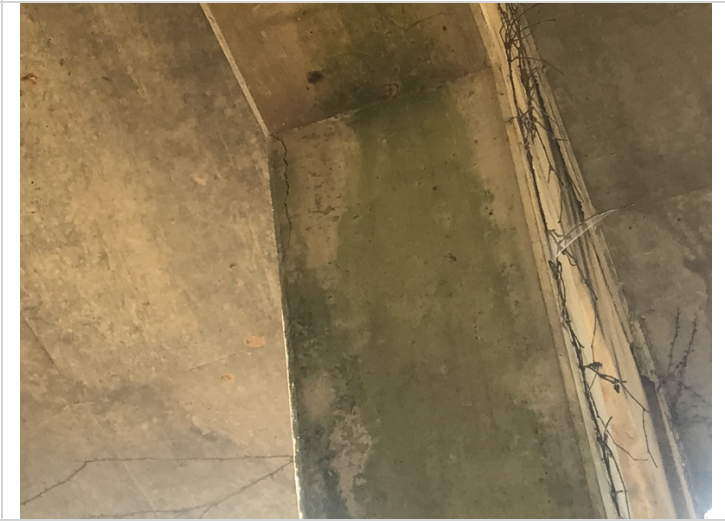
Bent 4 column 3 has large crack.

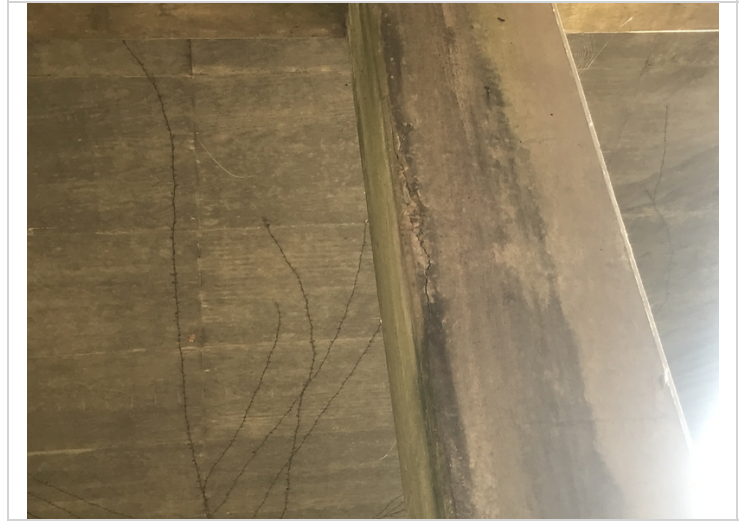
Bent 3 column 3 has delam.

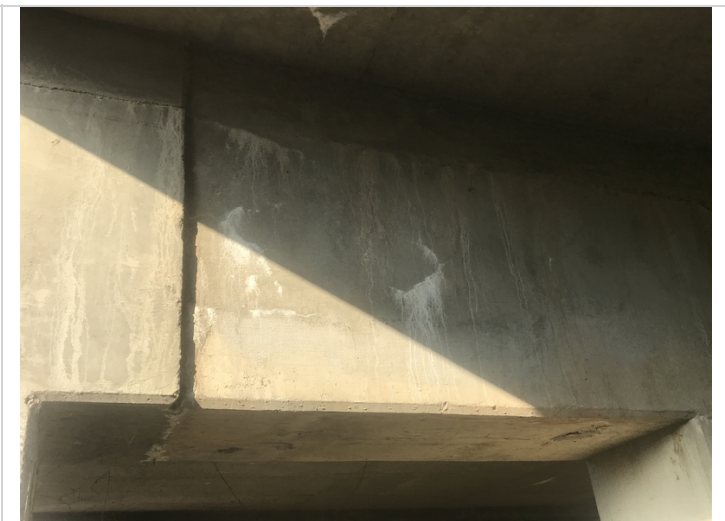
(234) Exposed rebar at bent 4 And delamination. Bent 5 has large spall and delamination on the bottom of the cap and efflorescence on the ahead side.							
301	Pourable Joint Seal	LF	160	0	160	0	0
2310	Leakage	LF	160	0	160	0	0

Bent 5 cap ahead has cracks with efflorescence.

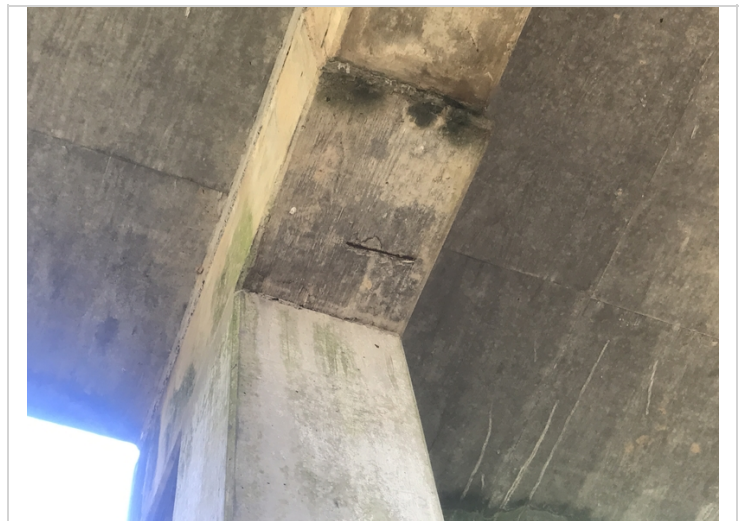
Bent 4 cap bottom has spall with exposed rebar.

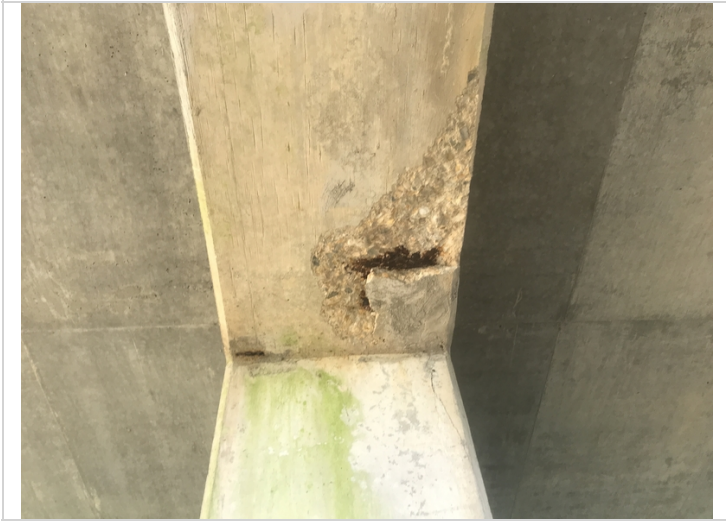
Bent 5 cap bottom has spall with exposed rebar.

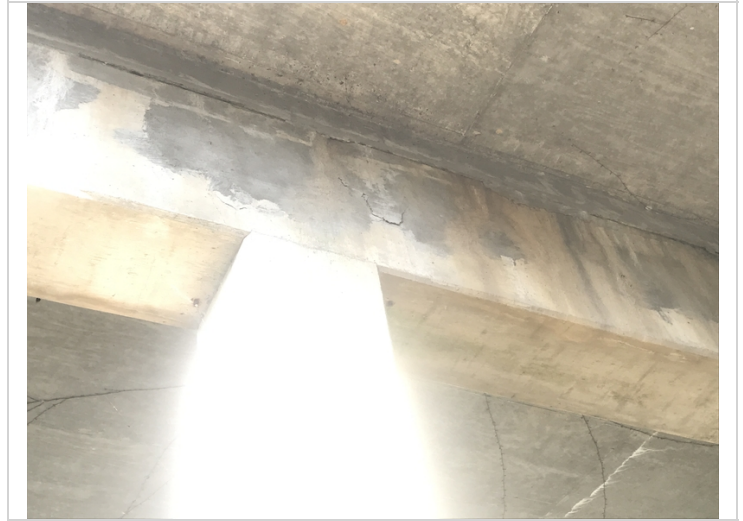
Bent 4 cap ahead has delam.

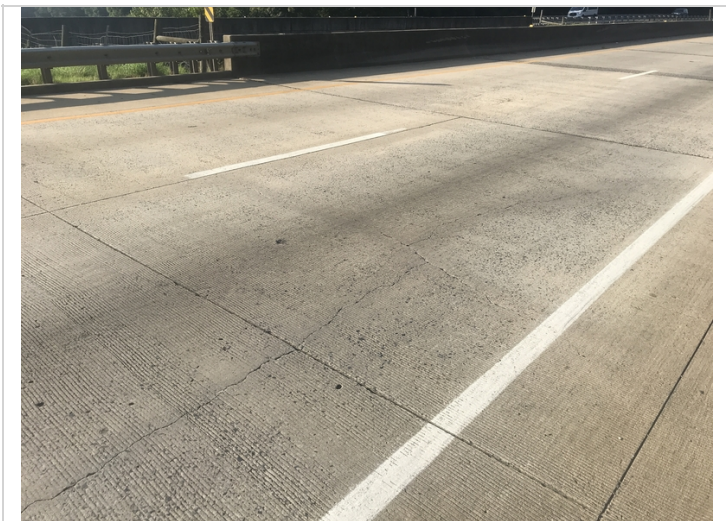
ELEMENTS	DESCRIPTION	UNITS	TOTAL	CS1	CS2	CS3	CS4
1130	Cracking (RC and Other)	SF	160	0	0	160	0
4000	Settlement	SF	12	0	12	0	0
(321) Both approach slabs have large cracks.							
331	Reinforced Concrete Bridge Railing	LF	300	270	30	0	0
1080	Delamination/Spall/Patched Area	LF	20	0	20	0	0
1130	Cracking (RC and Other)	LF	10	0	10	0	0

Large unsealed cracks in the east approach slab.

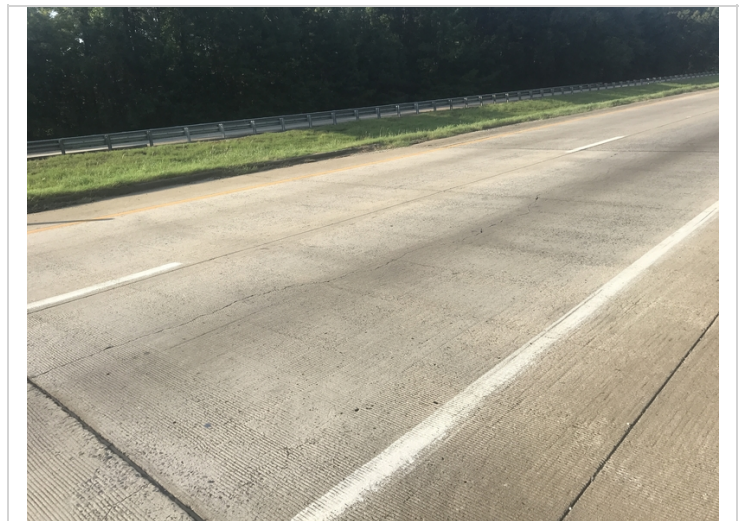
West approach slab has large unsealed longitudinal crack.

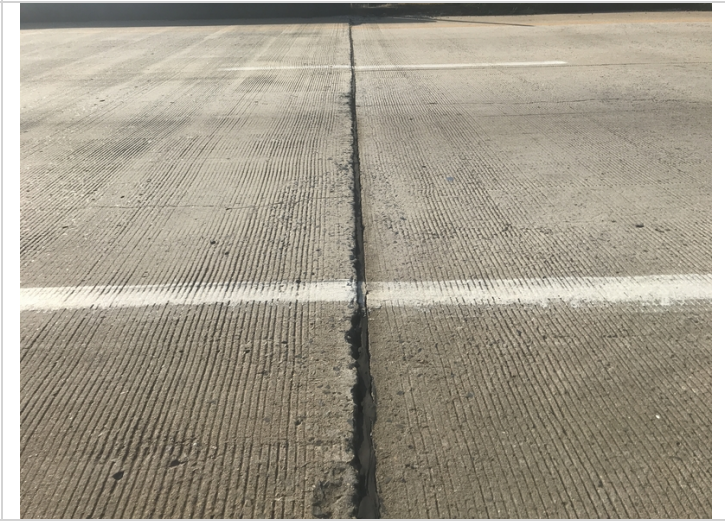
(301) All joints have lost bond and are leaking.							
321	Reinforced Concrete Approach Slab	SF	2888	2716	12	160	0

Bent 1 joint seal has lost bond and is leaking. Common all joint seals.

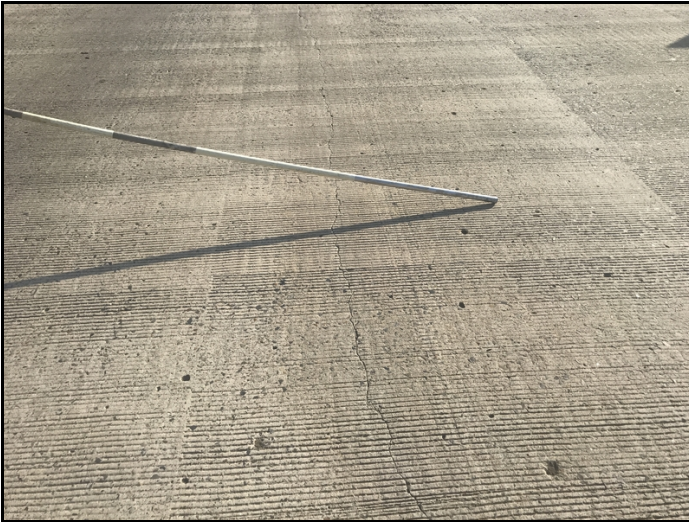
Large unsealed longitudinal cracks.

Span 5 deck has longitudinal crack that reflects through to the soffit at centerline.

Type of Work: Repair (General)

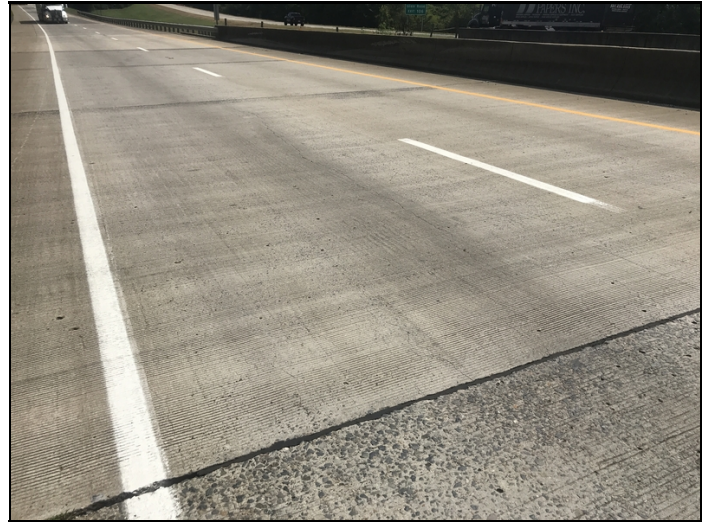
Span 2, large longitudinal crack.

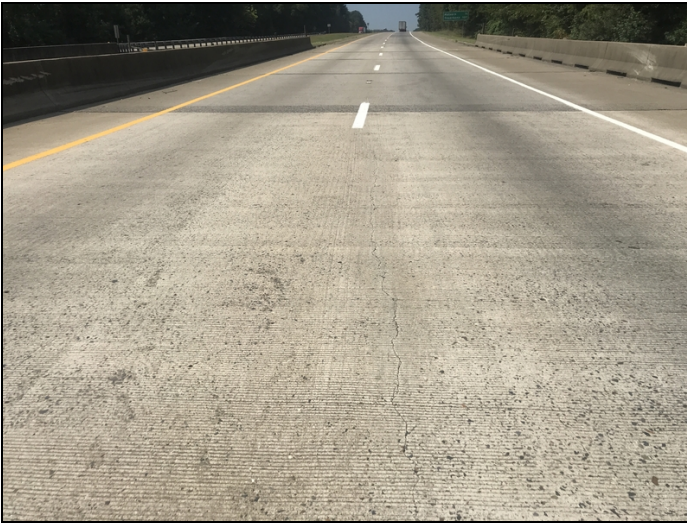
Span 5 large longitudinal cracks.

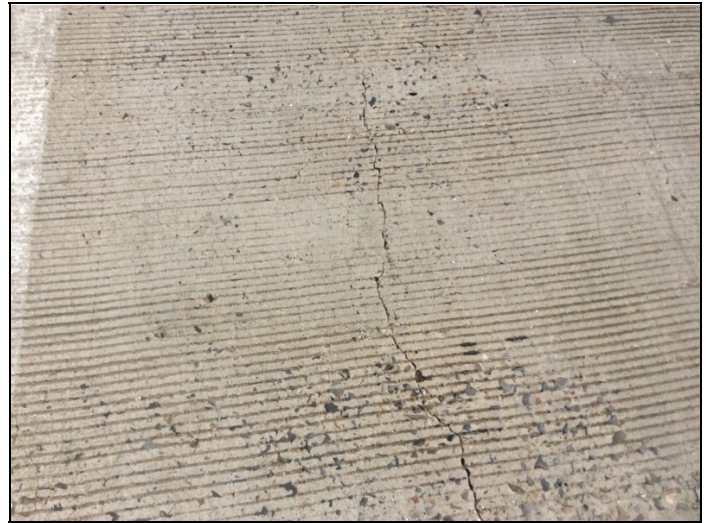
Deck has large unsealed cracks.
