Asset #B3245(Routine)

I-30 EB Log 105.28 over TEN MILE CREEK

Location: 0.18 MI S SALIN CO LINE

Team Lead: Shane Byrd, Inspection Date: 08/25/2021

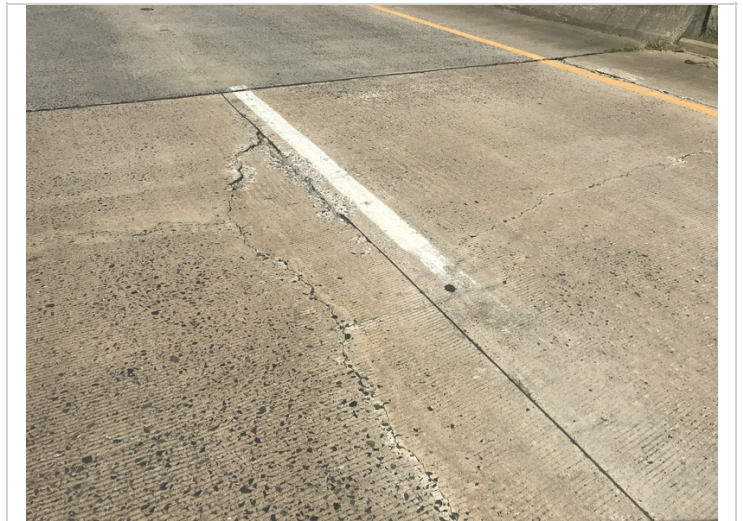
ELEMENTS	DESCRIPTION	UNITS	TOTAL	CS1	CS2	CS3	CS4
(321) Both Approach slabs have deep spalls and unsealed cracks.							
331	Reinforced Concrete Bridge Railing	LF	300	300	0	0	0

East approach slab has deep spalls.

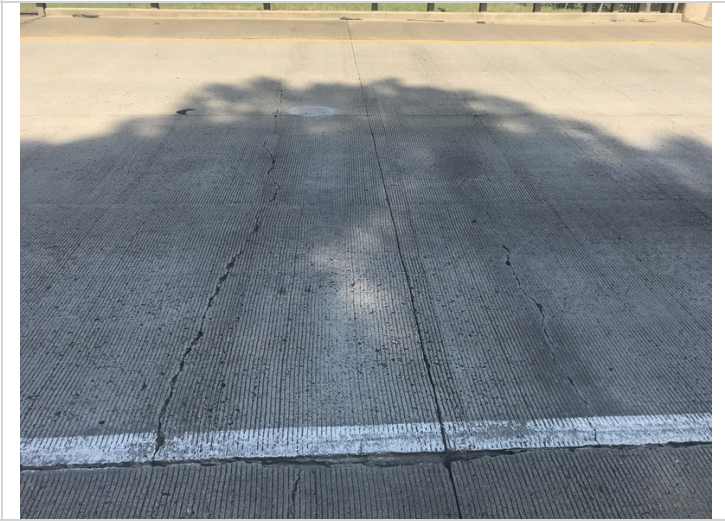
West approach slab has large unsealed cracks.

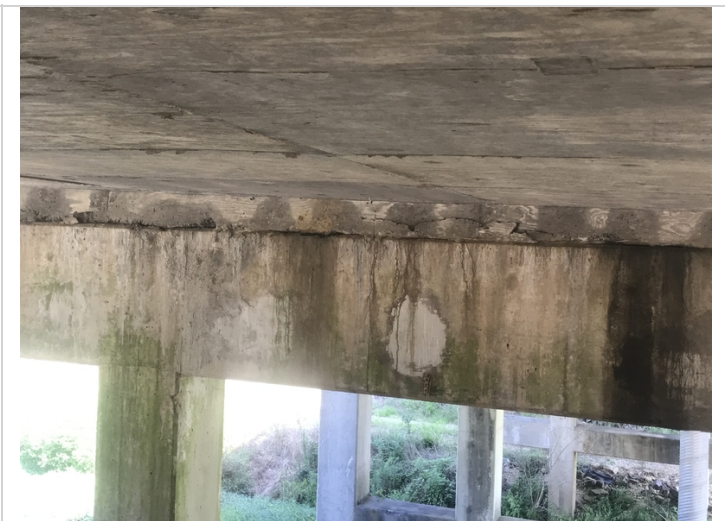
(38) Bottom of deck has cracks with efflorescence. Bent 1,2 and 6 the haunch area has spalling and delaminations over the caps.							
205	Reinforced Concrete Column	EA	20	12	4	4	0
1090	Exposed Rebar	EA	4	0	0	4	0
1130	Cracking (RC and Other)	EA	2	0	2	0	0
1190	Abrasion/Wear (PSC/RC)	EA	2	0	2	0	0

Deck haunch at bent 2 has spalls and delams.

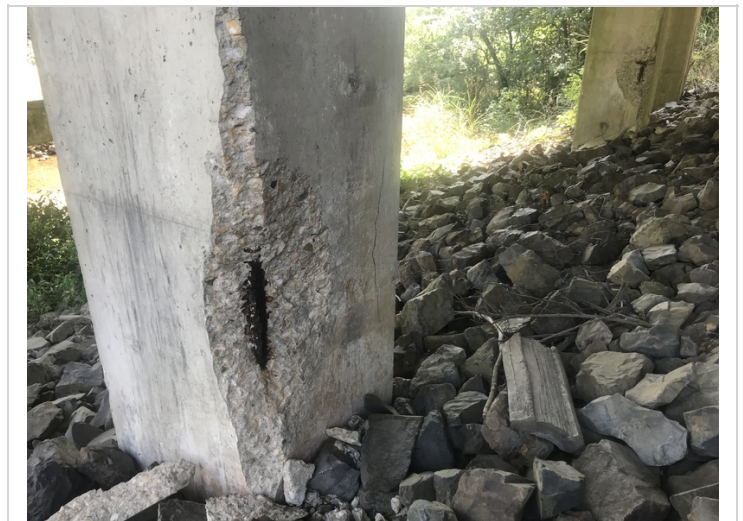
(205) Bent 2 columns 2 and 3 and column 5 at bent 5 have large spalls with rebar exposed. Bent 3 columns 2 and 3 have abrasion. Bent 3 column 3 has crack. Bent 4 columns 2 and 3 have large delamination. Bent 4 column 3 has crack.							
210	Reinforced Concrete Pier Wall	LF	180	175	0	5	0
1130	Cracking (RC and Other)	LF	5	0	0	5	0

Bent 2 columns 2&3 have large spalls with exposed rebar.

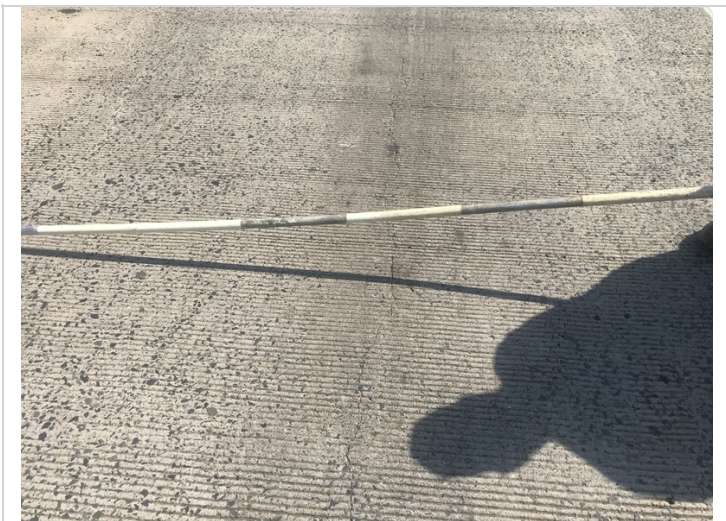
Deck span 5 has longitudinal unsealed crack that reflects through to the soffit.

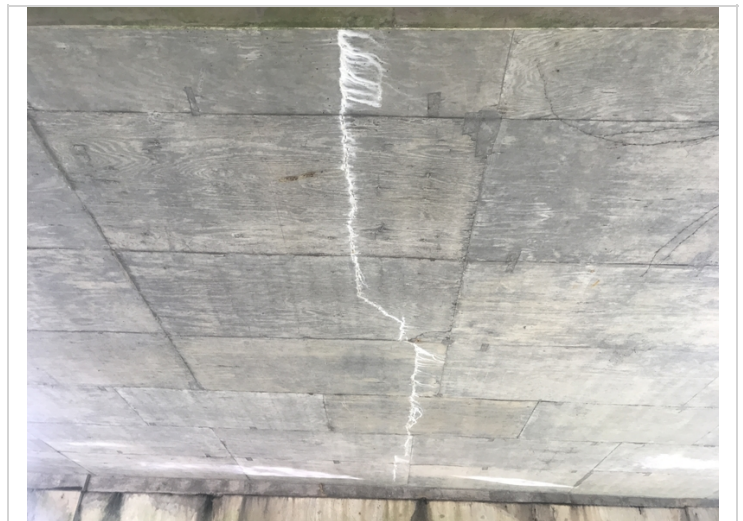
Span 2 soffit has cracks with efflorescence at centerline, common all spans.

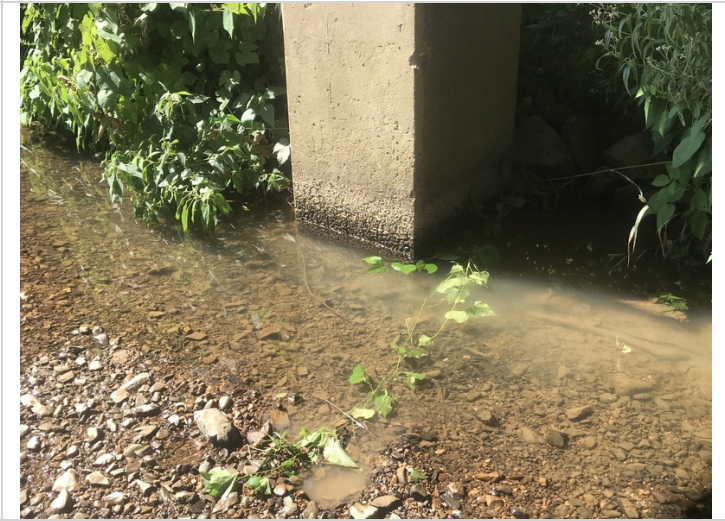
Bent 3 column 3 has abrasion at water line, common column 2.

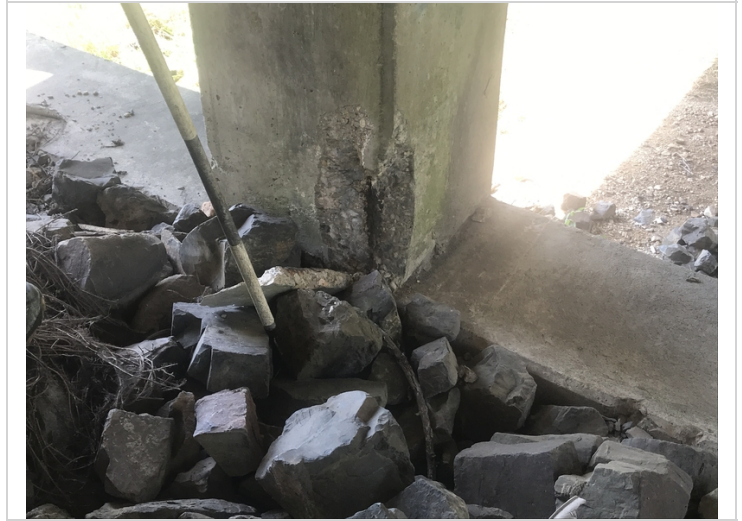
Bent 5 column 5 has large spall with exposed rebar.

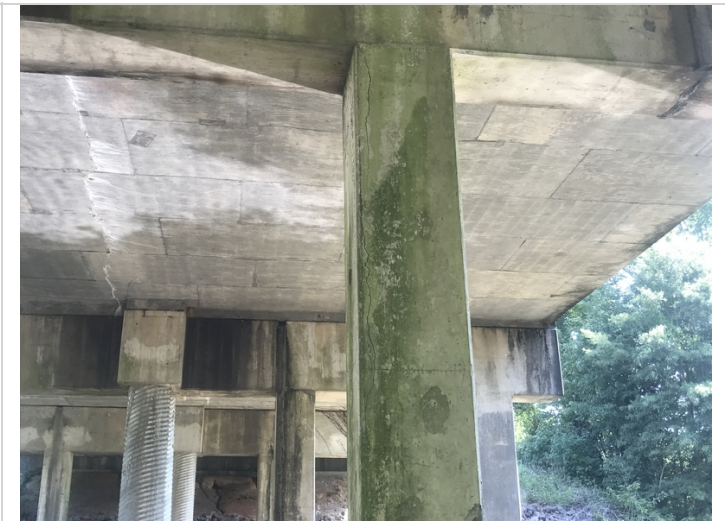
Bent 3 column 3 has crack.

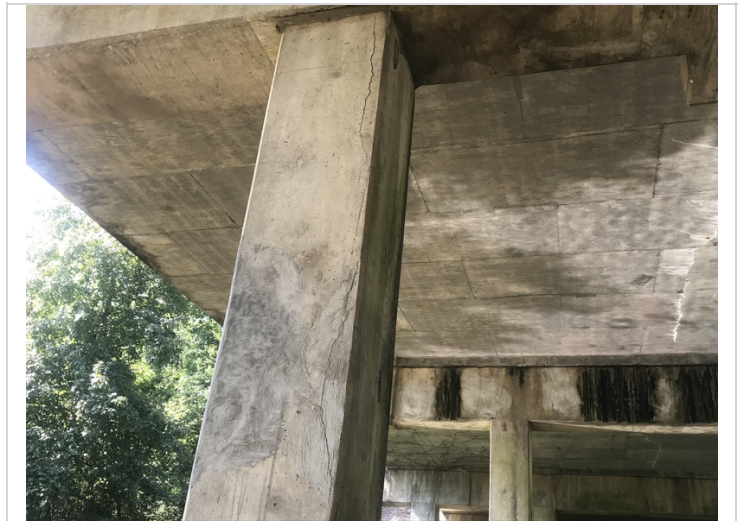
Bent 4 column 5 has crack.

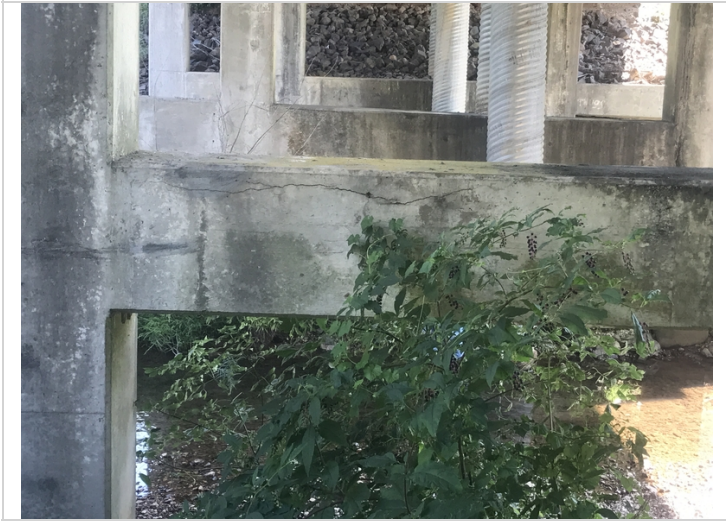
Pier wall (interior strut) at bent 3 between columns 2&3 has crack.

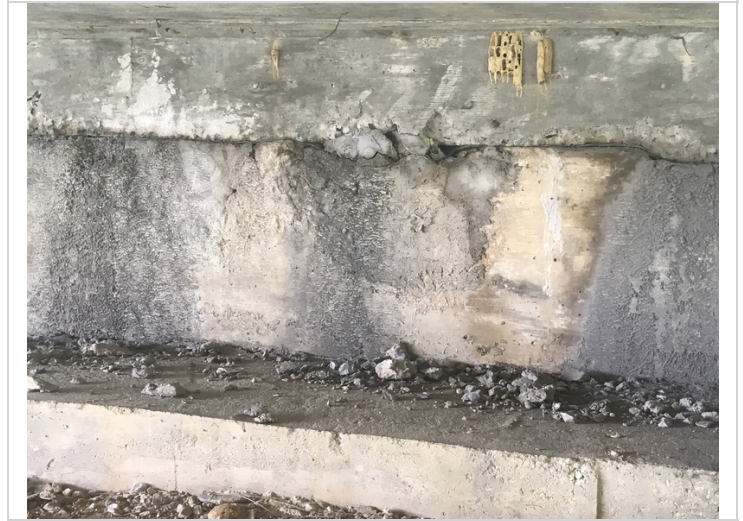
Bent 6 abutment patched area is spalling.

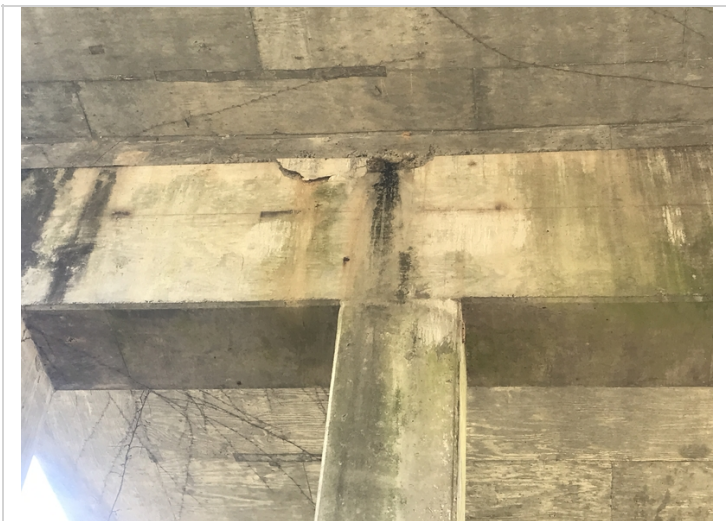
(234) Bent 4 has large delaminations.							
301	Pourable Joint Seal	LF	160	0	154	0	6
2310	Leakage	LF	154	0	154	0	0
2330	Seal Damage	LF	6	0	0	0	6
(301) All joints have lost bond and are leaking.							
321	Reinforced Concrete Approach Slab	SF	2888	2777	15	96	0
1080	Delamination/Spall/Patched Area	SF	23	0	15	8	0
1130	Cracking (RC and Other)	SF	88	0	0	88	0

Bent 4 cap back has large delam.

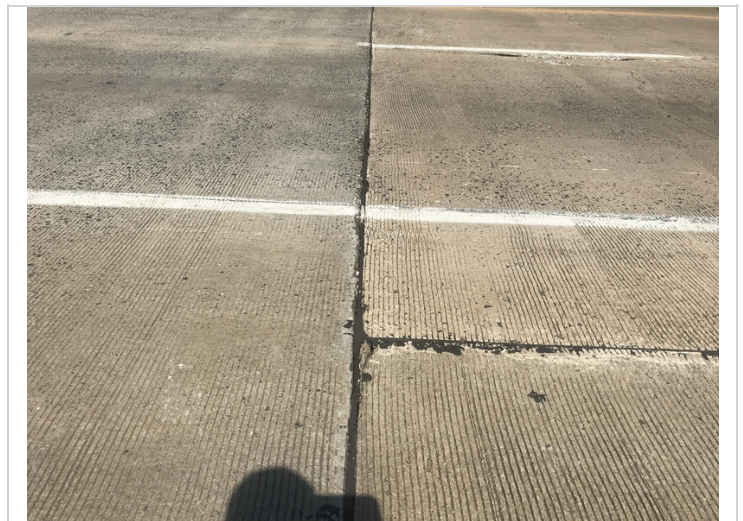
Bent 6 joint seal has lost bond and is leaking, common all joint seals.

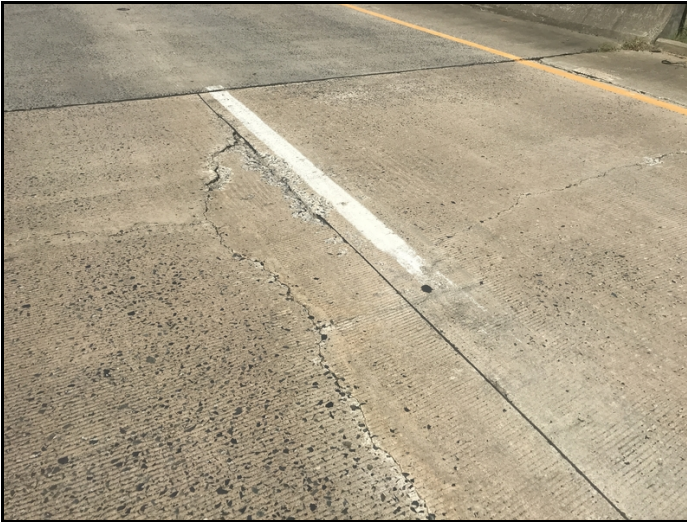
Both approach slabs has a deep spall and unsealed cracks.

East approach slab has deep spalls.

Type of Work: Repair (General)

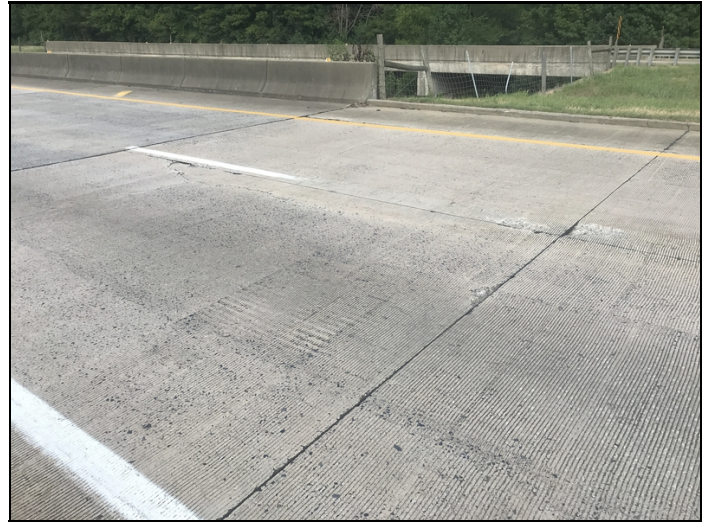
Large spalls and large cracks in east approach slab.

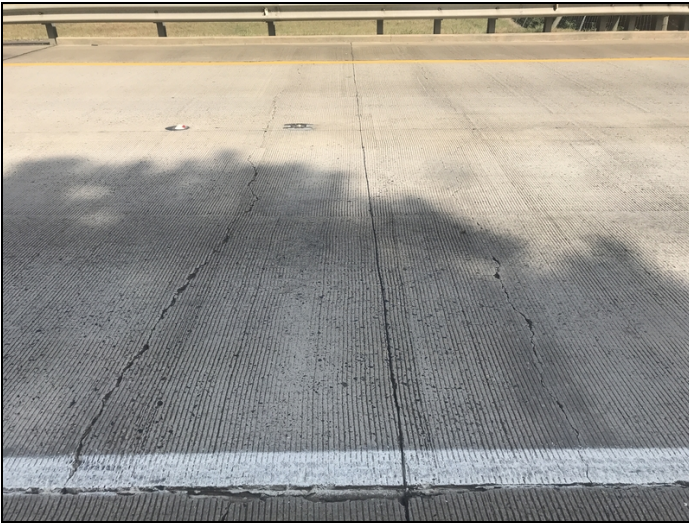
West approach slab, large cracks.

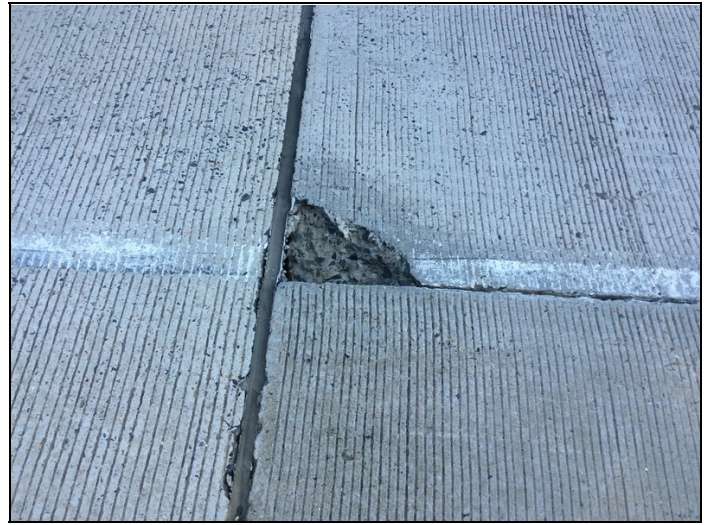
Approach slab at abutment 1 has a deep spall and unsealed cracks.

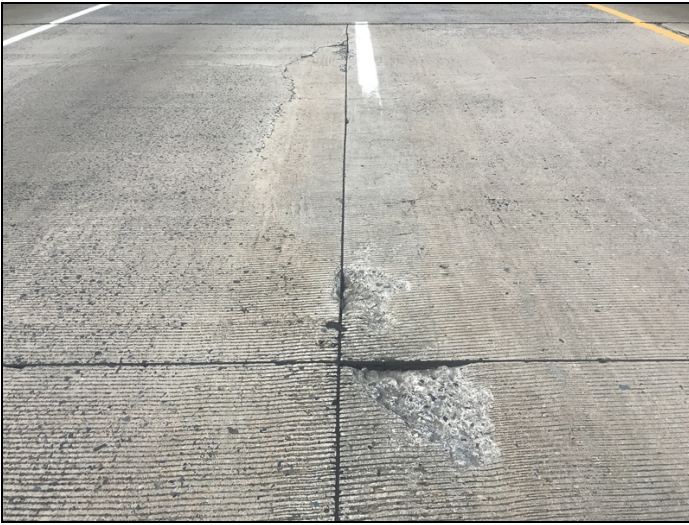
Large spalls and large cracks in east approach slab.

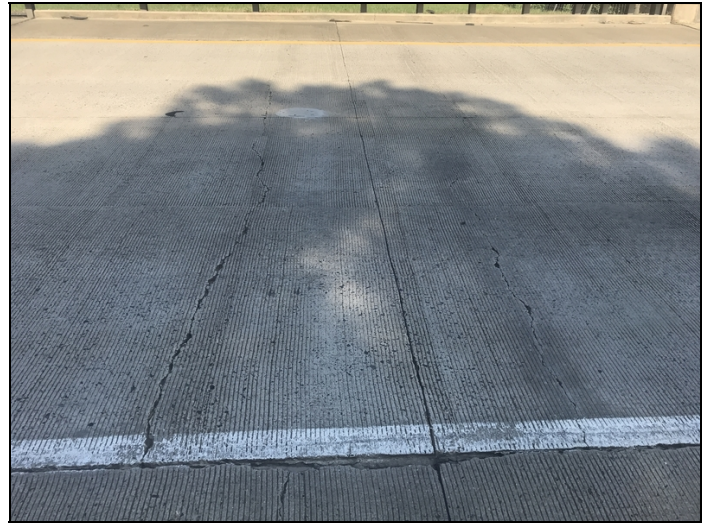
West approach slab has large unsealed cracks.

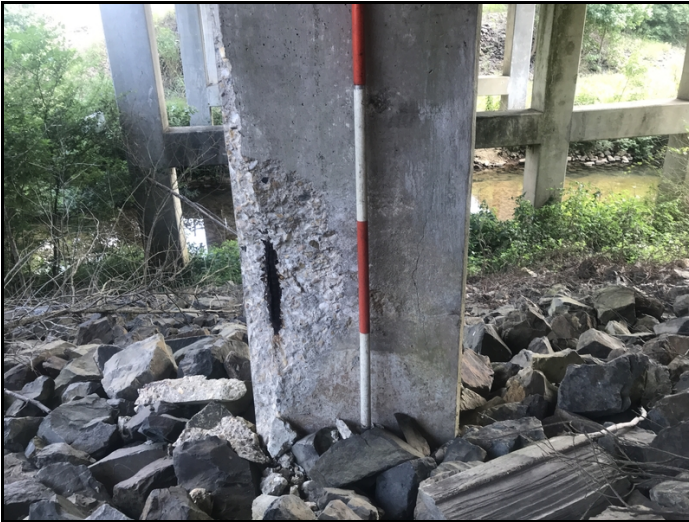
Bent 2 columns 2 and 3 and column 5 at bent 5 have large spalls with rebar exposed.

Bent 2 column 2, large spall with exposed rebar with section loss.

Type of Work: Repair (General)

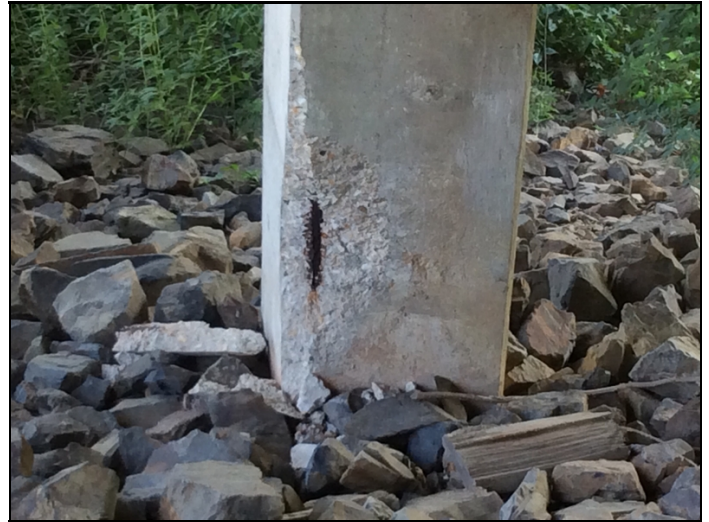
Bent 2 columns 2 and 3 have large spalls with rebar exposed

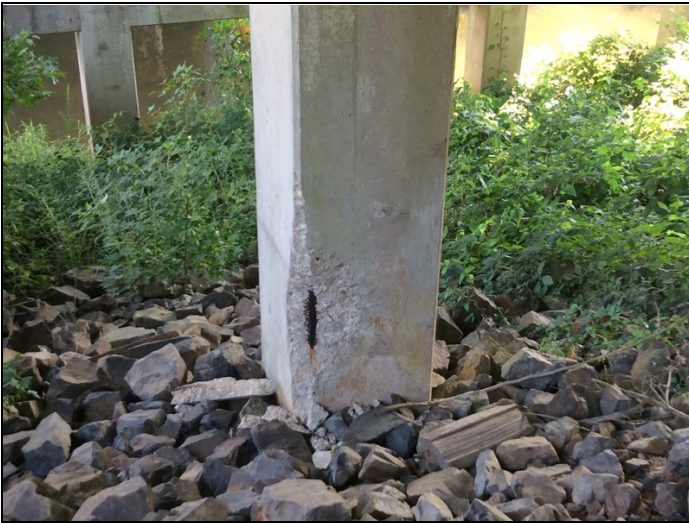
Bent 2 column 2 spall with exposed rebar

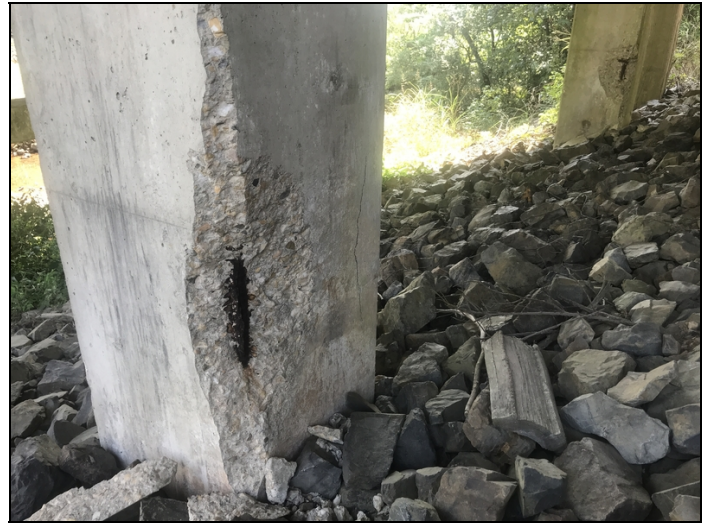
Bent 2 columns 2&3 have large spalls with exposed rebar.

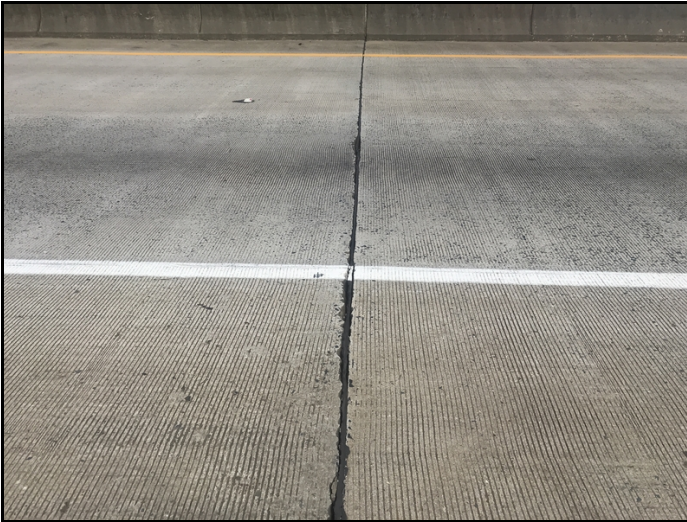
Deck has large unsealed cracks and missing joint seals.

Bent 3, loss of bond and leaking.

Type of Work: Repair (General)

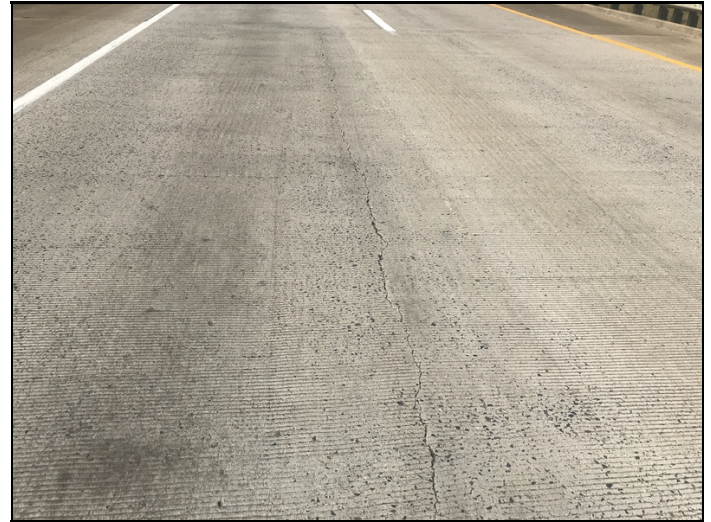
Span 1, large unsealed longitudinal crack.

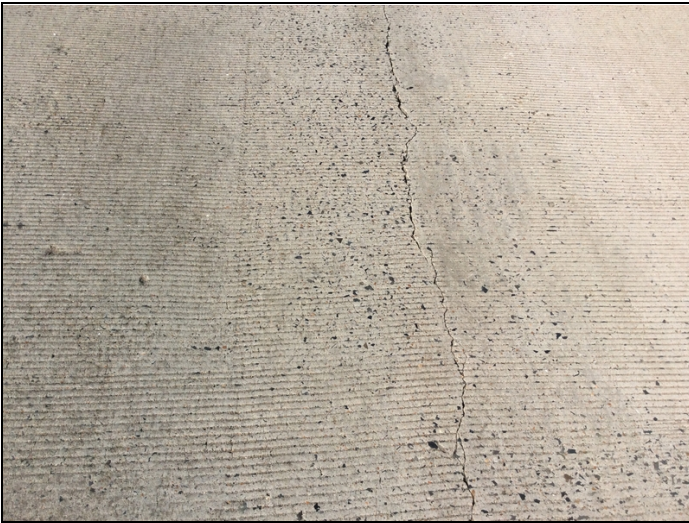
Deck has large unsealed cracks.

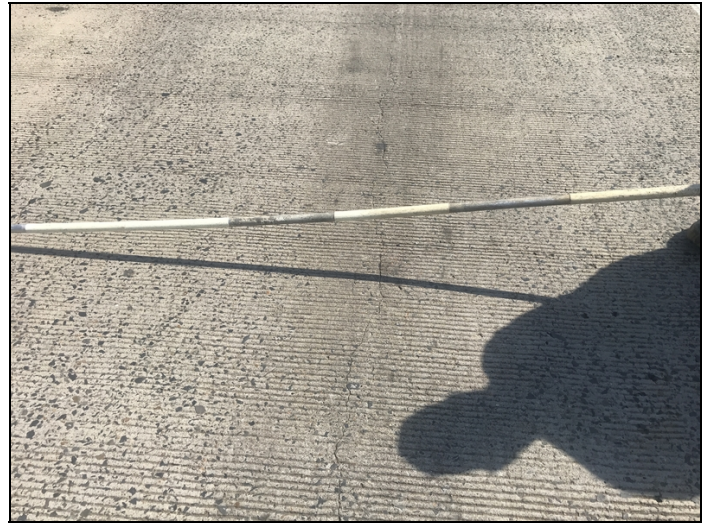
Deck span 5 has longitudinal unsealed crack that reflects through to the soffit.
