Asset #A3430(Routine, Underwater type 2)

I-30 WB Log 103.69 over RAYBURN CREEK

Location: 5.7 MI NO JCT 270 & I 30

Team Lead: Shane Byrd, Inspection Date: 02/14/2022

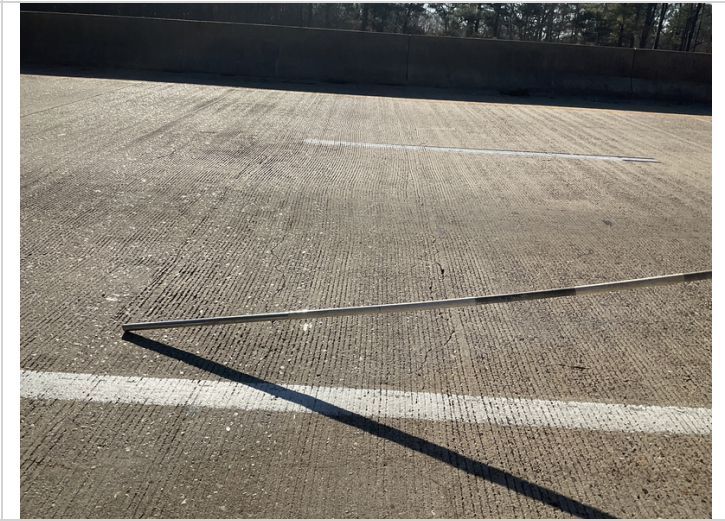
(12) Span 1 has a small spall. All spans have longitudinal and transverse cracking. 0.050 inch avg. Scattered cracks with efflorescence on the soffit overhangs.							
107	Steel Open Girder/Beam	LF	1416	1416	0	0	0
515	Steel Protective Coating	SF	11540	0	11540	0	0
3430	Oxide Film Degradation Color/Texture Adherence(Steel Protective Coatings)	LF	11540	0	11540	0	0

Span 4 deck large transverse cracks.

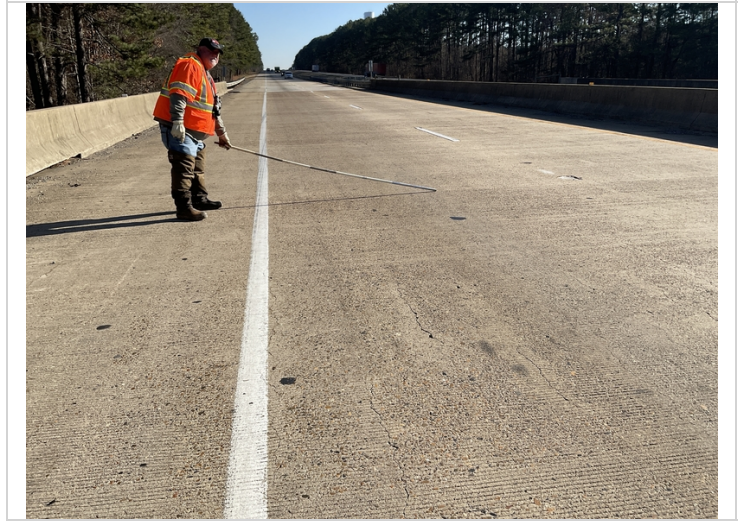
Span 2 large longitudinal and transverse cracks.

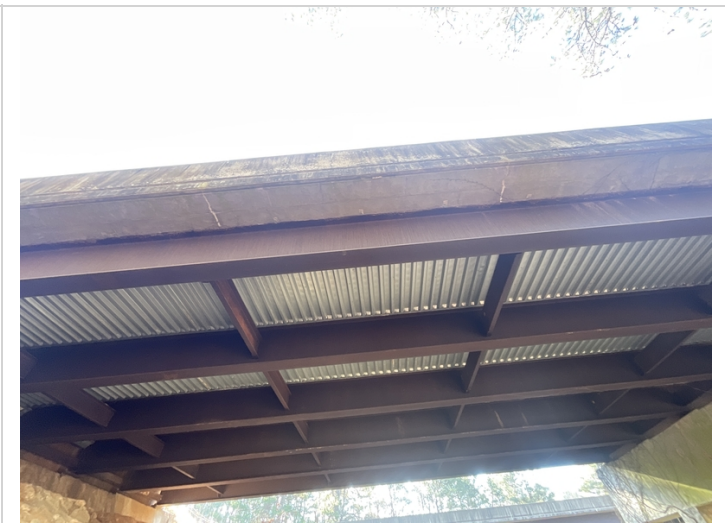
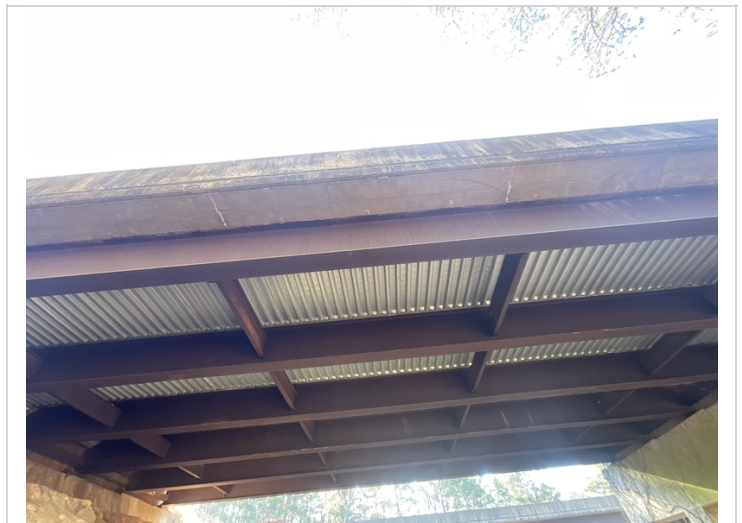
Cracks with efflorescence in soffit overhang common all spans both sides.

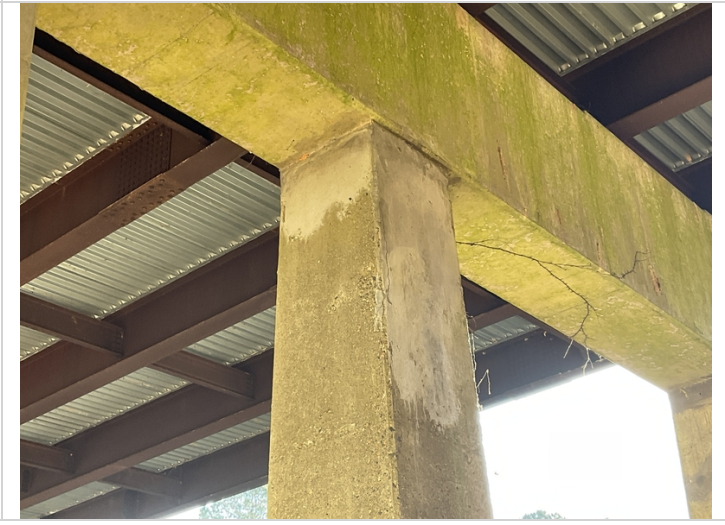
(205) Bent 2, columns 2 & 3 have delams below the cap. Column 4 has small spalls and abrasion at the water line							
210	Reinforced Concrete Pier Wall	LF	44	44	0	0	0
215	Reinforced Concrete Abutment	LF	84	69	15	0	0
1120	Efflorescence/Rust Staining	LF	8	0	8	0	0
1130	Cracking (RC and Other)	LF	7	0	7	0	0

Bent 2 column 2 delam on back side.

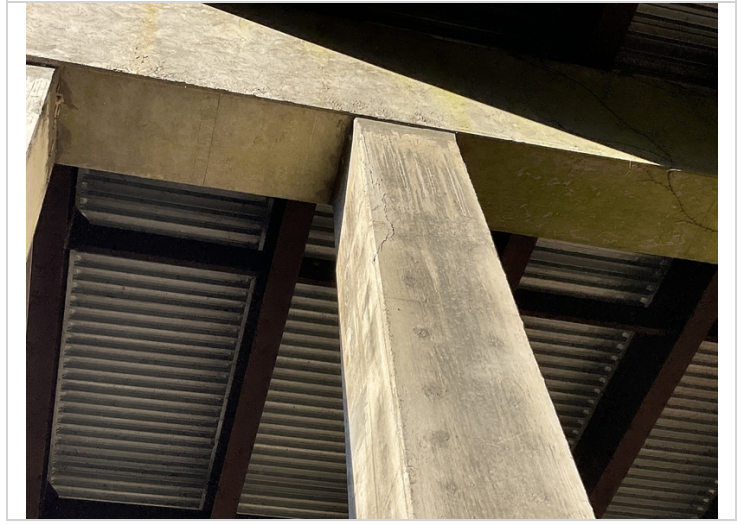
Bent 2 column 3 delam on ahead side.

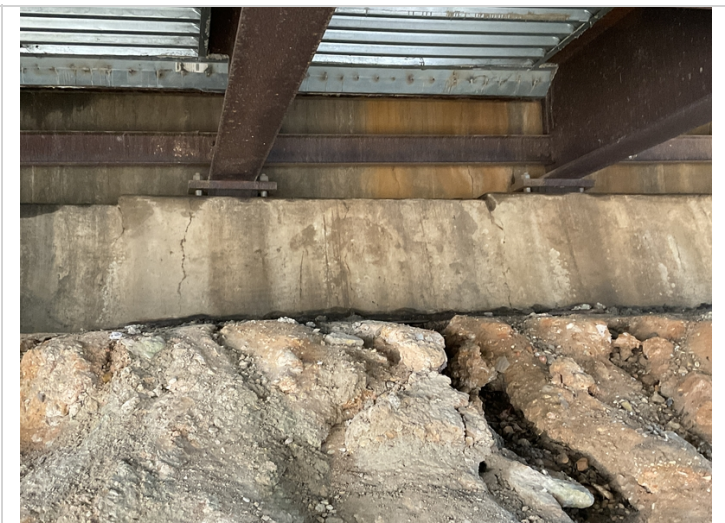
(215) small vertical cracks in the face of both abutments Cracks with efflorescence in the back wall of bent 1.							
234	Reinforced Concrete Pier Cap	LF	123	123	0	0	0
302	Compression Joint Seal	LF	80	0	40	40	0
2320	Seal Adhesion	LF	40	0	40	0	0
7000	Damage	LF	40	0	0	40	0

Small vertical cracks in abutment at bent 5.

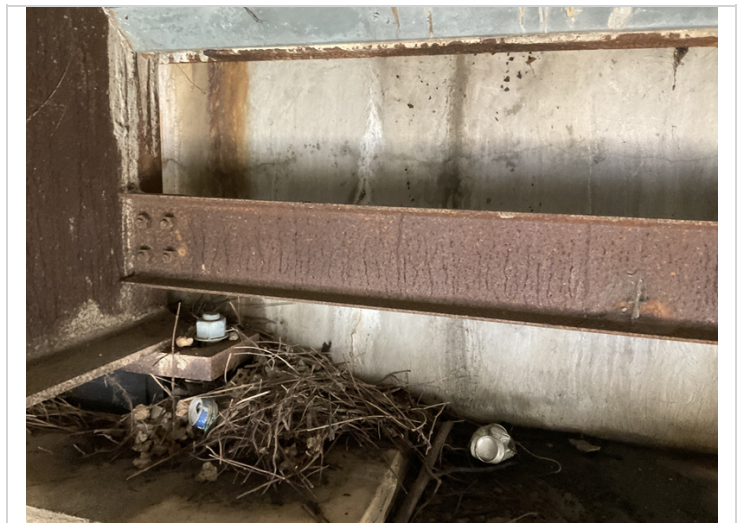
Cracks with efflorescence in back wall at bent 1.

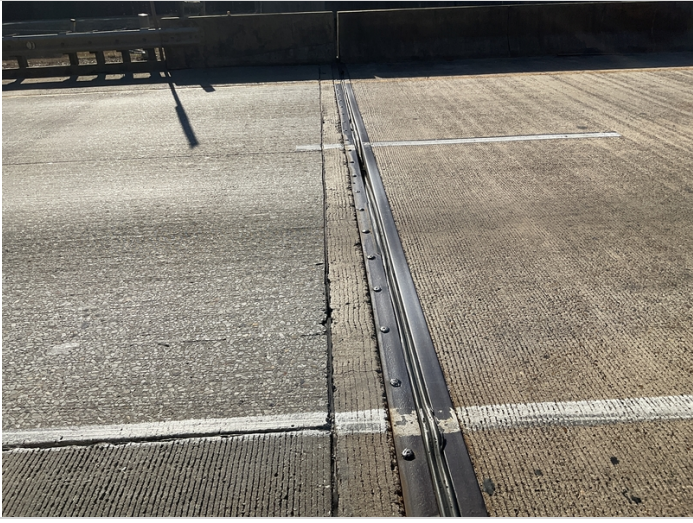
(302) The seal at bent 1 has lost bond and leaks. The joint armor at bent 5 is loose and broken in both lanes							
310	Elastomeric Bearing	EA	30	30	0	0	0
321	Reinforced Concrete Approach Slab	SF	2000	1910	90	0	0
1130	Cracking (RC and Other)	SF	90	0	90	0	0
331	Reinforced Concrete Bridge Railing	LF	472	426	46	0	0
1130	Cracking (RC and Other)	LF	46	0	46	0	0

Joint armor at bent 5 loose under traffic.

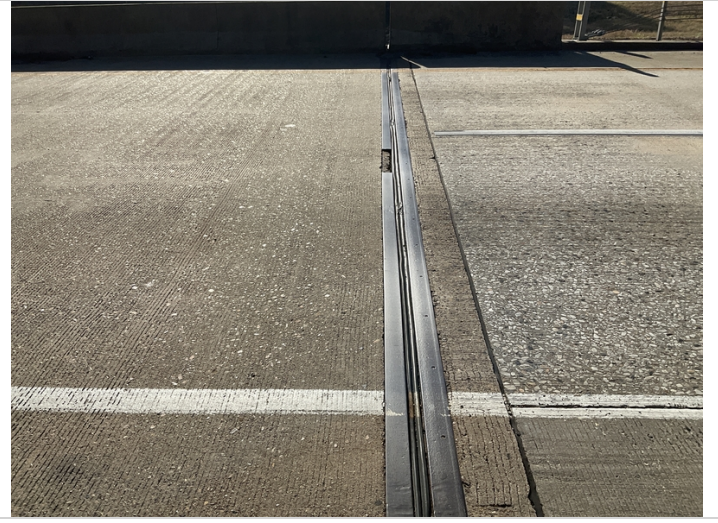
Bent 1 joint armor has two foot of armor missing.

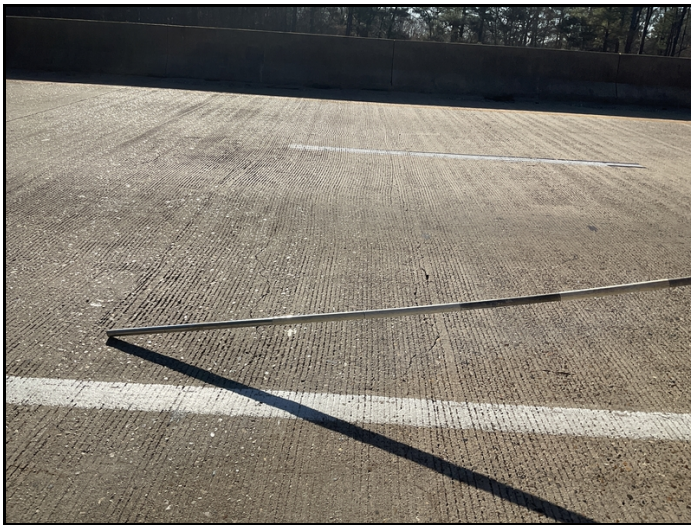
All spans have unsealed longitudinal and transverse cracks. 0.050 inch avg. width.

Span 4 deck large transverse cracks.

**Type of Work:** Repair (General)

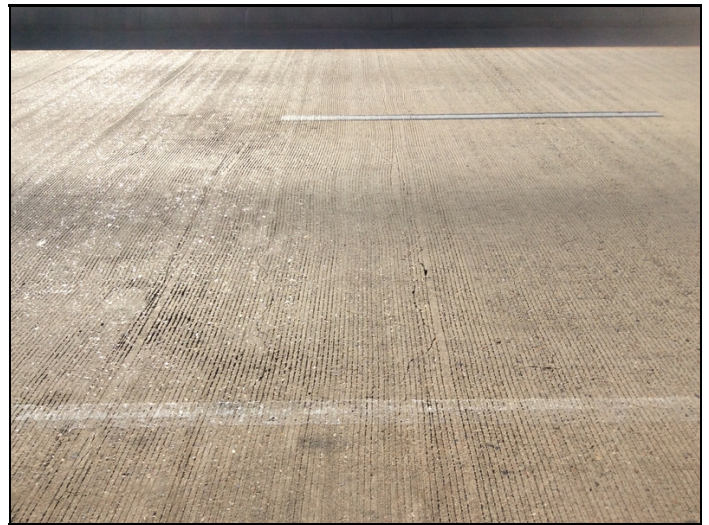
Transverse cracks in span 3.

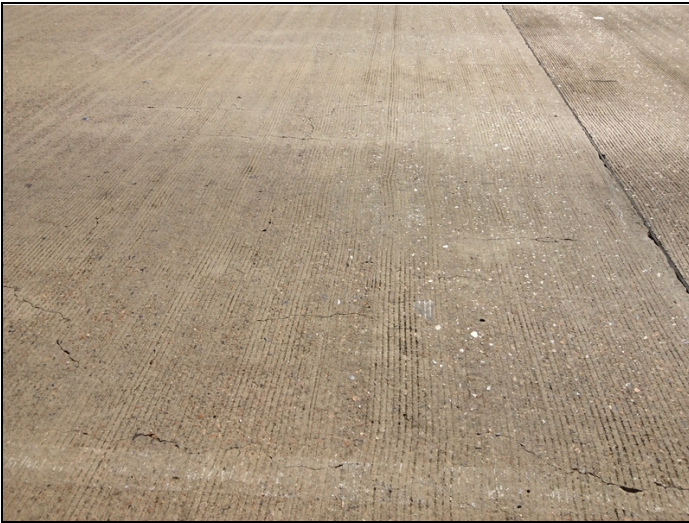
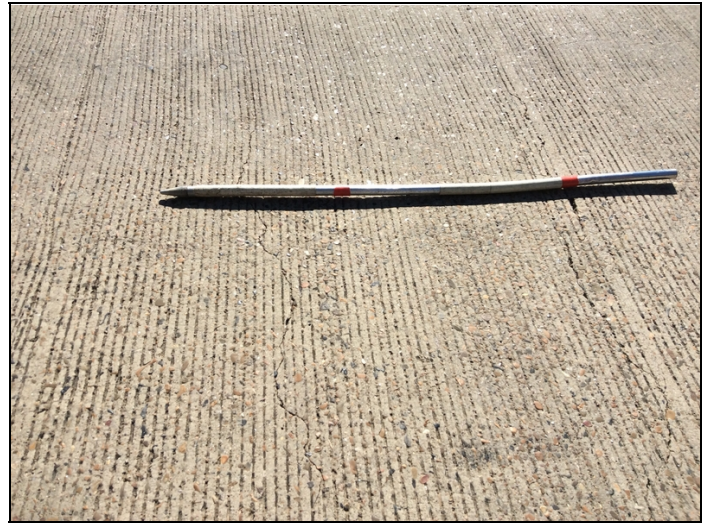
Span 3 longitudinal and transverse cracks up to 0.050"

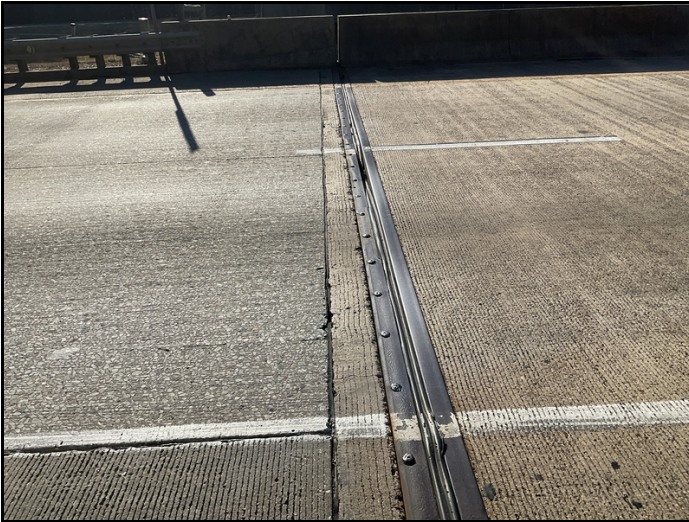
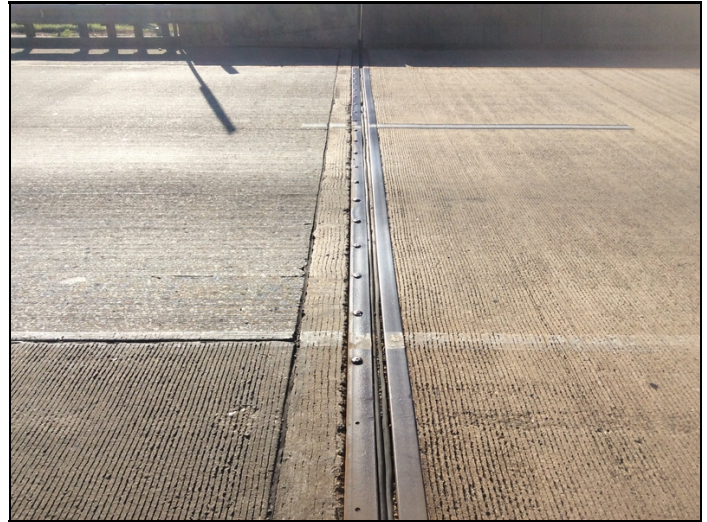
The joint armor is broken and loose at bent 5.

Joint armor at bent 5 loose under traffic.

The joint armor is loose at bent 5.

**Type of Work:** Repair (General)

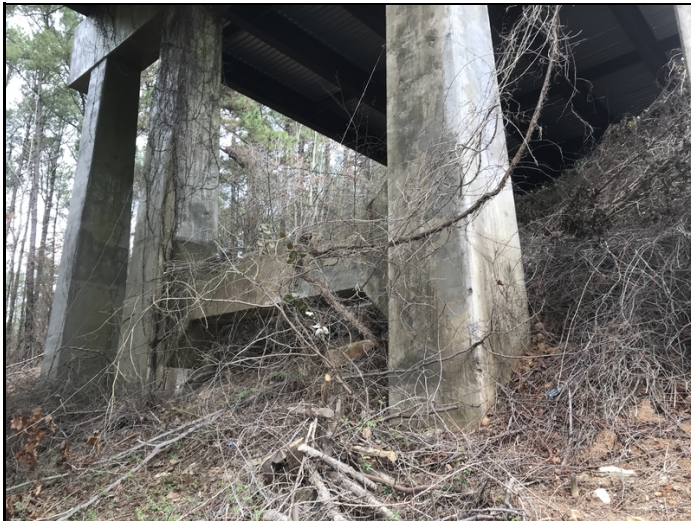
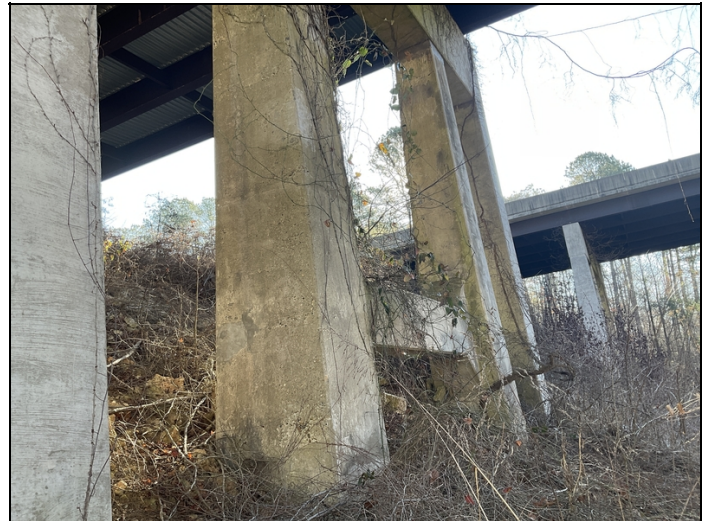
vines growing on columns at bent 3 and 4

some trees and brush have been removed but there are still large vines growing on the columns and on the caps

Vines growing at bent 4

Vines growing at Bent 4.

**Type of Work:** (Inactive) (Inactive) 1 - Clean

Assigned to Hot Spring County 7/20/2020
