Asset #B3430(Routine, Underwater type 2)

I-30 EB Log 103.70 over RAYBURN CREEK

Location: 1.76 MI S SALINE CO

Team Lead: Shane Byrd, Inspection Date: 02/14/2022

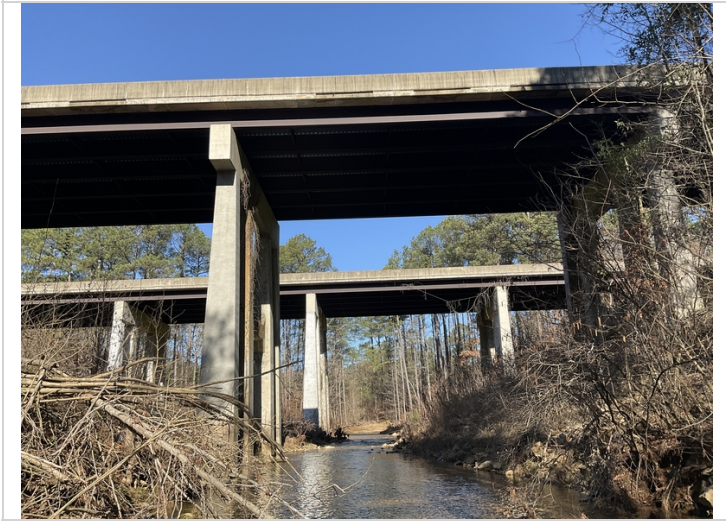
Elevation.

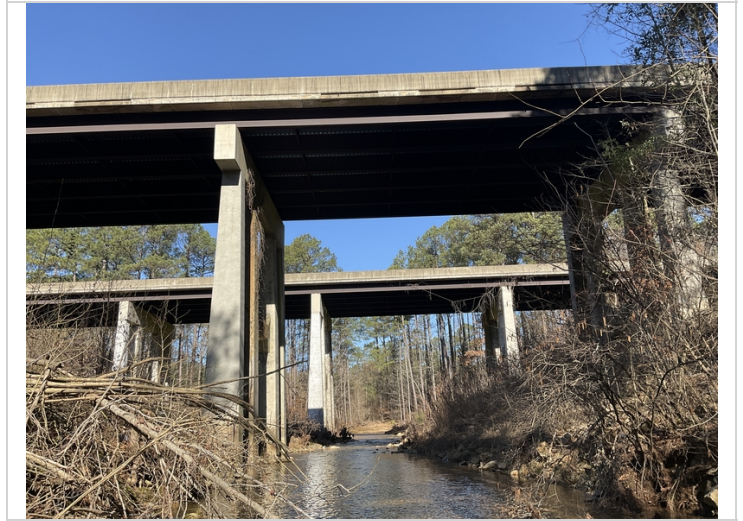
Elevation.

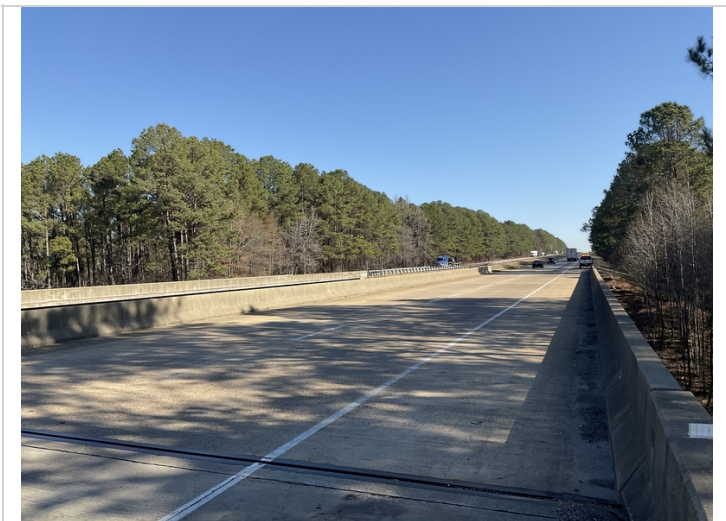
Deck overview.

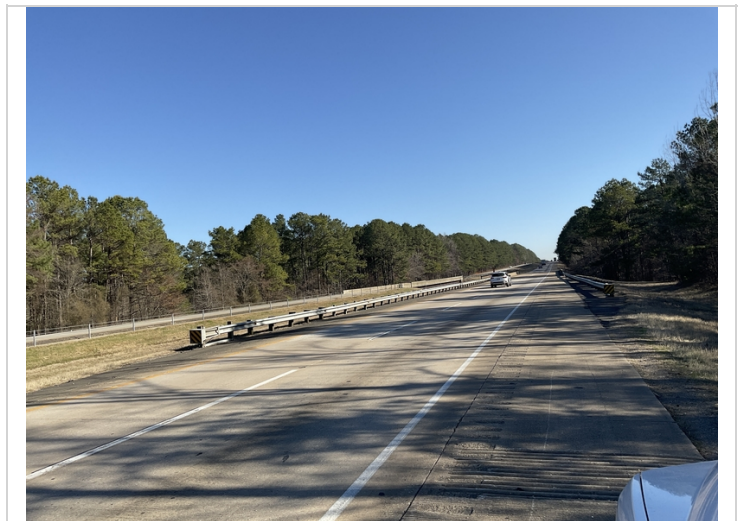
Approach eastbound.

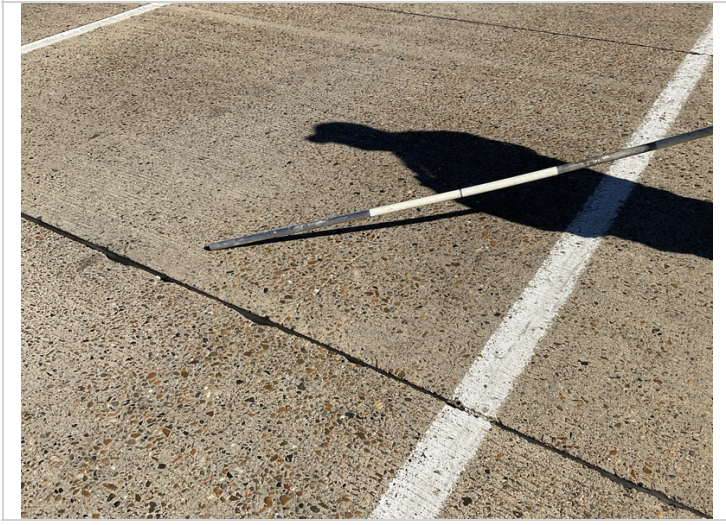
(12) Scattered transverse and longitudinal cracks. 0.030 inch avg. Cracks with efflorescence in soffit of overhang.							
107	Steel Open Girder/Beam	LF	1416	1416	0	0	0
515	Steel Protective Coating	SF	11540	0	11540	0	0
3430	Oxide Film Degradation Color/Texture Adherence(Steel Protective Coatings)	LF	11540	0	11540	0	0

Span 2 longitudinal crack.

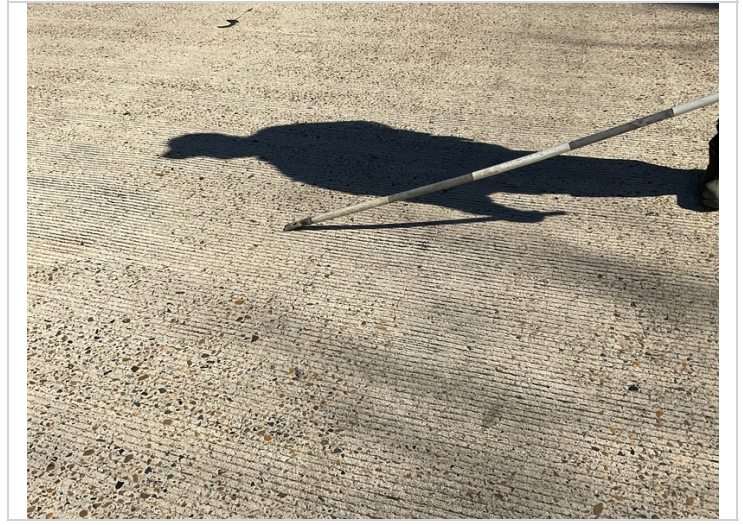
Span 4 longitudinal crack.

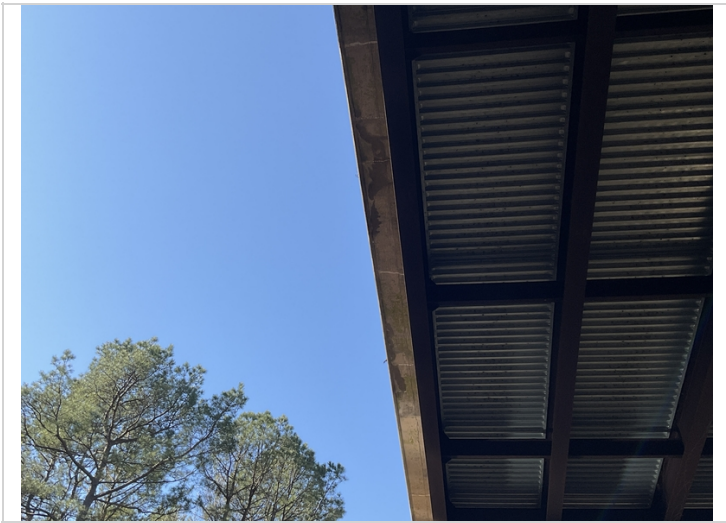
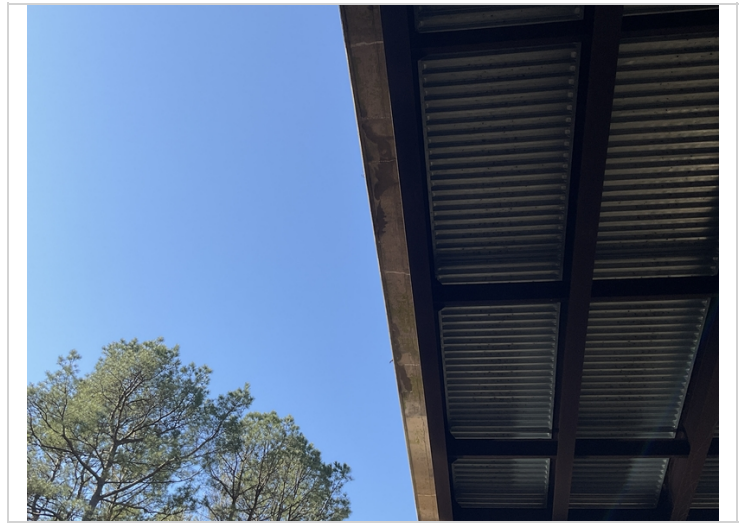
Cracks with efflorescence in soffit overhang common all spans both sides.

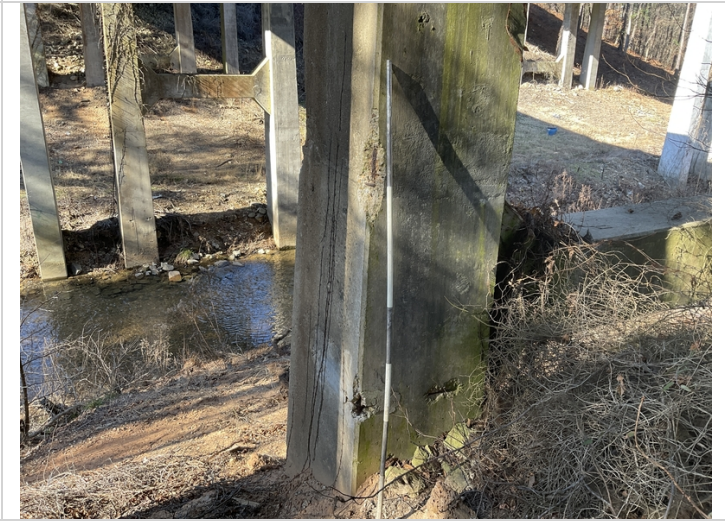
(205) Bent 2 column 2&3 have a delamination on the right side. And column 2 has small rebar exposed on the left side Bent 3 column 3 ahead has a spall with exposed rebar.and abrasion in columns 2 and 3 at water line Bent 4 column 3 has spalls with exposed rebar.							
210	Reinforced Concrete Pier Wall	LF	44	44	0	0	0
215	Reinforced Concrete Abutment	LF	84	69	15	0	0
1120	Efflorescence/Rust Staining	LF	15	0	15	0	0

Bent 4 column 3 ahead side spalls with exposed rebar.

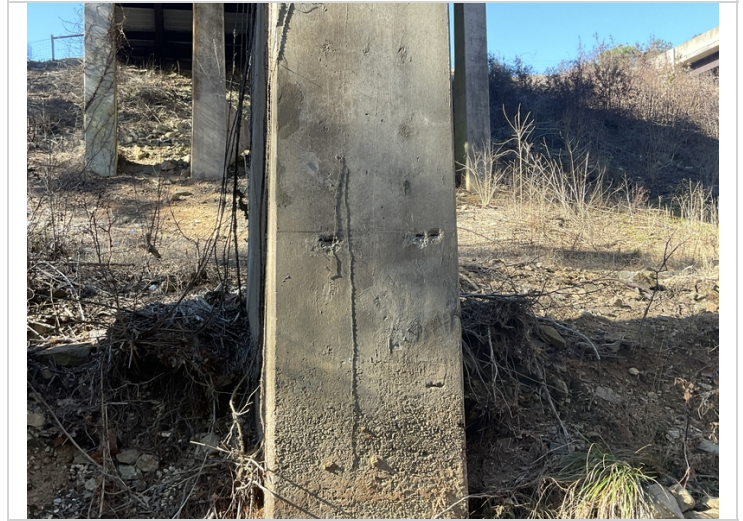
Small spalls with exposed rebar bent 3 column 3 ahead.

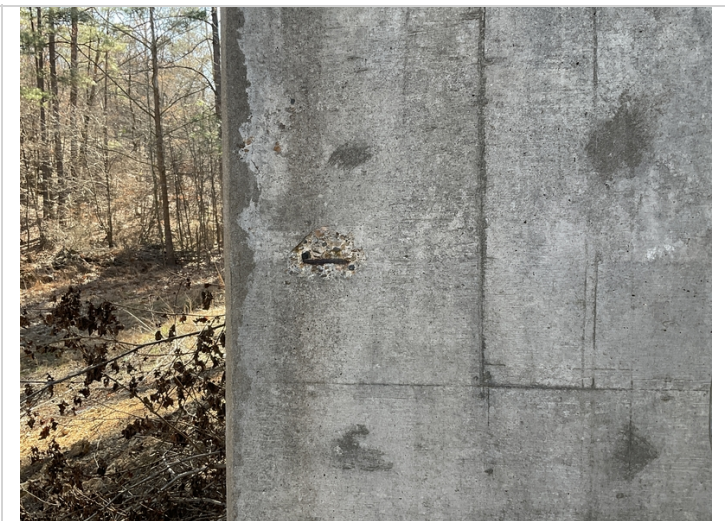
Bent 2 column 2 has small spall with exposed rebar on left.

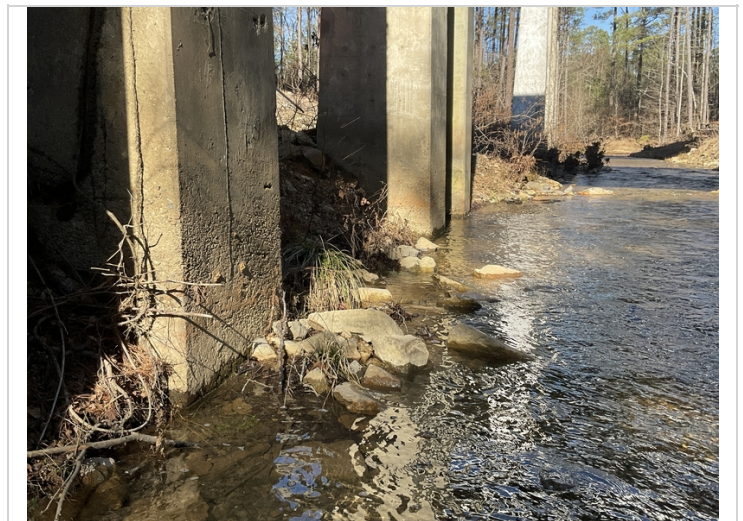
Bent 3 columns 2 & 3 have abrasion at waterline.

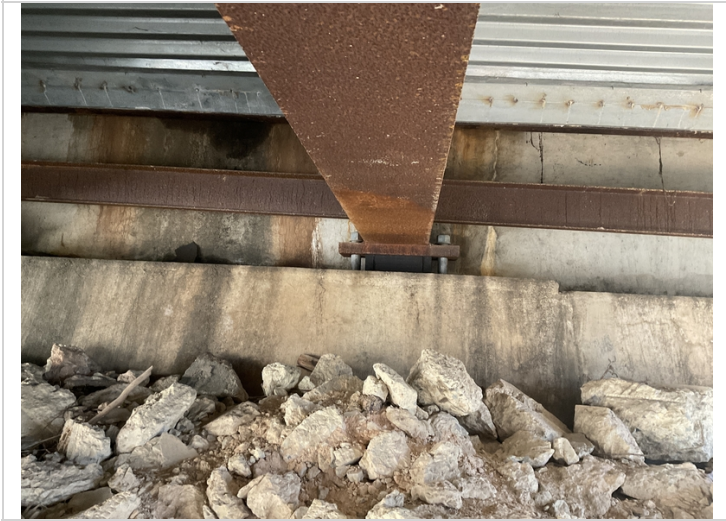
(215) Vertical cracks with efflorescence in both abutments							
234	Reinforced Concrete Pier Cap	LF	123	123	0	0	0
302	Compression Joint Seal	LF	80	0	80	0	0
2310	Leakage	LF	80	0	80	0	0

Bent 5 cracks with efflorescence in back wall.

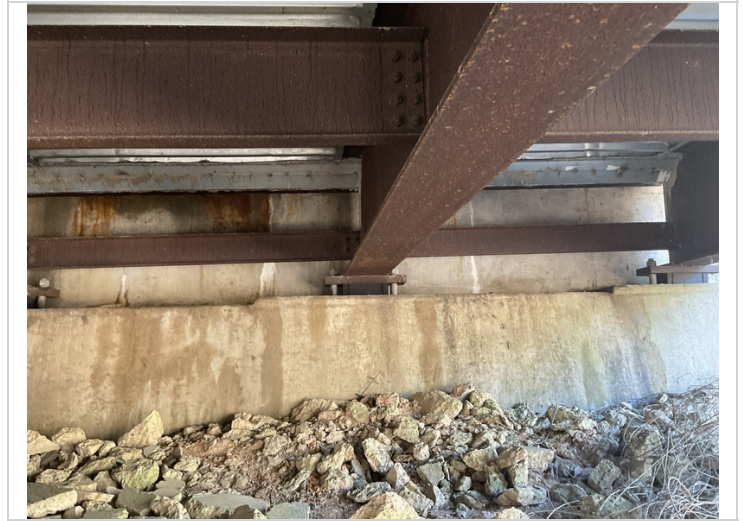
Bent 1 cracks with efflorescence in the back wall.

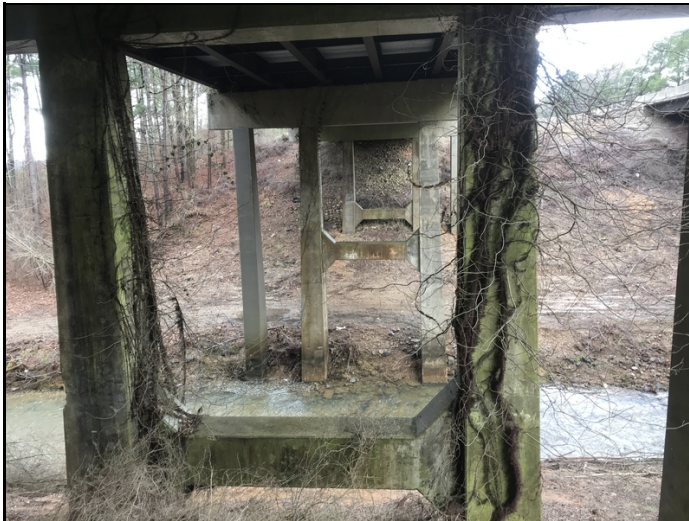
vines growing on columns up to the bottom of the deck

trees and brush have been removed but vines are still growing on the columns up to the bottom of the deck

large Vines growing at bent 4

Assigned to Hot Spring County 7/16/2020 to address vines.

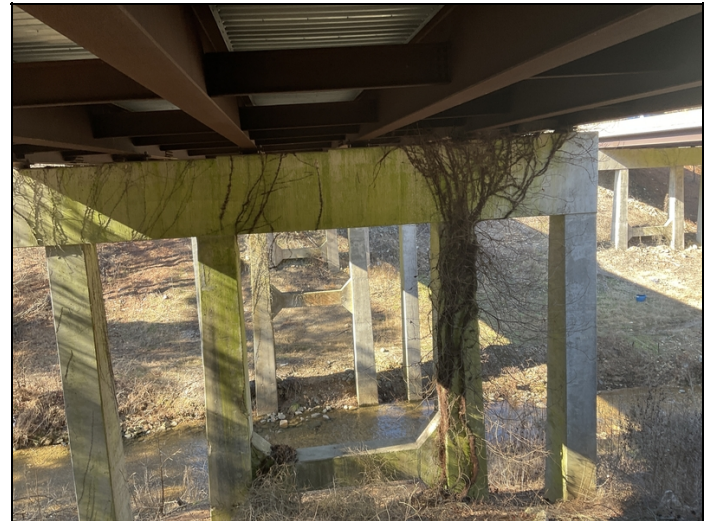
Vines growing on columns and cap at bent 4.
