Asset #A3431 (Routine)

I 30-SEC 21 WB over CR 70 Stringtown Rd

Location: 6.1 MI N JCT I- 30 & 270

Team Lead: Chris Doggett, Inspection Date: 07/14/2022

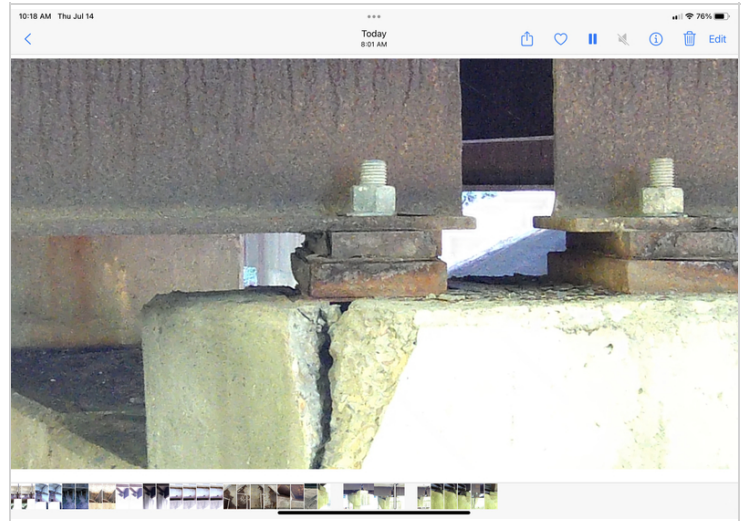
Bent 3, span 3, girder 1: pedestal is cracked and delamed under the bearing. Approximately half of the bearing area is compromised. 2022

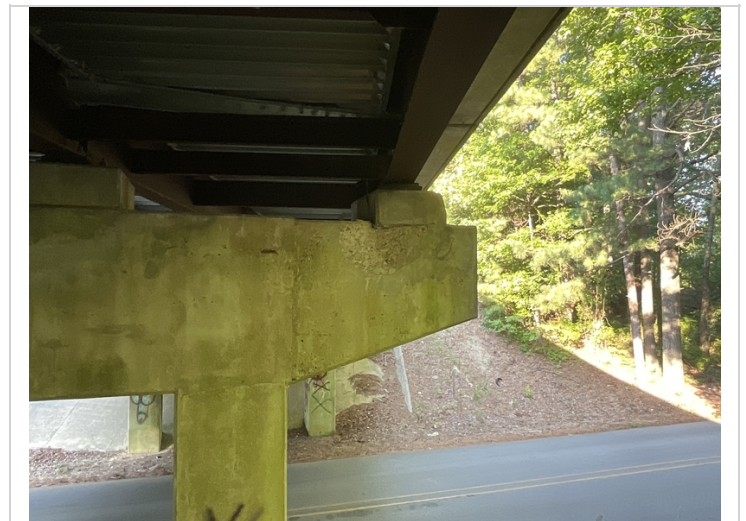
Bent 3, girder 1: cap is spalled.

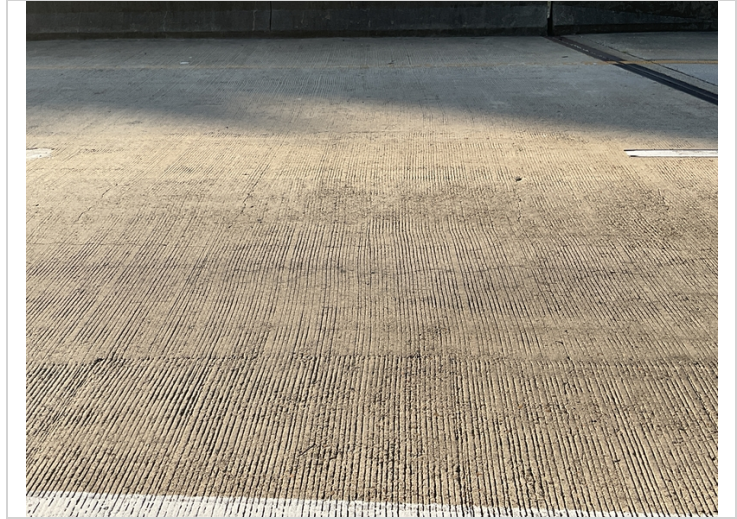
Span 1: large unsealed transverse and longitudinal cracks

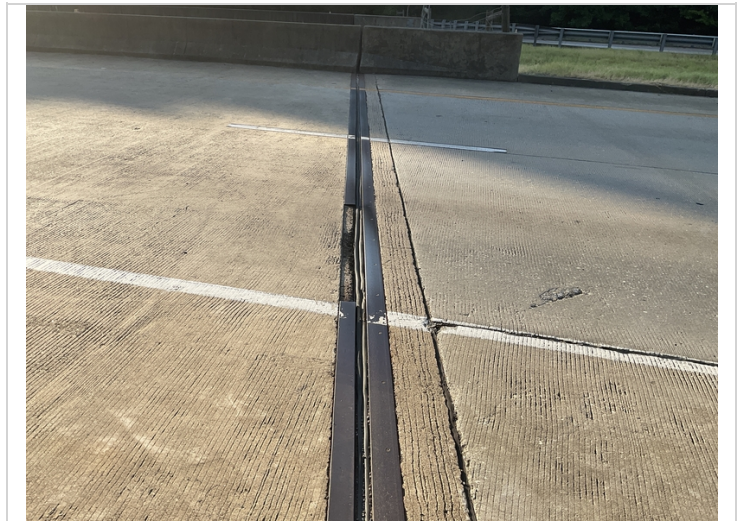
Bent 1: section of joint armor missing and joint is leaking.

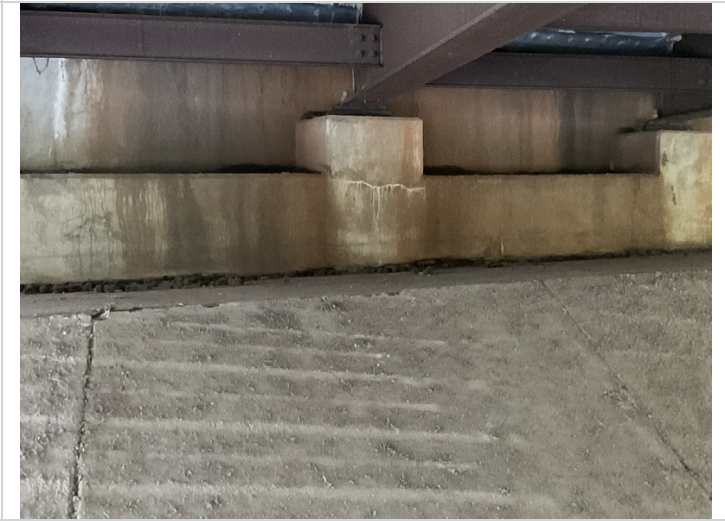
Bent1, girder 4: pedestal has transverse crack with efflorescence staining. Similar condition at bent 4, pedestals 4&5.

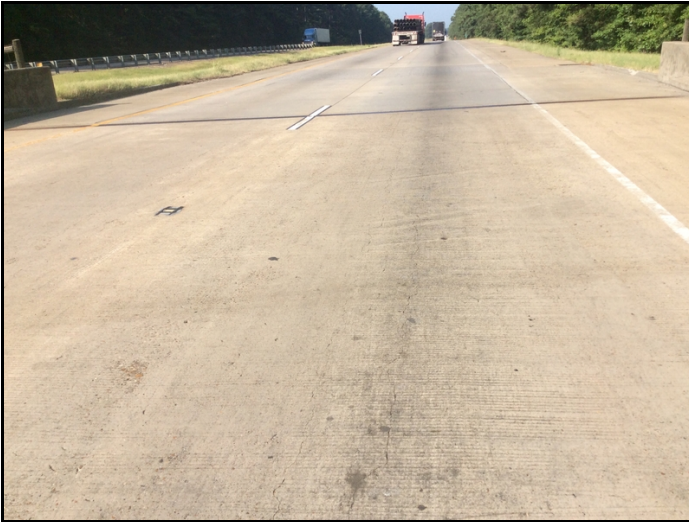
Moderate to large deck cracking in all spans. 0.30 - .040 in. at 3 to 5 ft. spacing.

Longitudinal cracks, span 1.

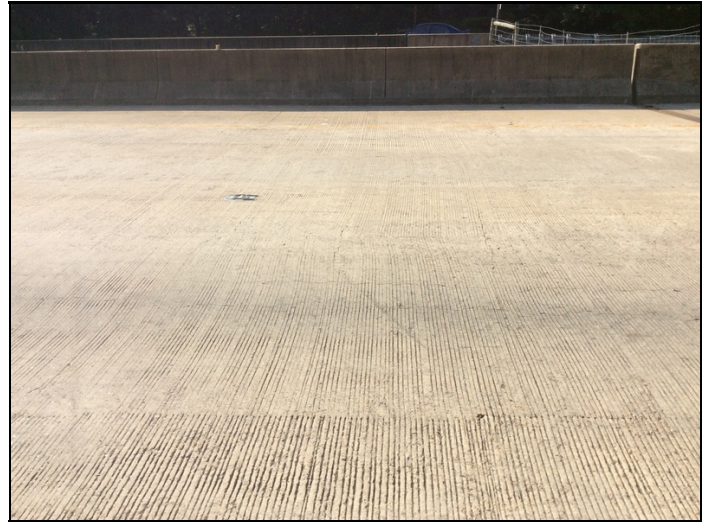
Span 1 large transverse cracks.

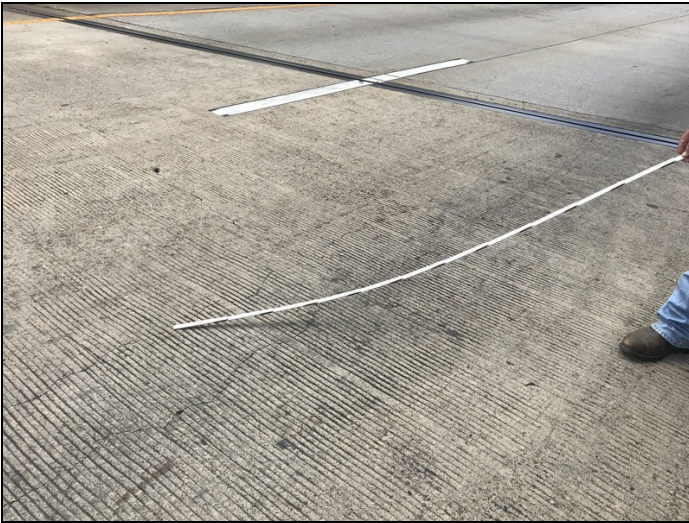
Transverse and longitudinal cracks in span 1 of the deck.

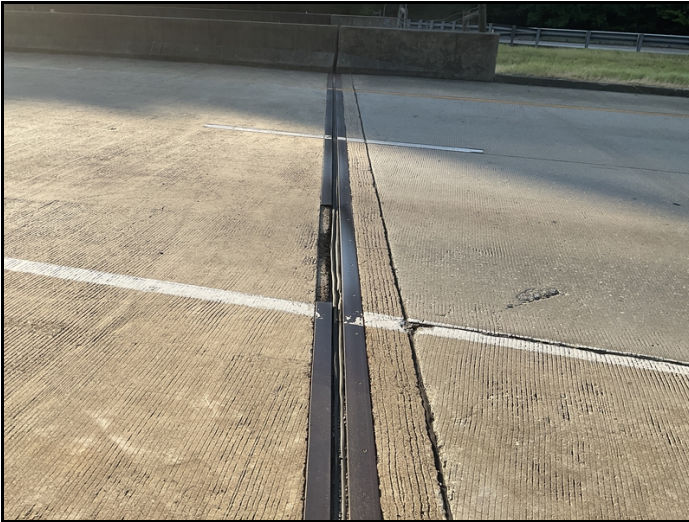
The joint armor is loose under traffic at both abutments

Bent 1: section of joint armor missing and joint is leaking.  
2022

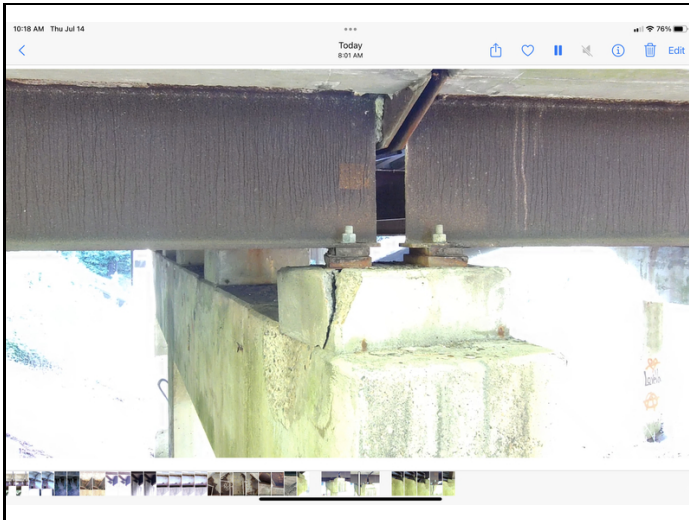
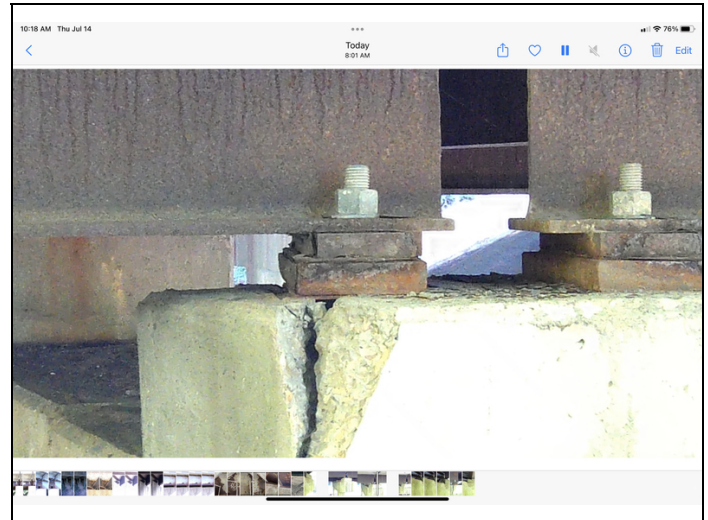
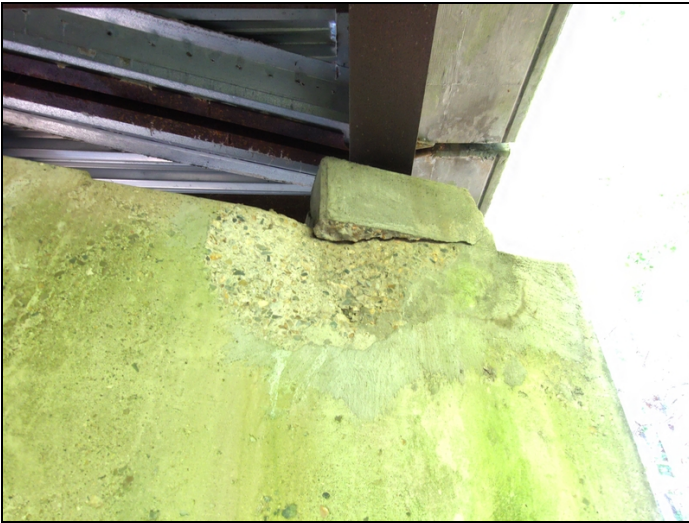
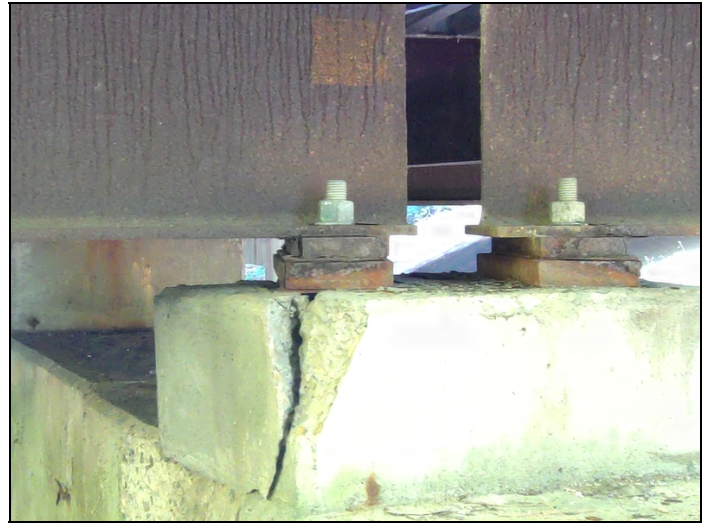
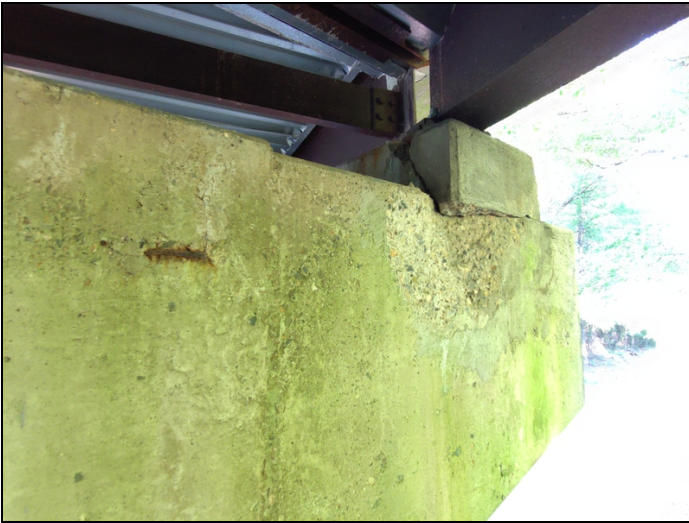
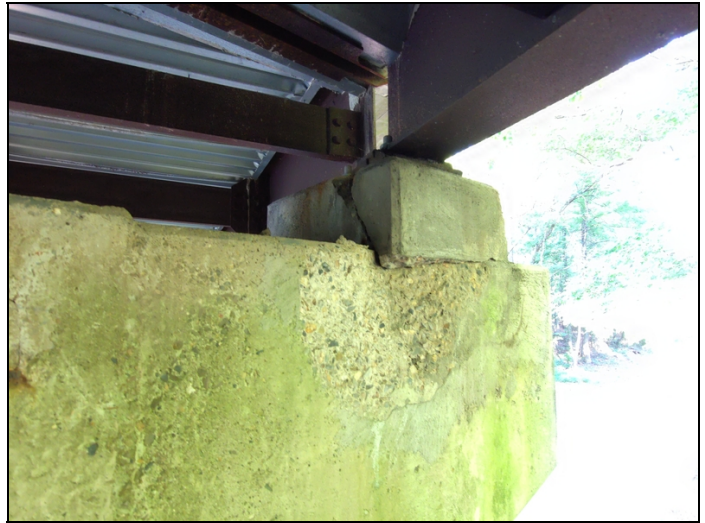
Bent 3, span 3, girder 1: pedestal is cracked and delamed under the bearing. Approximately half of the bearing area is compromised. 2022

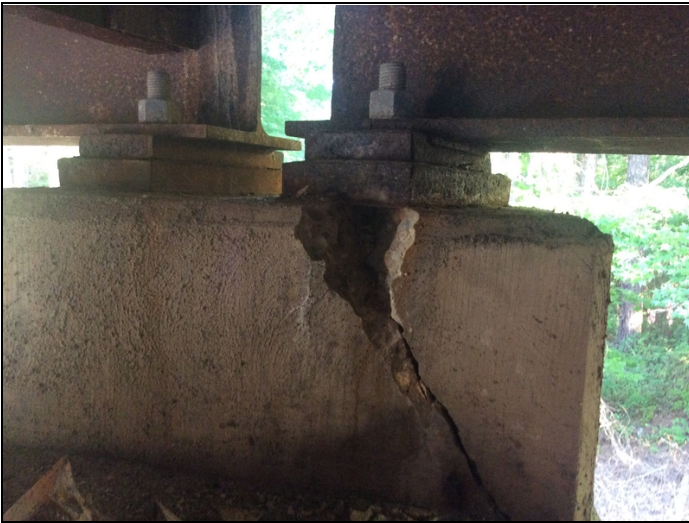
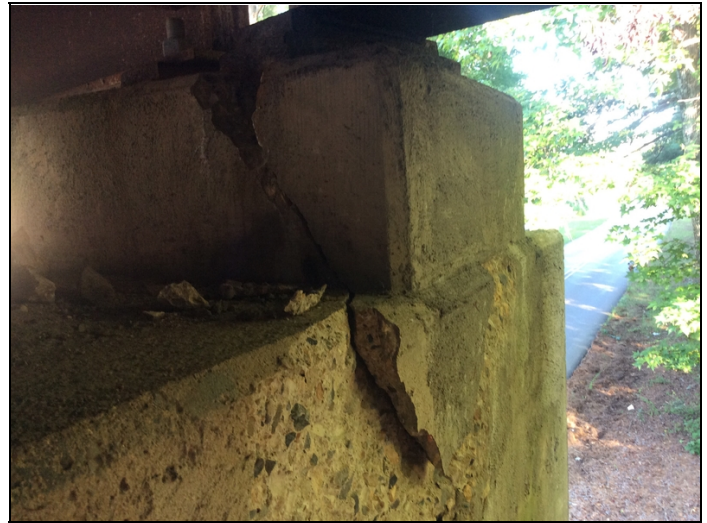
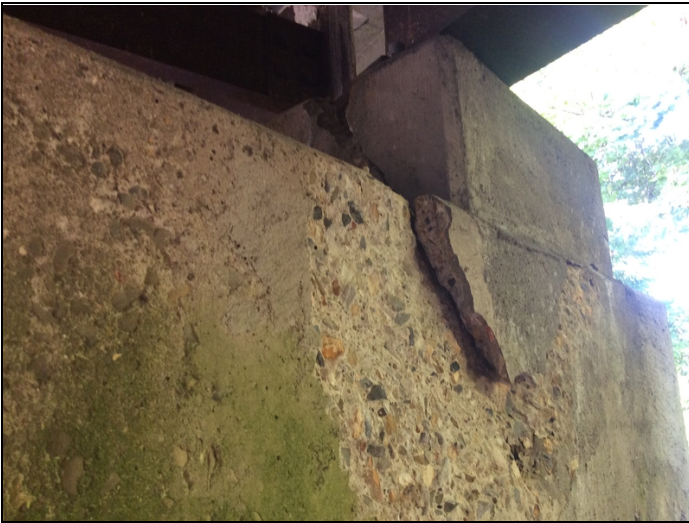
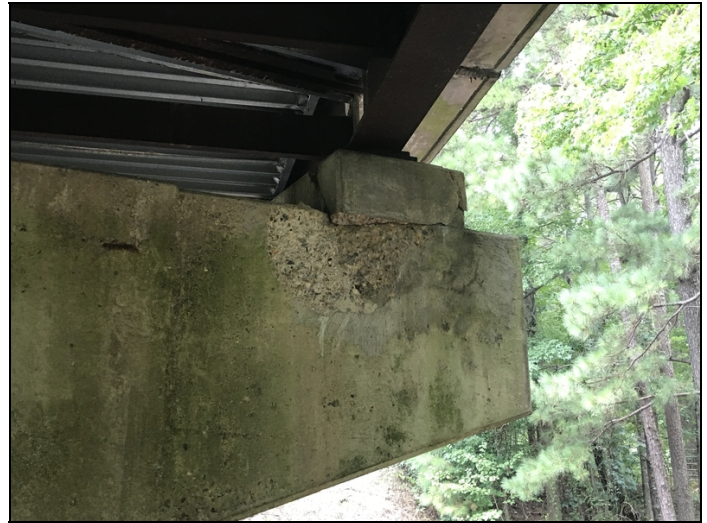
Cap: Bent 3 girder 1 raised bearing seat has a spall under bearing, also a crack that extends through the riser under the bearing. Photo attached.

Bent 3 girder 1 raised bearing seat has a spall under bearing, also a crack that extends through the riser under the bearing.

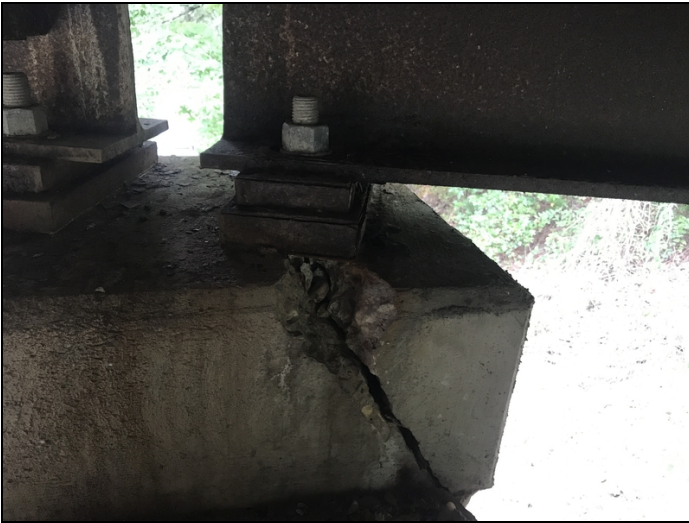
Bent 3 span 3 pillar block bearing pad has large delamination under bearing

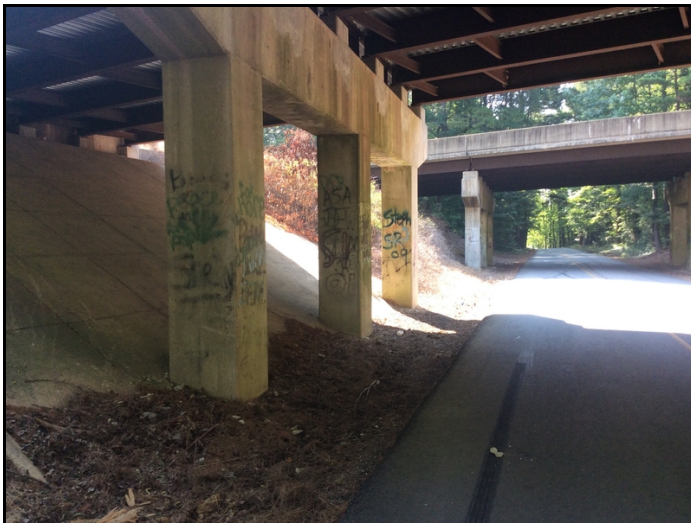
Graffiti on all columns that has offensive wording.

Assigned Hot Springs 06301 10/31/18
