Asset #B3431 (Routine)

I 30-SEC 21 EB over CR 70 Stringtown Rd

Location: 1.31 MI S OF SALINE CO

Team Lead: Chris Doggett, Inspection Date: 07/14/2022

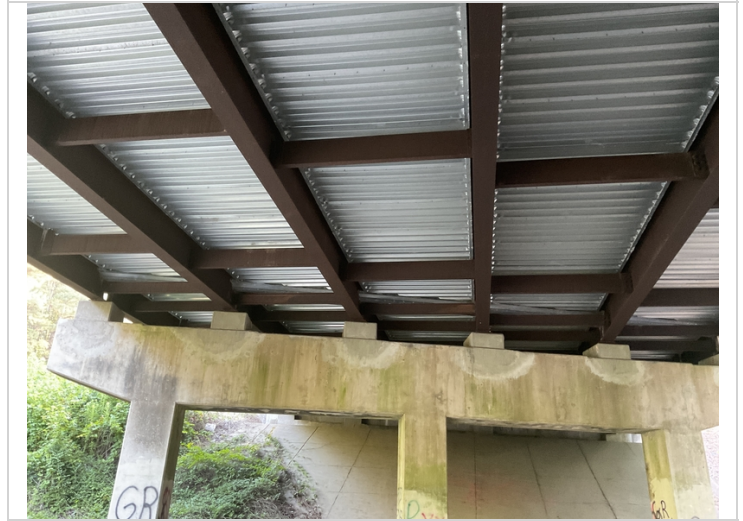
Soffit view

ELEMENTS	DESCRIPTION	UNITS	TOTAL	CS1	CS2	CS3	CS4
12	Reinforced Concrete Deck	SF	4754	4536	218	0	0
1120	Efflorescence/Rust Staining	SF	48	0	48	0	0
1130	Cracking (RC and Other)	SF	170	0	170	0	0
(12) Deck has two longitude cracks running full length structure, soffits have cracks with efflorescence.

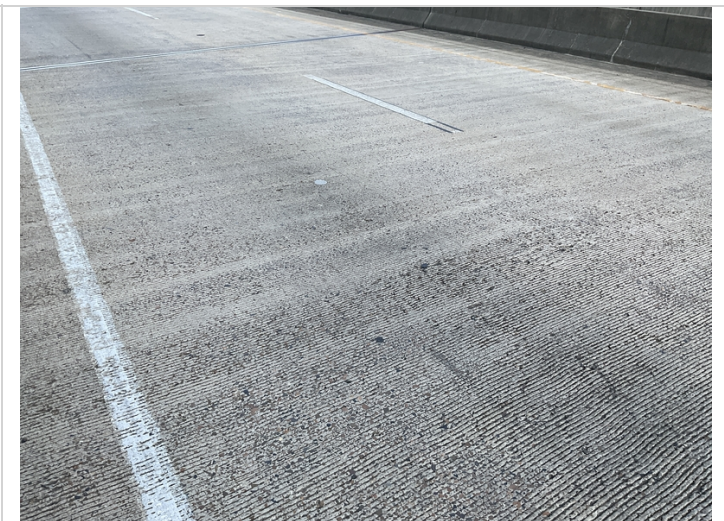
Span 2: multiple unsealed transverse and longitudinal cracking.
