Asset #A3432(Routine)

I-30 WB Log 104.52 over NINE MILE CR

Location: 6.1 MI NO JCT I-30 & 270

Team Lead: Shane Byrd, Inspection Date: 08/25/2021

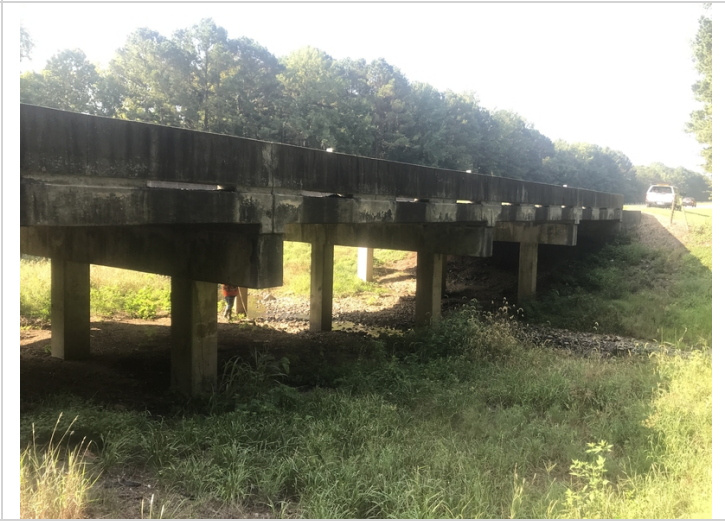
Elevation.

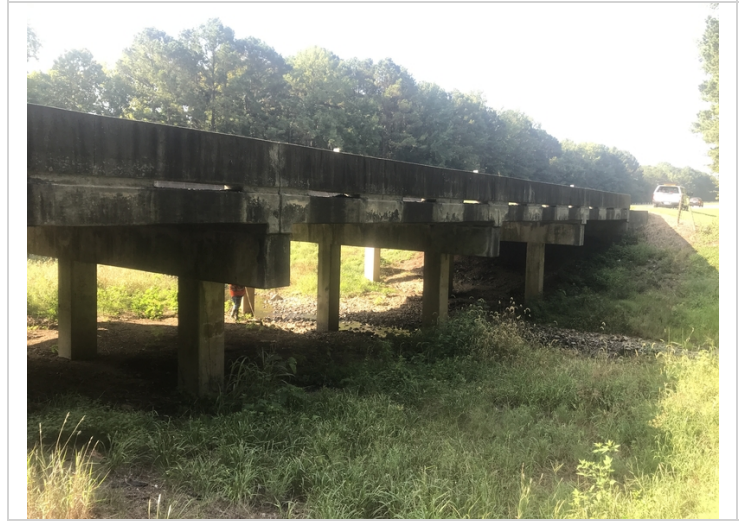
Elevation.

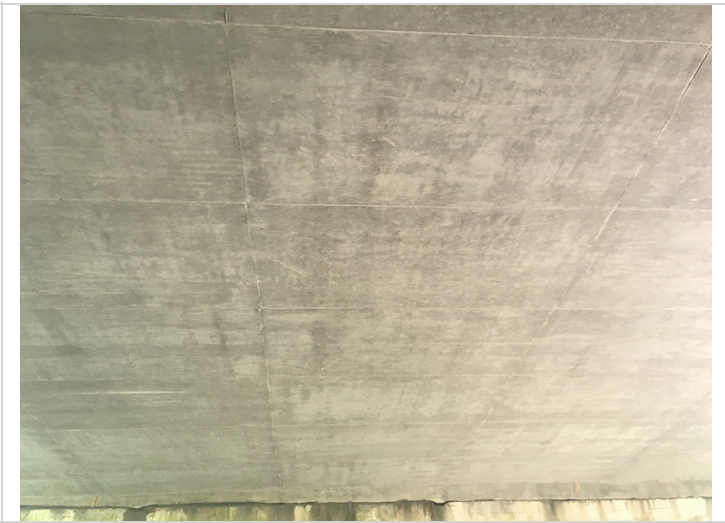
Deck span 3 soffit overview.

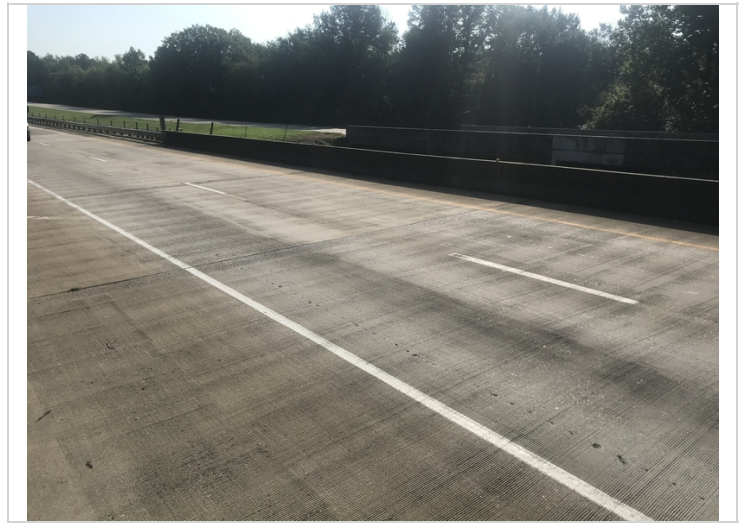
Deck overview.

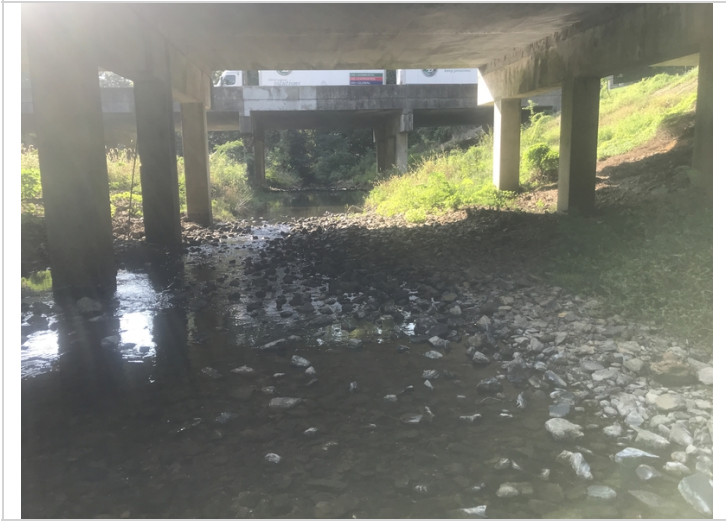
Channel

61 - Channel/Channel Protection (7 - Bank protection is in need of minor repairs. River control devices and embankment protection have a little minor damage. Banks and/or channel have minor amounts of drift.)

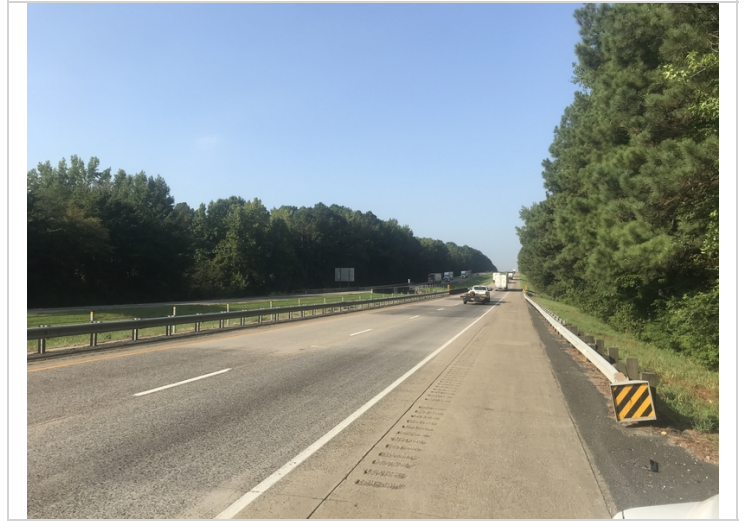
Approach westbound

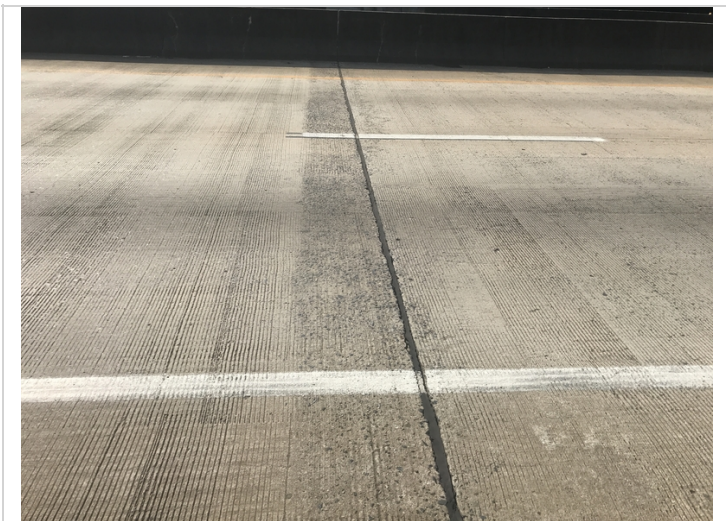
Deck at bent 3 has abrasion, common bent 2.

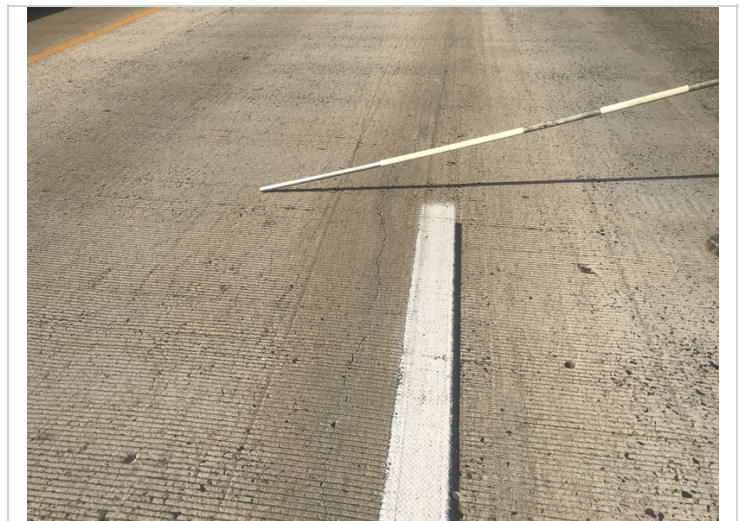
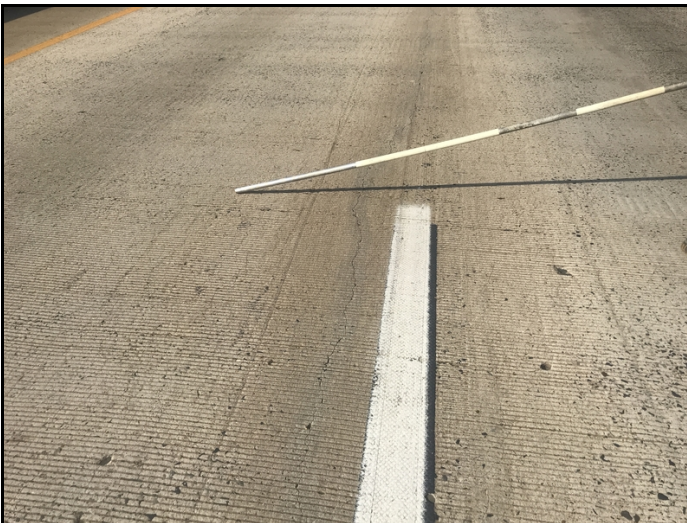
Deck span 2 has unsealed longitudinal crack that reflects through to the soffit.

Deck has unsealed cracks and a spall filled with asphalt at west end of bridge.

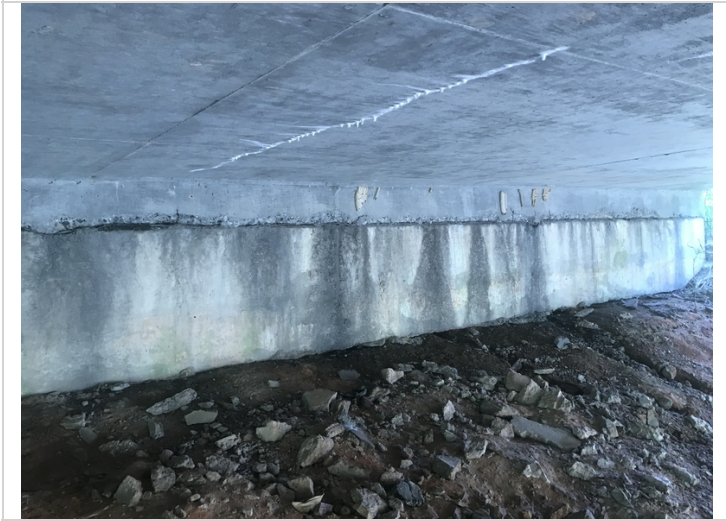
(38) Bottom of deck has cracks with efflorescence and rust . Span 1 has spall filled with asphalt. Bent 5, the slab haunch is spalled and has delaminations the entire length of the abutment.							
205	Reinforced Concrete Column	EA	9	6	2	1	0
1080	Delamination/Spall/Patched Area	EA	1	0	0	1	0
1190	Abrasion/Wear (PSC/RC)	EA	2	0	2	0	0

Bent 5 slab haunch has spalls entire length.

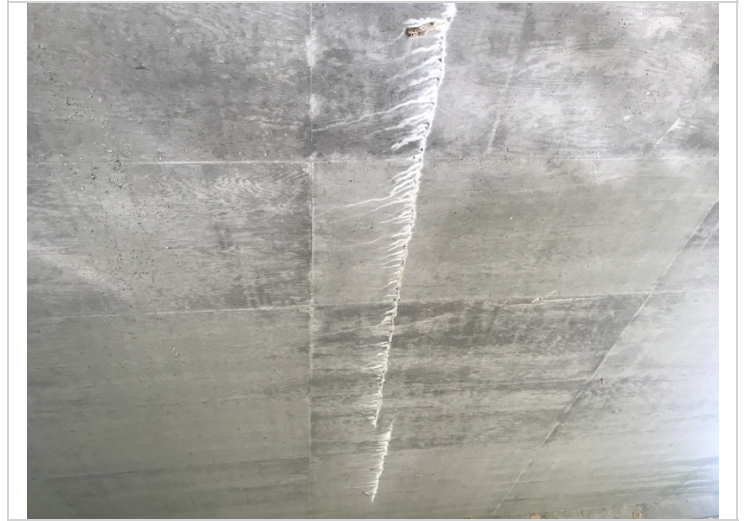
Span 2 soffit has cracks with efflorescence.

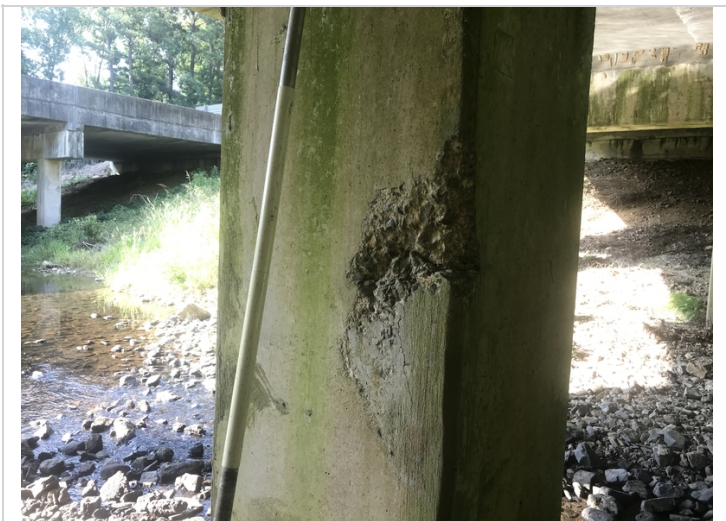
(205) Column 2 at bent 3 has a large spall, columns 1 and 3 have abrasion.							
215	Reinforced Concrete Abutment	LF	95	84	11	0	0
1080	Delamination/Spall/Patched Area	LF	7	0	7	0	0
1130	Cracking (RC and Other)	LF	4	0	4	0	0

Bent 3 column 2 has spall.

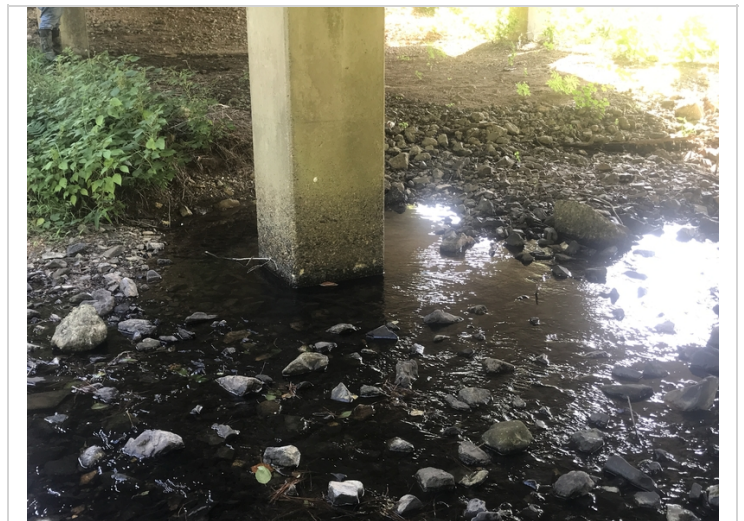
Bent 3 column 1 has abrasion, common columns 2&3.

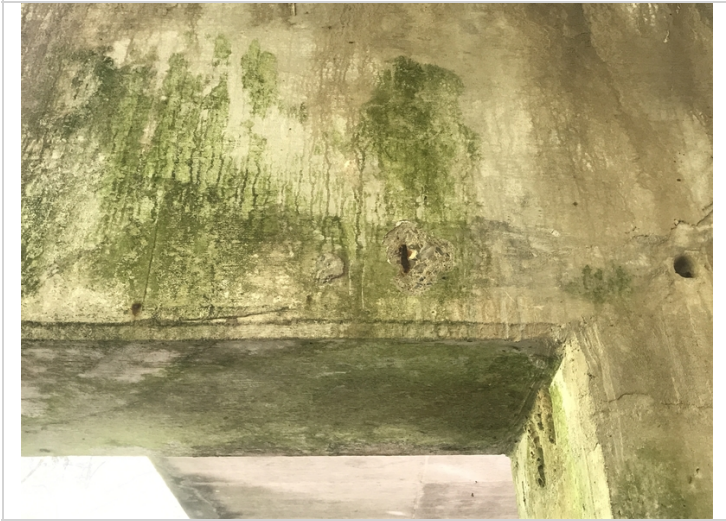
(234) Bents 2 and 3 caps have patched areas. Bent 2 cap back has small spall with exposed rebar. Bent 3 ahead and bottom has spalls with exposed rebar. Bent 4 cap left end has small spall with exposed rebar.							
301	Pourable Joint Seal	LF	120	0	120	0	0
2310	Leakage	LF	120	0	120	0	0

Bent 2 cap back has spall with exposed rebar.

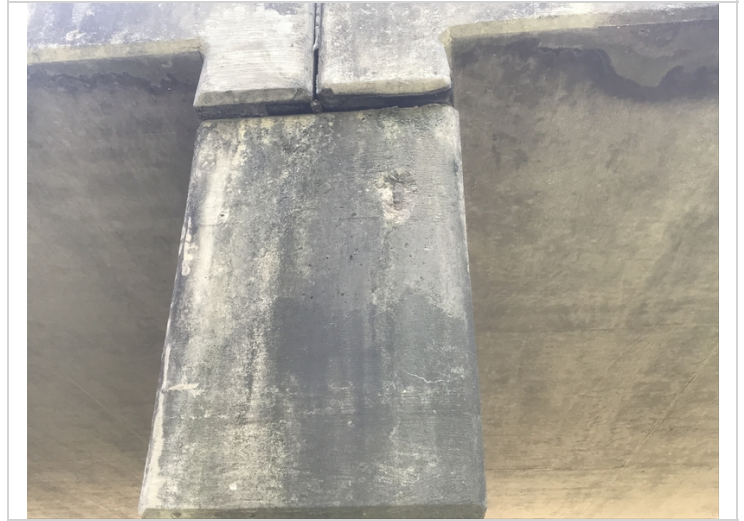
Bent 4 cap left end has small spall with exposed rebar.

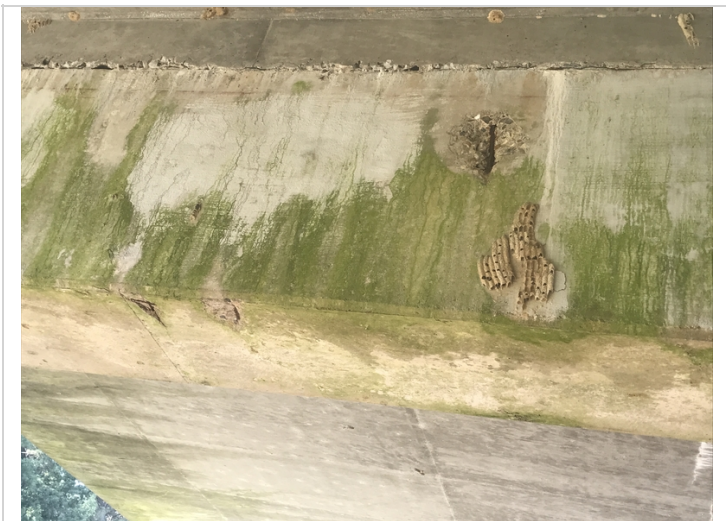
Bent 3 cap ahead and bottom have spalls with exposed rebar.

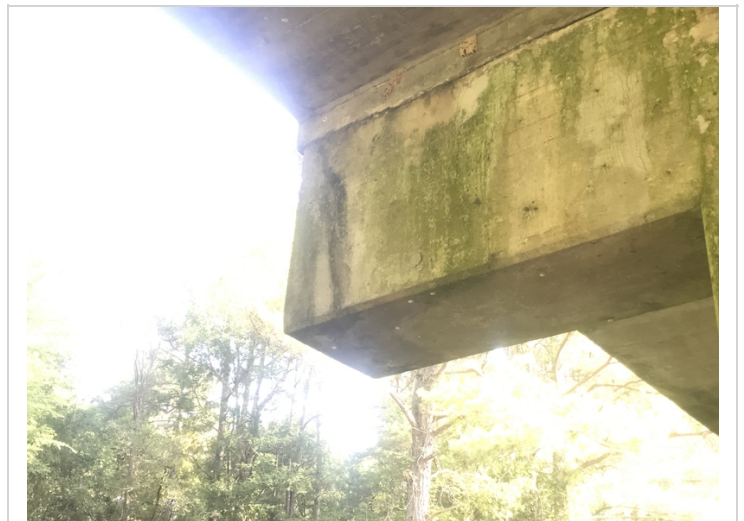
Bent 3 cap left side has patched area.

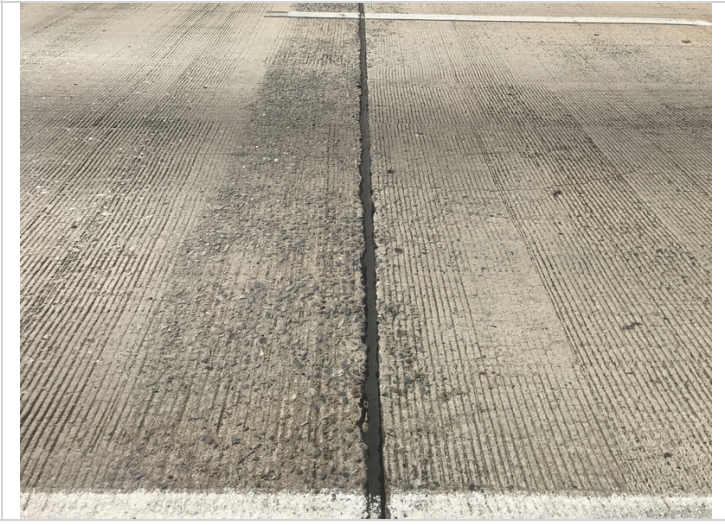
(301) All joint seals leak.							
321	Reinforced Concrete Approach Slab	SF	2888	2804	82	2	0
1080	Delamination/Spall/Patched Area	SF	2	0	0	2	0
1130	Cracking (RC and Other)	SF	82	0	82	0	0

Joint seal at bent 3 has lost bond and is leaking common all joints.

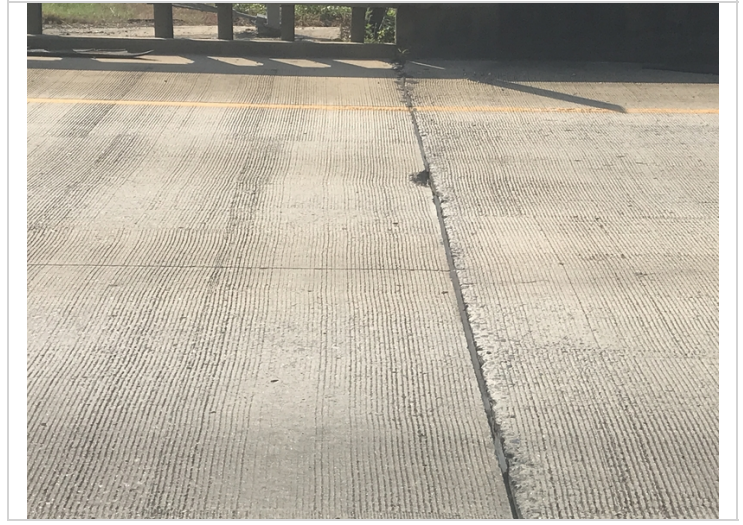
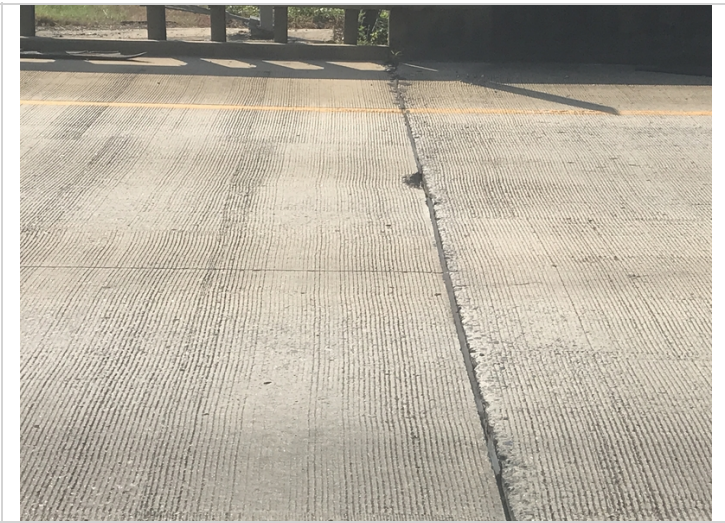
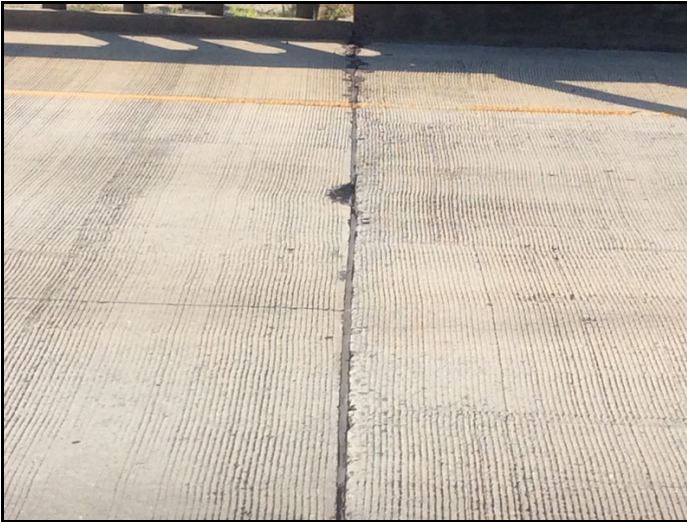
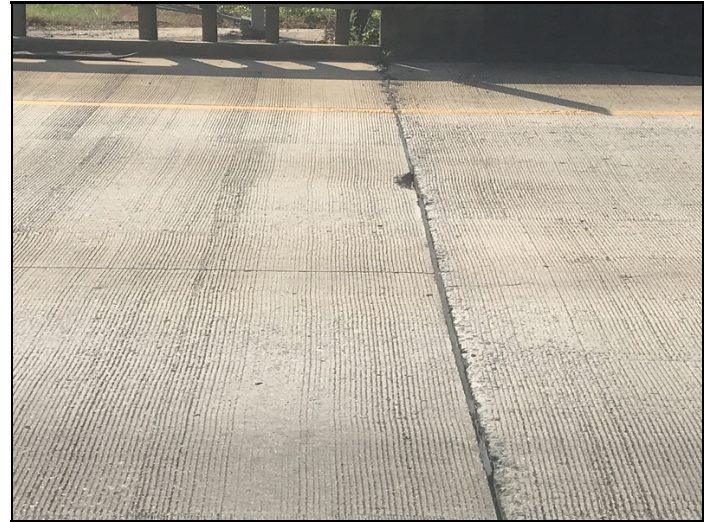
(321) Approach slab at east end of bridge has 2 spalls and large cracks.							
331	Reinforced Concrete Bridge Railing	LF	240	215	25	0	0
1130	Cracking (RC and Other)	LF	25	0	25	0	0

East approach slab spall

Spalls in east approach slab. Spalls have not been repaired. MSB 08/25/2021

Spalls in east approach slab

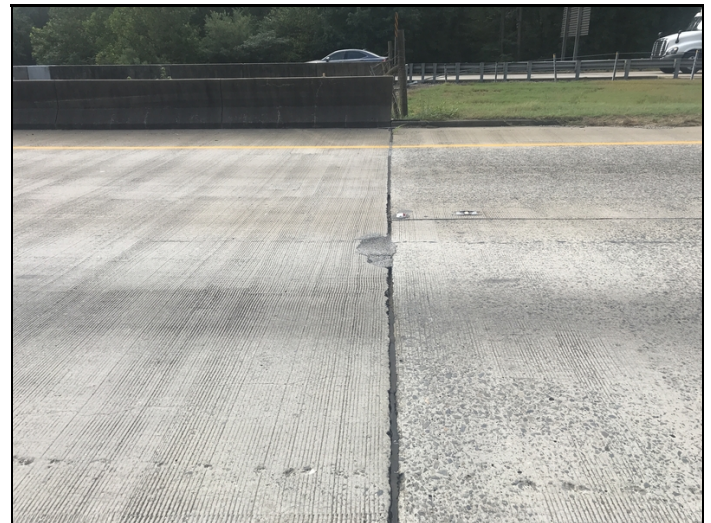
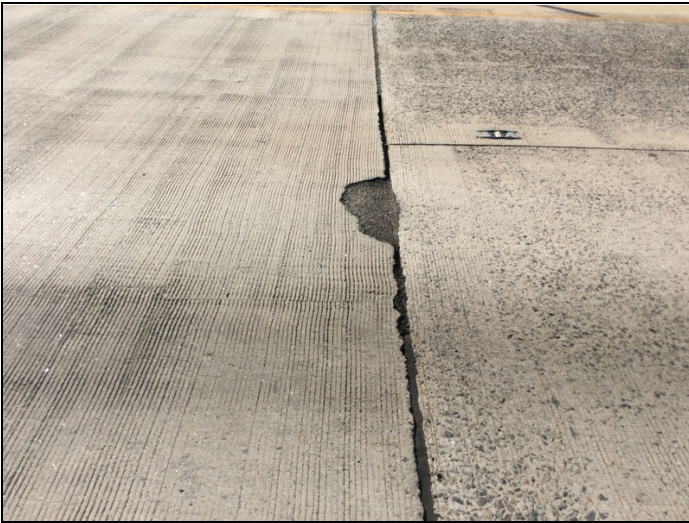
Asphalt patch span 1.

Deck has a spall filled with asphalt at west end of bridge.

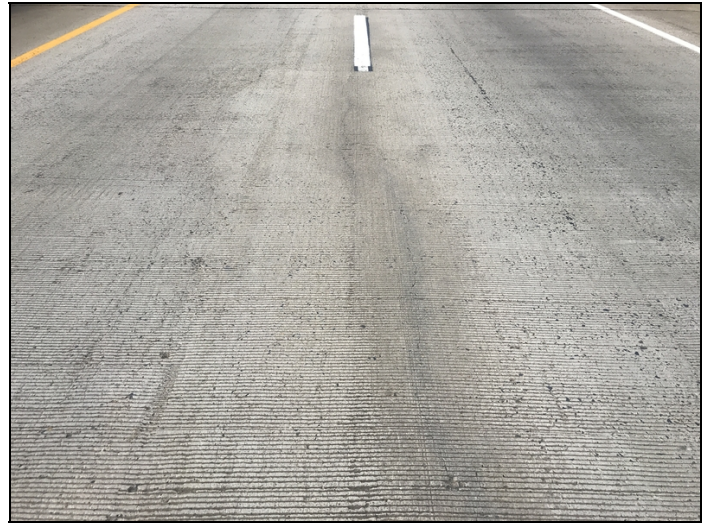
Span 4, longitudinal cracks.

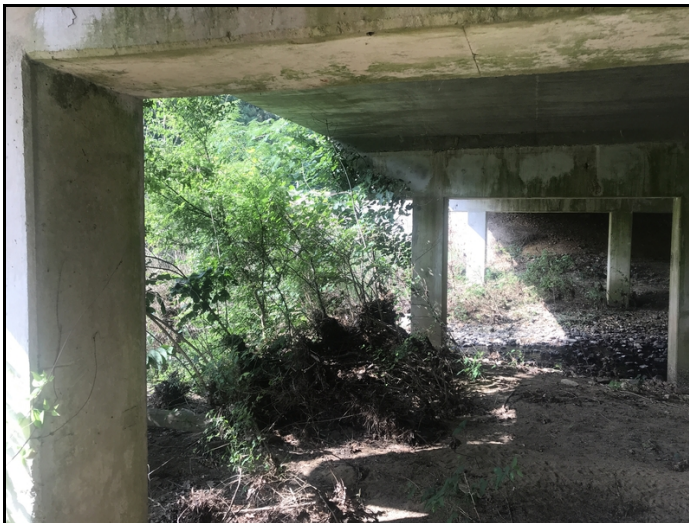
Trees growing under and near the bridge.

Span 3, trees growing under bridge.

Cut trees and brush Brush has been removed. MSB 08/25/2021.

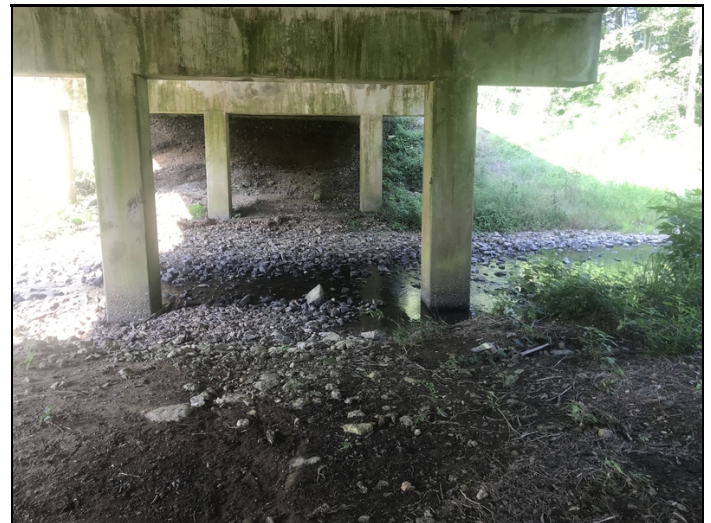
Trees growing under bridge have been removed.
