Asset #B3432(Routine)

I-30 EB Log 104.52 over NINE MILE CR

Location: 0.94 MI S OF SALINE CO

Team Lead: Shane Byrd, Inspection Date: 08/25/2021

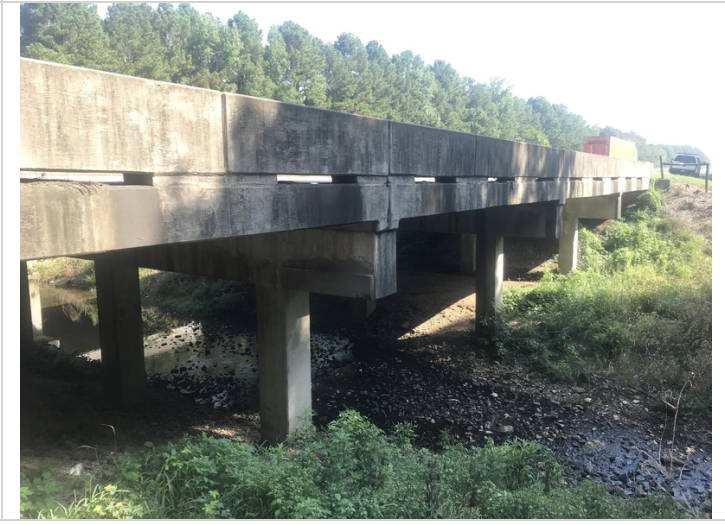
Elevation.

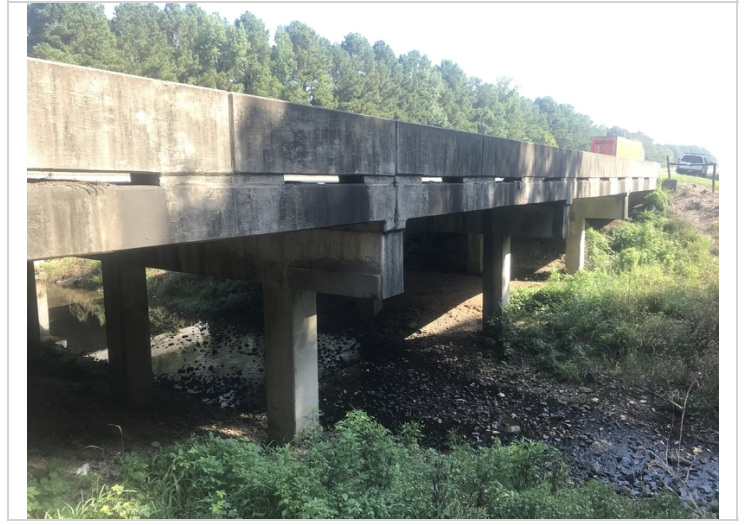
Elevation.

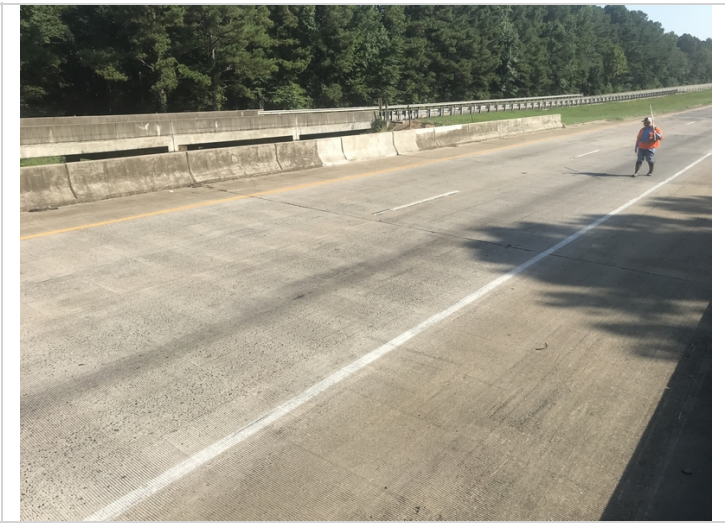
Deck overview.

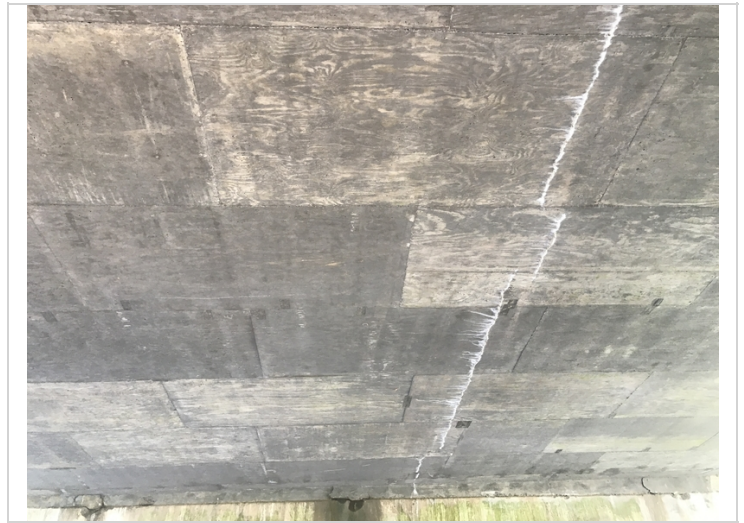
Span 2 soffit overview.

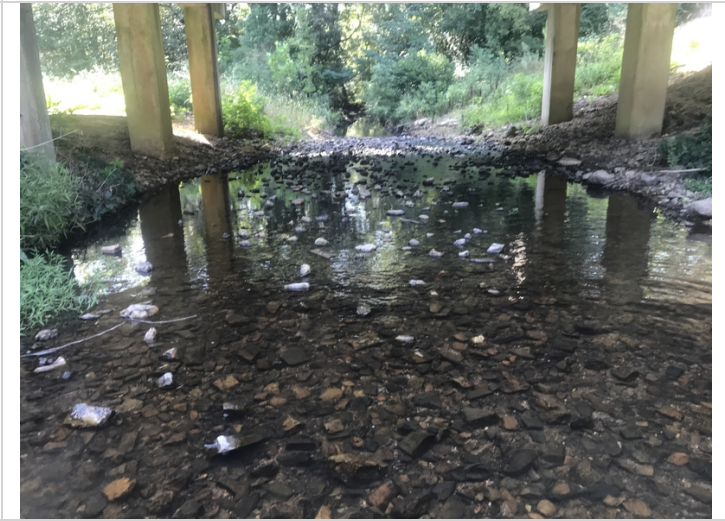
Channel

61 - Channel/Channel Protection (7 - Bank protection is in need of minor repairs. River control devices and embankment protection have a little minor damage. Banks and/or channel have minor amounts of drift.)

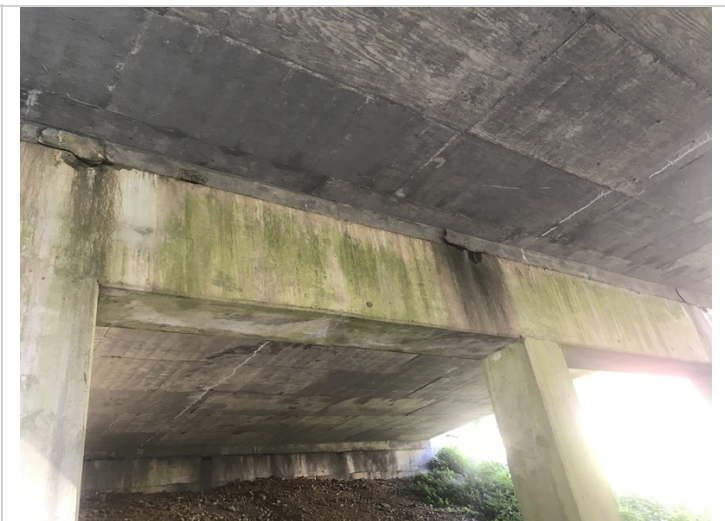
(38) Deck has unsealed cracks. Bottom of deck has cracks with efflorescence. Small spalls and delamination above bents 2 and 4 in the deck haunch. Spall in slab at span 4 above bent 4 cap right side.							
205	Reinforced Concrete Column	EA	9	3	6	0	0
1190	Abrasion/Wear (PSC/RC)	EA	6	0	6	0	0

Deck haunch above bent 2 has large delams.

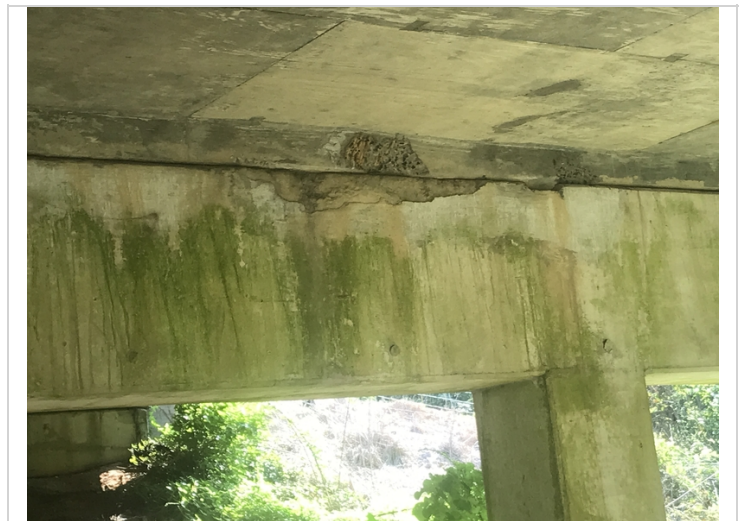
Deck haunch above bent 4 back has spalls.

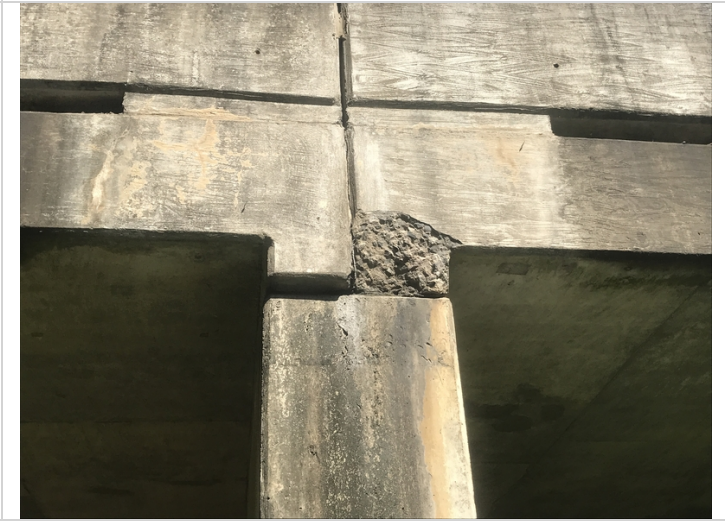
Spall in slab at span 4 above bent 4 cap right side.

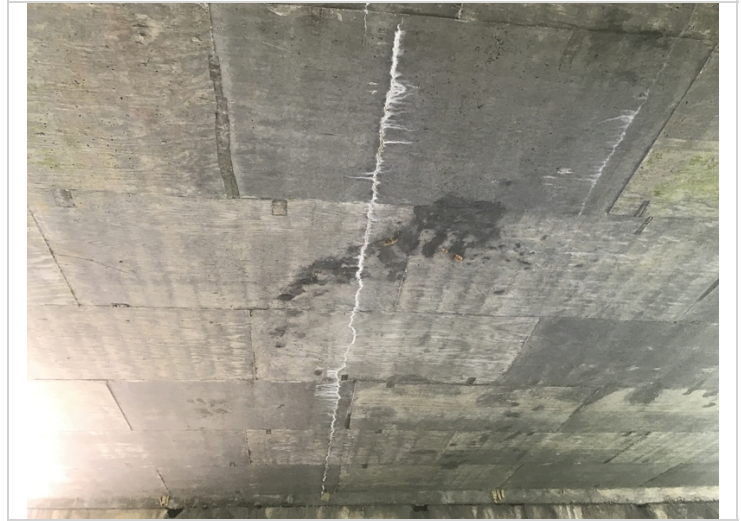
Span 1 soffit has cracks with efflorescence at centerline.

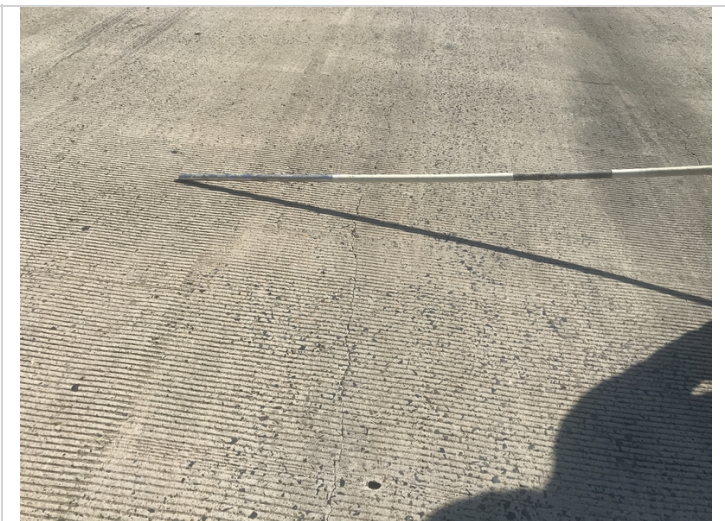
Span 1 has unsealed longitudinal crack that reflects through to the soffit.

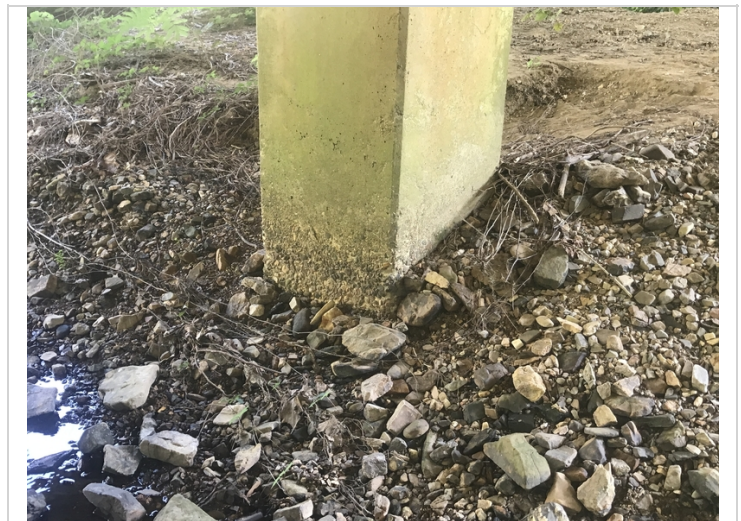
(205) Columns at bents 3 and 4 have minor abrasion.							
215	Reinforced Concrete Abutment	LF	95	93	2	0	0
1080	Delamination/Spall/Patched Area	LF	2	0	2	0	0

Bent 3 column 2 has abrasion, common all columns at bents 3&4.

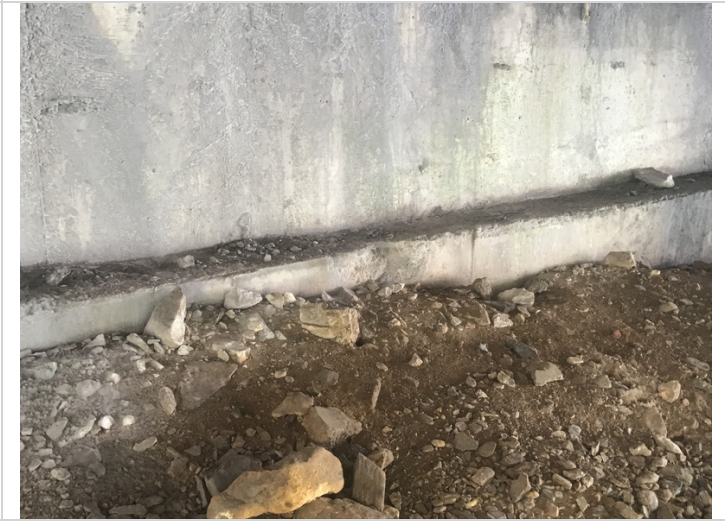
(215) Bent 1 has small spalls.							
234	Reinforced Concrete Pier Cap	LF	129	106	22	1	0
1080	Delamination/Spall/Patched Area	LF	17	0	17	0	0
1090	Exposed Rebar	LF	1	0	0	1	0
1130	Cracking (RC and Other)	LF	5	0	5	0	0

Bent 1 abutment has small spalls.

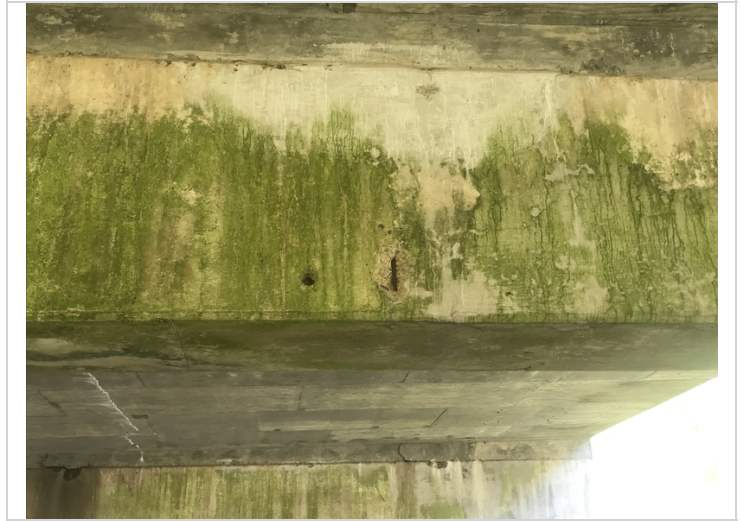
Bent 3 cap ahead has spall with exposed rebar.

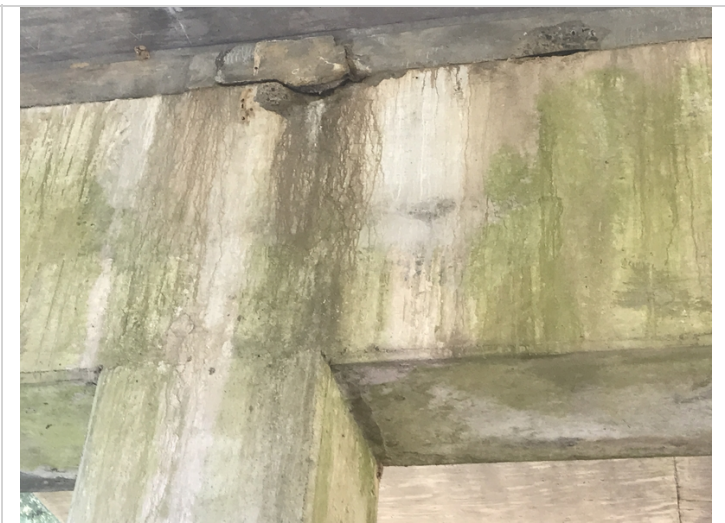
Bent 2 cap ahead has contact spall above column3.

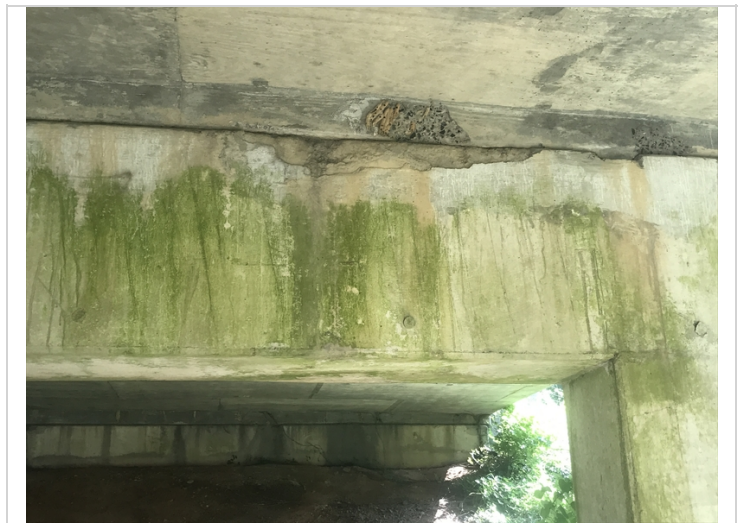
Bent 4 cap back has spalled area.

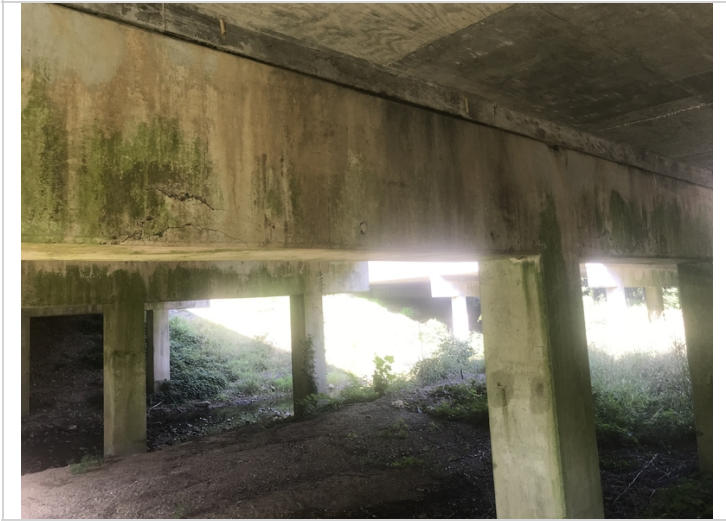
Bent 4 cap ahead has delams.

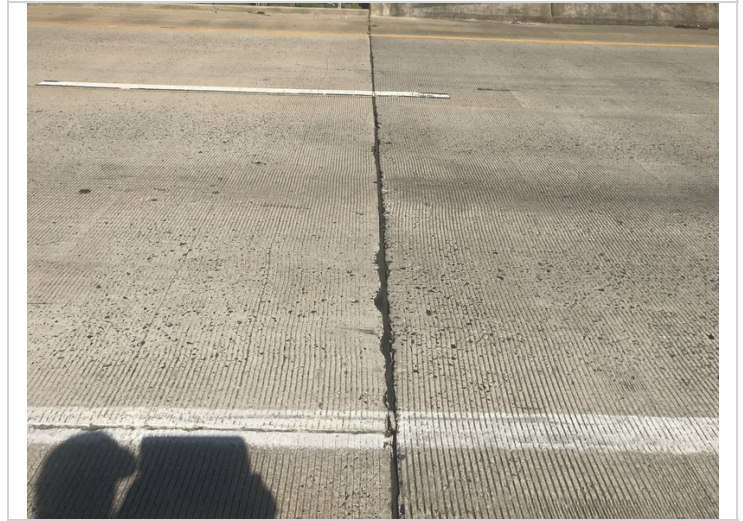
(301) All seals have lost bond and are leaking. Bent 2 has small spalls at the joint.							
321	Reinforced Concrete Approach Slab	SF	2888	2830	0	58	0
1130	Cracking (RC and Other)	SF	58	0	0	58	0

Bent 1 joint seal has lost bond and is leaking, common all joint seals.

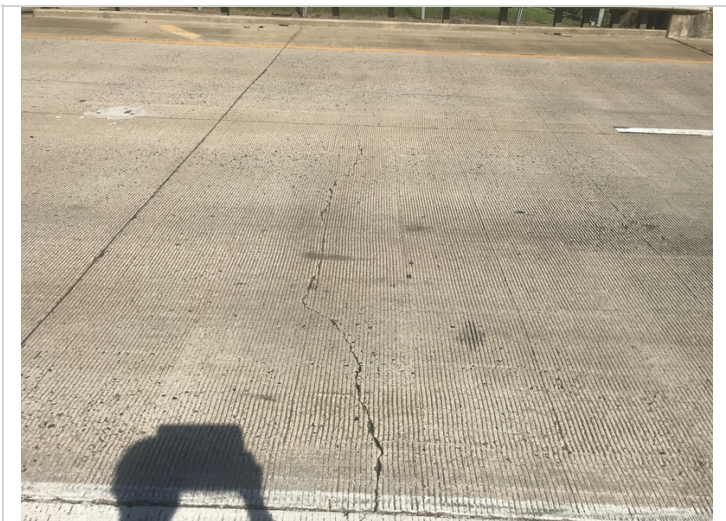
(321) Approach slab at abutment one has a large unsealed crack.							
331	Reinforced Concrete Bridge Railing	LF	240	205	35	0	0
1080	Delamination/Spall/Patched Area	LF	25	0	25	0	0
1130	Cracking (RC and Other)	LF	10	0	10	0	0

Large unsealed cracks in west approach slab.

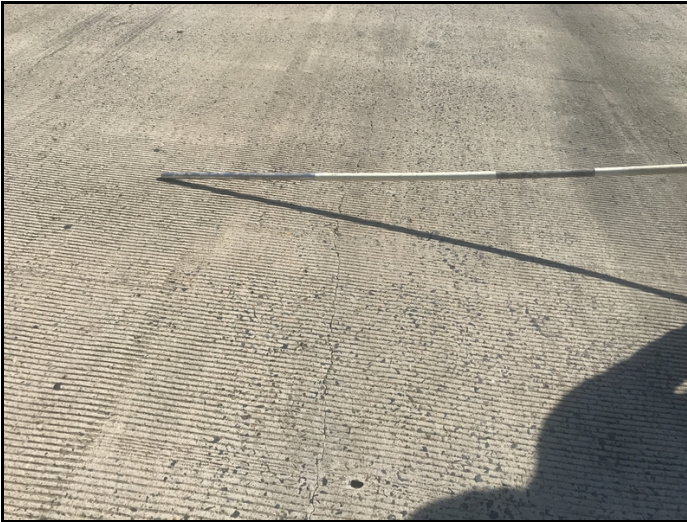
Deck has large unsealed cracks.

Span 1 has unsealed longitudinal crack that reflects through to the soffit.

Type of Work: Repair (General)

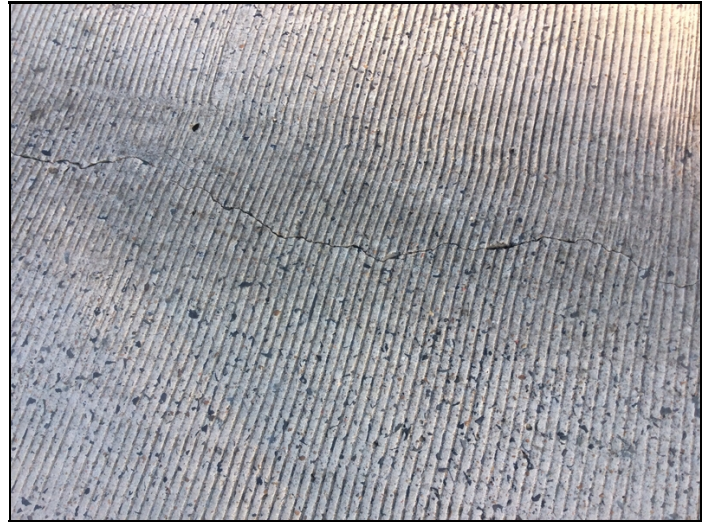
Deck has large unsealed cracks

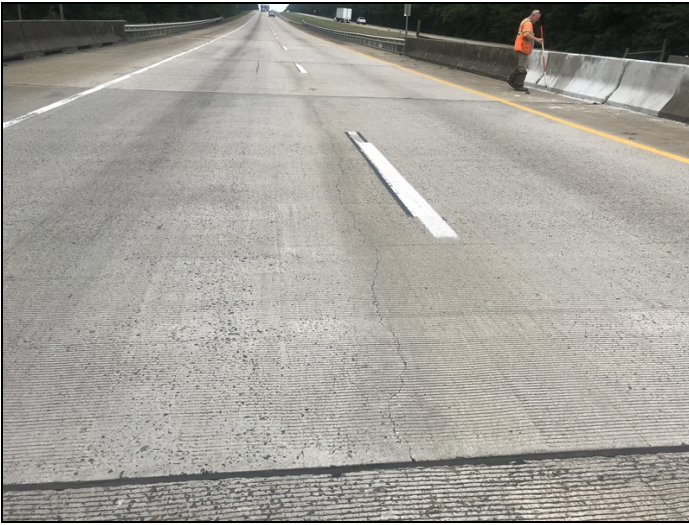
Large longitudinal crack.

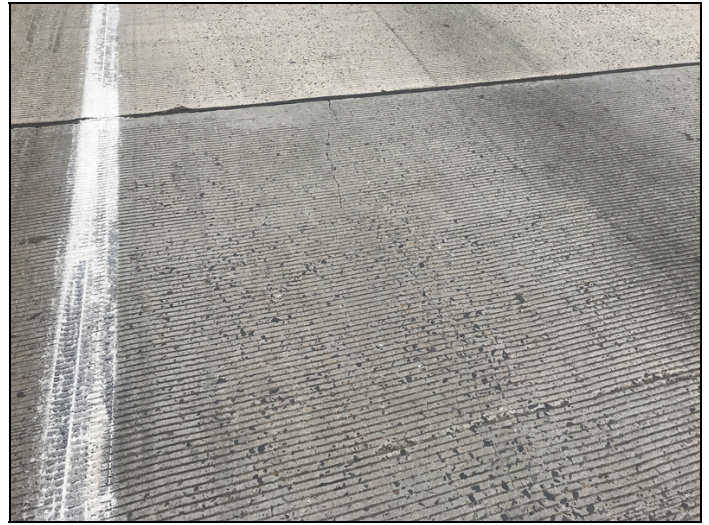
Span 3, large unsealed crack.
