Asset #M3028(Routine)

I-30 WB Log 101.49 over CREEK

Location: 3.5 MI N JCT US 270

Team Lead: Shane Byrd, Inspection Date: 06/14/2022

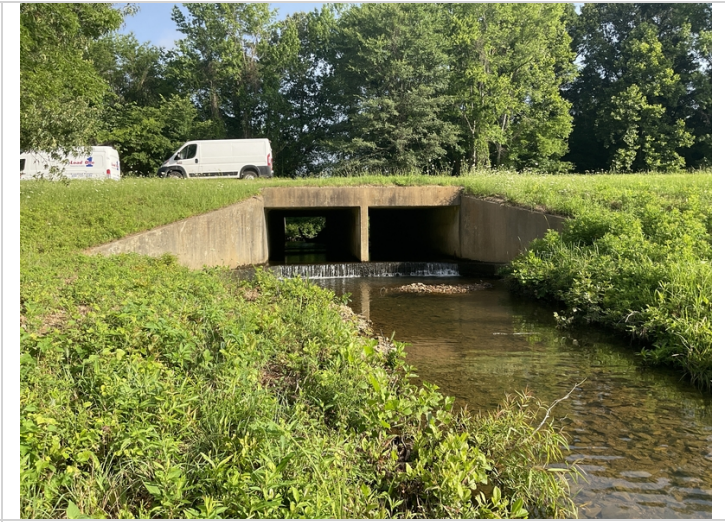
Elevation.

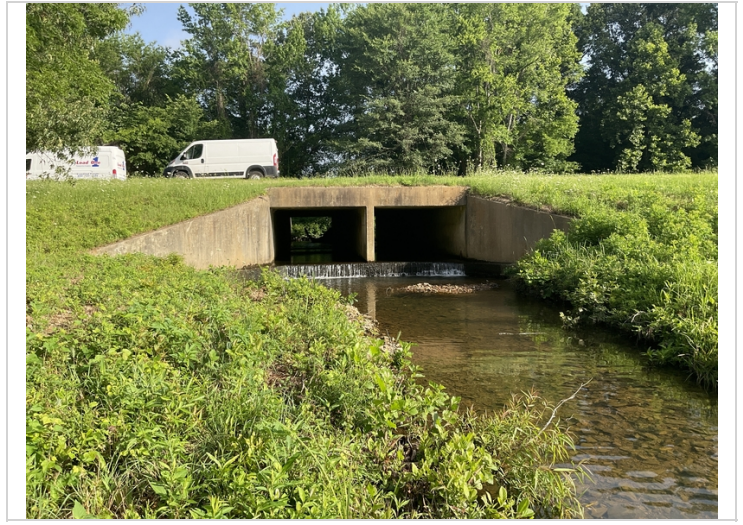
Elevation.

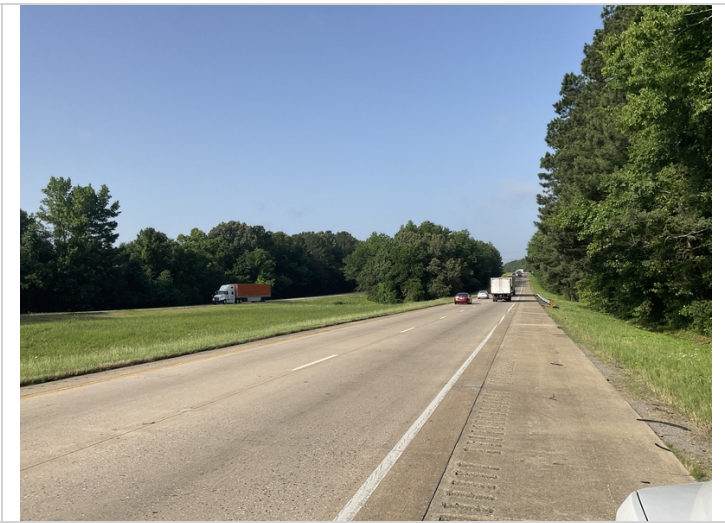
Approach westbound.

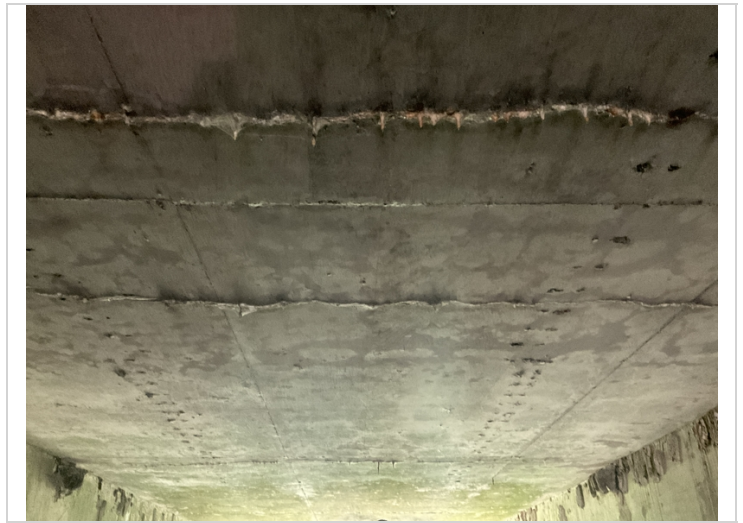
Cracks with efflorescence in top of barrel 2.

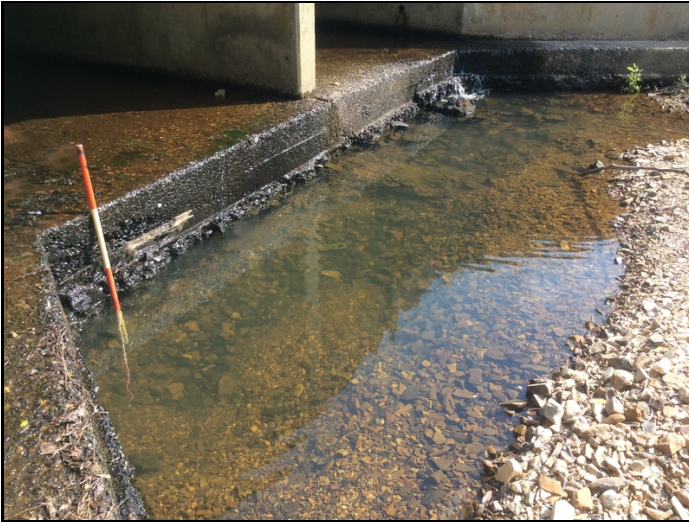
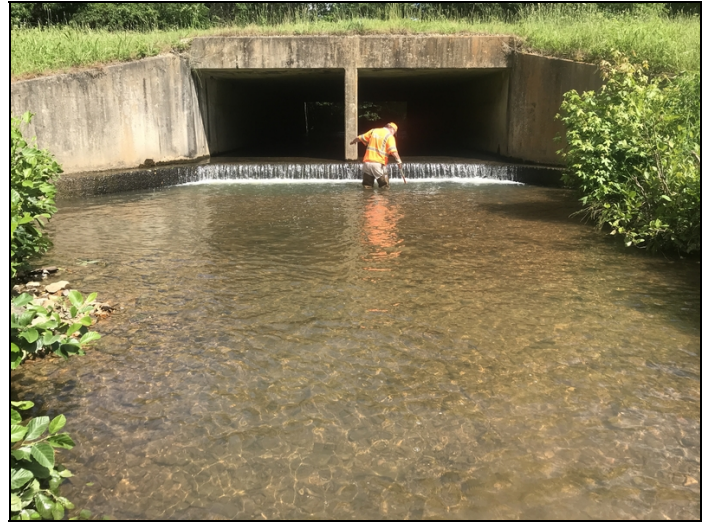
ELEMENTS		DESCRIPTION	UNITS	TOTAL	CS1	CS2	CS3	CS4
241	Reinforced Concrete Culvert	LF	162	139	23	0	0	
1120	Efflorescence/Rust Staining	LF	22	0	22	0	0	
6000	Scour	LF	1	0	1	0	0	
(241) Outlet end of culvert has its footing exposed due to scour action.

Scour at outlet end

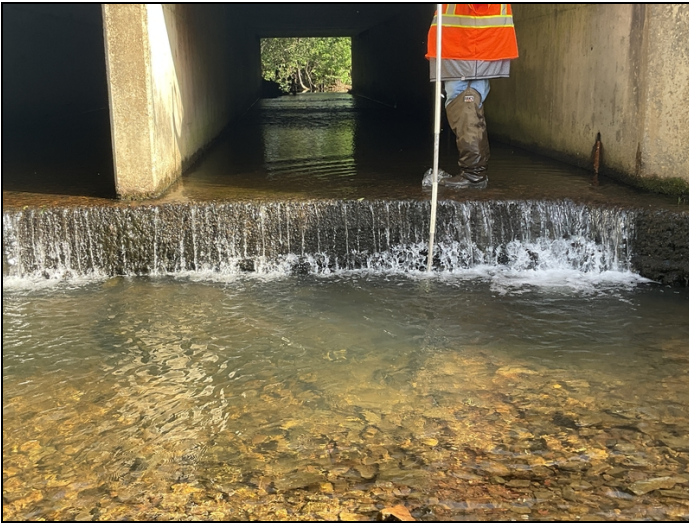
Scour at outlet end.

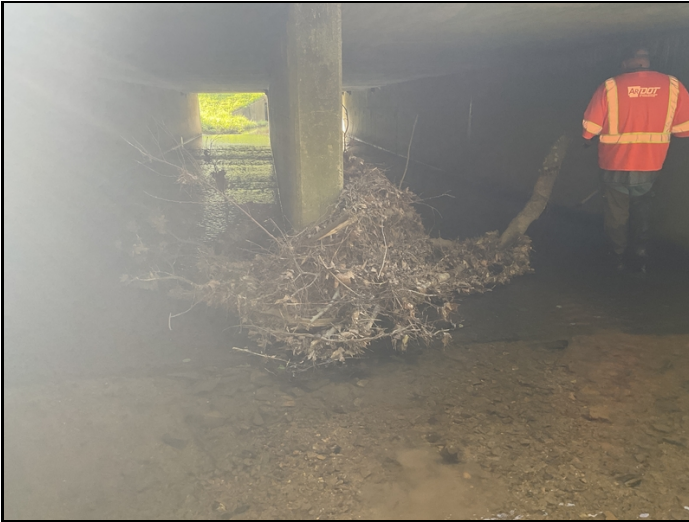
Logs and debris restricting water flow at inlet end of box culvert.

**Type of Work:** (Inactive) (Inactive) 1 - Clean
