Asset #M3029(Routine)

I-30 EB Log 101.49 over CREEK

Location: 3.5 MI N JCT US 270

Team Lead: Shane Byrd, Inspection Date: 06/14/2022

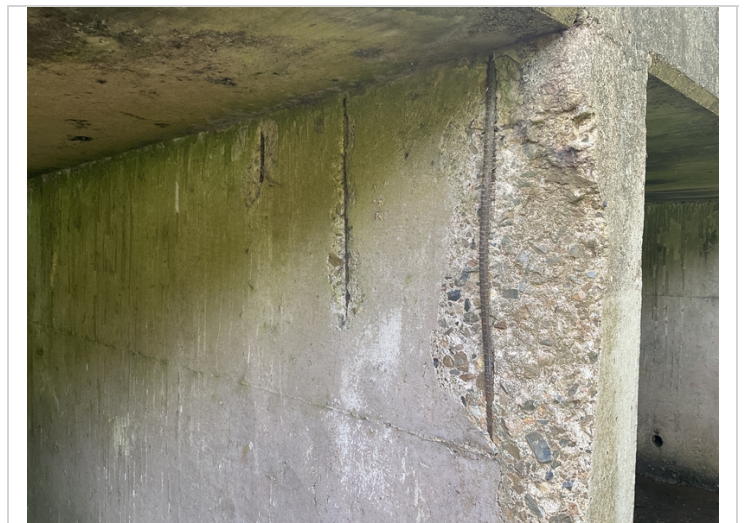
Spall with exposed rebar at inlet end of divider wall.

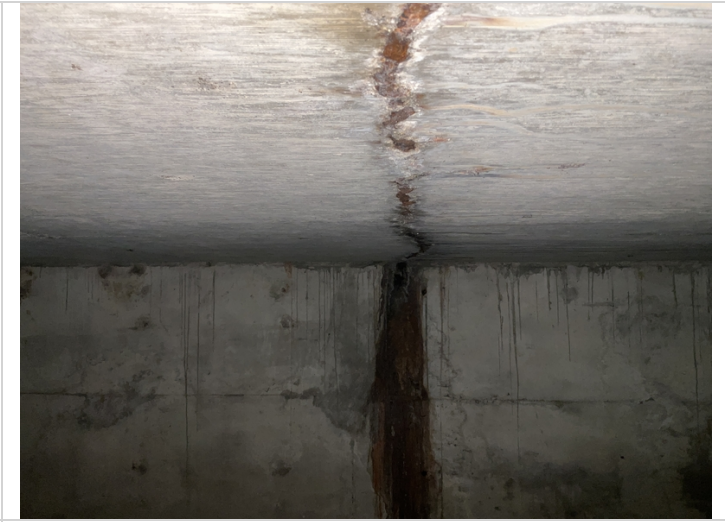
Cracks with efflorescence and rust staining in barrel 1.
