Asset #M3030(Routine)

I -30 EB Log 107.4 over CREEK

Location: 3.8 MI SW JCT US 70 I -30

Team Lead: Chris Doggett, Inspection Date: 01/05/2022

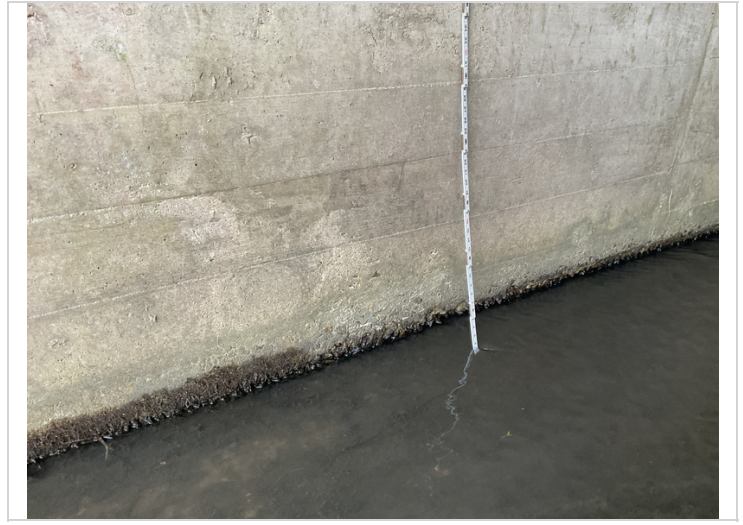
Barrel 1: Both barrels with abrasion at the bottom of the divider walls.

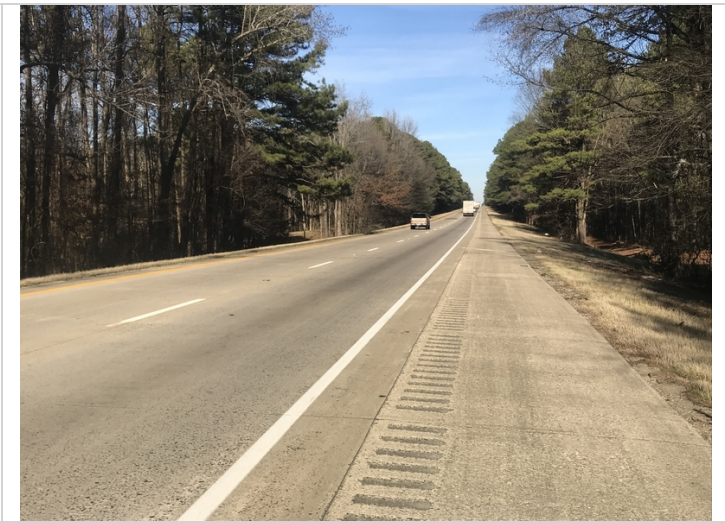
Approach West to East.

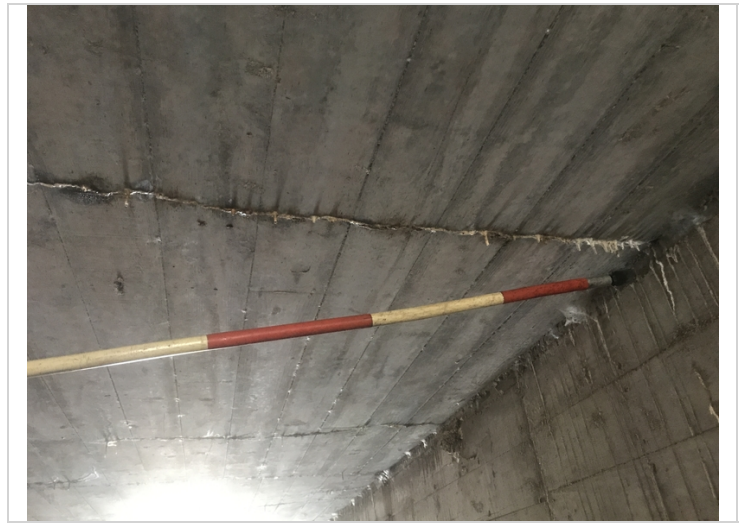
Barrel 1 has cracks with efflorescence in top of barrel.
Common barrel 2.

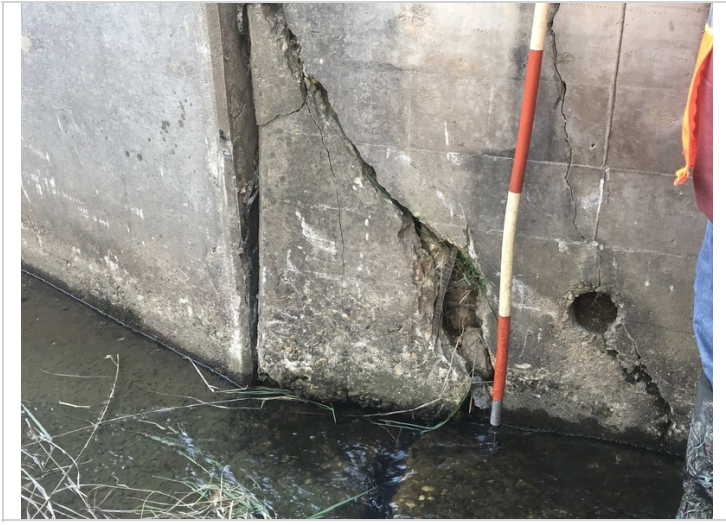
Outlet end of barrel 2 has exposed rebar.

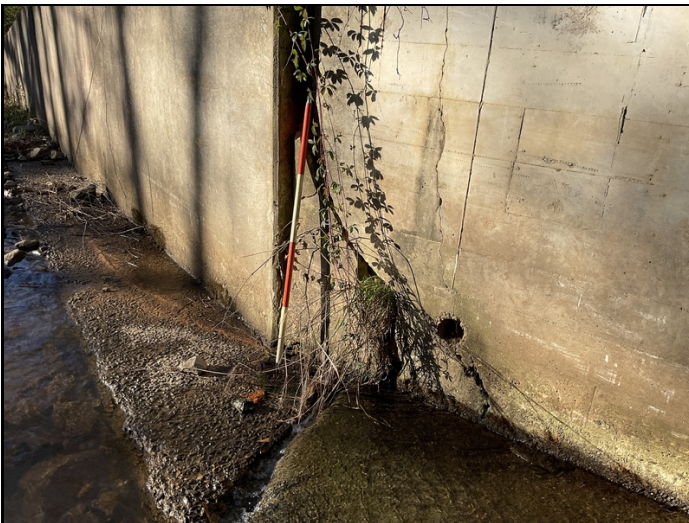
Outlet end barrel 1: Spall with exposed rebar.

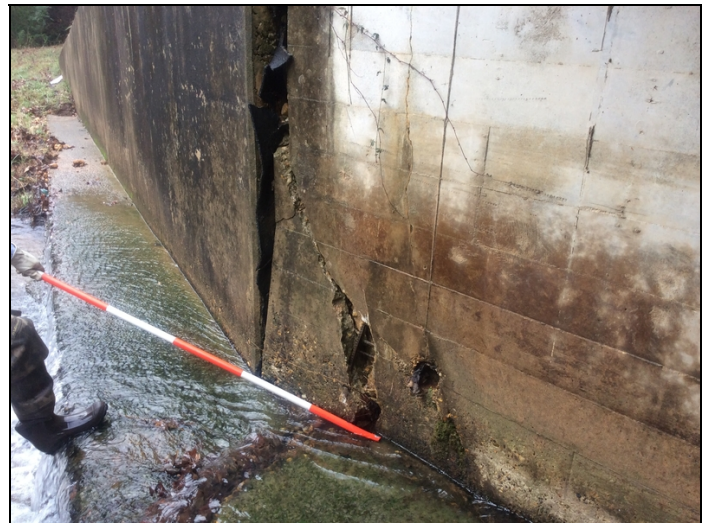
Barrel 1 outlet end spall with exposed rebar.

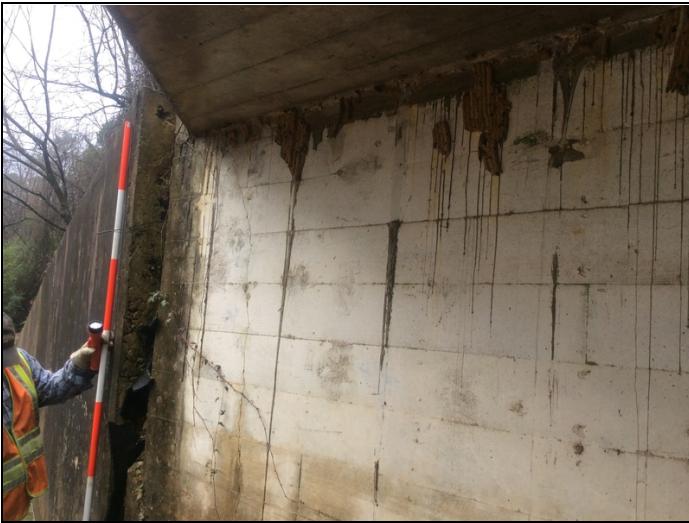
Wing wall at barrel 1 is leaning in due to past scour action.

Wing wall at barrel 1 is leaning in due to scour action.
