Asset #X0282(Routine)

I-30 WB Log 107.4 over CREEK

Team Lead: Chris Doggett, Inspection Date: 01/05/2022

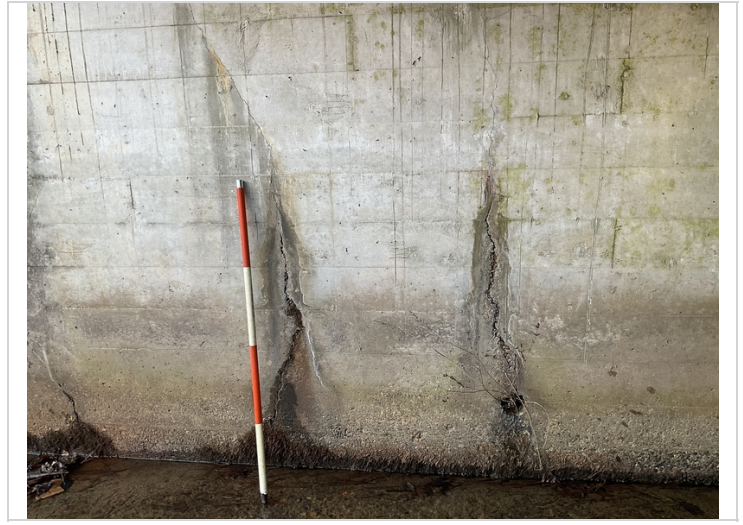
Barrel 1: large vertical cracks near the outlet

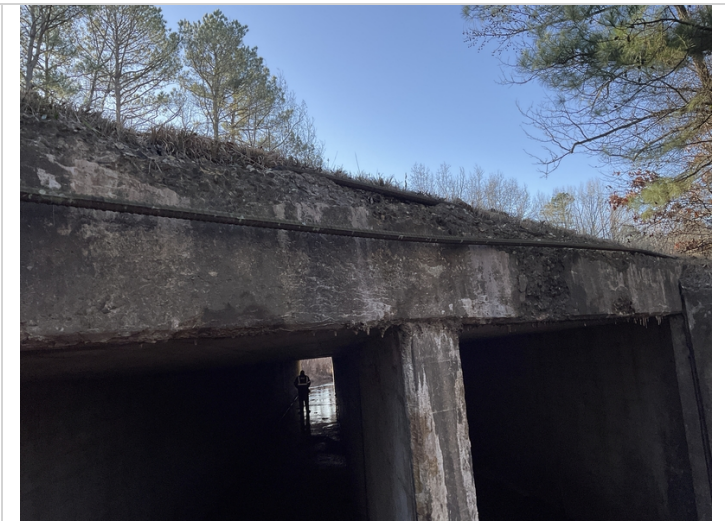
ELEMENTS	DESCRIPTION	UNITS	TOTAL	CS1	CS2	CS3	CS4
241	Reinforced Concrete Culvert	LF	302	0	300	2	0
1090	Exposed Rebar	LF	2	0	0	2	0
1120	Efflorescence/Rust Staining	LF	24	0	24	0	0
1130	Cracking (RC and Other)	LF	72	0	72	0	0
1190	Abrasion/Wear (PSC/RC)	LF	204	0	204	0	0
(241) Small cracks with light effloresce in the tops of both barrels. Deterioration to head wall on inlet end of box with exposed rebar. (1120-241) Both barrels has cracks with efflorescence in top of box.

Inlet end with spall and exposed rebar

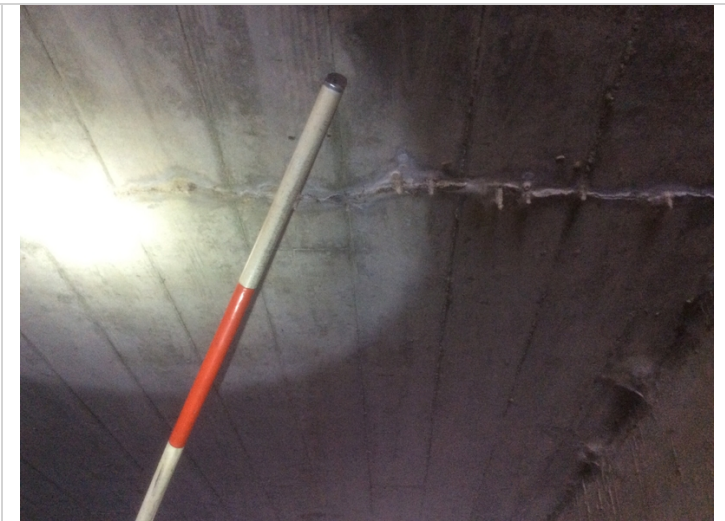
Cracks with efflorescence in the top of barrel one.

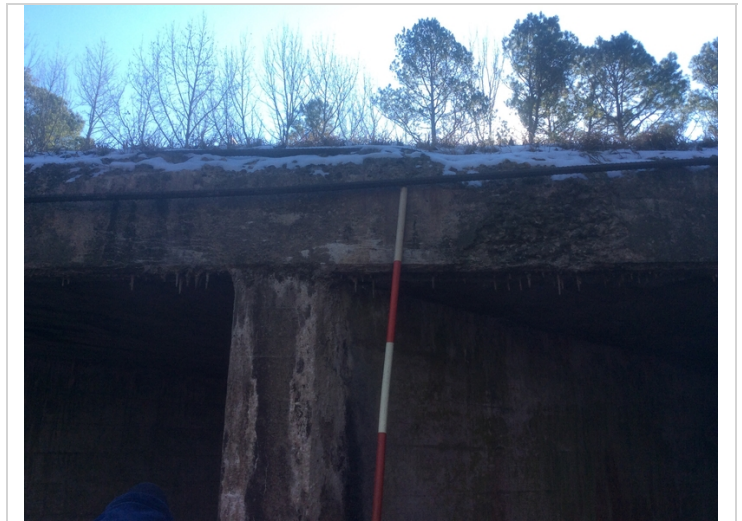
Deterioration to head wall on inlet end of box with exposed rebar.

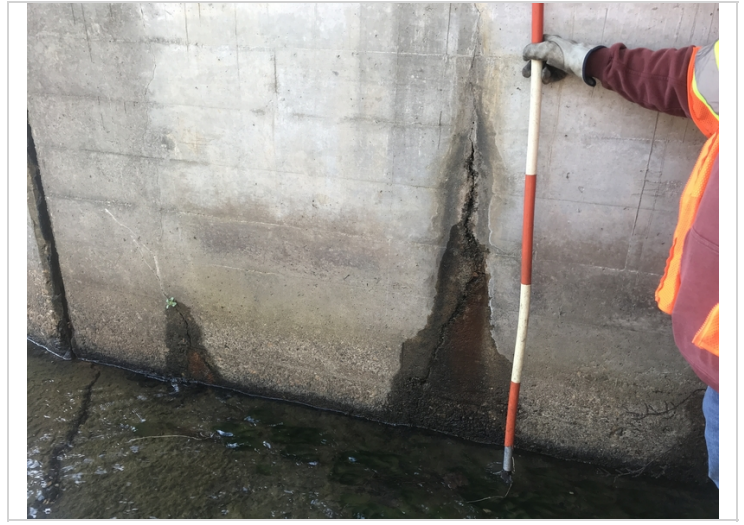
Barrel 2 outlet end has crack in wall. Common along both barrels.

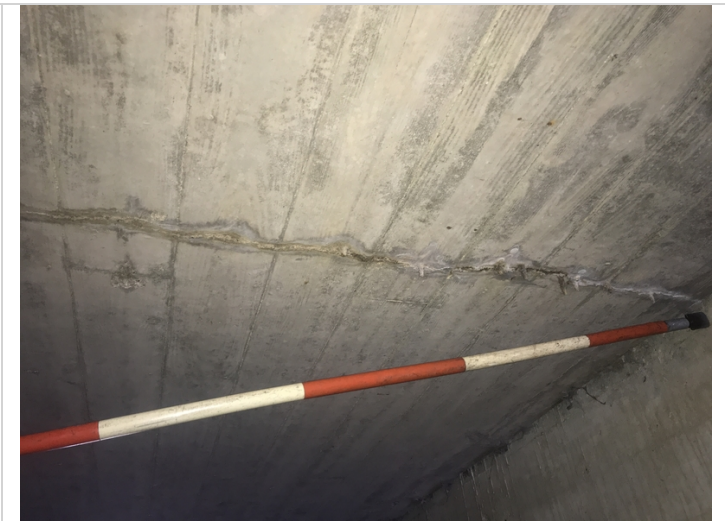
Top of barrel 2 has cracks with efflorescence.
