Asset #A3424(Routine)

I-30 WB Log 97.06 over Ouachita Rvr& Riverview

Team Lead: Shane Byrd, Inspection Date: 06/20/2022

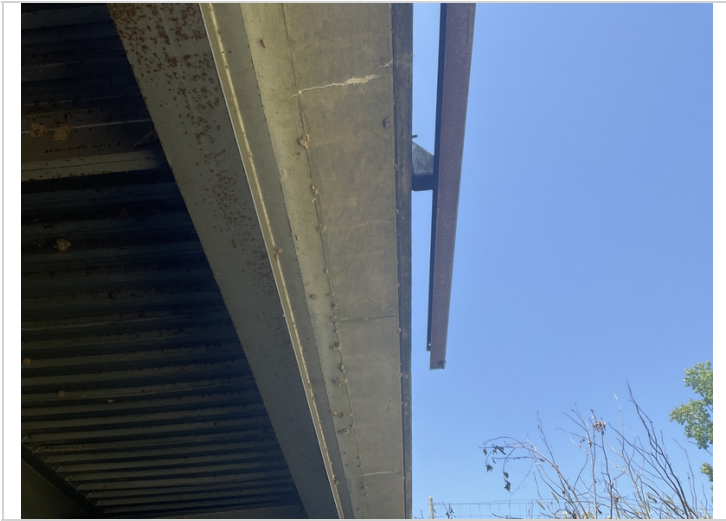
Cracks with efflorescence on left side overhang.

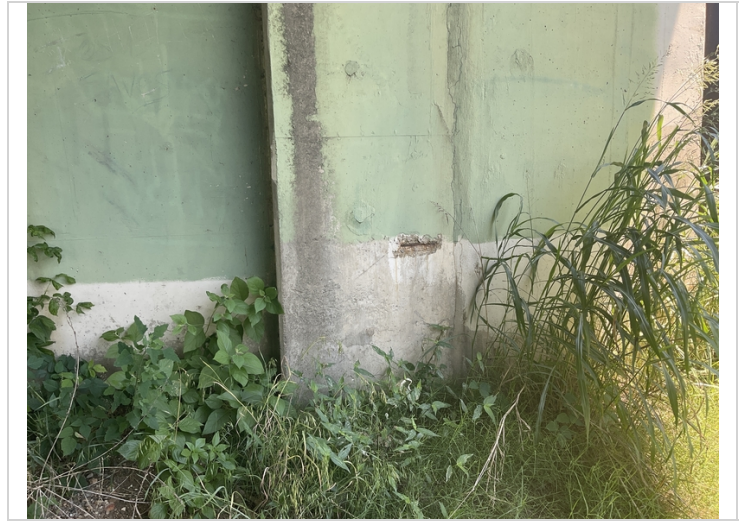
Pier wall 6 right column back spall with exposed rebar.

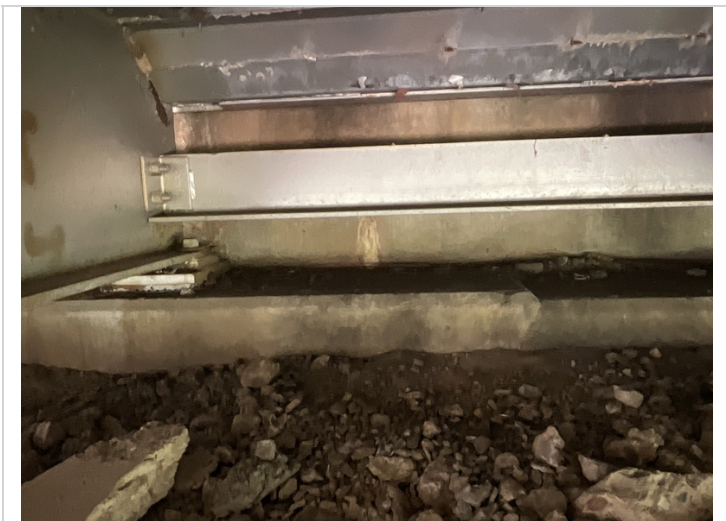
(215) Cracks with efflorescence in the in the back walls of abutments.							
220	Reinforced Concrete Pile Cap/Footing	LF	112	0	84	28	0
6000	Scour	LF	112	0	84	28	0

Bent 1 cracks with efflorescence in back wall.

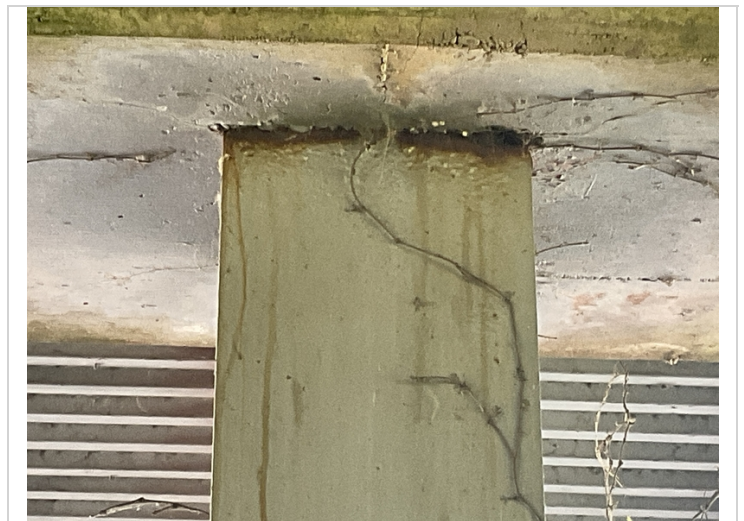
Bent 3 steel pile 3 deep pitting to flange at cap.

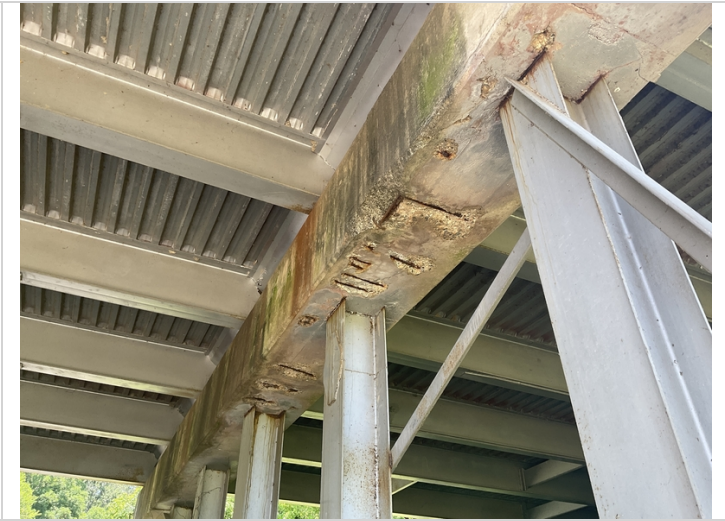
(234) Bent 3, face and underside of cap has 11' of spalls with exposed reinforcing steel.

Bent 3 spalls with exposed rebar in bottom of pier cap.

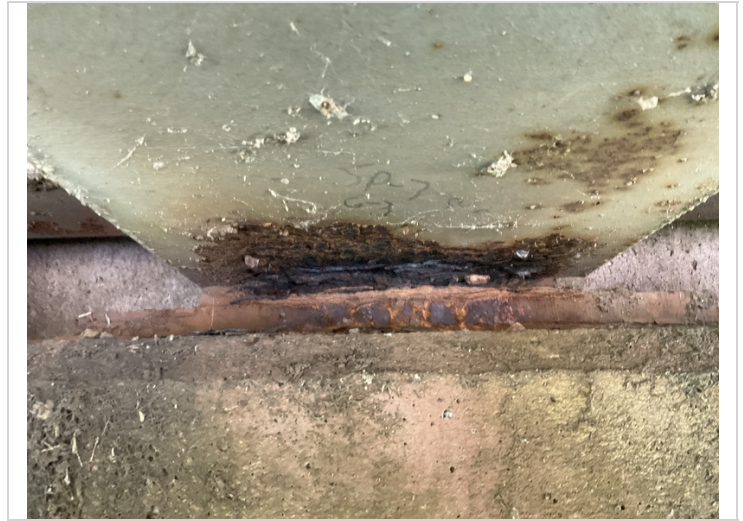
Beams ends have section loss to lower and upper webs. Top flanges on exterior girders have corrosion in scattered locations. Paint system has scattered locations of peeling paint and freckled rust on bottom flanges and scattered locations of freckled rust in the webs. Pier 2 girder 2 span 4, section loss to lower web and hole in stiffener at diaphragm connection. Span 7 at pier 5 girder 3 bottom flange deep pitting.

Span 7 at pier 5 girder 3 bottom flange deep pitting.

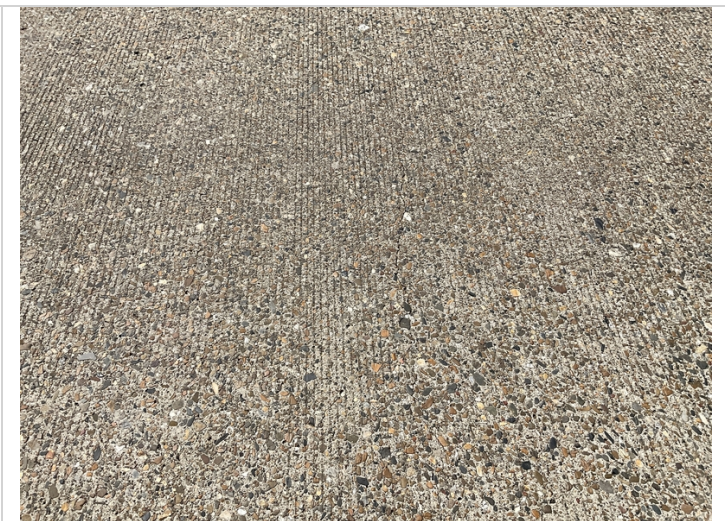
Deck span 3 transverse cracks.

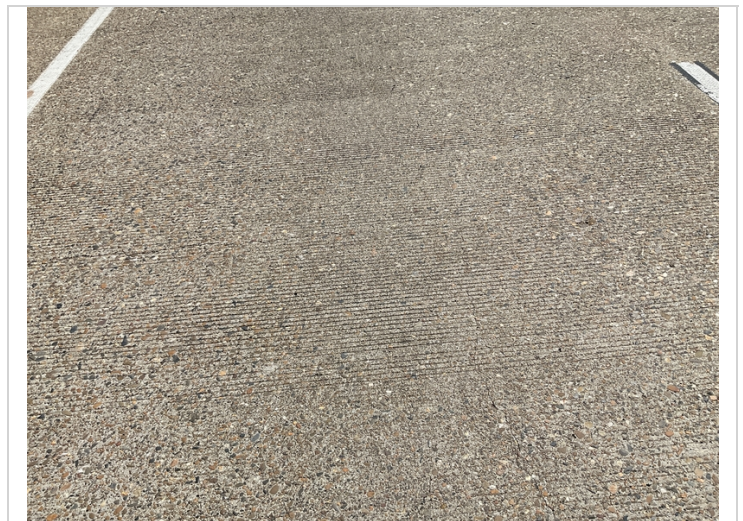
Deck span 5 transverse and longitudinal cracks.

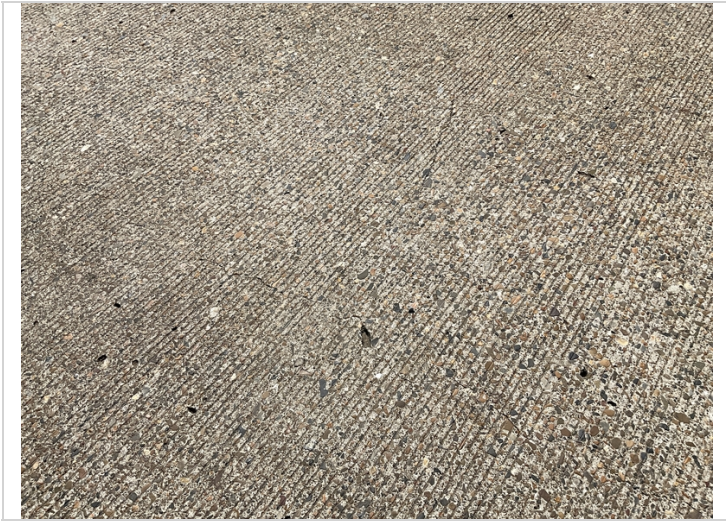
Deck span 7 transverse and longitudinal cracks.

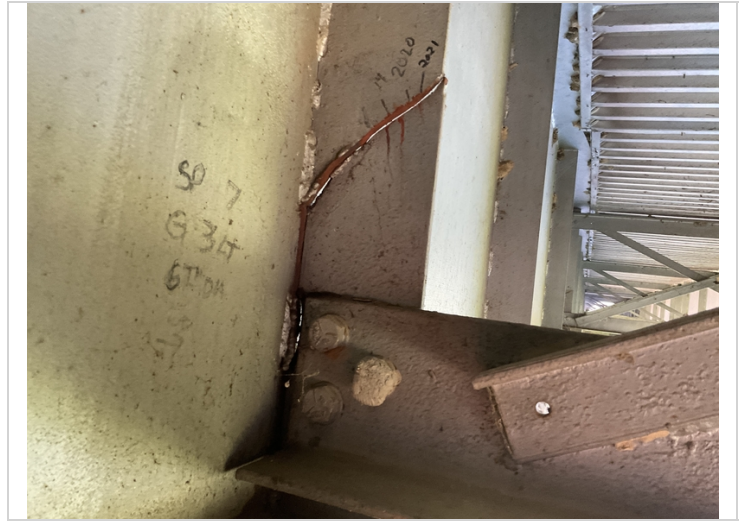
Span 7 girder 3 diaphragm 6 left side crack has propagated all the way thru the diaphragm vertical diaphragm bracket at web.

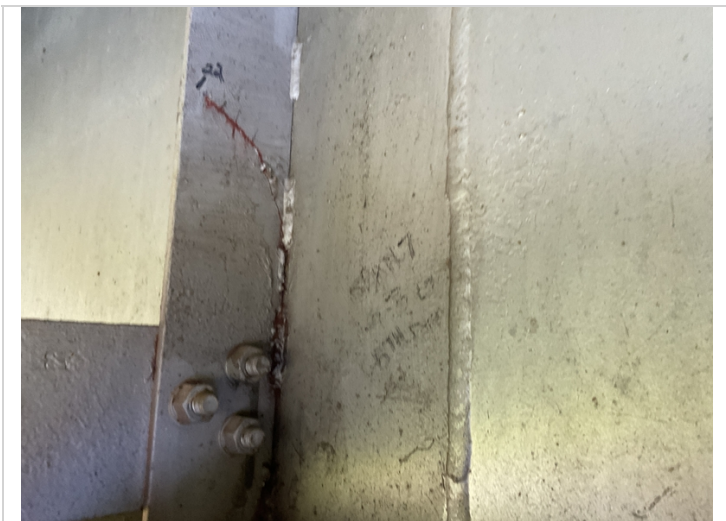
Span 7 girder 3 diaphragm 5 left side vertical diaphragm bracket at web crack has propagated 1" 1/8"

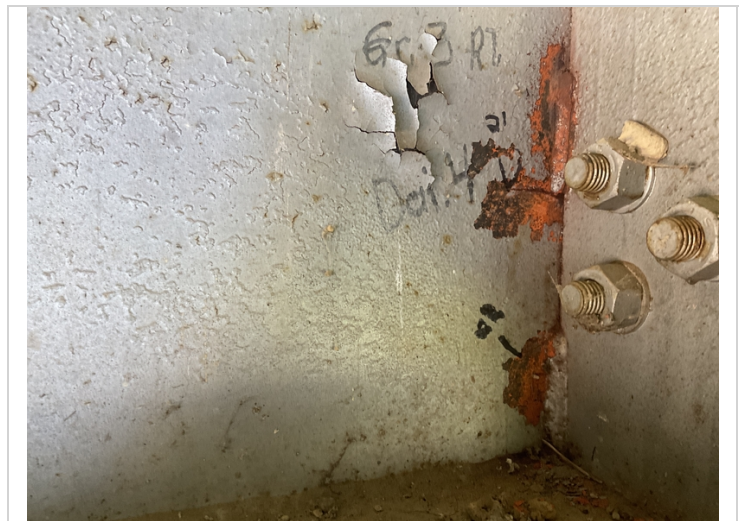
(107) Span 5 Girder 3 diaphragm 3,Span 6 Girder 3 diaphragm 3, Span 7 girder 3 diaphragm 3, Span 7 Girder 3 diaphragm 4.
Cracks in the web that have propagated from diaphragm welds. See Photos.

Span 7 girder 3 diaphragm 4 right side back of diaphragm cracks in the web.

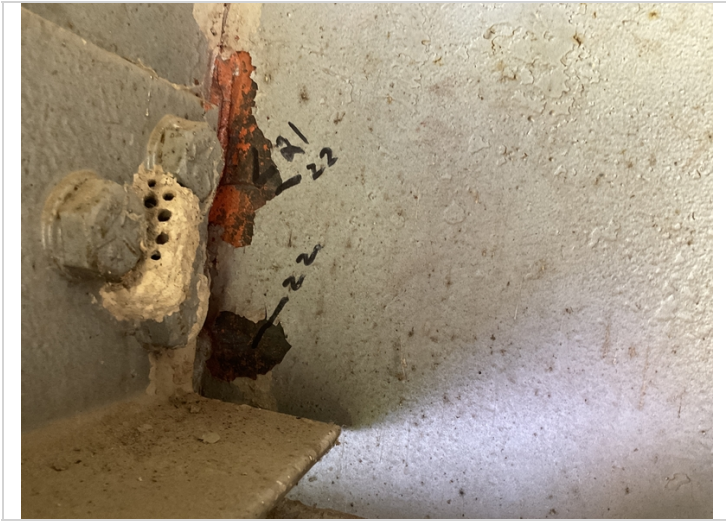
Span 7 girder 3 diaphragm 4 right side ahead of diaphragm cracks in the web.

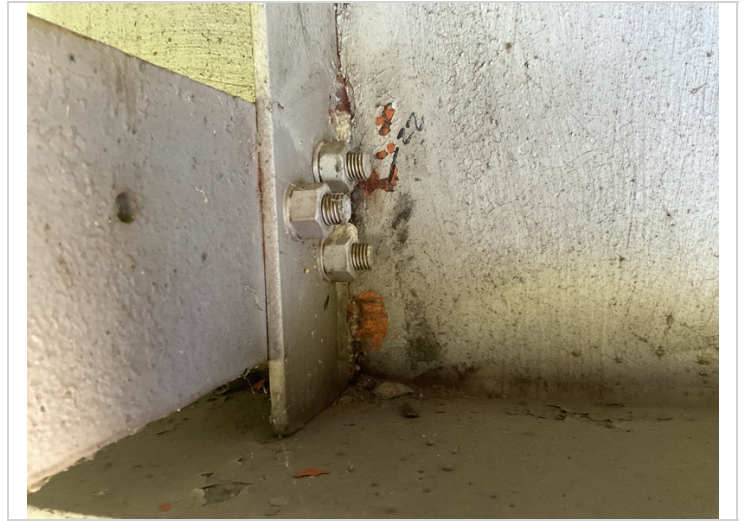
Span 7 girder 3 diaphragm 4 left side back of diaphragm cracks in the web.

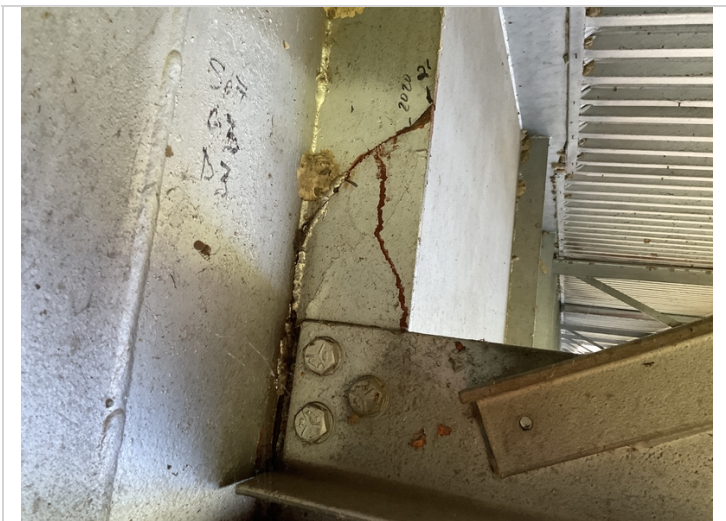
Span 7 girder 3 diaphragm 3 left side crack has propagated all the way thru the diaphragm vertical diaphragm bracket at web.

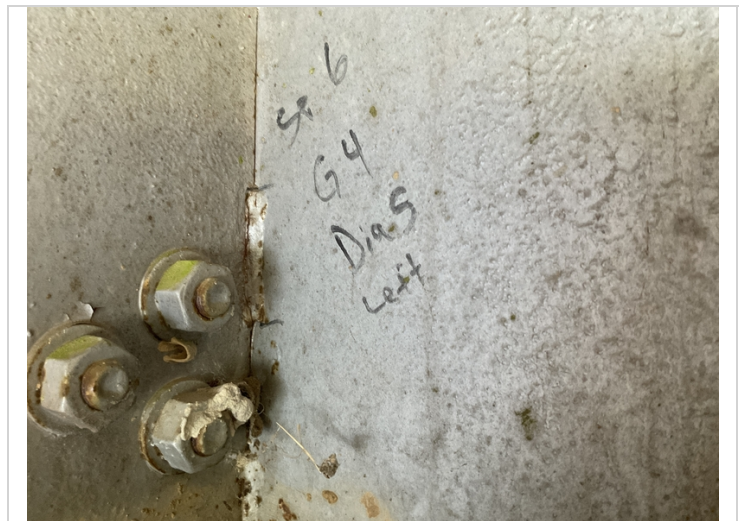
Span 6 girder 4 diaphragm 5 back broke weld.

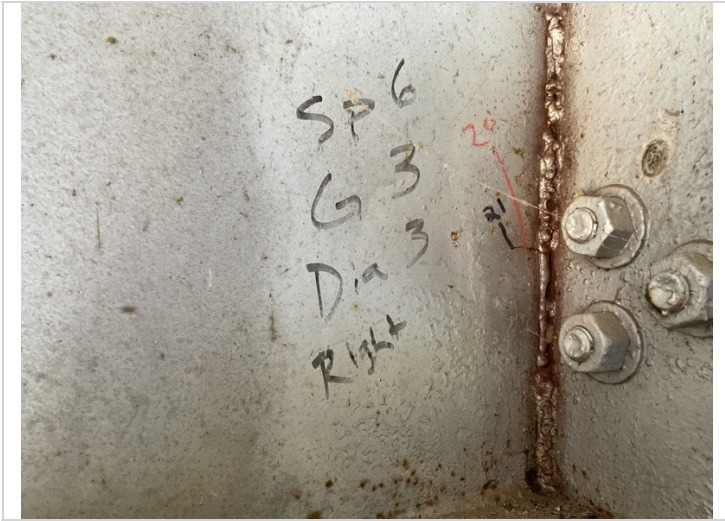
Span 6 girder 3 diaphragm 3 right side back crack in the web.

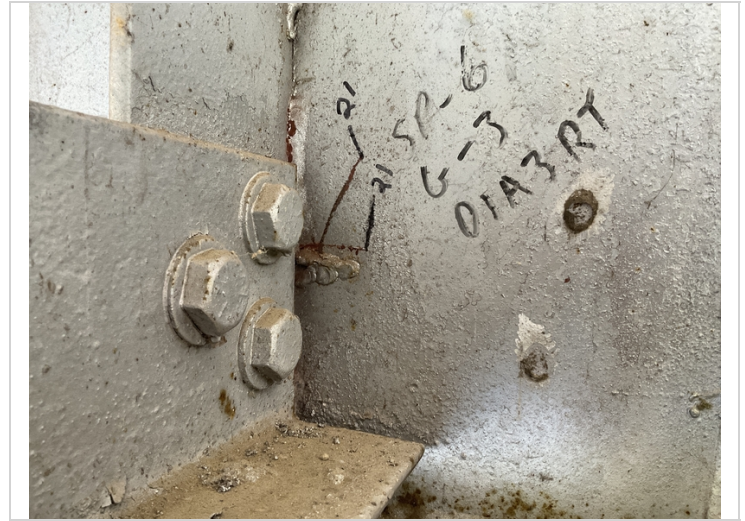
Span 6 girder 3 diaphragm 3 right side ahead cracks in the web.

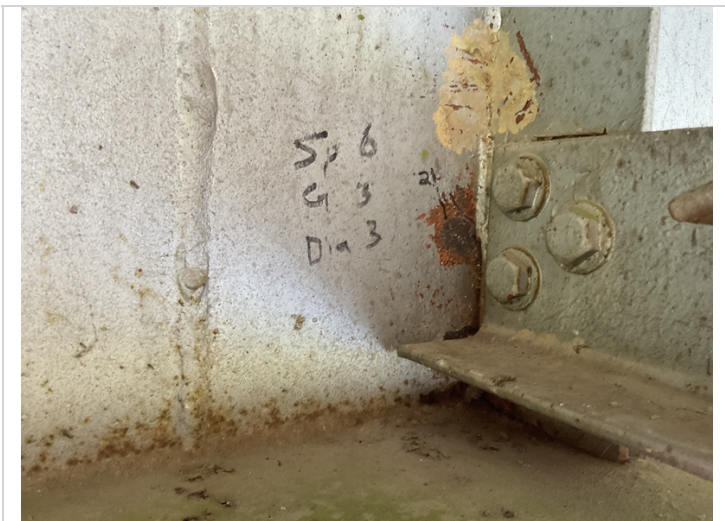
Span 6 girder 3 diaphragm 3 left side ahead crack in the web. Common back side of diaphragm this location.

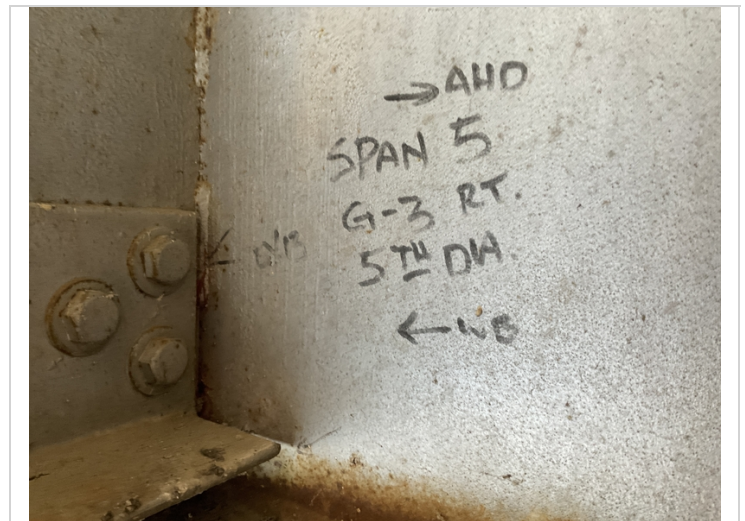
Span 5 girder 3 diaphragm 5 broke welds. Common ahead and back both sides of girder.

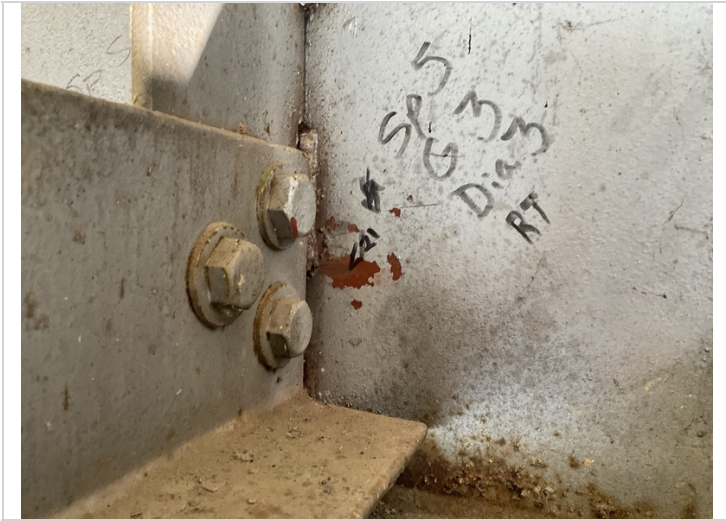
Span 5 girder 3 diaphragm 3 right side ahead. Crack in the web. Common both sides of girder ahead and back.

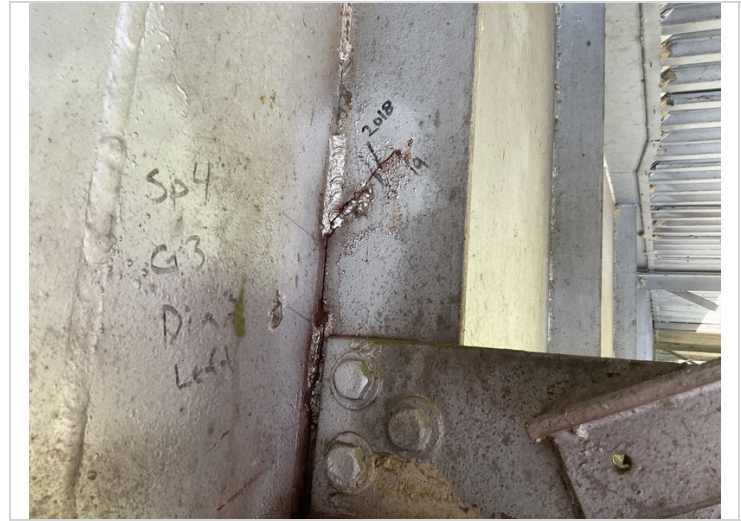
Span 4 girder 3 diaphragm 3 crack in the vertical diaphragm brace.

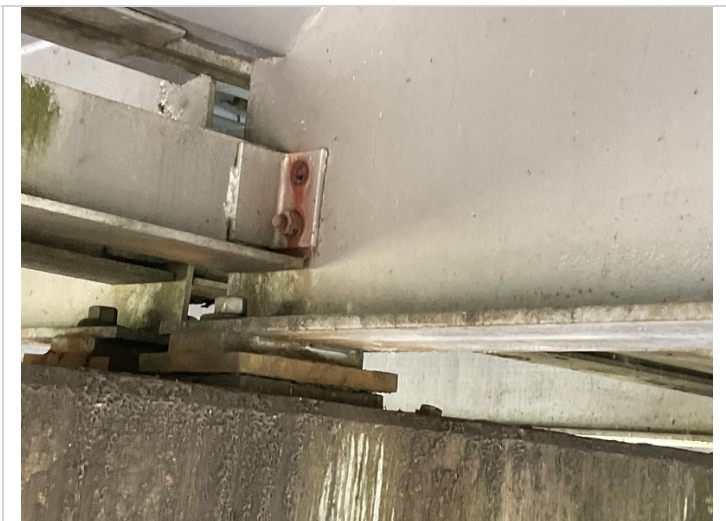
Span 2 beam 3 missing diaphragm bolt.

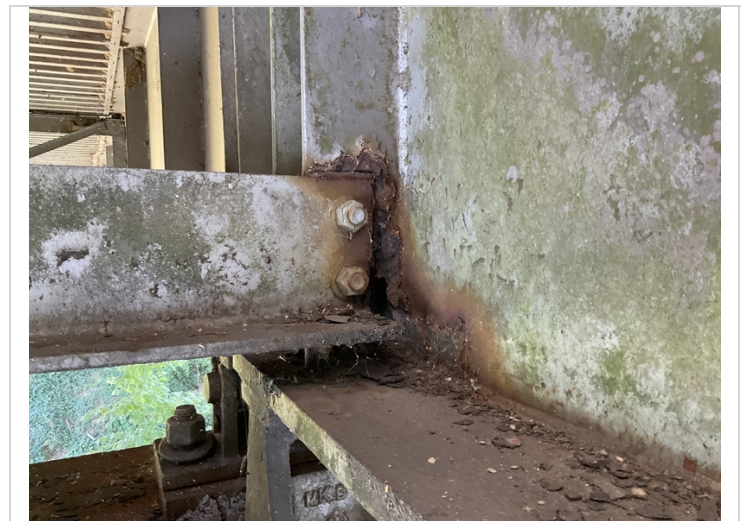
Pier 2 girder 2 span 4, section loss to lower web and hole in stiffener at diaphragm connection.

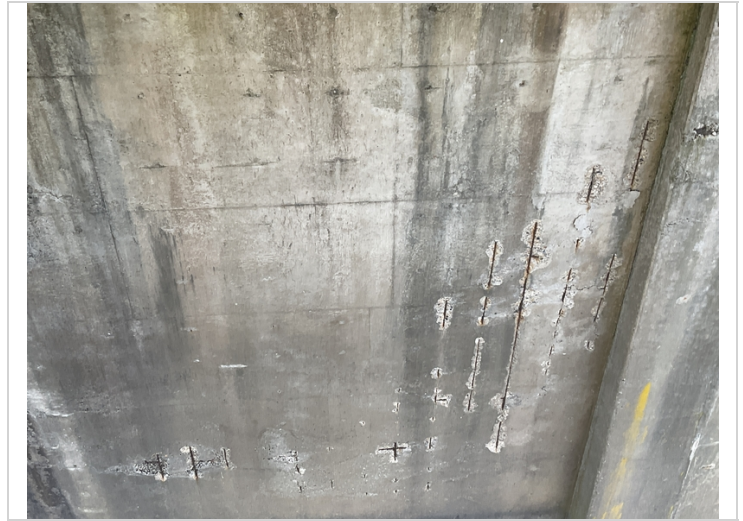
Pier wall 4 back spalls with exposed rebar.

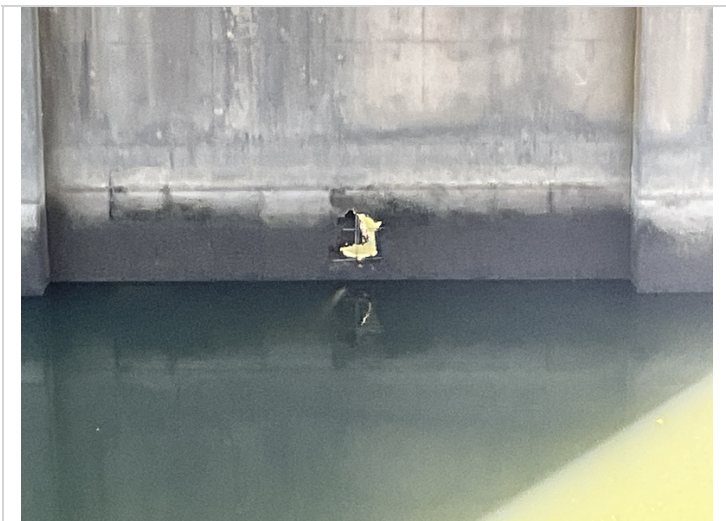
Pier wall 5 severe abrasion.

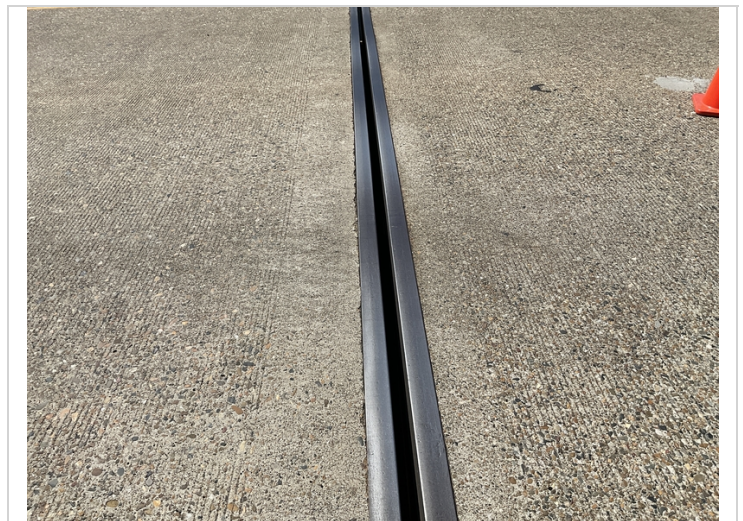
Joint seal missing b ent 4.

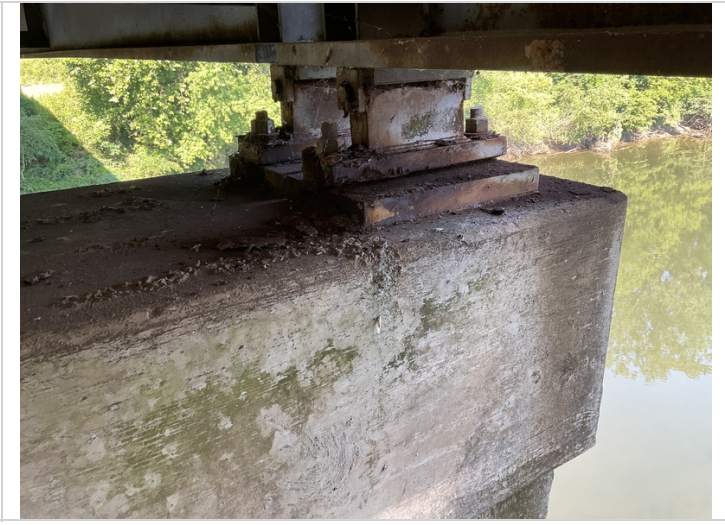
Pier 3 movable bearing under girder 1 corrosion.

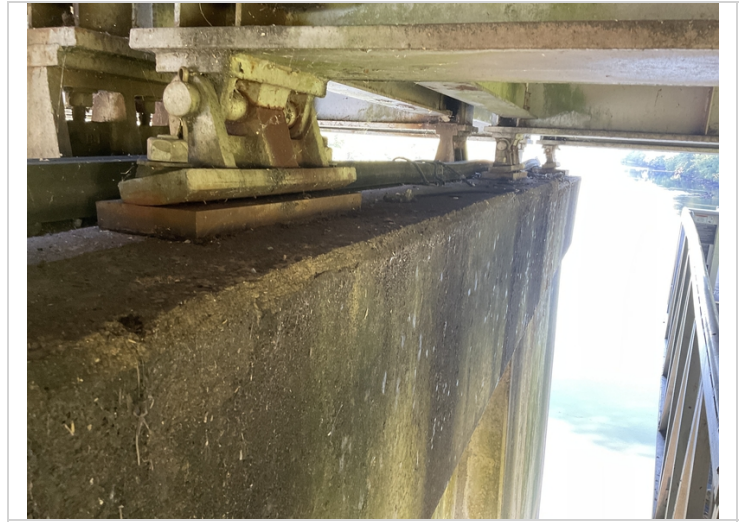
Pier 4 bearing are rotated back.

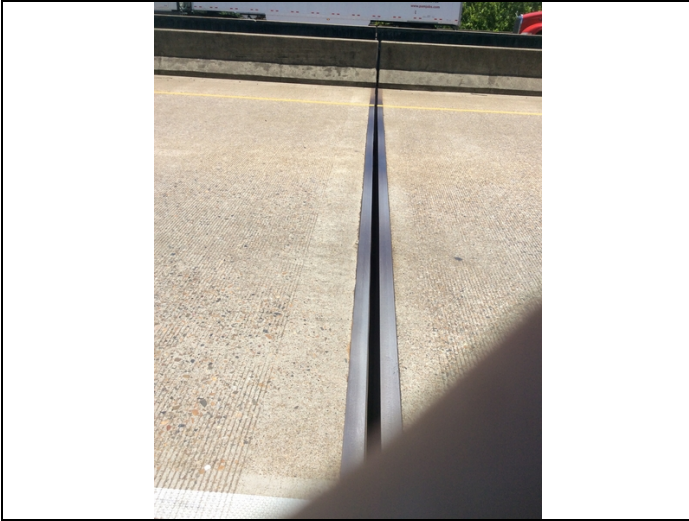
Joint seal have fallen out at pier 1,2,4 & 5

Pier 1, joint seal has fallen through.

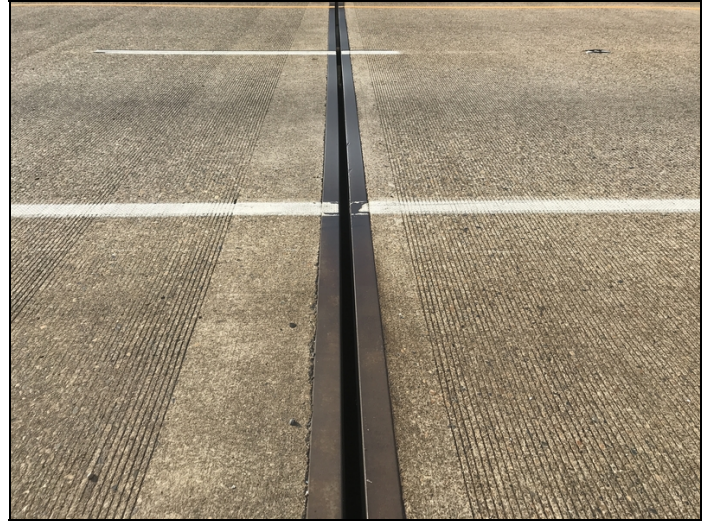
Pier 4, missing joint seal.

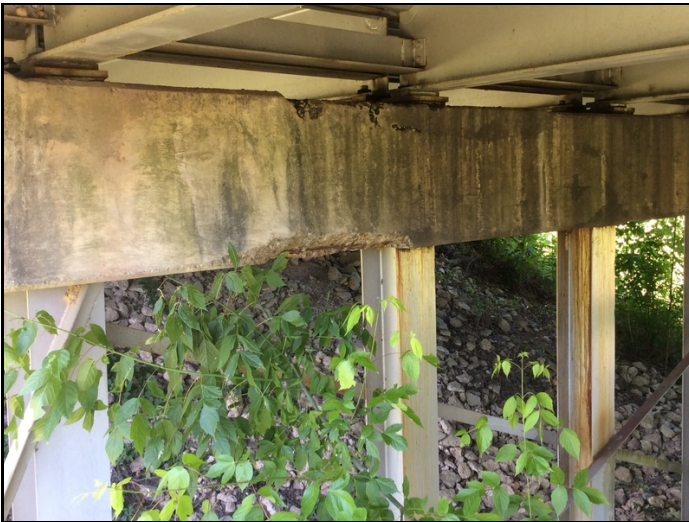
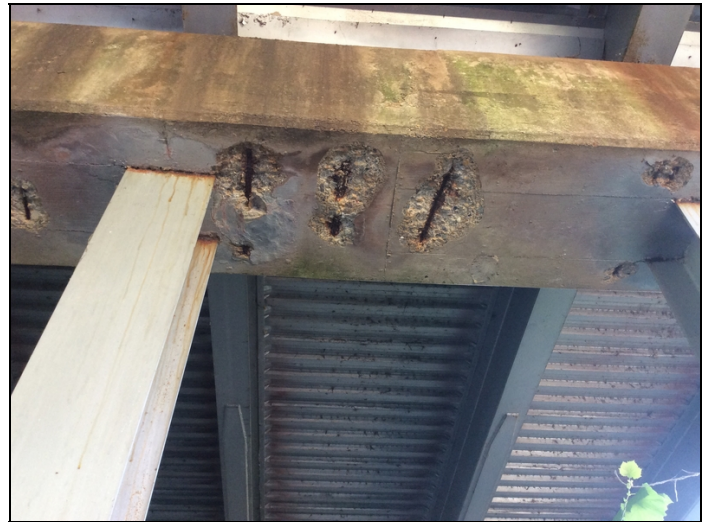
Bent 2 & 3 cap spalls with exposed rebar.
Added 6/26/2018 Cap at bent 2 has been repaired.

Bent 3 between piles 4 and 5 spalls with exposed reinforcing steel.

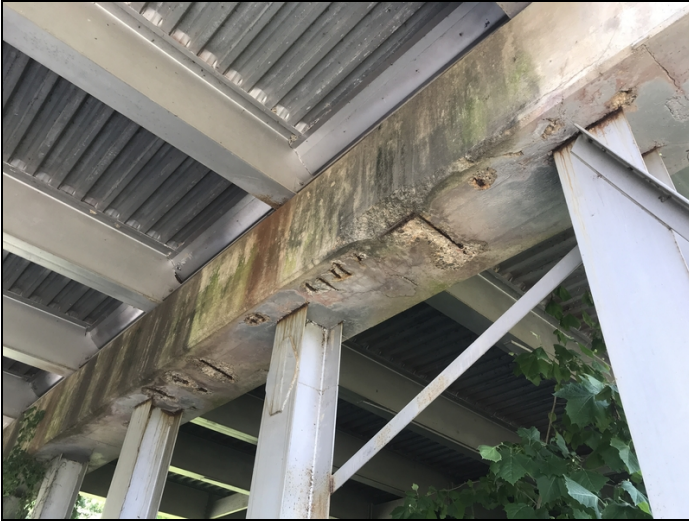
Bent 3, spalls with exposed rebar on the cap.

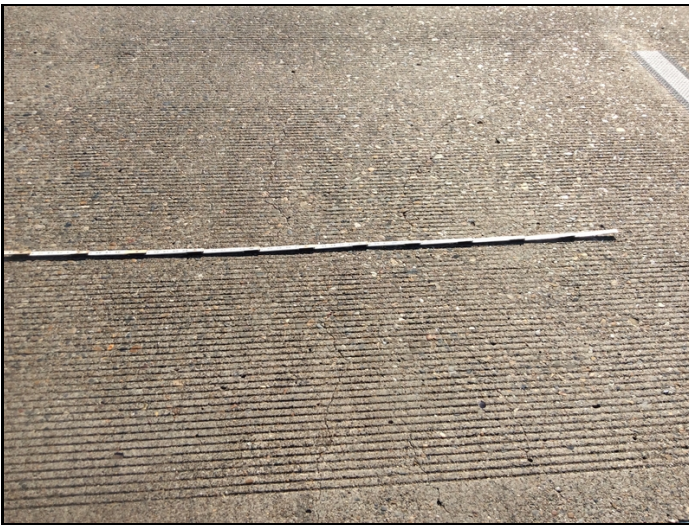
Deck has sealable transverse/longitude cracks in all spans.

Span 3, longitudinal cracks up to .025".

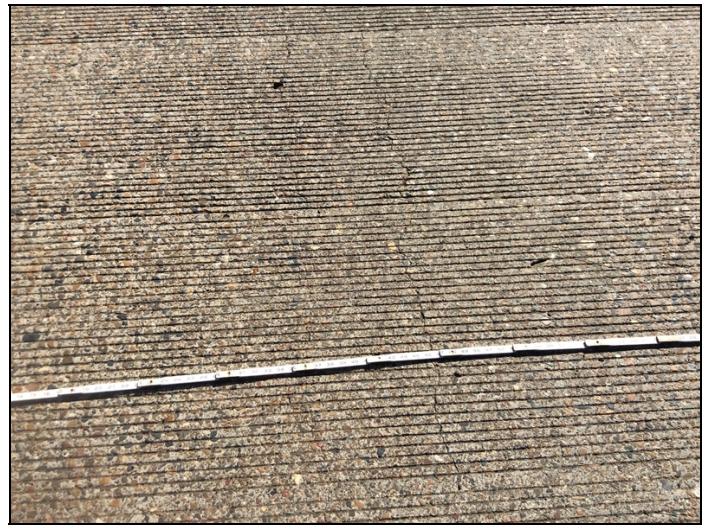
Span 8, longitudinal & transverse cracks up to .020".

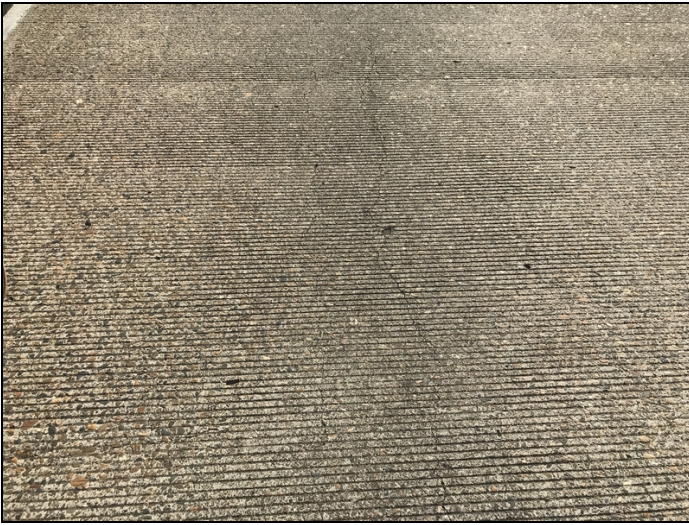
Span 9 longitudinal cracks.

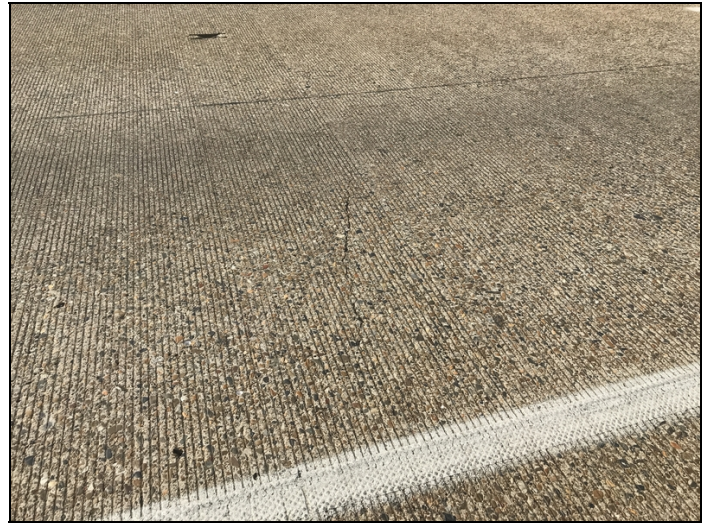
Span 7, large transverse cracks.

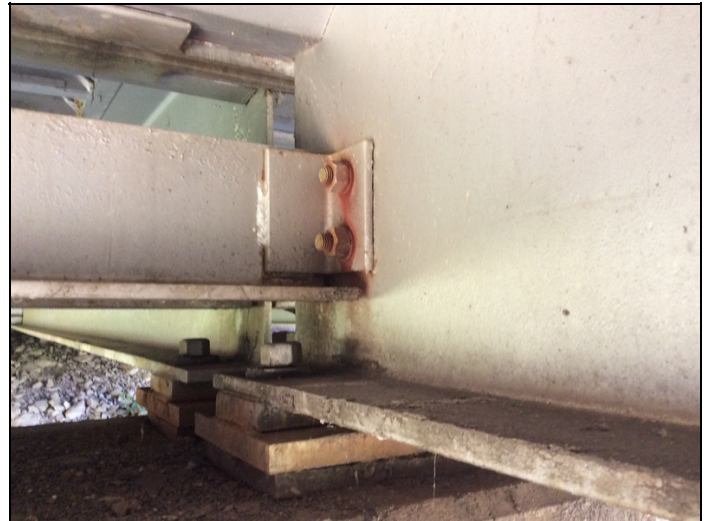
Bent 2 girder 3 ahead side loose bolts in diaphragm connection.

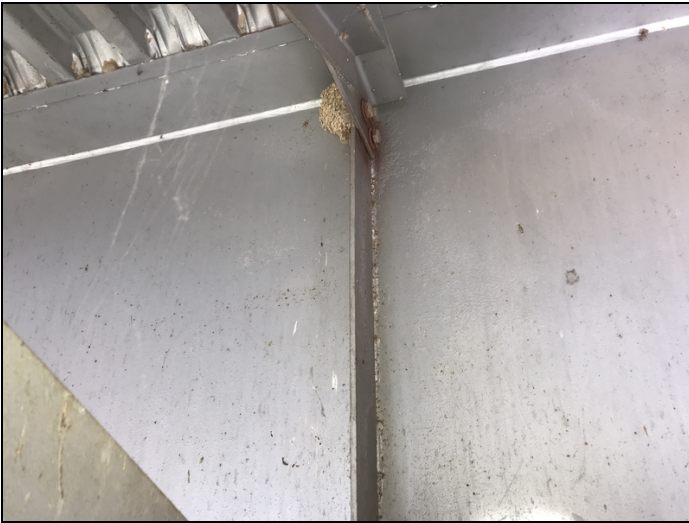
Span 5 g2 dia 4 loose bolts

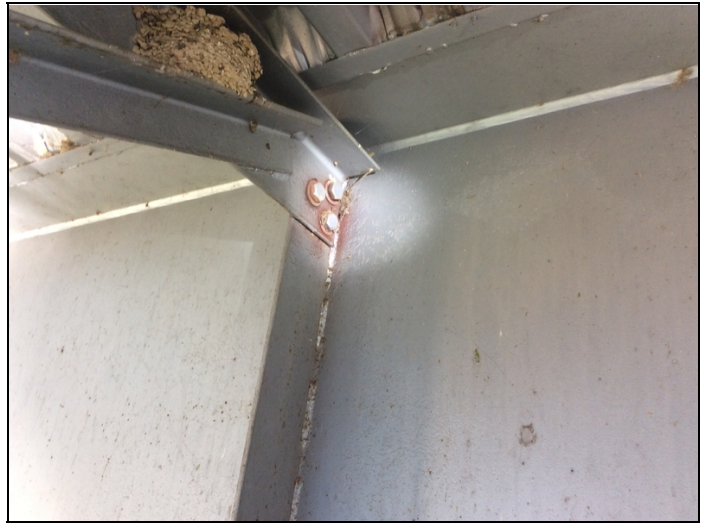
Span 5 girder 2 right, diaphragm 4, bolts are loose at top.

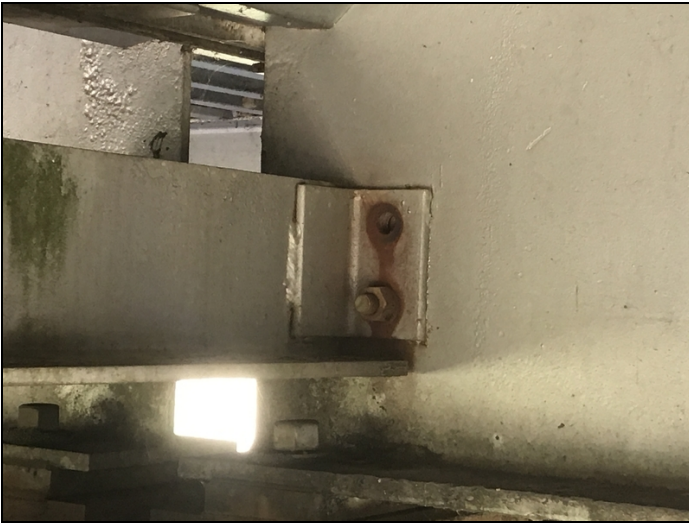
Span 2 girder 3, missing bolt.

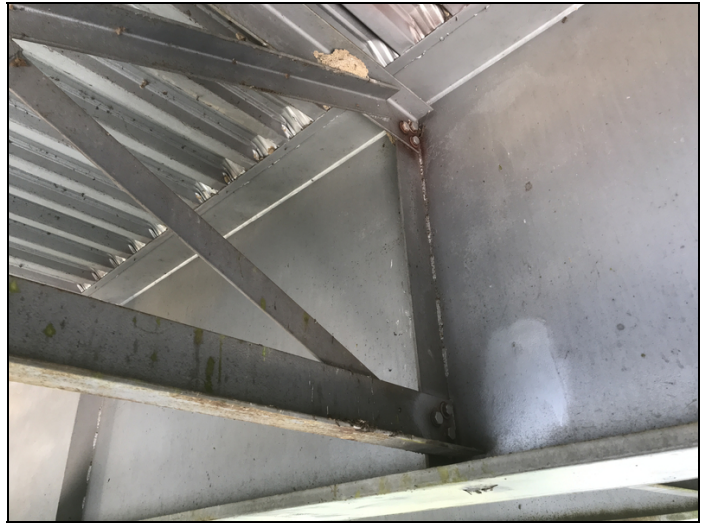
Span 5, loose bolts in top of diaphragm

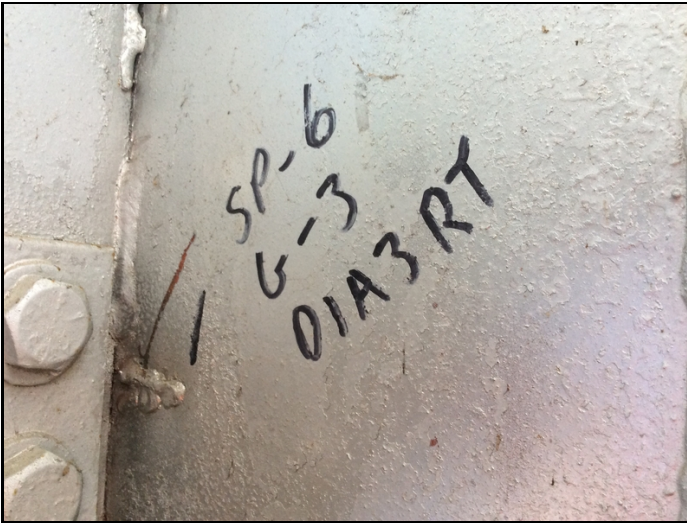
Span 6 girder 3 diaphragm 3 crack in web.

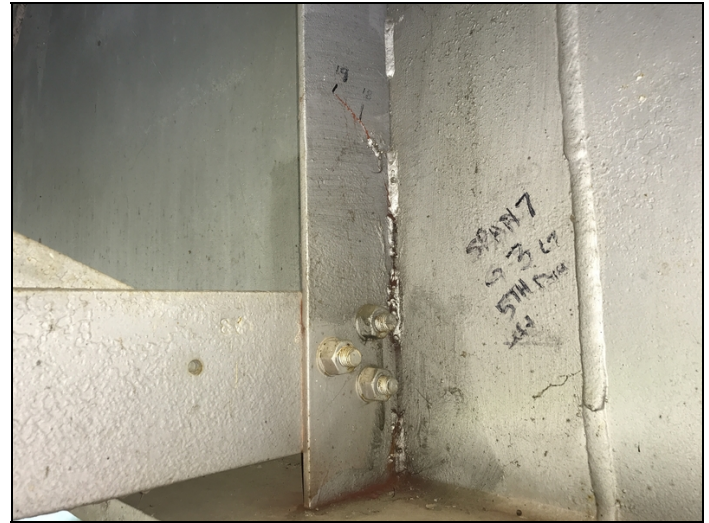
span 7 g3 d5 crack in diaphragm clip/ stiffener has 1 3/4" of growth

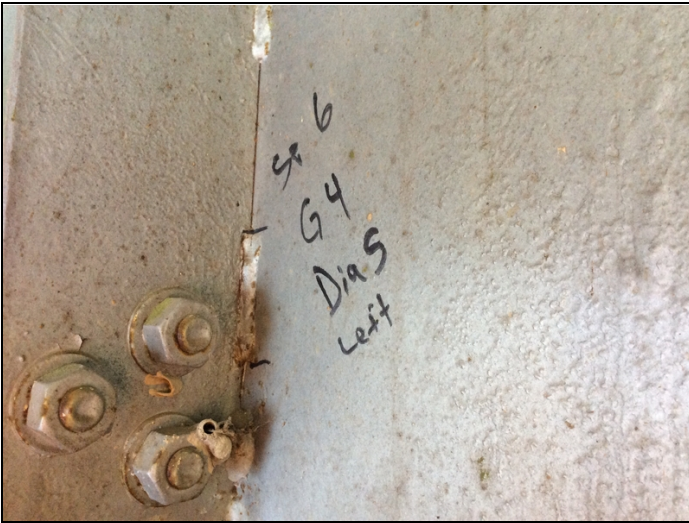
Span 6 girder 4 diaphragm 5 crack in weld.

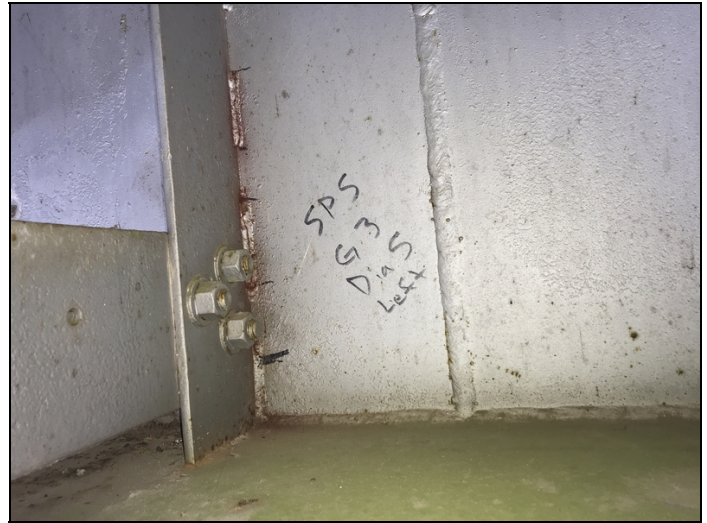
Span 5 g3 d5 has No change

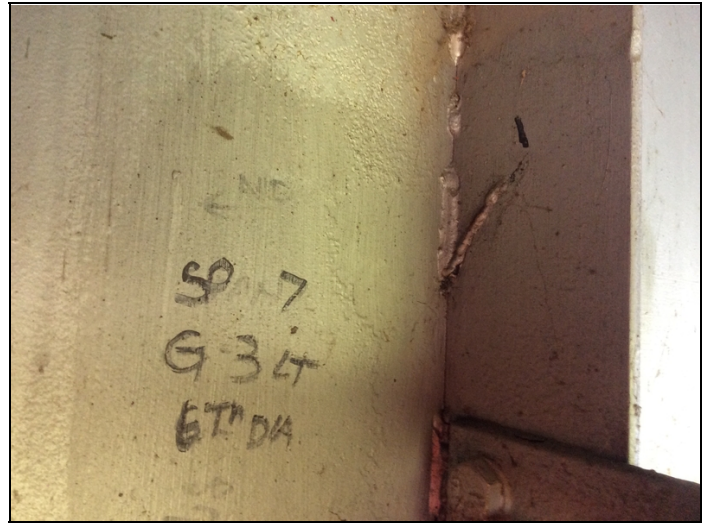
Span 7 girder 3 diaphragm 6, crack in stiffener.

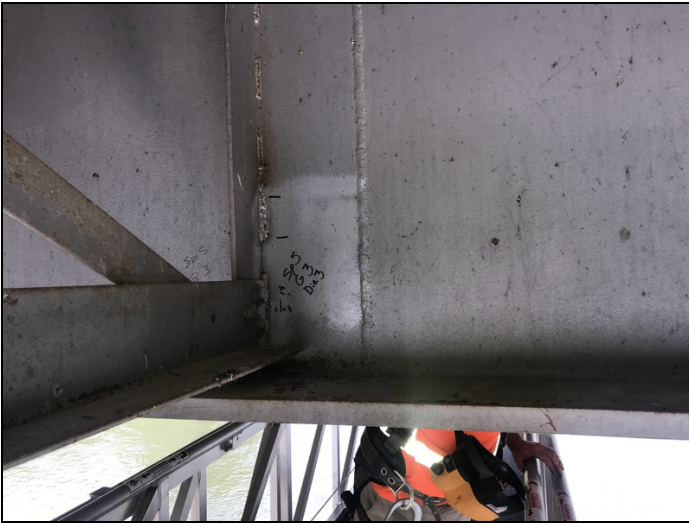
Span 5 g3 d3 has a 1 1/2" Crack in web

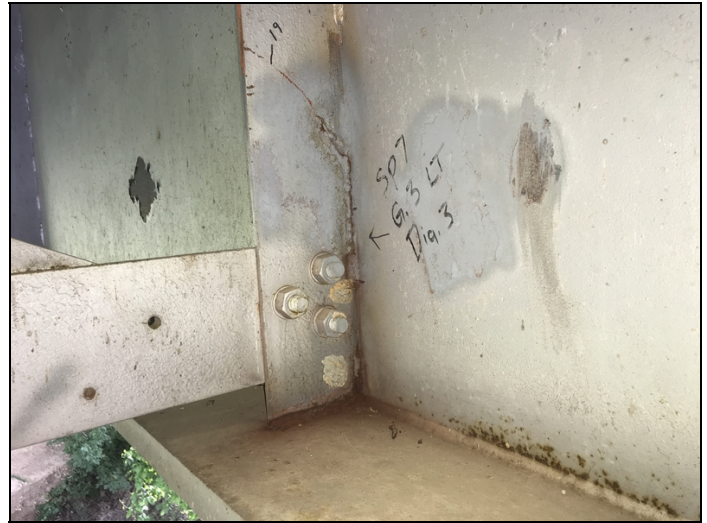
sp7 g3 dia3 repair welds have broken and crack has migrated through diaphragm clip/stiffener

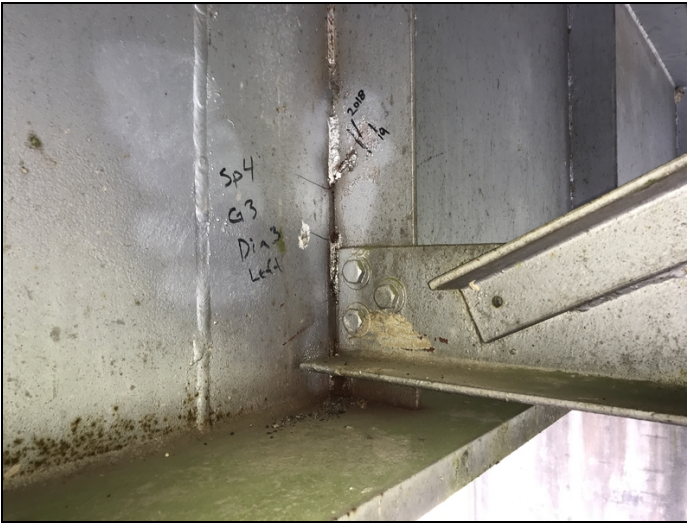
Span 4 g3 dia 3 crack in diaphragm clip/stiffener has
3/4" growth

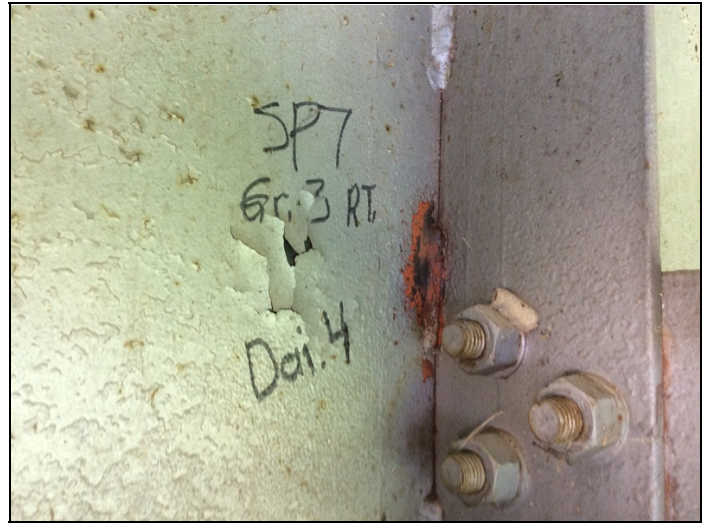
Span 7 girder 3 diaphragm 4 crack in weld.

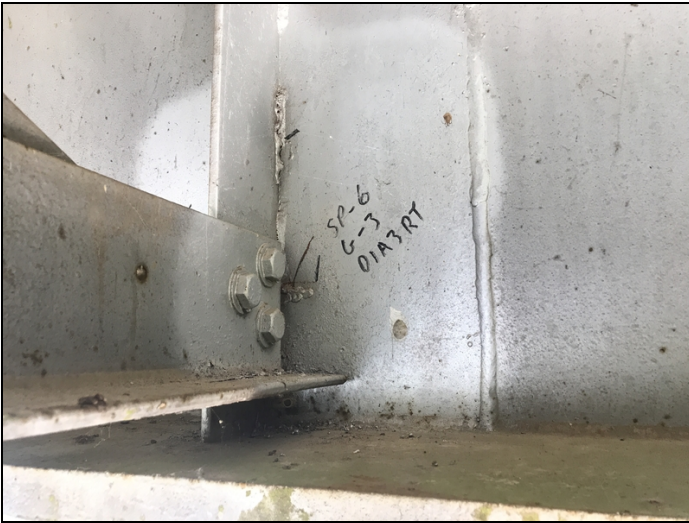
span 6 g3 d3 has No change

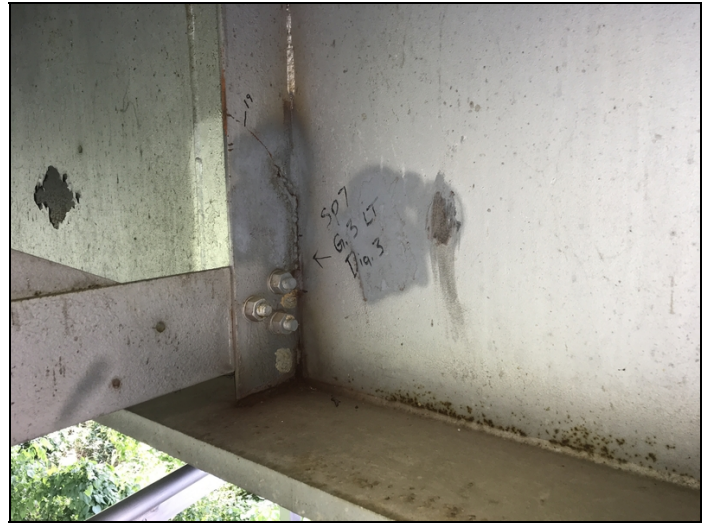
sp7 g3 dia3 repair welds have broken and crack has migrated through diaphragm clip/stiffner

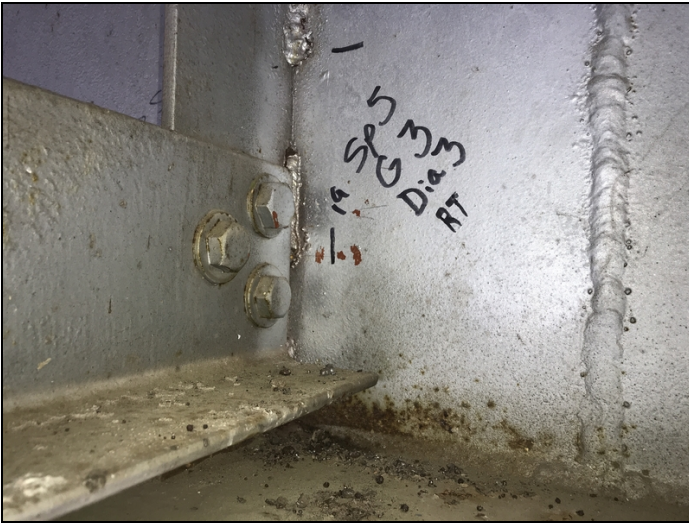
Span 5 g3 d3 has a 1 1/2" Crack in web

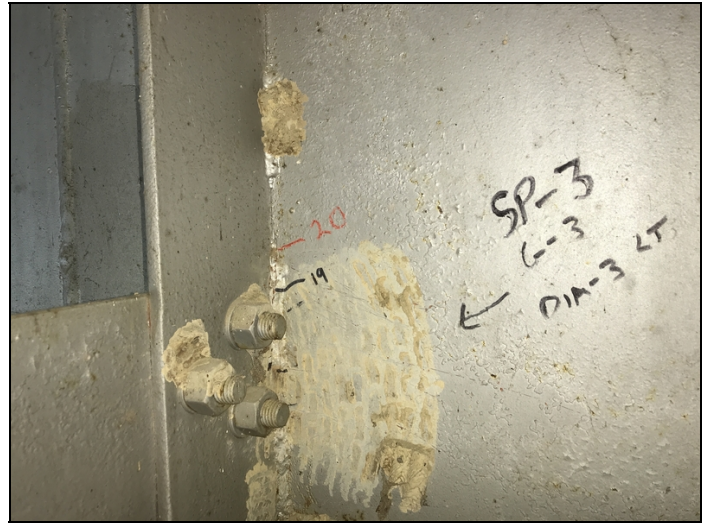
Span 3, girder 3, diaphragm 3, crack in weld has grown.

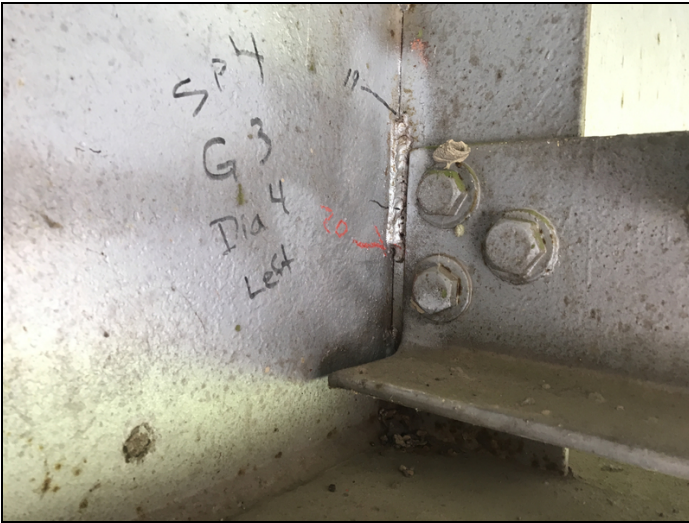
Span 4, girder 3, diaphragm 4, crack in weld has grown.

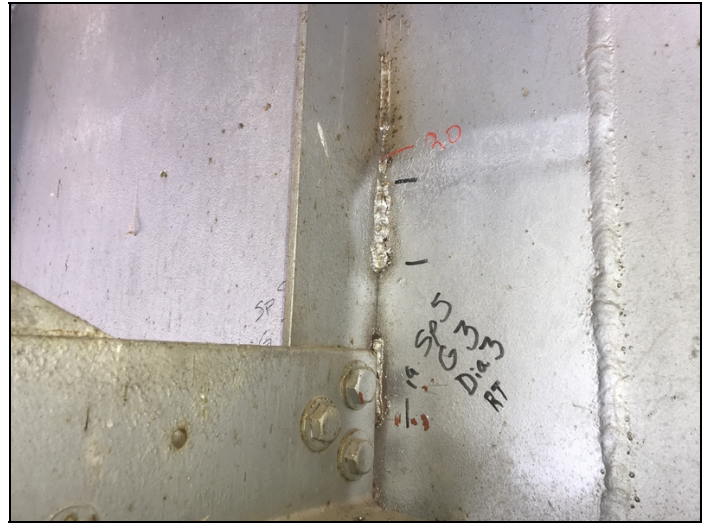
Span 5, girder 3, diaphragm 3, crack in weld has grown.

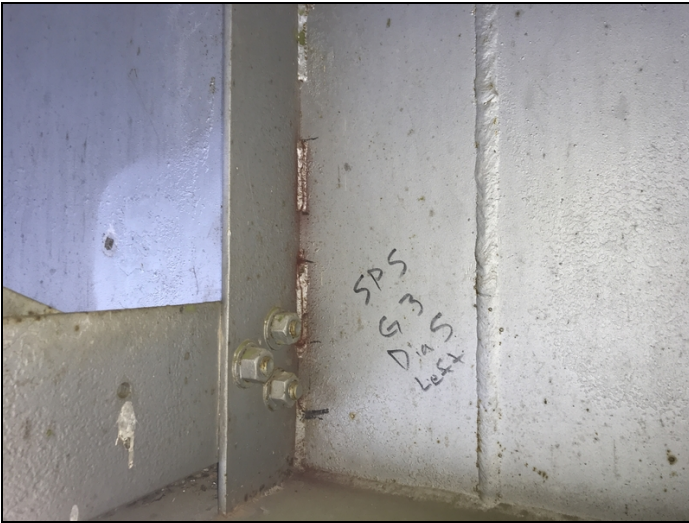
Span 5, girder 3, diaphragm 5, cracks in welds.
