Asset #A3424(Routine)

I-30 WB Log 97.06 over Ouachita Rvr& Riverview

Team Lead: Shane Byrd, Inspection Date: 06/20/2022

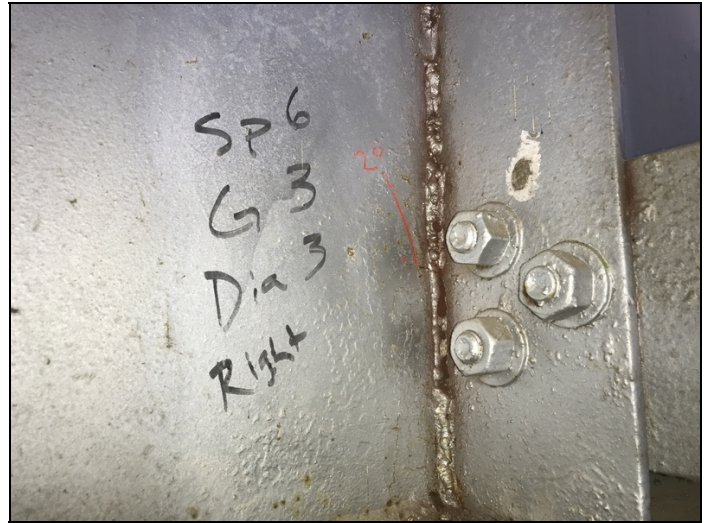
Span 6 girder 3 diaphragm 3, cracks in weld.

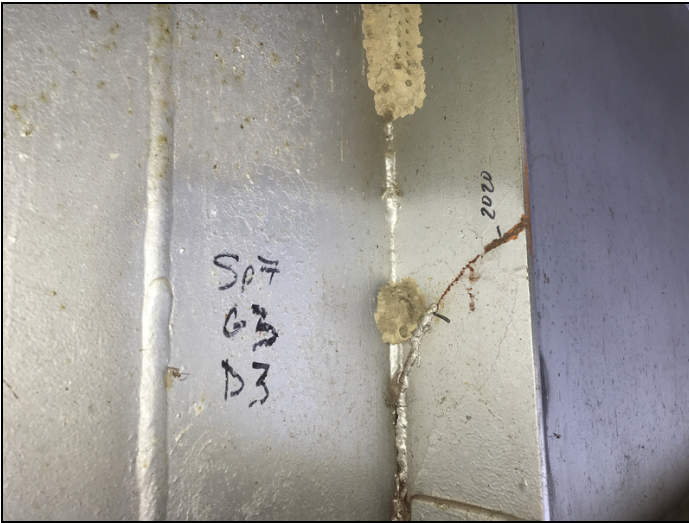
Span 7, girder 3 diaphragm 3, crack in diaphragm stiffener has grown.

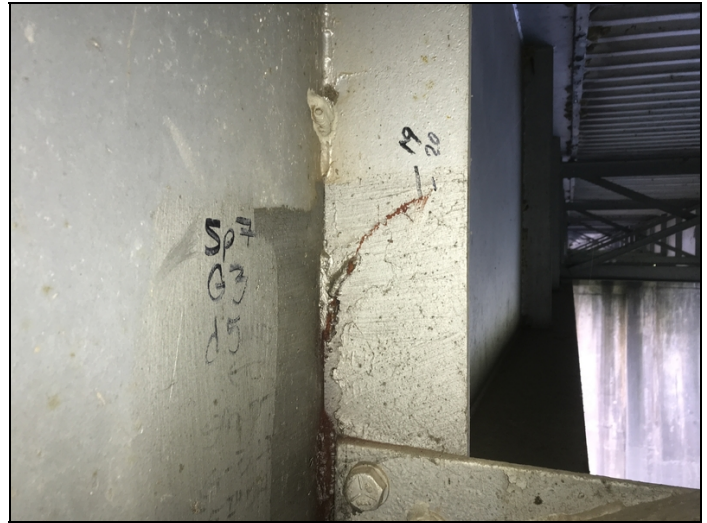
Span 7, girder 3, diaphragm 5, crack in stiffener has grown.

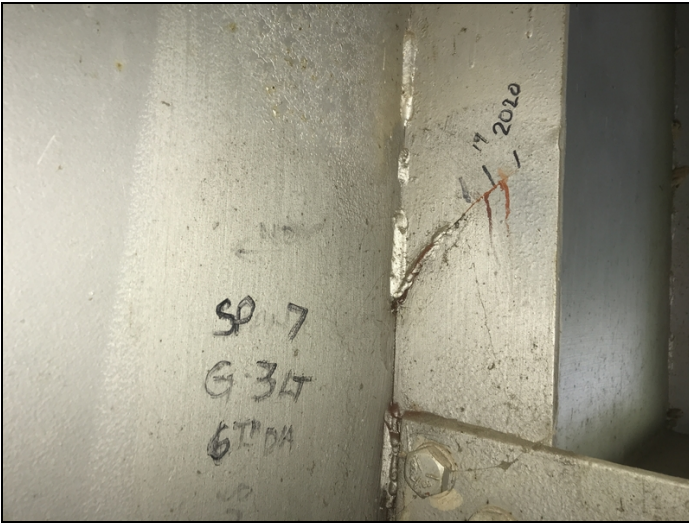
Span 7, girder 3, diaphragm 6, crack in stiffener has grown.

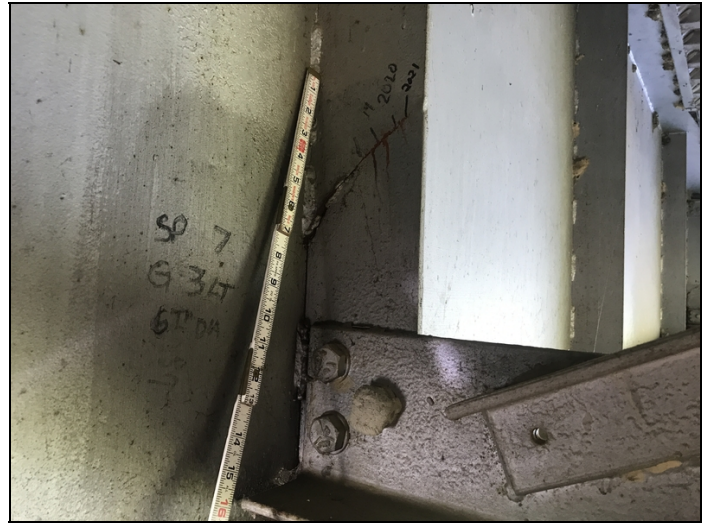
Span 7 girder 3 left side at diaphragm 6 cracked welds and crack in the vertical diaphragm stiffener. Crack has propagated a half inch since last inspection

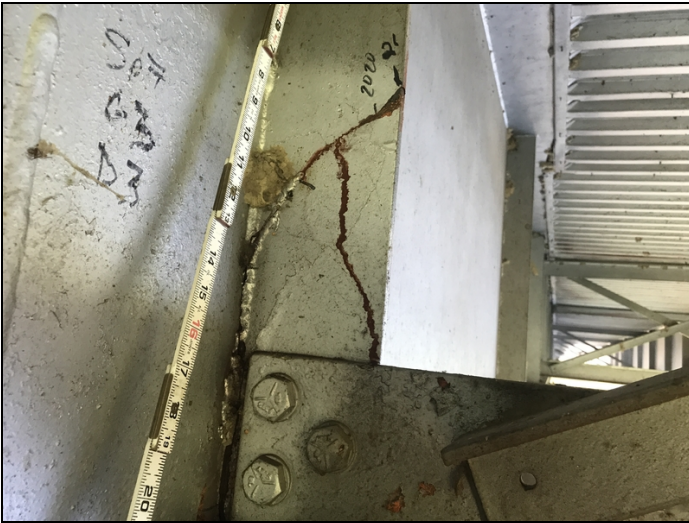
Span 7 girder 3 left side at diaphragm 3 cracked welds and crack in the vertical diaphragm stiffener. Crack has propagated a one and quarter inch since last inspection. Crack has propagated all the way thru vertical diaphragm stiffener.

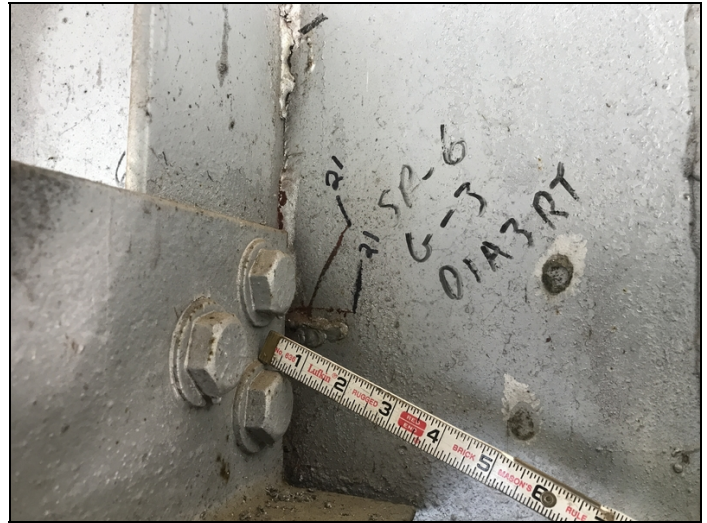
Span 6 girder 3 right side at diaphragm 3 ahead crack in the web.

Two cracks in the web

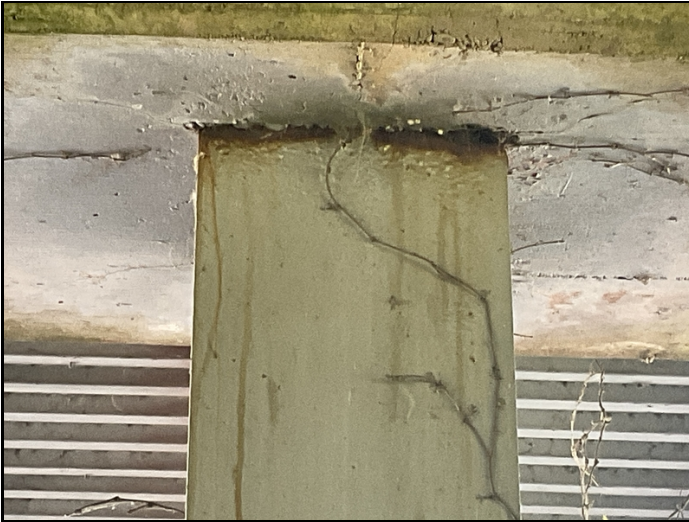
Bent 3 steel pile have active corrosion with moderate pitting below cap

Bent 3 steel pile 3 deep pitting to flange at cap.

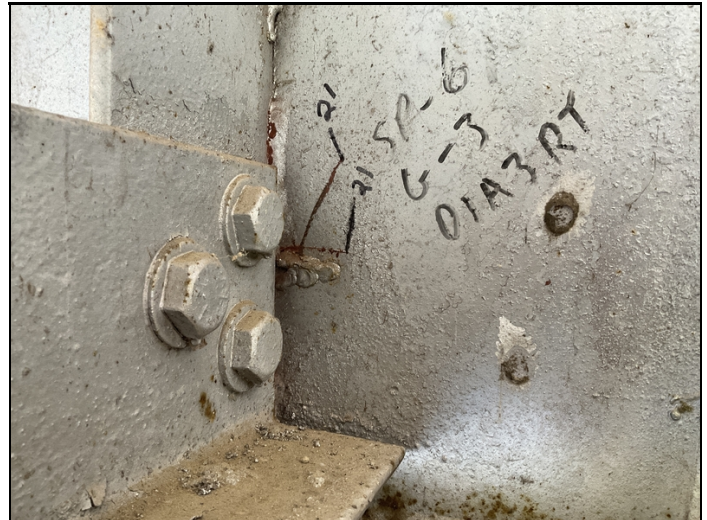
Span 5 Girder 3 diaphragm 3, Span 6 Girder 3 diaphragm 3, Span 7 girder 3 diaphragm 3, Span 7 Girder 3 diaphragm 4. Cracks in the web that have propagated from diaphragm welds. See Photos.

Span 6 girder 3 diaphragm 3 right side ahead cracks in the web.

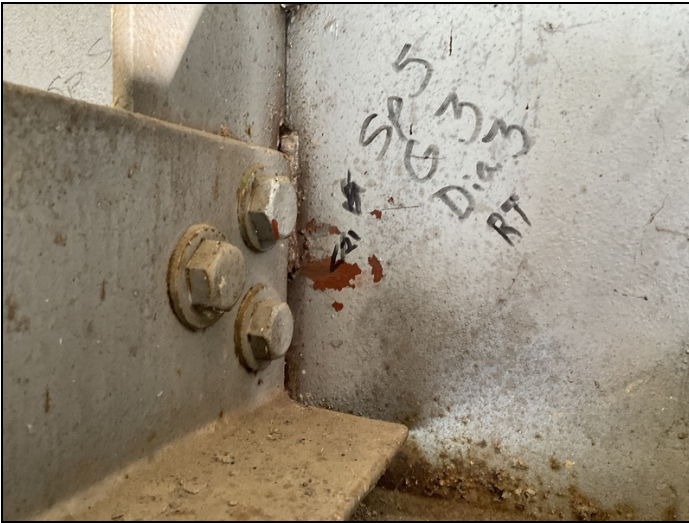
Span 5 girder 3 diaphragm 3 right side ahead. Crack in the web. Common both sides of girder ahead and back.
