Asset #B3424(Routine)

I-30 EB Log 97.06 over Ouachita Rvr; Riverview

Location: 1 MI S OF JCT 270

Team Lead: Shane Byrd, Inspection Date: 06/20/2022

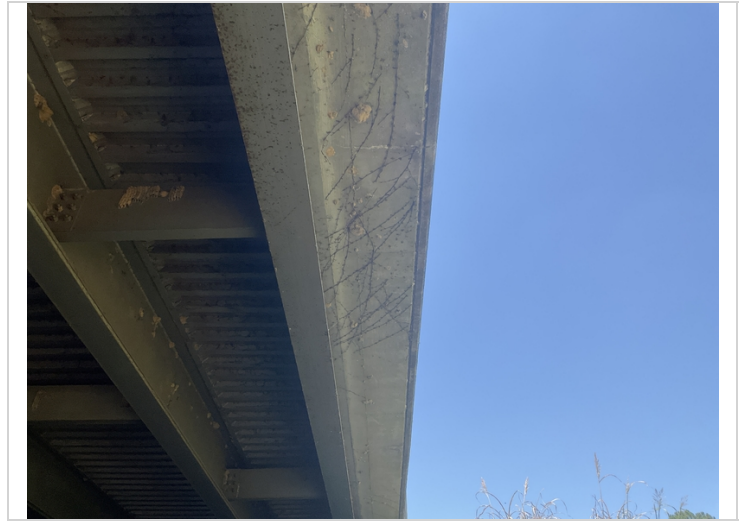
Cracks with efflorescence in the left soffit overhang common right side.

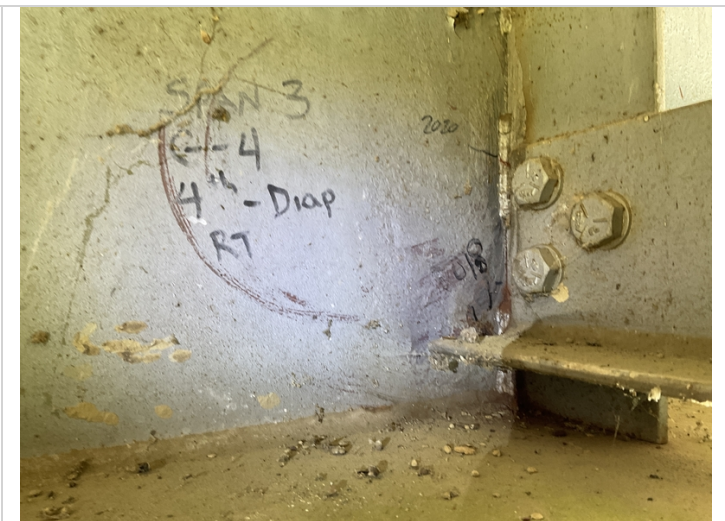
Span 3 girder 4 diaphragm 4 right side back has broke welds crack has propagated into the web.

Added 6/27/2018: Span 3 girder 4 diaphragm 4, crack in web at bottom diaphragm weld. .  
Span 4 girder 4 diaphragm 4 crack in weld.Span 3 girder 3 right side at diaphragm 4 right side one crack. in the girder web and cracks in the diaphragm welds.  
Span 7 girder 3 diaphragm 4 crack in weld.

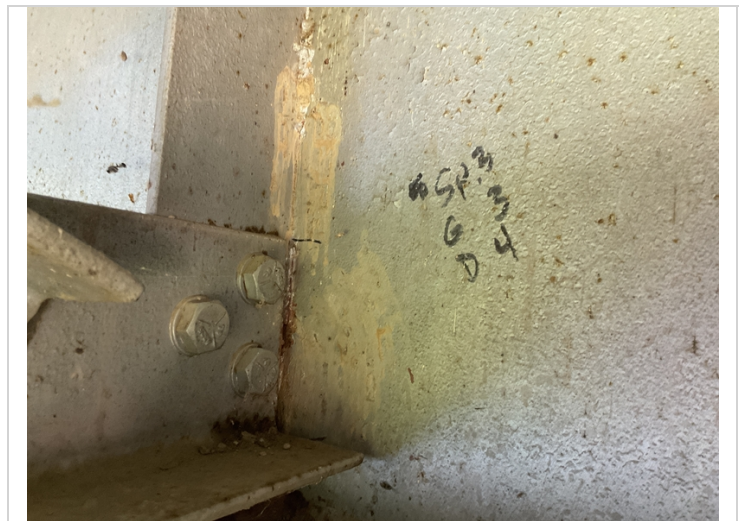
Span 3 girder 3 diaphragm 4 left side back has broke weld.

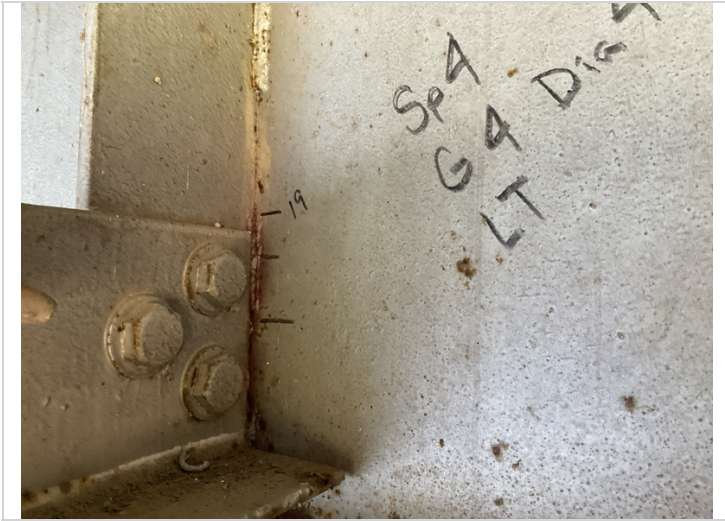
Span 4 girder 4 diaphragm 4 left side back broke welds.  
Common on right side.

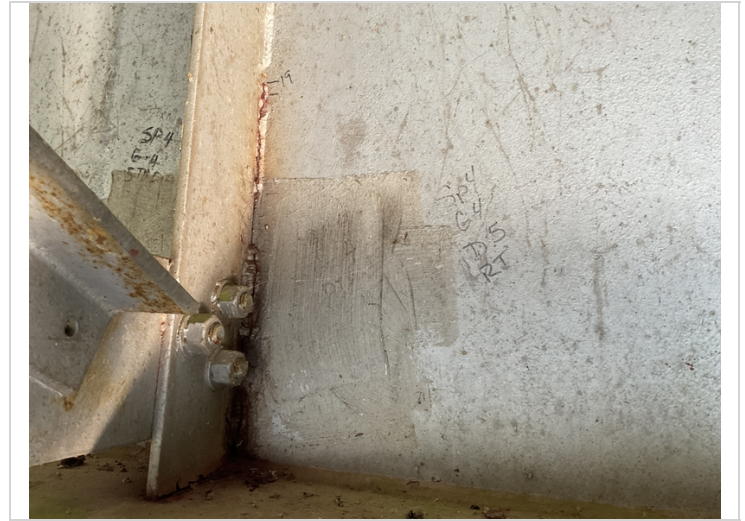
Span 4 girder 4 diaphragm 5 right side broke welds on  
diaphragm

Crack in the welds of diaphragm bracket at Span 4 girder 4 diaphragm 5.  
Span 6 girder 4 left side at diaphragm 6 ahead.  
Span 7 girder 4 left side at diaphragm 4 and 5.

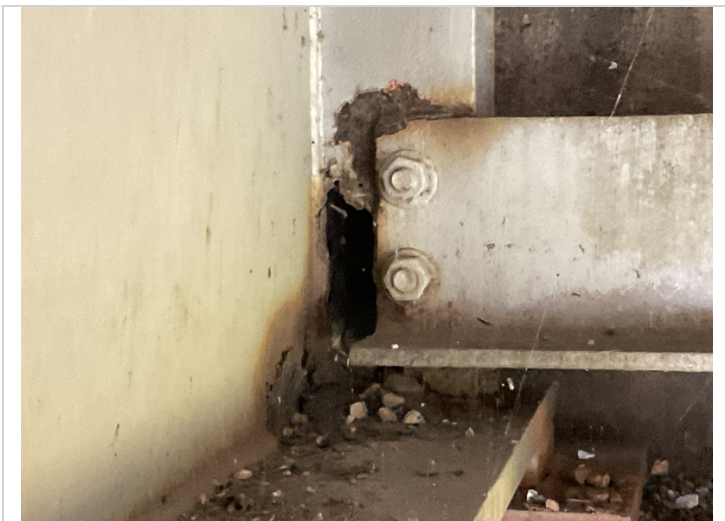
Span 3 girder 4 left side pier 1 girder left side hole in the  
vertical diaphragm brace and pitting in the lower web.

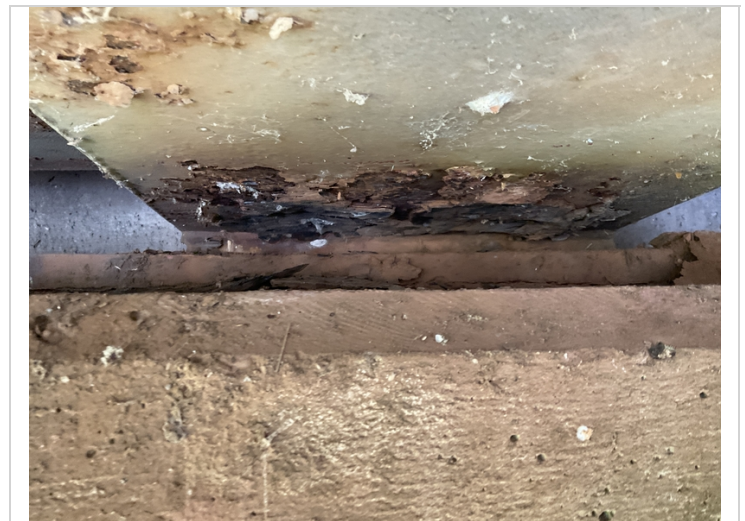
Span 3 girder 4 at pier 1 active corrosion with deep pitting to  
bottom flange.

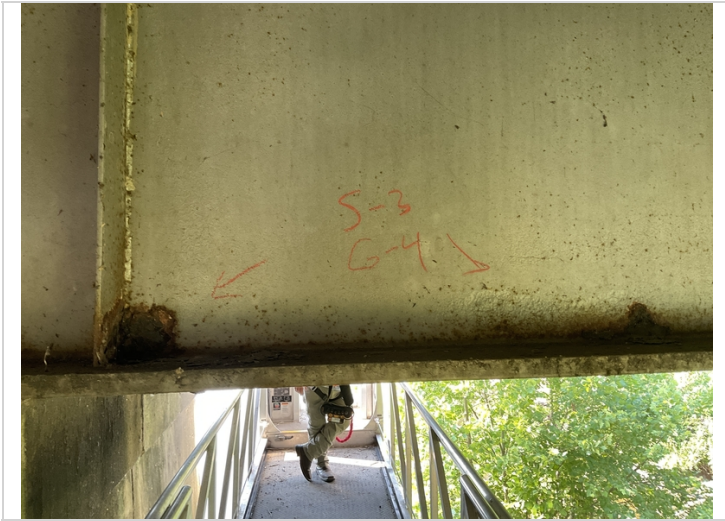
Span 3 girder 4 active corrosion with moderate pitting to lower web.

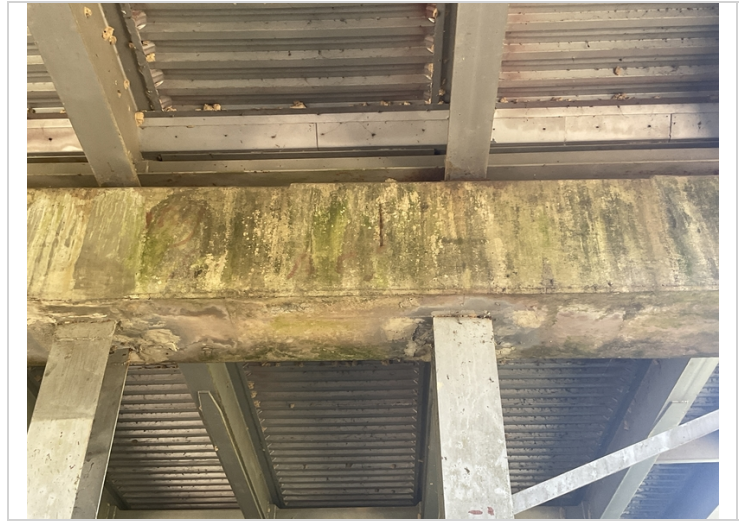
(234) Bent 2 cap ahead spall with exposed rebar.							
Caps have areas of vertical cracks and spalls.

Bent 2 cap ahead spall with exposed rebar above pile 3.

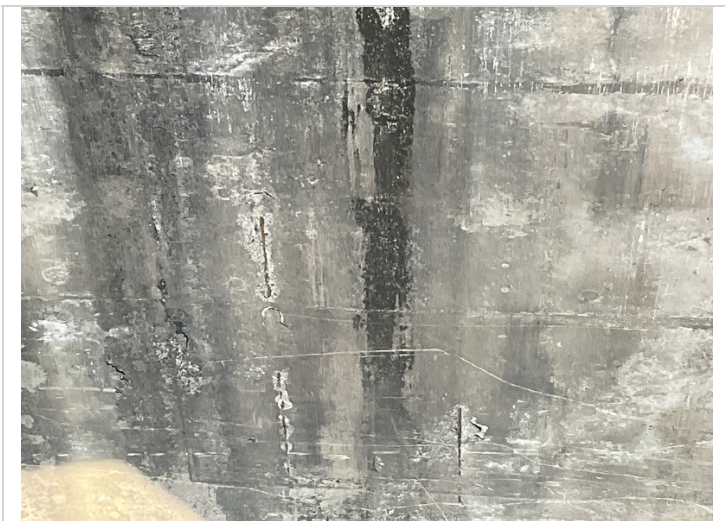
Pier wall 2 ahead spall with exposed rebar.

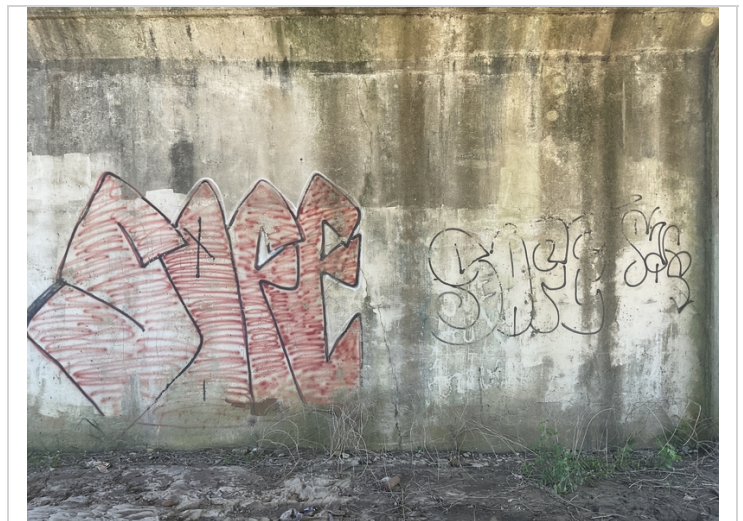
Bent 3 vertical crack in pier wall.

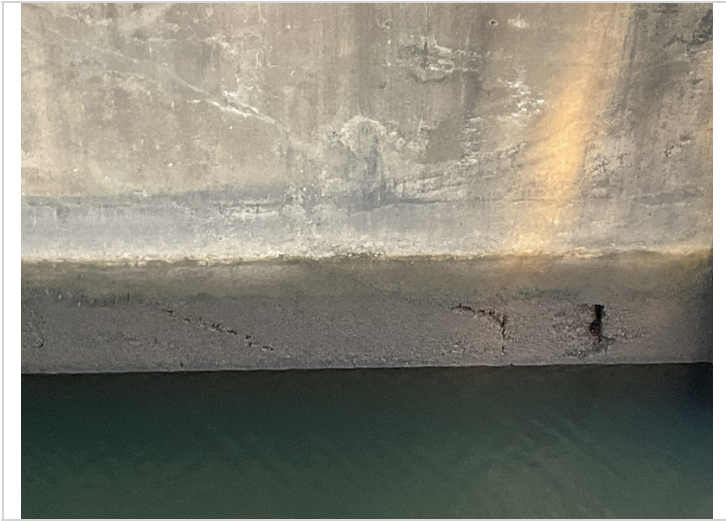
Pier wall 3 back severe abrasion.

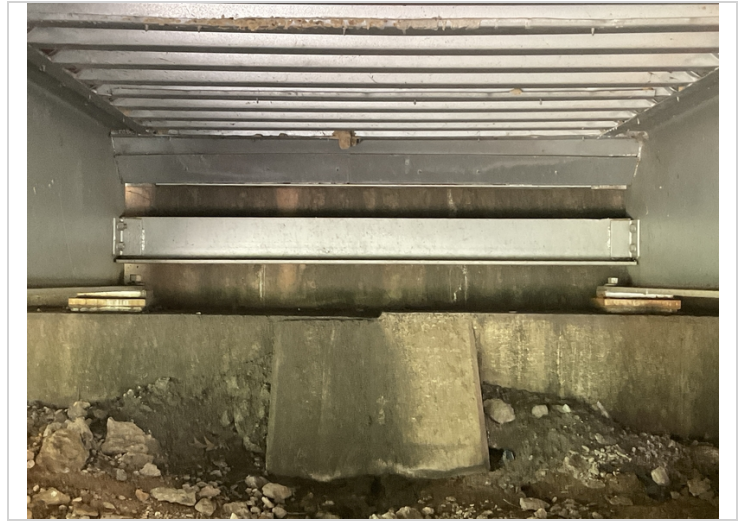
(215) Both abutments have cracks with efflorescence in the back wall.							
220	Reinforced Concrete Pile Cap/Footing	LF	98	0	98	0	0
6000	Scour	LF	98	0	98	0	0
(6000-220) See UW Inspection Report							
225	Steel Pile	EA	14	4	5	5	0
1000	Corrosion	EA	10	0	5	5	0

Bent 1 cracks with efflorescence in the back wall.

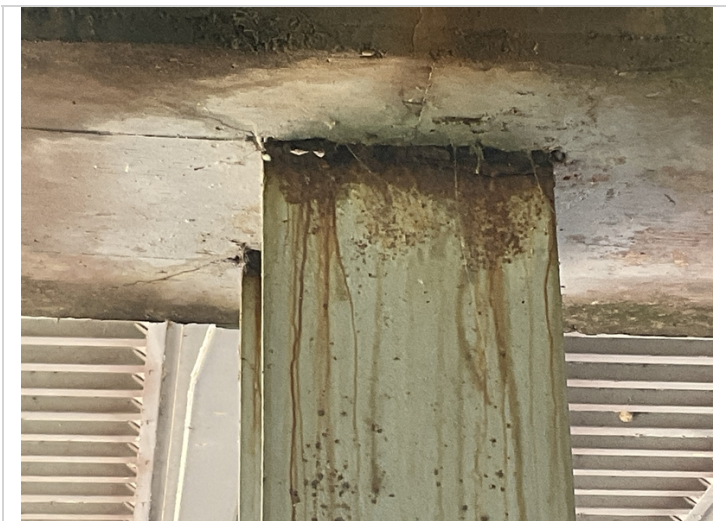
(225) Piling at bent 3 have corrosion at the bottom of the cap. Bent 3 pile 5 has section loss at the top of the pile.							
234	Reinforced Concrete Pier Cap	LF	324	312	6	6	0
1010	Cracking	LF	3	0	3	0	0
1080	Delamination/Spall/Patched Area	LF	3	0	3	0	0
1090	Exposed Rebar	LF	6	0	0	6	0

Bent 3 steel pile 5 has deep pitting and small holes in the flange at cap.

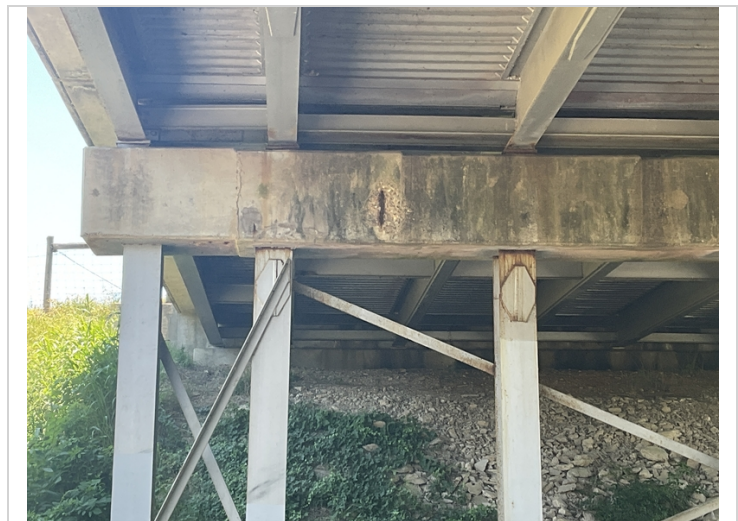
Bent 3 spall with exposed rebar on pier cap back between columns 2 and 3.

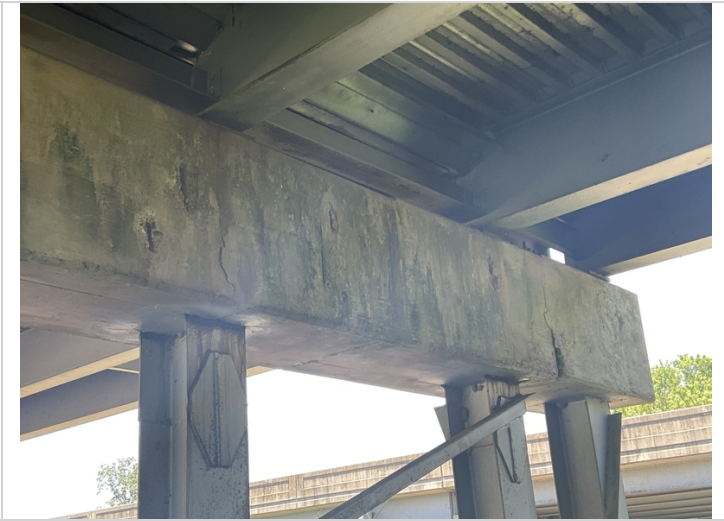
Bent 3 cap ahead spalls with exposed rebar.

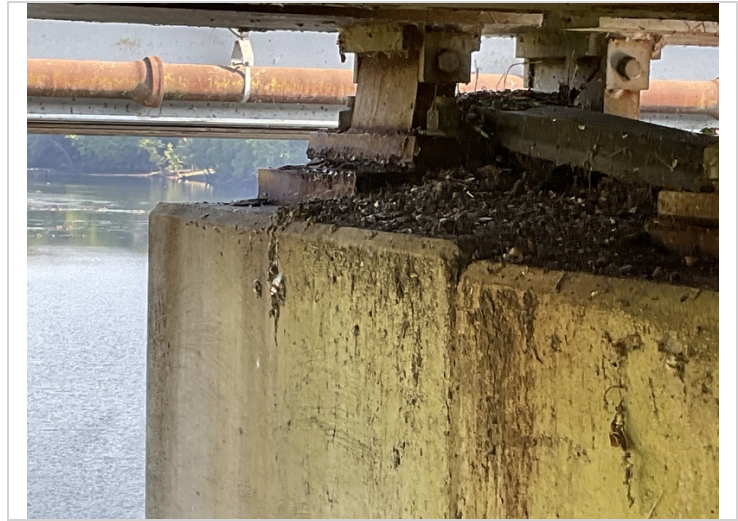
Pier 2 span 3 bearing 1 corrosion.

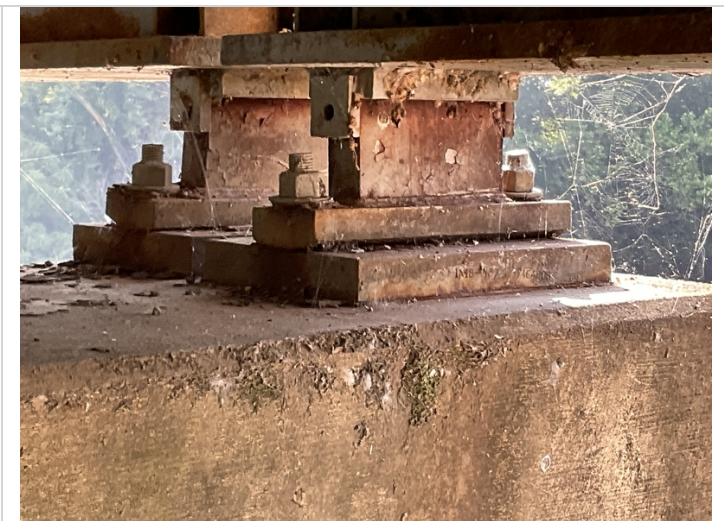
Pier 3 span 4 bearing 6 missing top bolt.

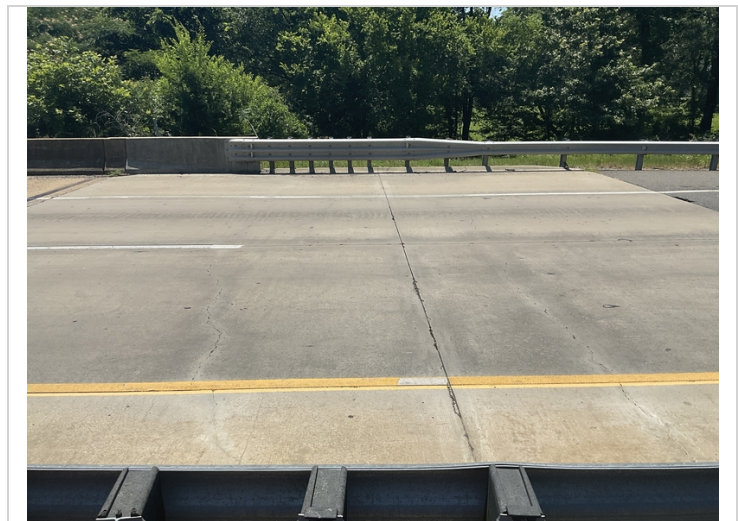
Transverse cracks in west approach slab.

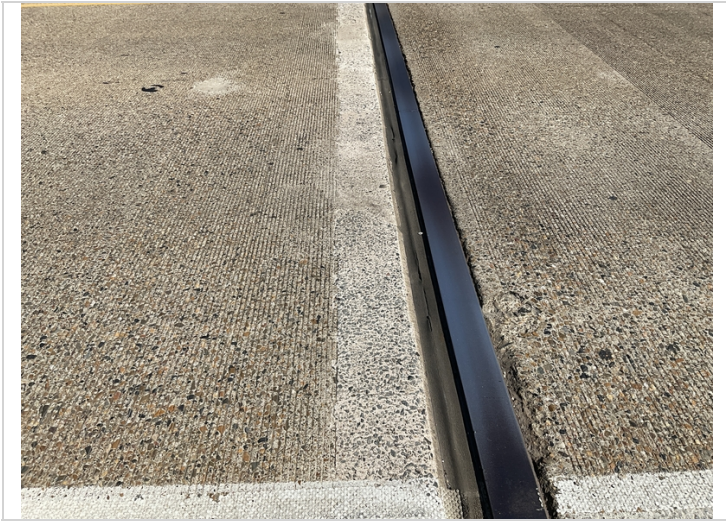
Deck at joint of pier 3 patched area.

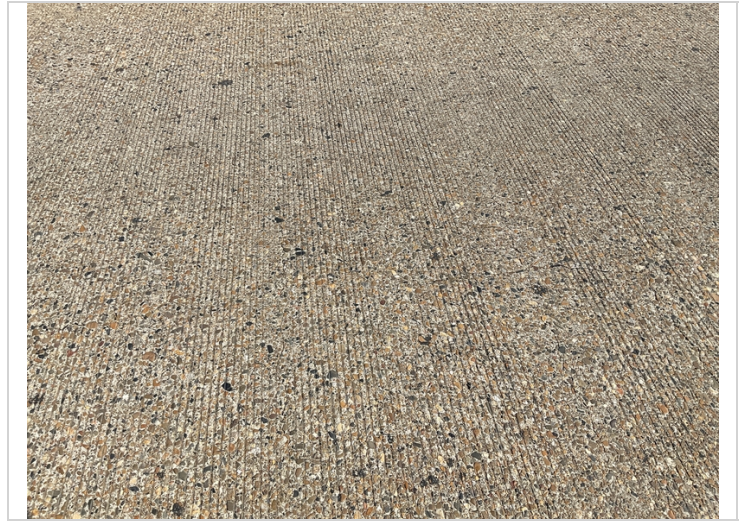
Deck span 7 transverse and longitudinal cracks.

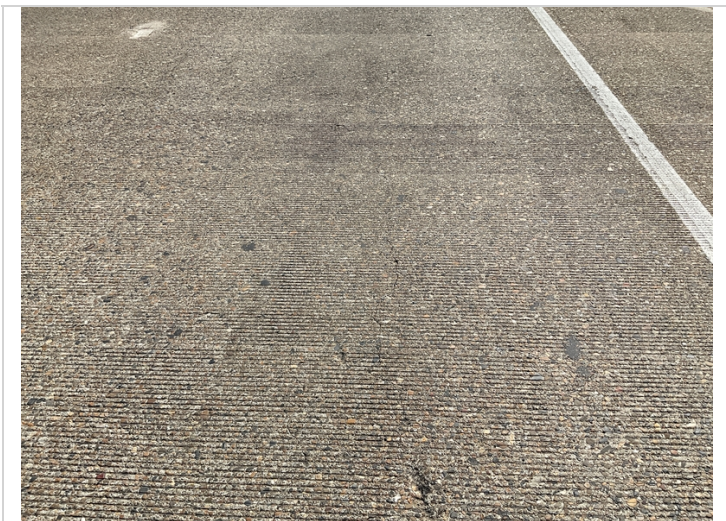
Deck span 2 transverse and longitudinal cracks.

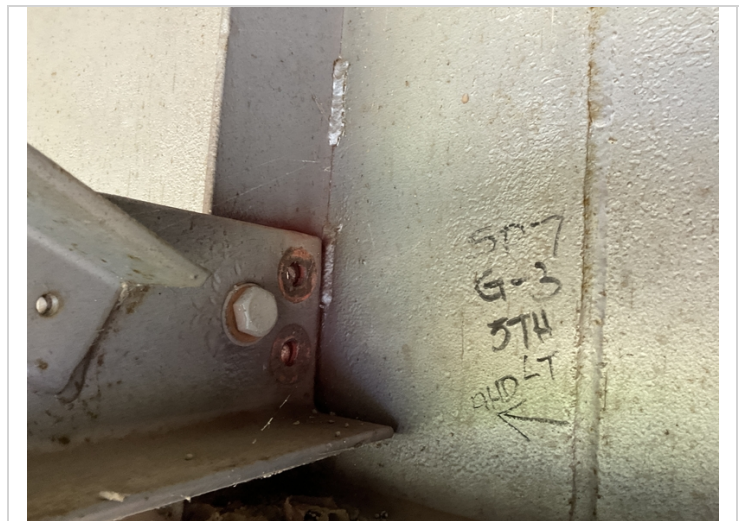
Span 7 girder 3 diaphragm 5 left side missing bolts.

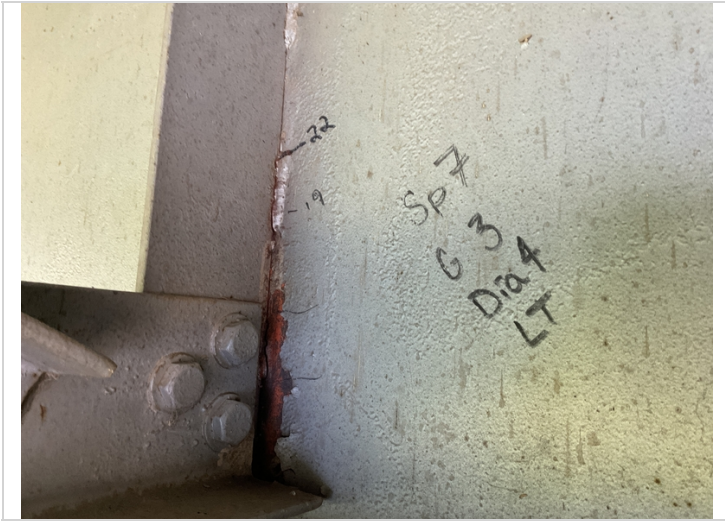
Span 7 girder 3 diaphragm 4 left side back broke welds.

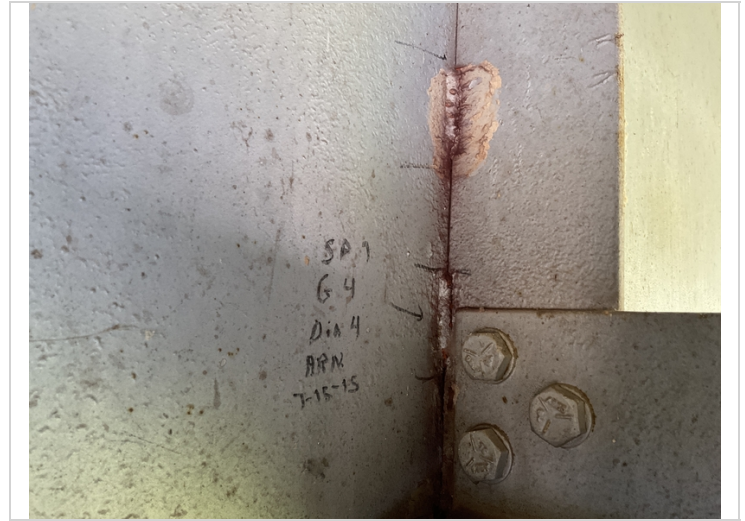
Span 7 girder 4 diaphragm 4 right side back broke welds.  
Common ahead this location.

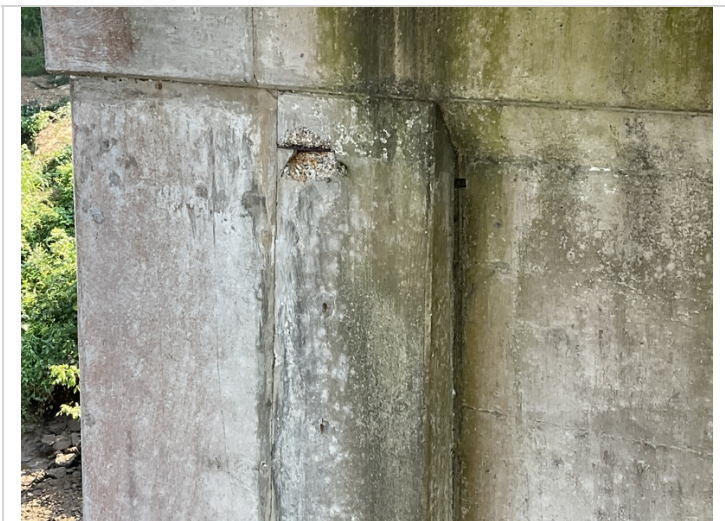
Pier 5 column 1 back spall with exposed rebar.

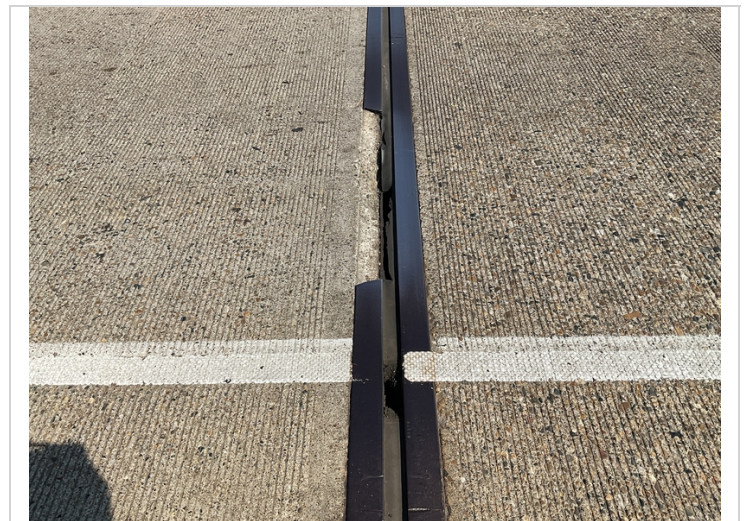
(301) Pier 3 has a spall adjacent to the header. Pier 4 has a 1" hole in joint seal at the white line and 4' of joint armor missing. Pier 5 has 1' hole at yellow line & 3' missing at right end.							
302	Compression Joint Seal	LF	301	246	0	0	55
2310	Leakage	LF	55	0	0	0	55

Pier 4 joint armor missing.

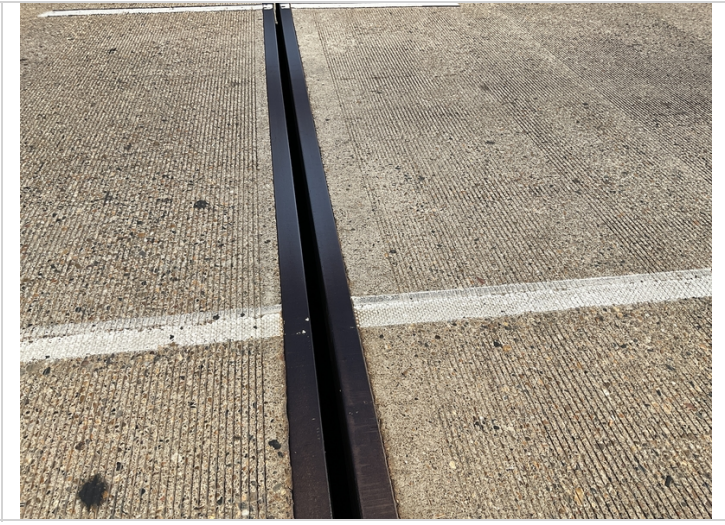
Pier 2 joint seal missing.

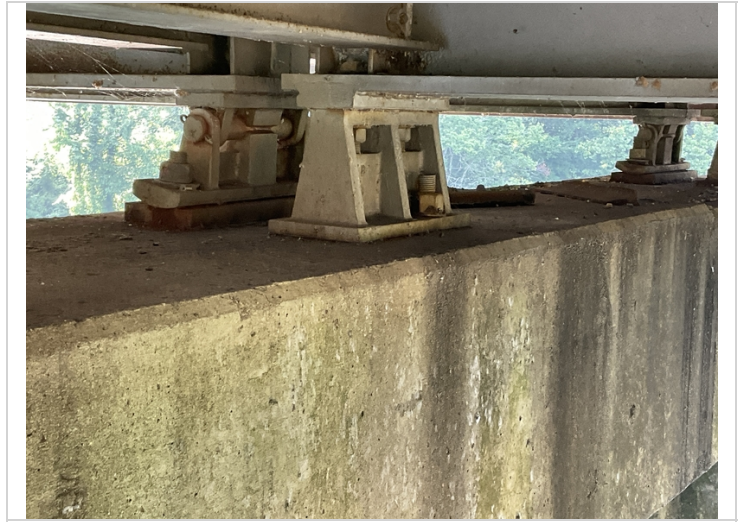
Pier 4 movable bearing are rotated back.

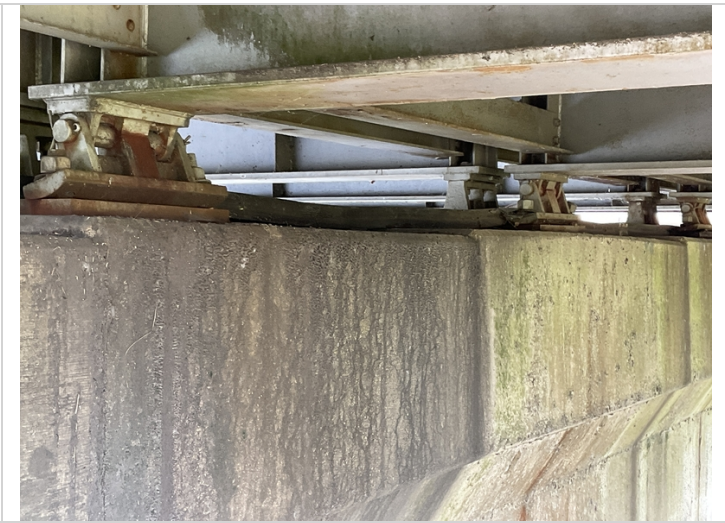
Pier 5 span 7 movable bearing are rotated back.

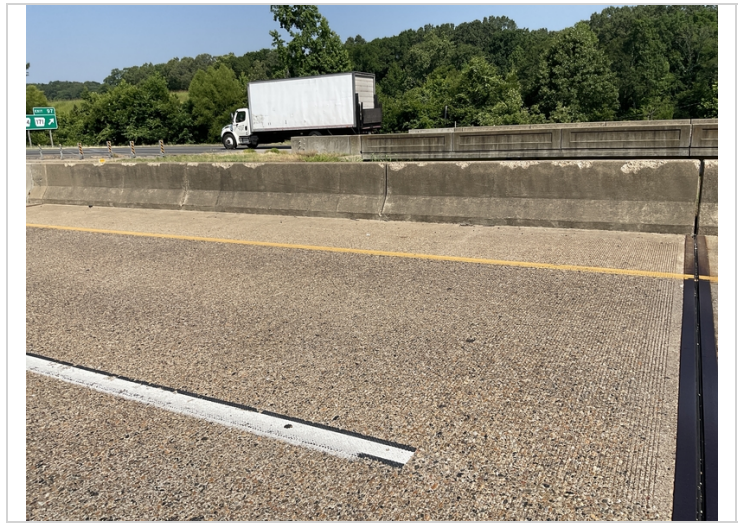
Span 1 left side spalls.

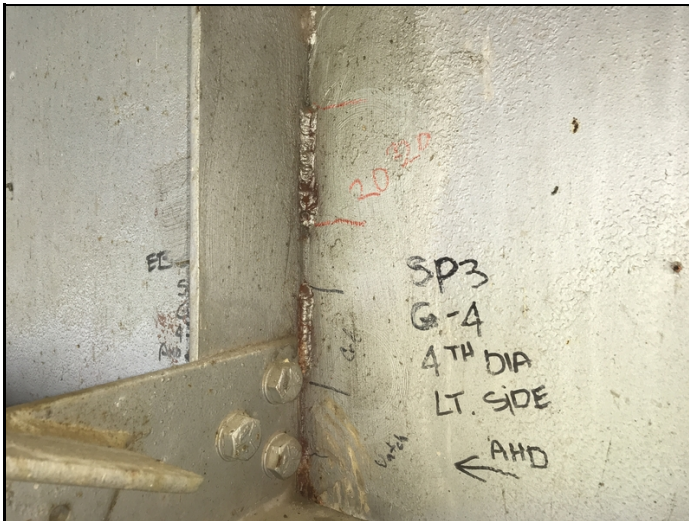
Span 3, girder 4, diaphragm 4, new crack in weld.

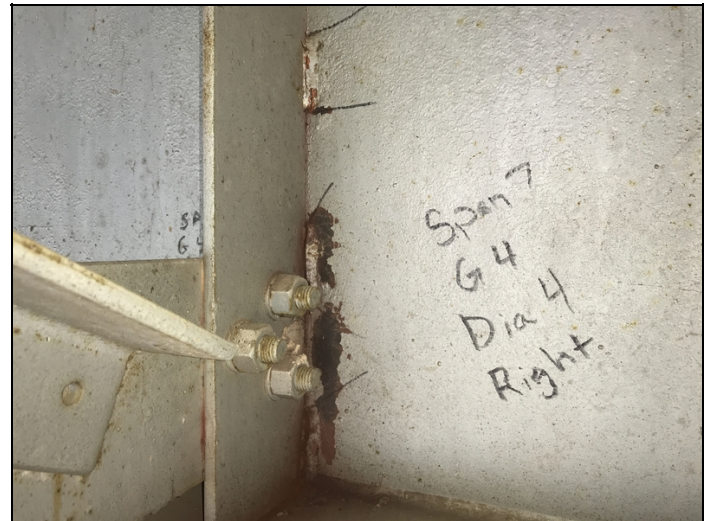
Span 7, girder 4, diaphragm 4, cracks in welds.

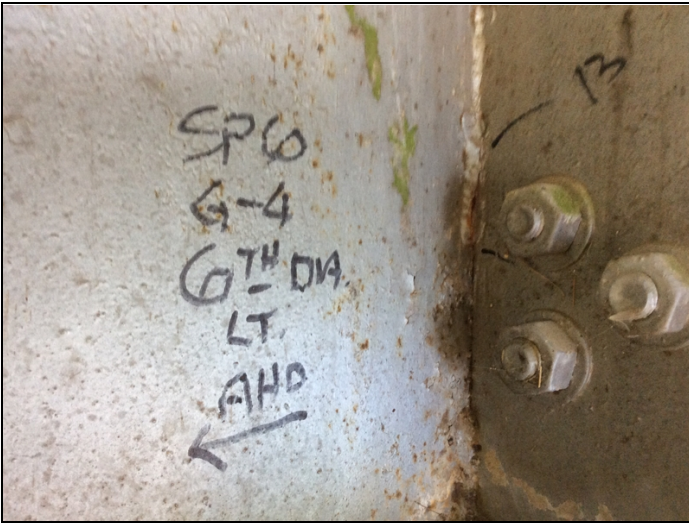
Span 6 girder 4 6th diaphragm has cracked welds.

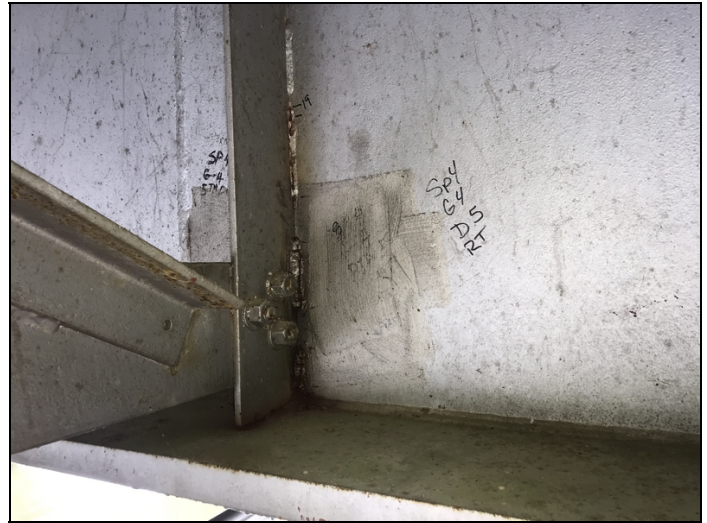
Span 4 g4 d5 diaphragm has Cracked welds

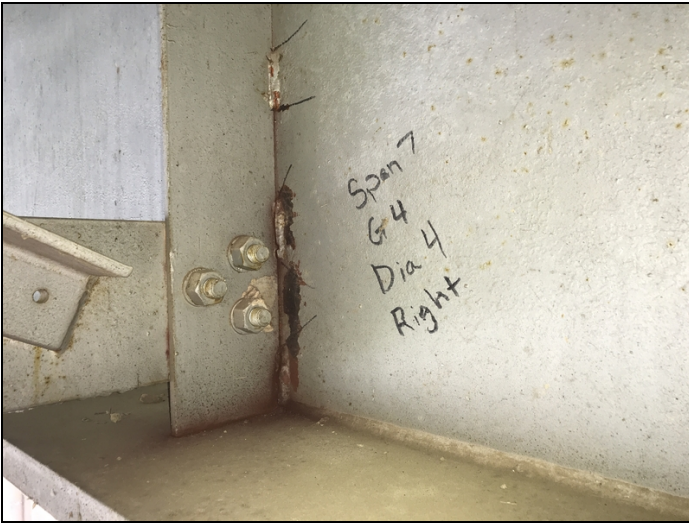
Span 7 g4 d4 the broken welds in stiffener have No change

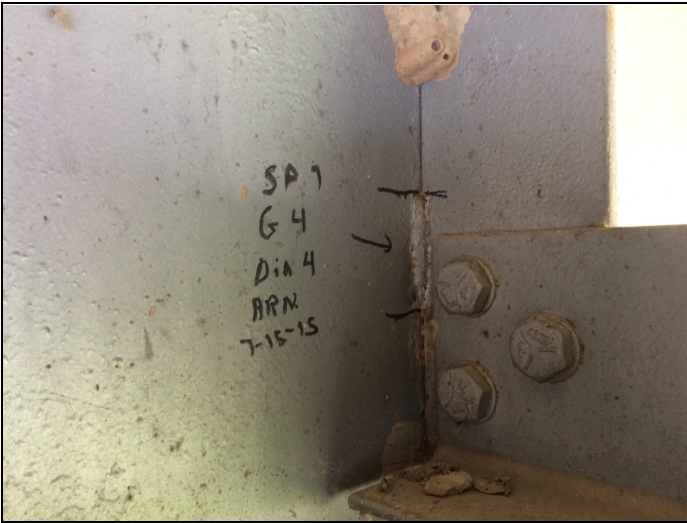
Span 7 girder 4 4th diaphragm has cracked welds.

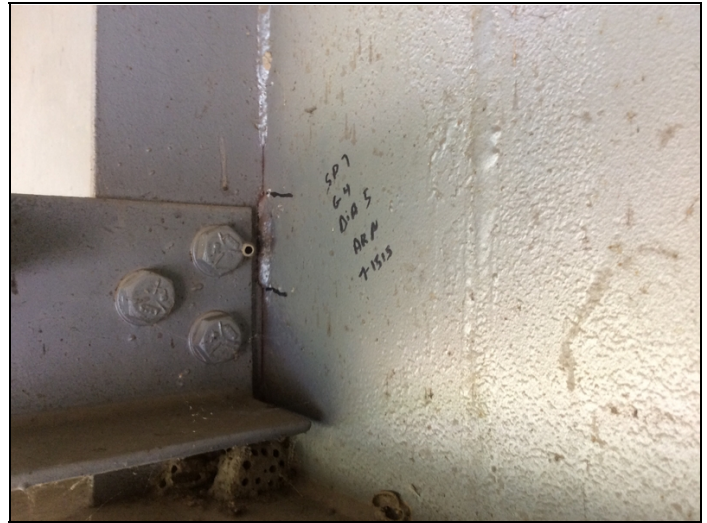
Span 7 girder 4 5th diaphragm has cracked welds.

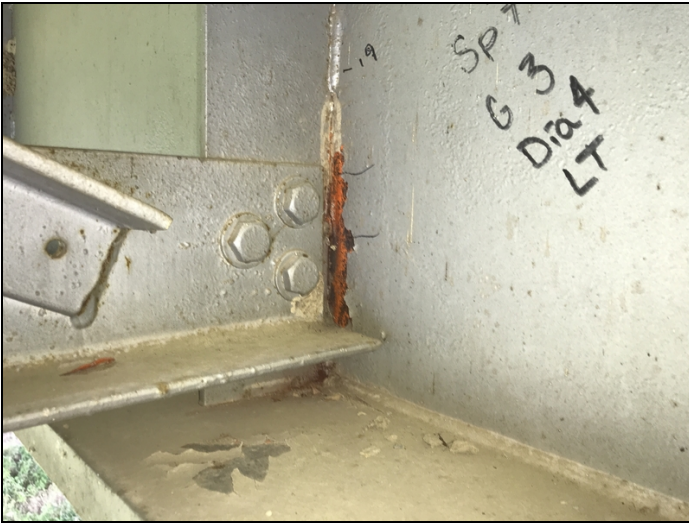
Span 7 g3 d4 cracks in welds have grown into next stitch weld

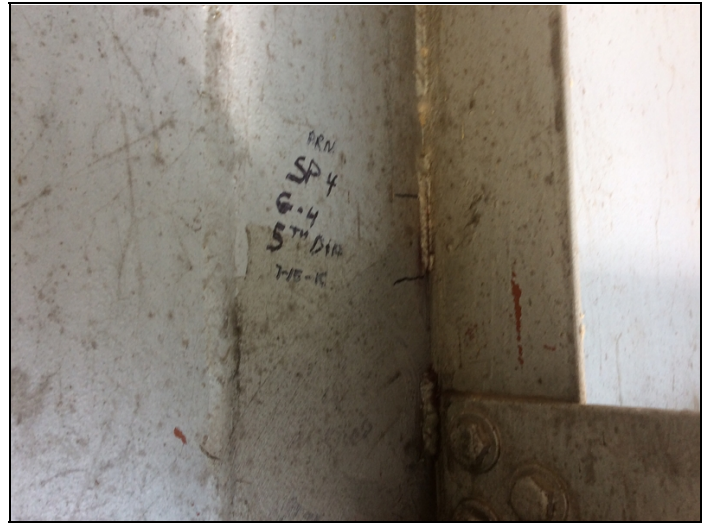
Span 4 girder 4 5th diaphragm has crack in weld.

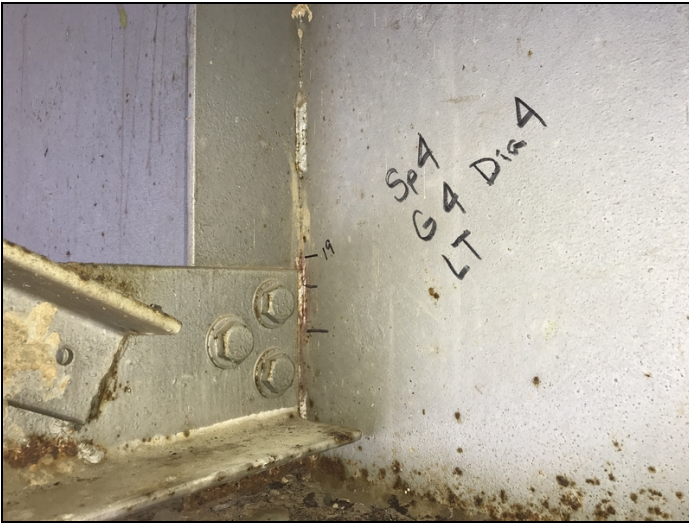
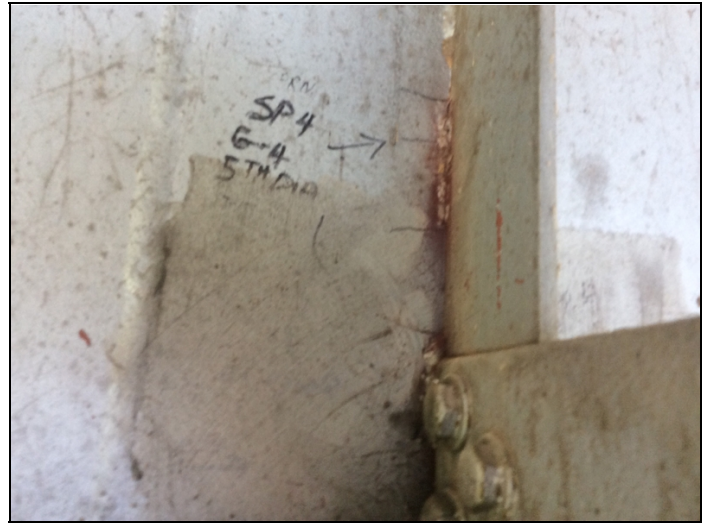
Span 4 g4 d4 left side stiffener has broken welds

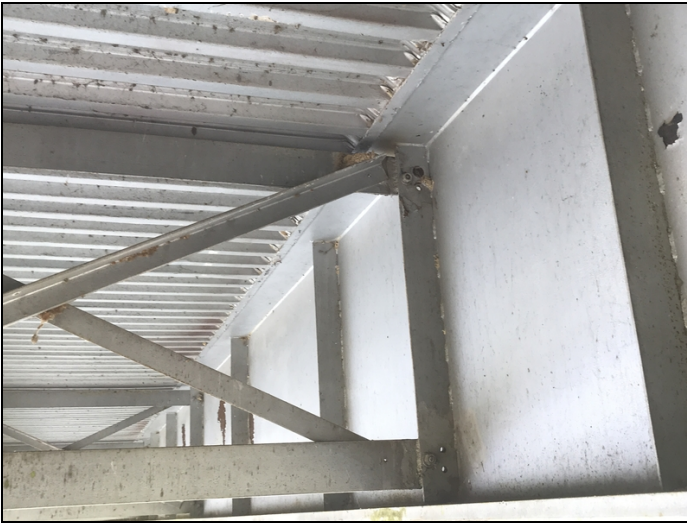
Span 6, girder 3, 4th diaphragm.

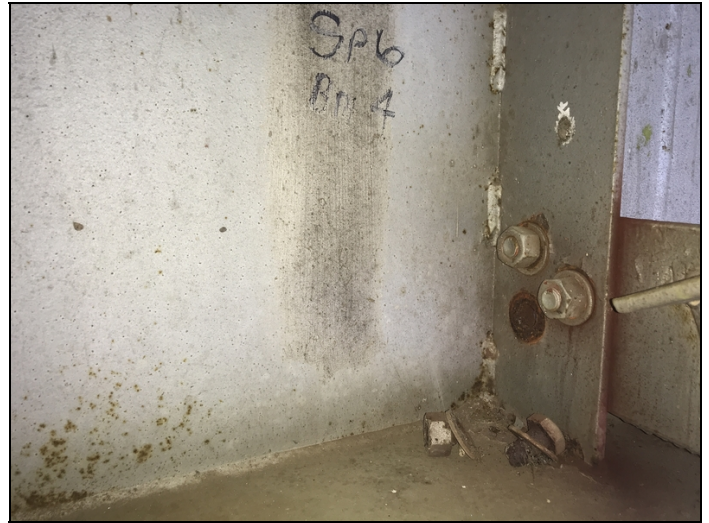
Span 6 girder 4, sheered bolt at diaphragm 4

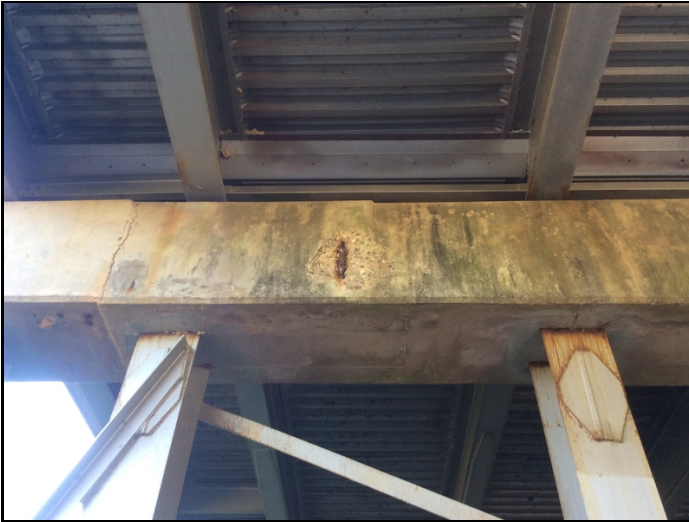
Bents 2 & 3 caps spalls with rebar Added 6/26/2018 Caps at bent 2 have been fixed.

Bent 3 backside, spall with exposed rebar.

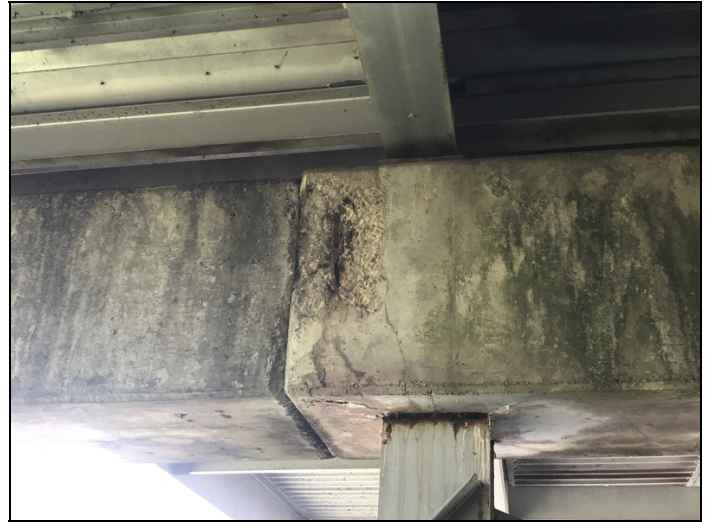
Bent 3, large spall with exposed rebar in the cap.

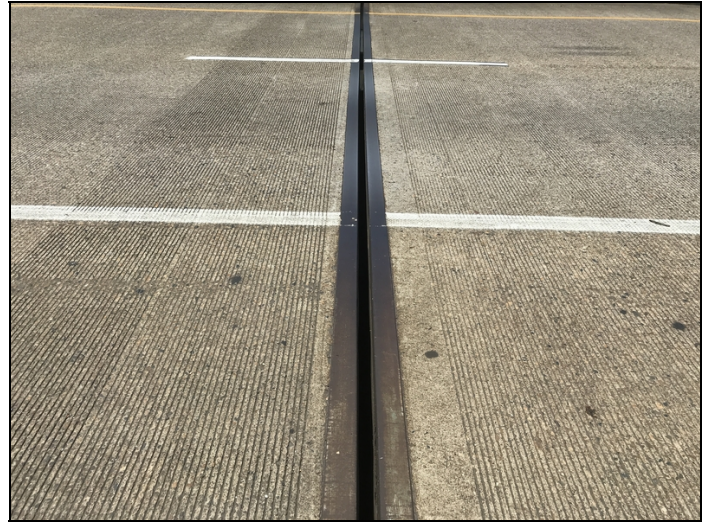
Joint seal at pier 2 has fallen out.

Pier 2, joint missing.

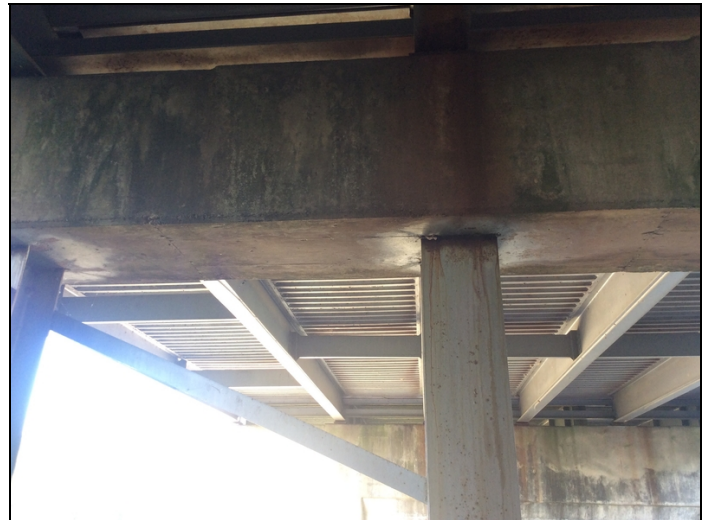
Bent 2 & 3 steel columns have active rust with pitting below caps. with column 4 having a 1" hole in the flange. Added 6/26/2018 - Bent 3 pile 5, hole in flange below cap. Bent 2 steel piles have been fixed.

Bent 3 pile 5, hole in flange below cap.

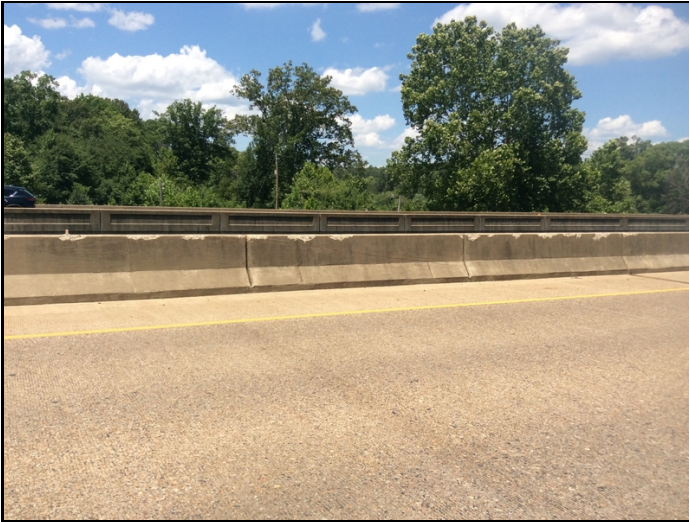
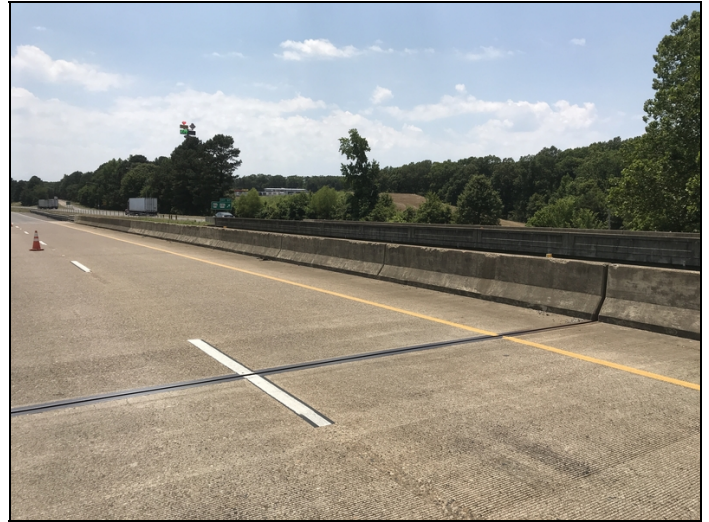
Span 1 thru 4 spalls on the left bridge rail due to traffic impact.

Left side, spalls in top of the bridge railing.

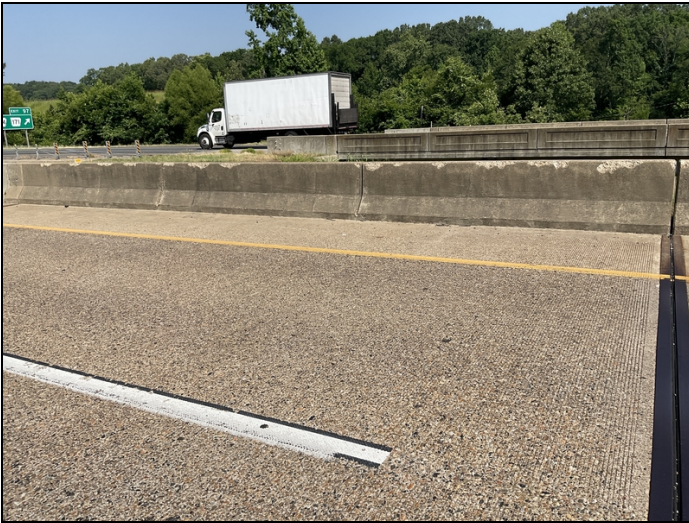
Span 1 left side spalls.

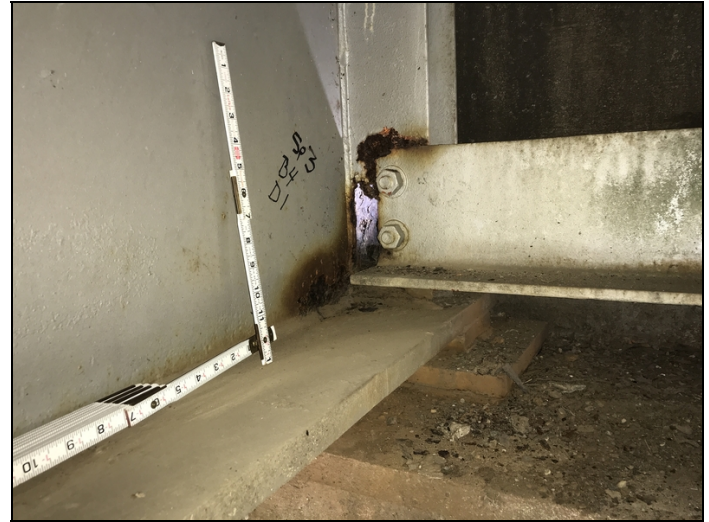
Hole in the diaphragm bracket at span 3 girder 4 diaphragm 1 at pier 1.

span 3 g4 dia1 diaphragm clip/stiffener has a 2"x4" hole at bottom connection and the web at girder 4 has up to 1/4" deep section loss

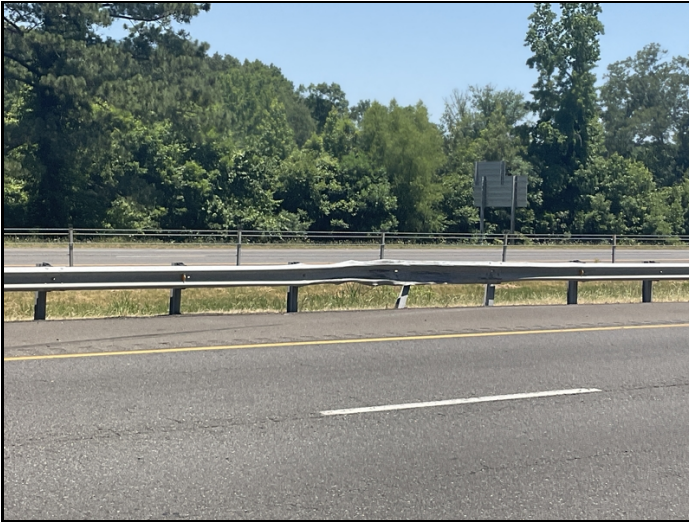
Bent 1 northwest guardrail damaged due to traffic impact.

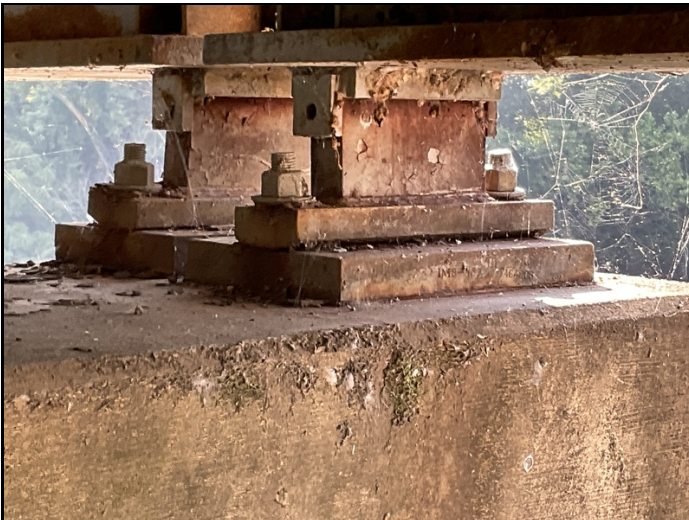
Pier 3 span 4 bearing 6 missing top bolt.  
Pier 5 span 7 bearing 6 loose top bolt

Pier 3 span 4 bearing 6 missing top bolt.

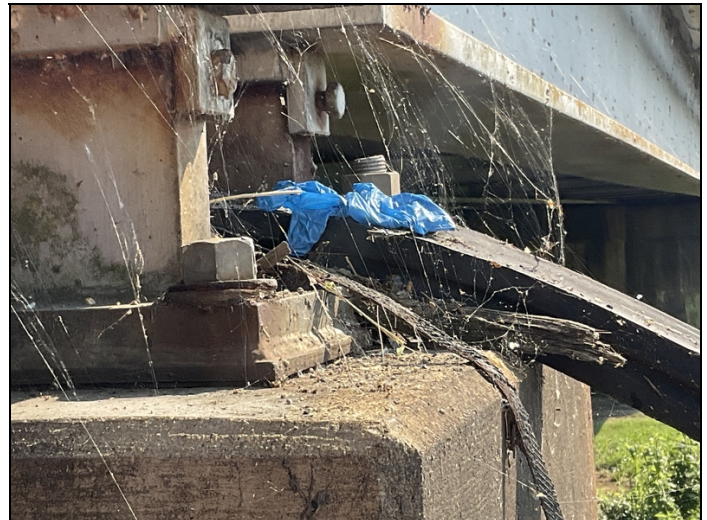
Pier 5 span 7 bearing 6 loose top bolt
