Asset #A5027 (Routine, Underwater type 2)

I-30 WB log 93.47 over CREEK

Location: 4.45 MI SW OF SH 270

Team Lead: Chris Doggett, Inspection Date: 10/26/2022

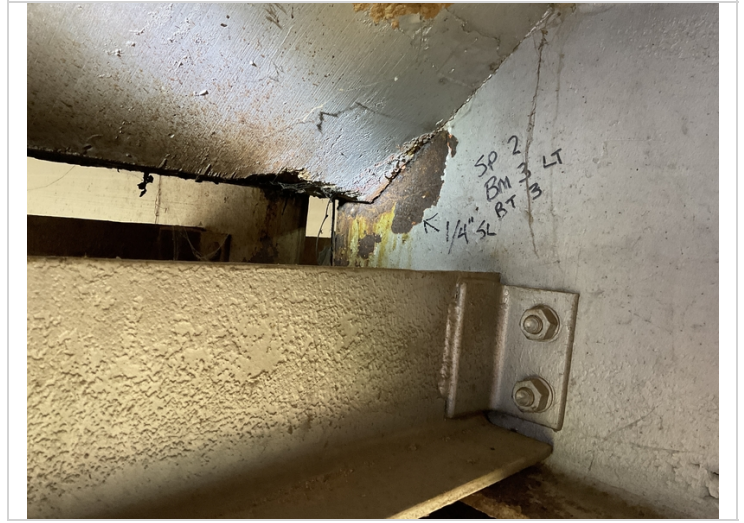
Up to 1/4" section loss at the haunch

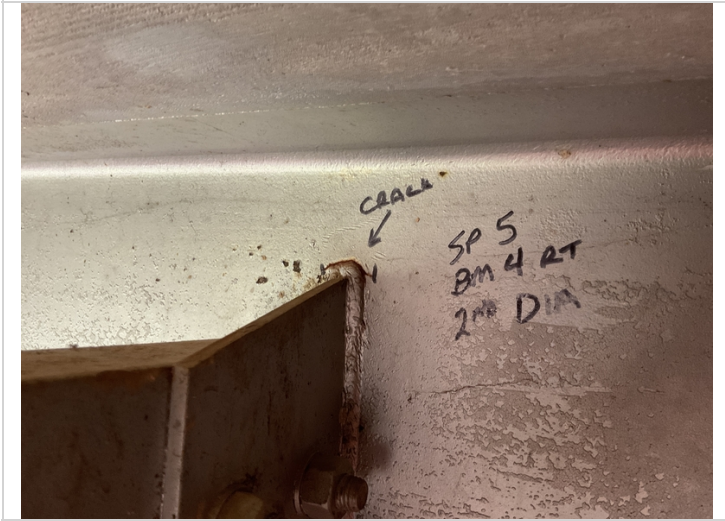
Crack propagates into the web. 2022

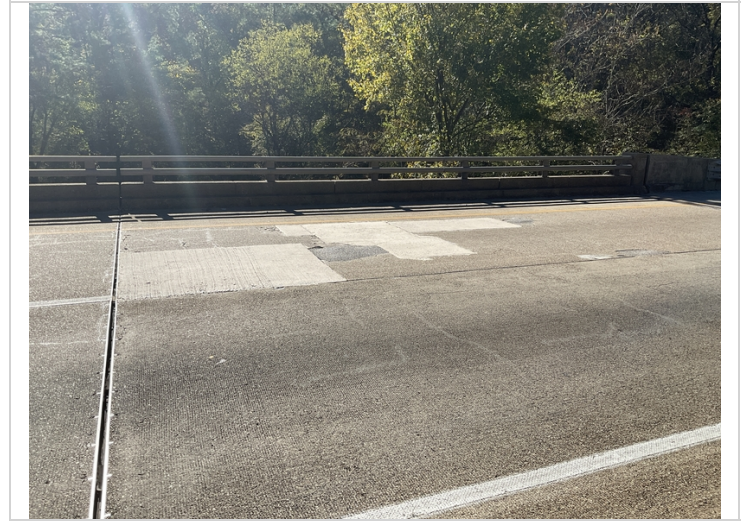
Span 1: multiple concrete patches and asphalt patches in this span.

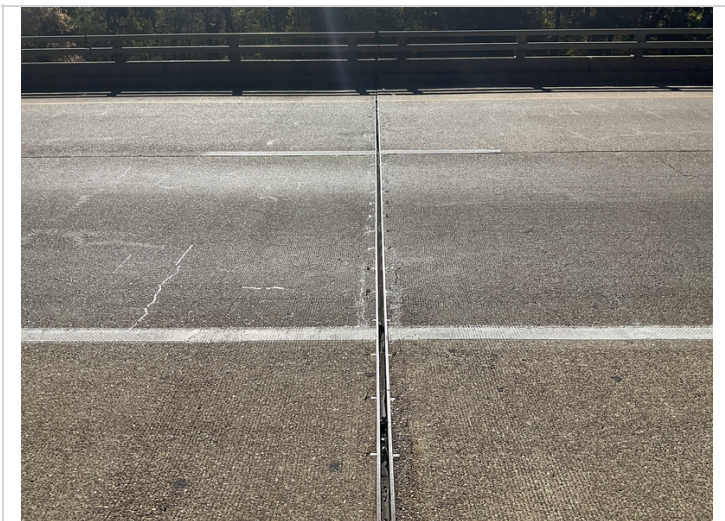
Bent 5: joint seal leaking

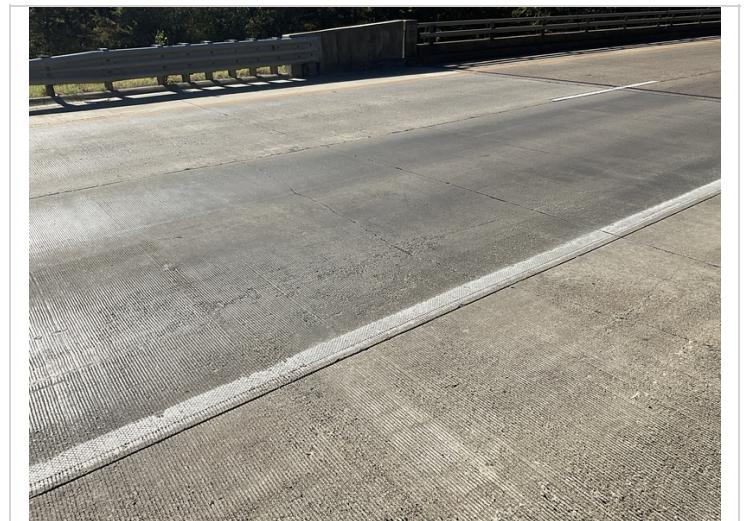
Approach slab with multiple large transverse cracks

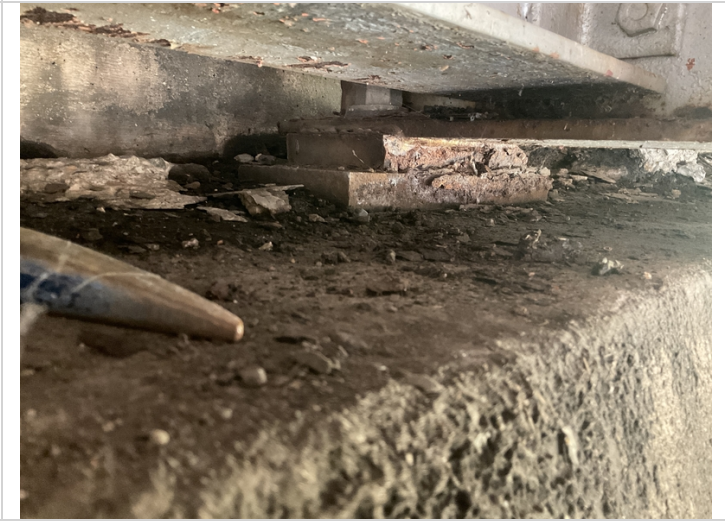
By 6, girder 4: bearing with typical corrosion at this bent.

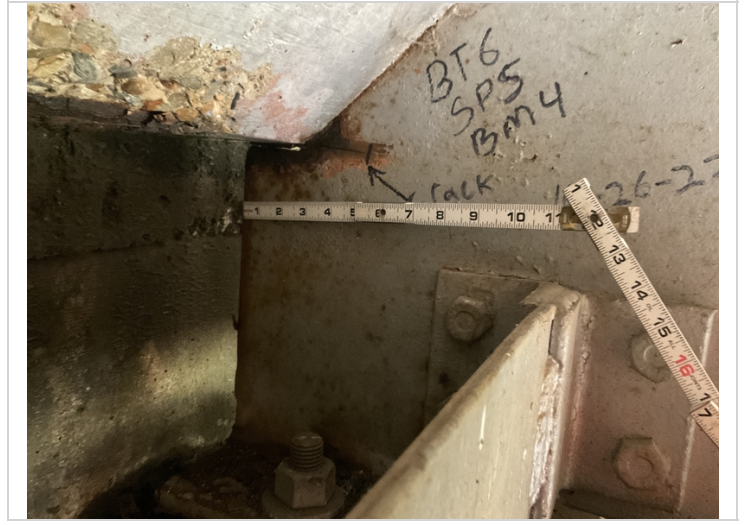
Large crack from the end of the beam into the web.

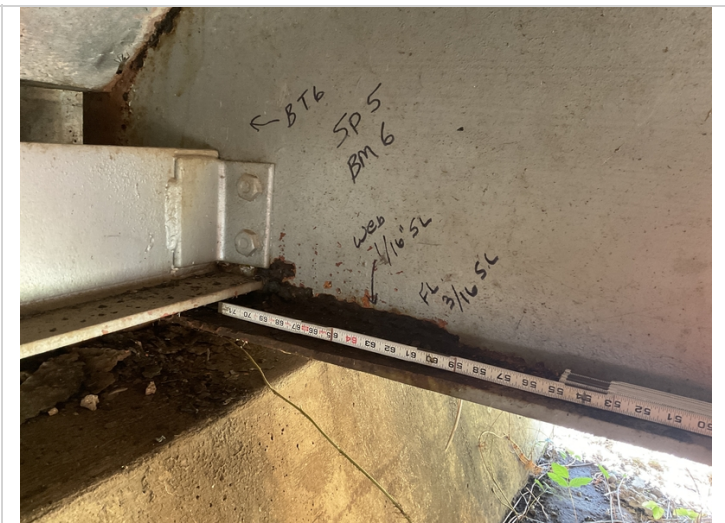
Beam 6, span 5, bent 6: up to 3/16" section loss to the bottom flange and 1/16" section loss to the lower web.

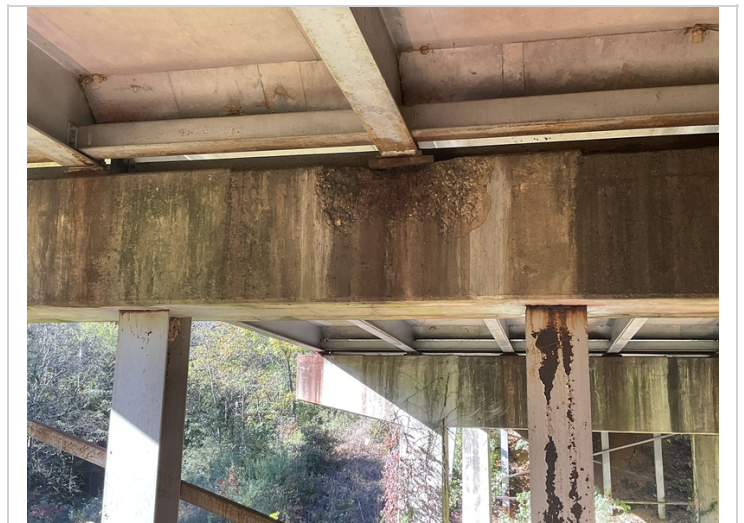
Ahead side of bent 4, girder 5: large spall under girder 5 with some loss to the bearing area

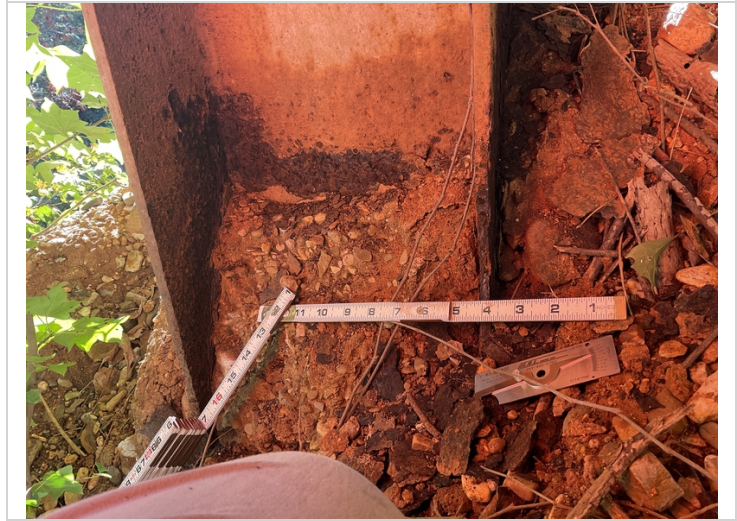
Bent 2, pile 4: at ground line all surfaces with measurable section loss up to 1/8". The right flange in the picture has 1/8" steel remaining.

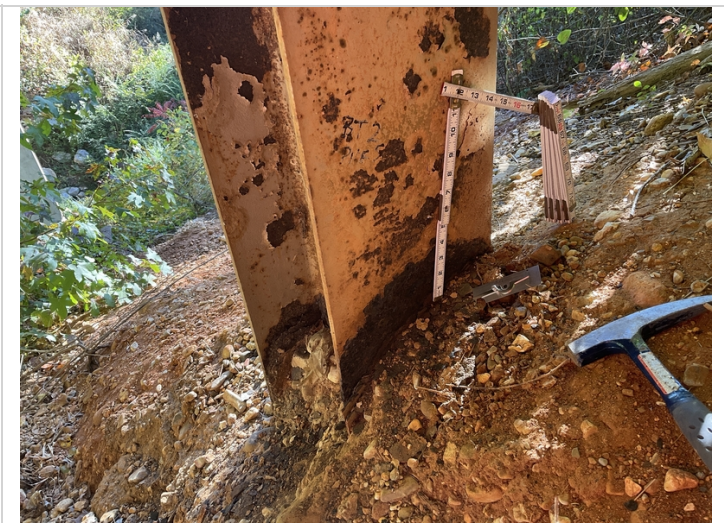
Bent 2, pile 5: up to 1/16" section loss from the ground up 4".

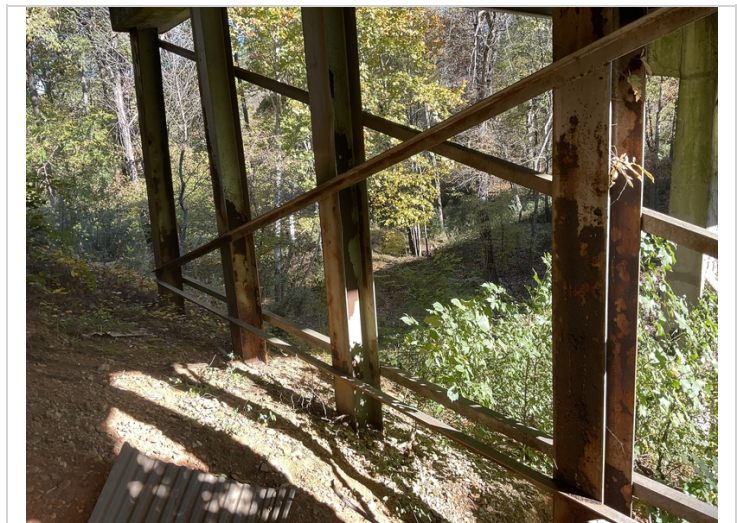
Bent 2: the paint has failed in numerous areas and surface rust and section loss to all piles.

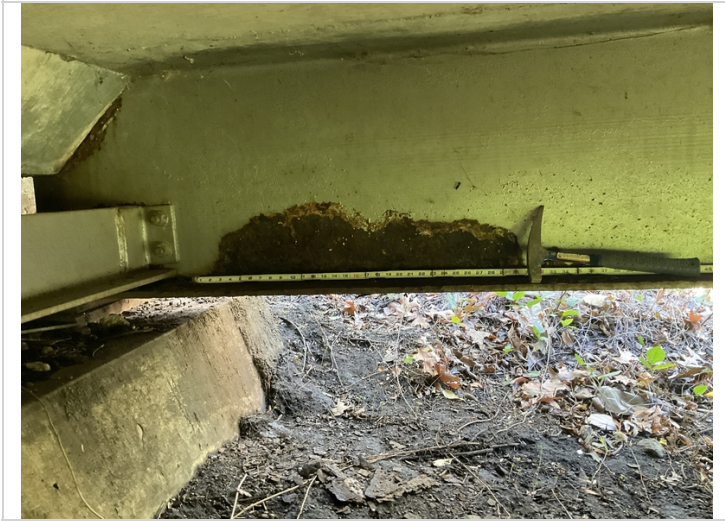
Span 1, girder 1: large area of section loss to the lower web and bottom flange.

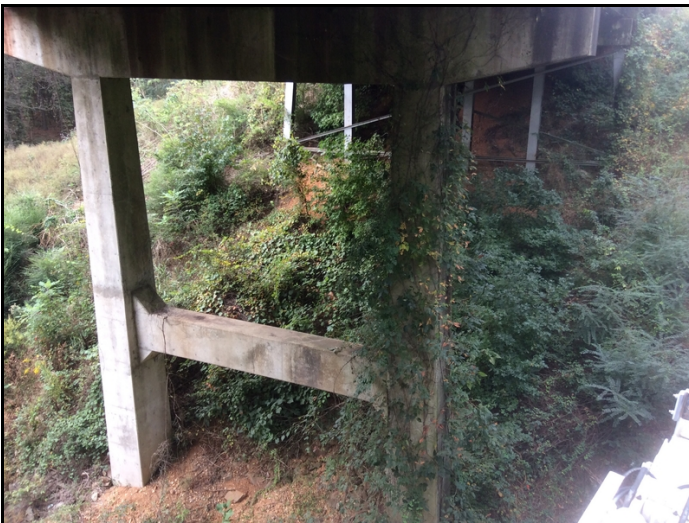
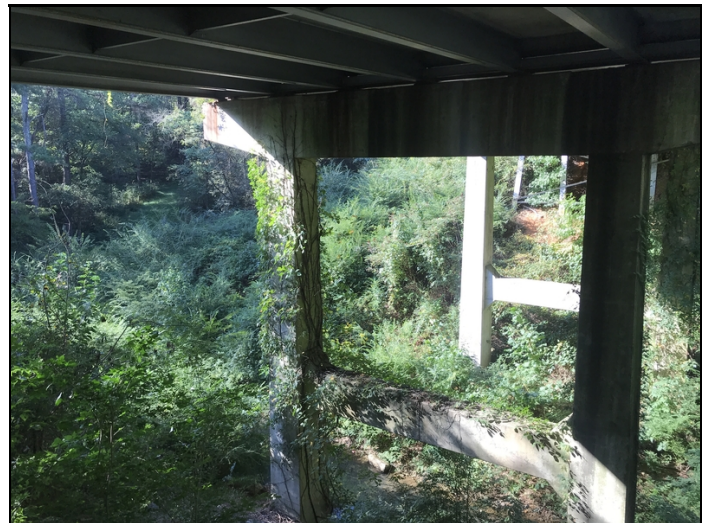
Bents 2 thru 5 vines and trees growing on and against bents.

Vines growing on columns at bents 3 and 4.

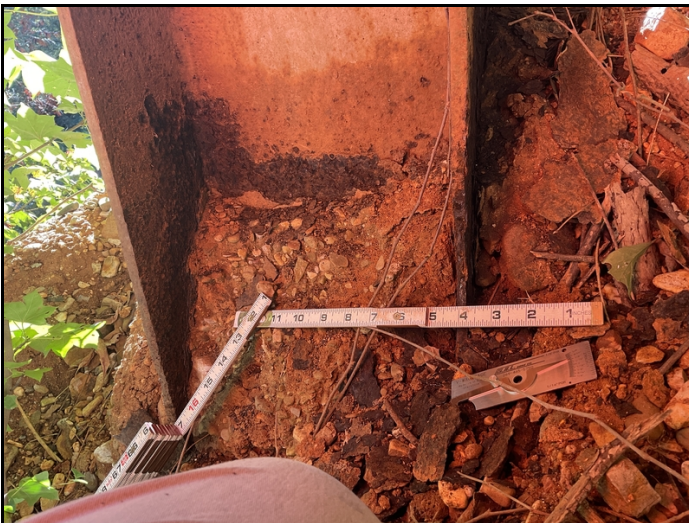
Bents 2 & 5 steel pile have active rust with pitting at ground line and below caps.

Bent 2, pile 4: at ground line all surfaces with measurable section loss up to 1/8". The right flange in the picture has 1/8" steel remaining.

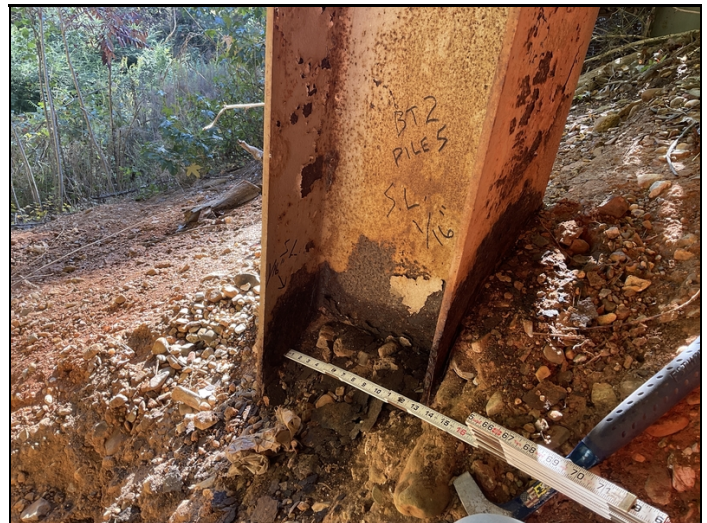
Bent 2, pile 5: at ground line all surfaces with measurable section loss up to 1/16".

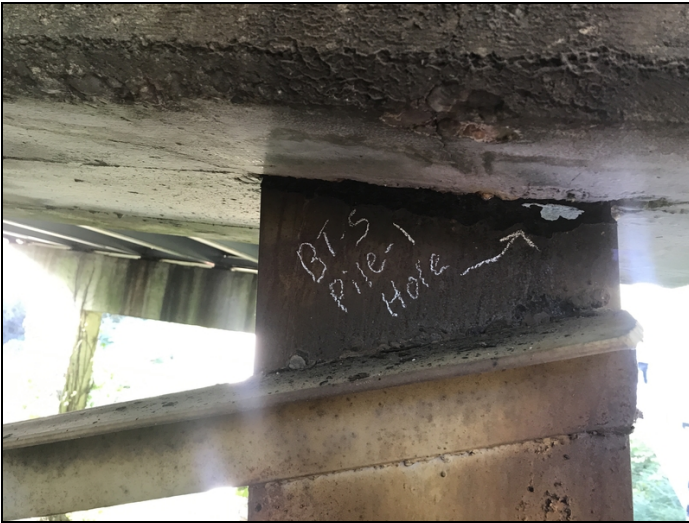
Bent 5 steel pile 1 hole in top of pile and section loss up to 3/16" .

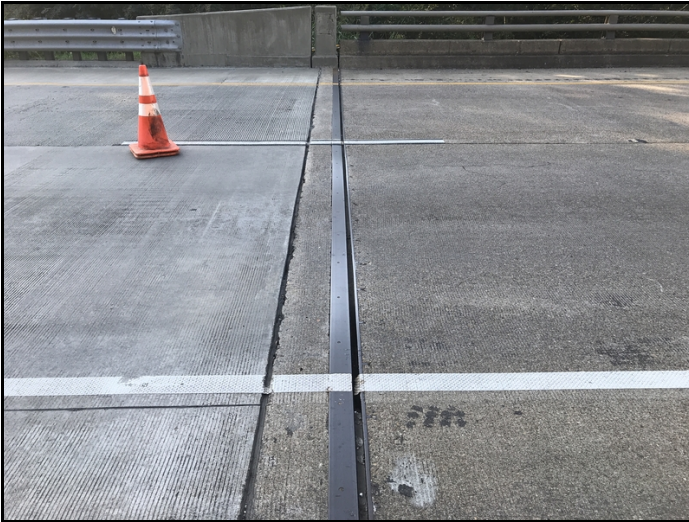
All joints are torn and leaking allowing debris to build up on bearings.

Bent 6 joint is leaking.

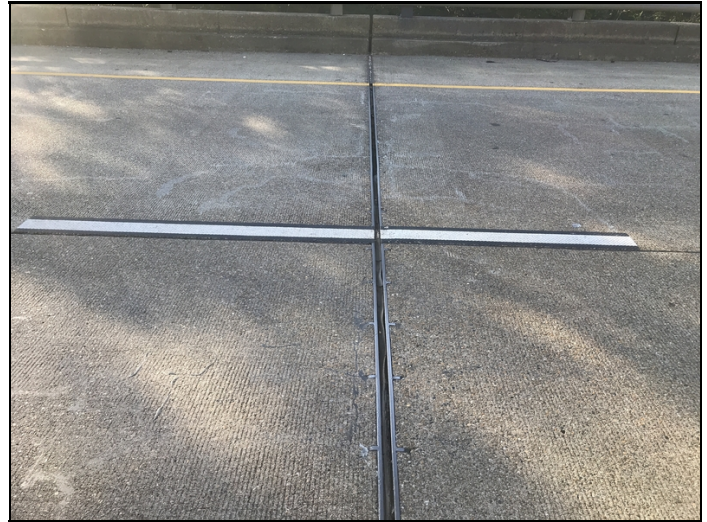
Bent 5 joint.

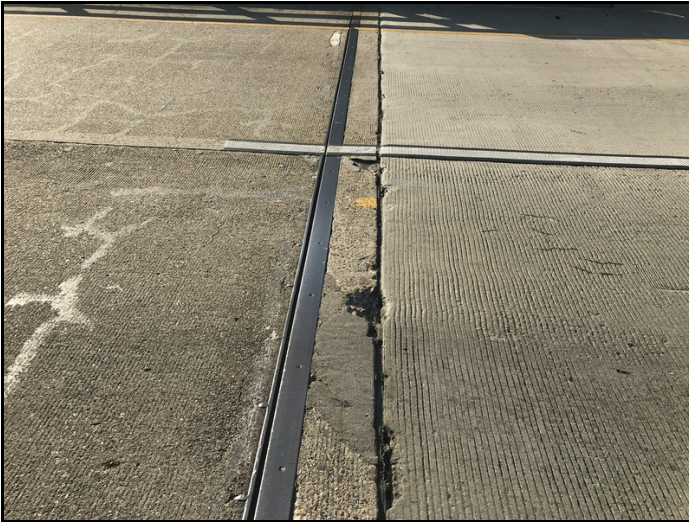
Bent 1 spalls in the top of back wall.

2 spalls in top of back wall at bent 1.

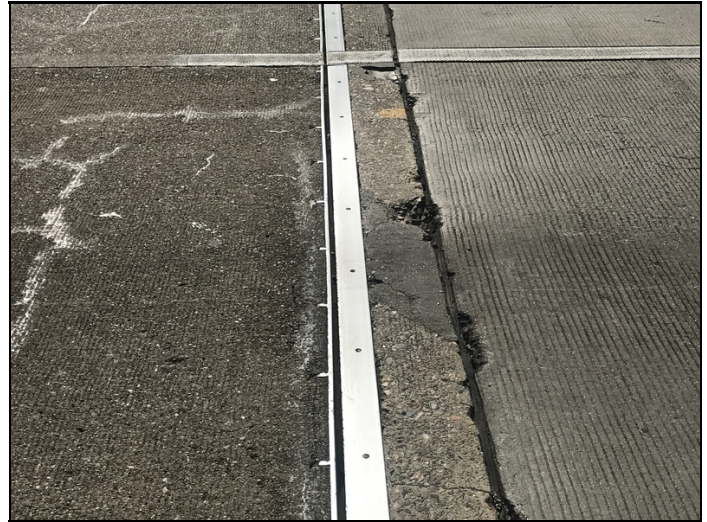
Bent 1 spalls in top of back wall.

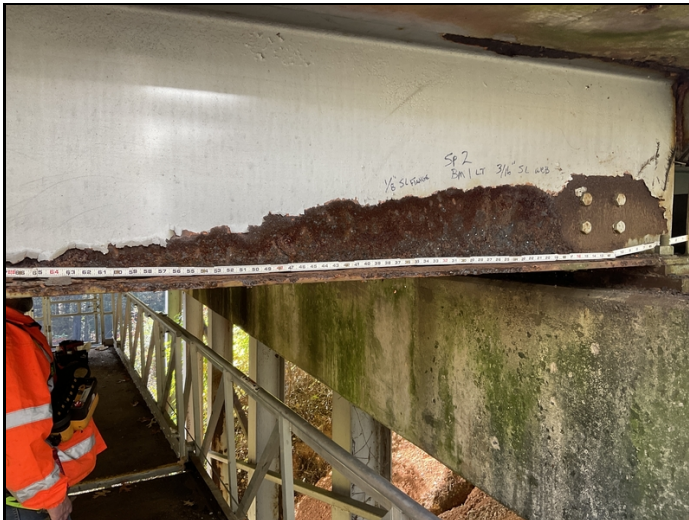
Beam ends at all bents have up to 1/4" section loss to the web at the deck haunch and along the bottom flanges. Photos attached.

More than 6 feet of the bottom flange and lower web with measurable section loss

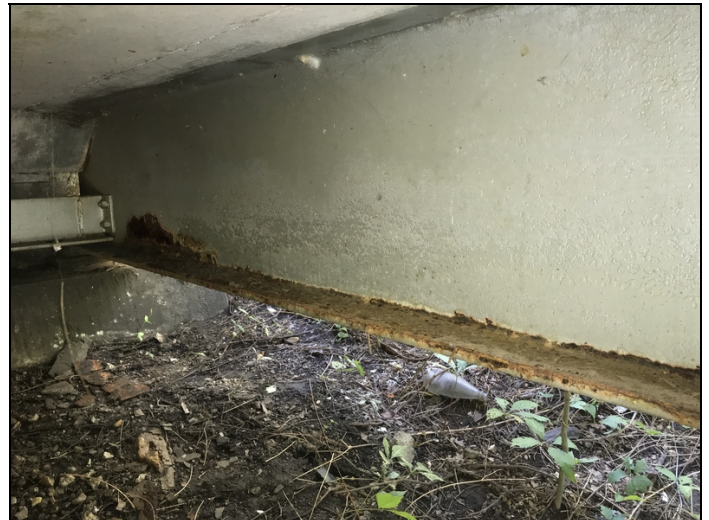
Span 1 girder 1 section loss in web and flange 20' in length.

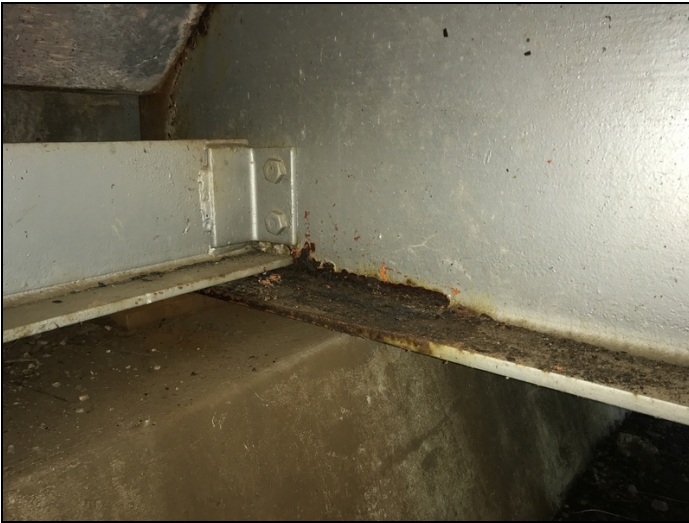
Bent 6 girder 6 section loss to bottom flange.

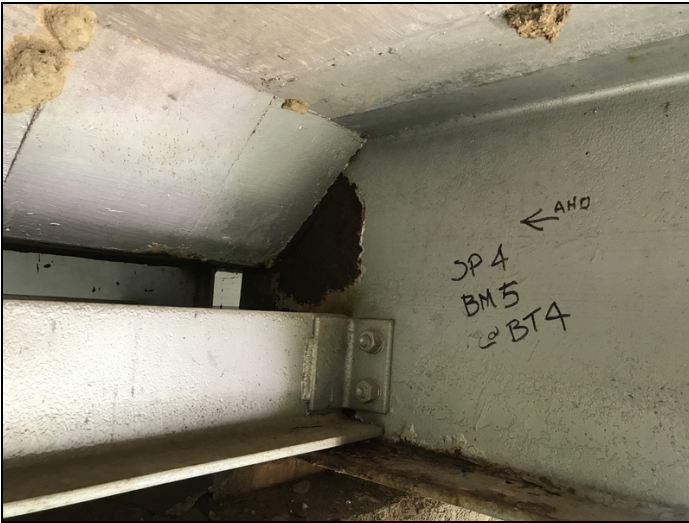
Bent 4 girder 5 back side section loss in web at the haunch area.

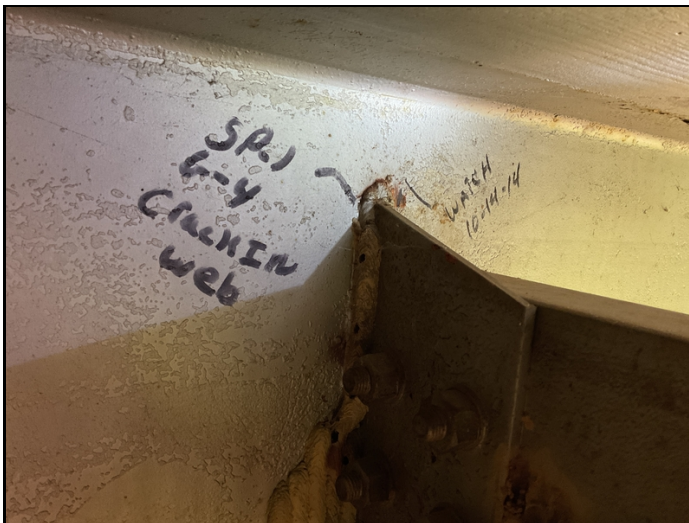
Crack propagates into the web 2022

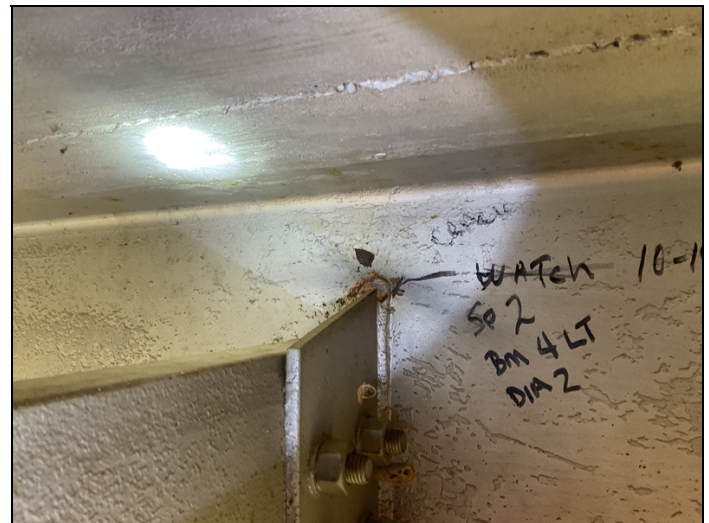
This crack propagates into the web 2022

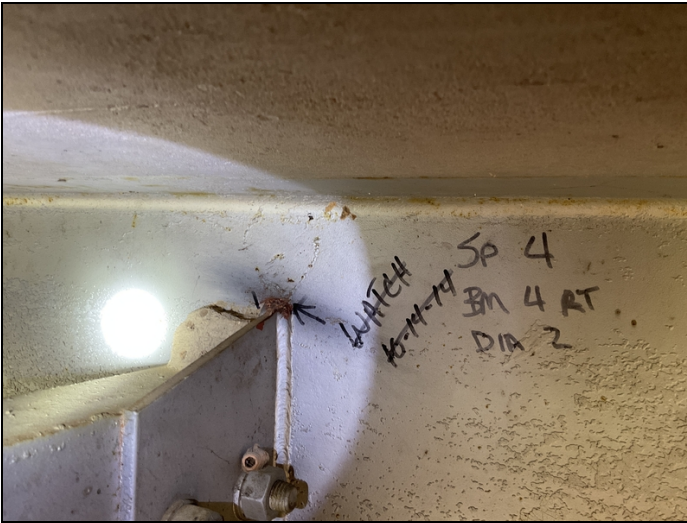
Crack propagates into the the web 2022

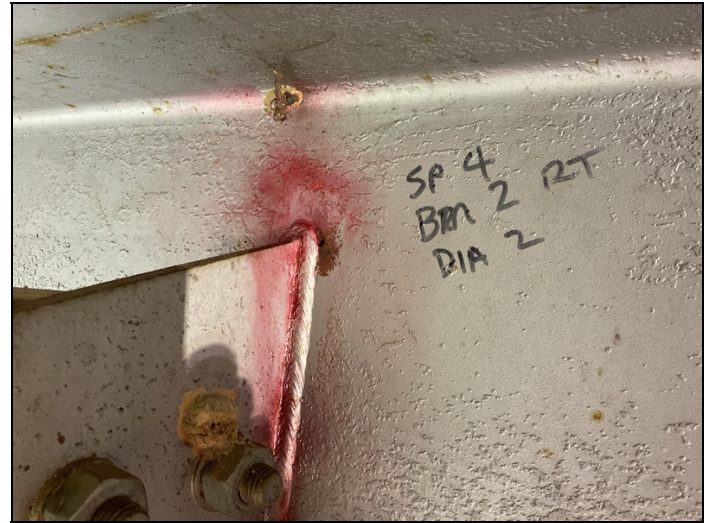
Crack in the toe of the weld. 2022

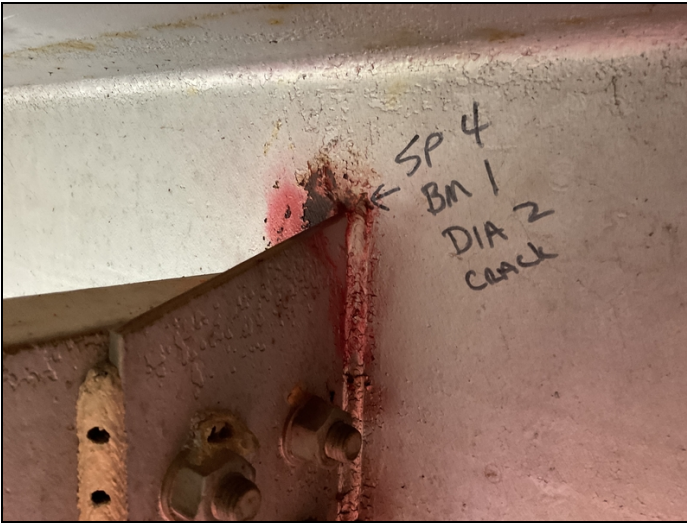
Crack in the toe of the weld. 2022

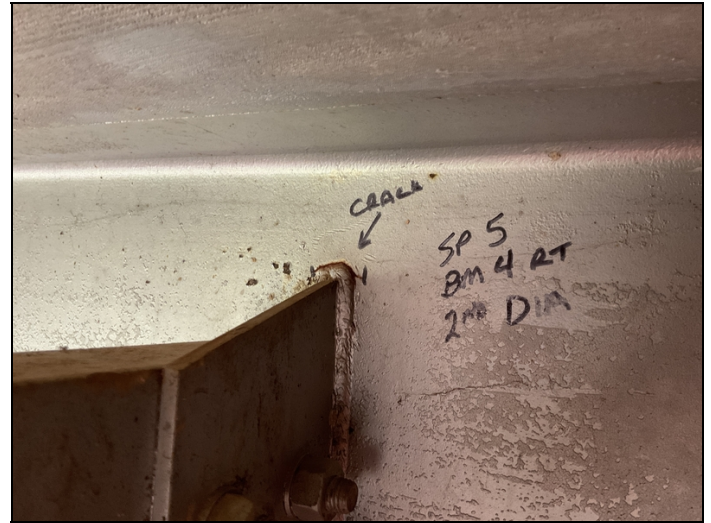
Crack propagates into the web. 2022

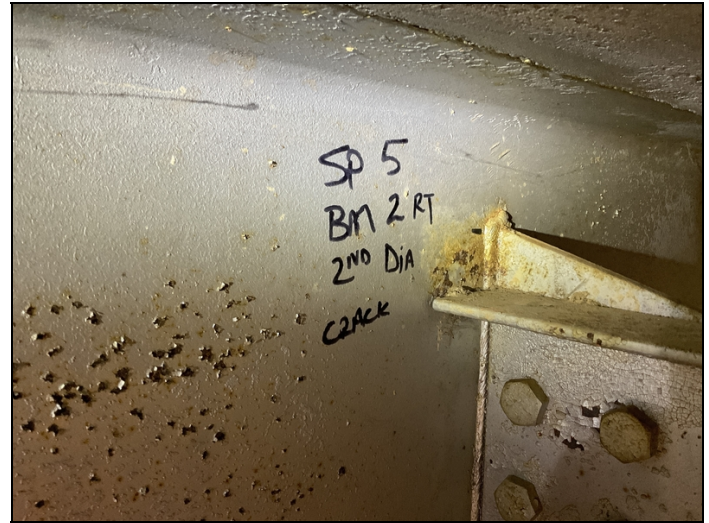
Crack in the weld. 2022

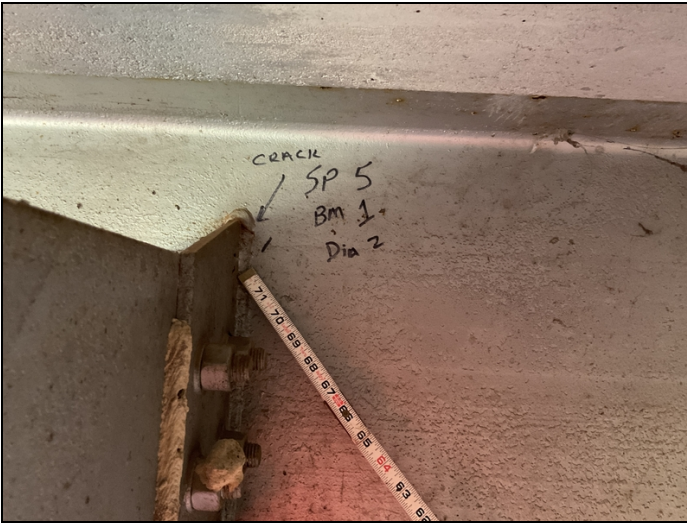
Crack propagates into the web 3/4". 2022

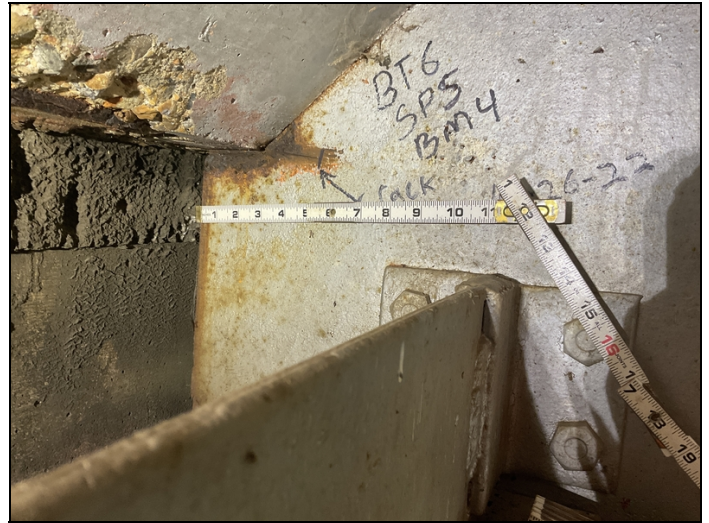
Large crack from the end of the beam into the web.

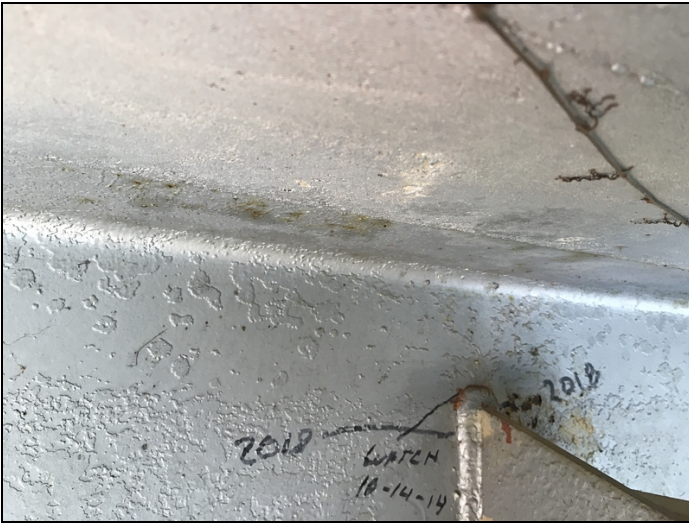
Span 2 girder 4 crack in top of weld in diaphragm connection.

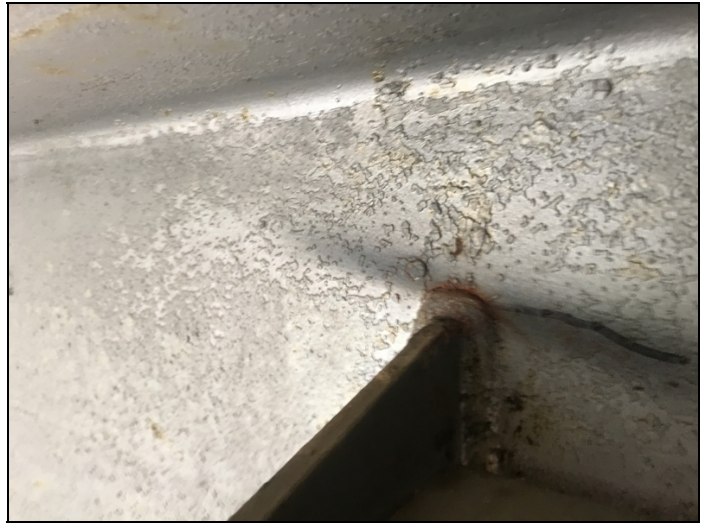
Span 4 beam 4 first diaphragm ahead of bent 2. Crack in the toe of weld at top diaphragm bracket.

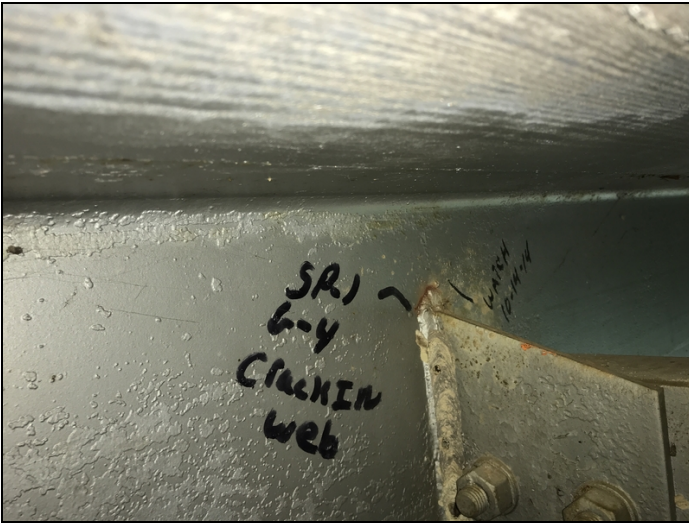
Span 1 girder 4 crack in web at top of diaphragm connection.

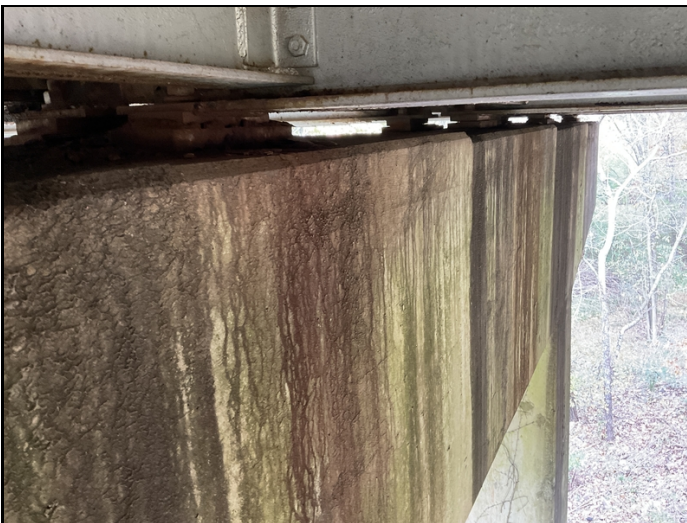
Bent 4: all bearings have large amounts of fretting rust coming from them due to them impacting when loads

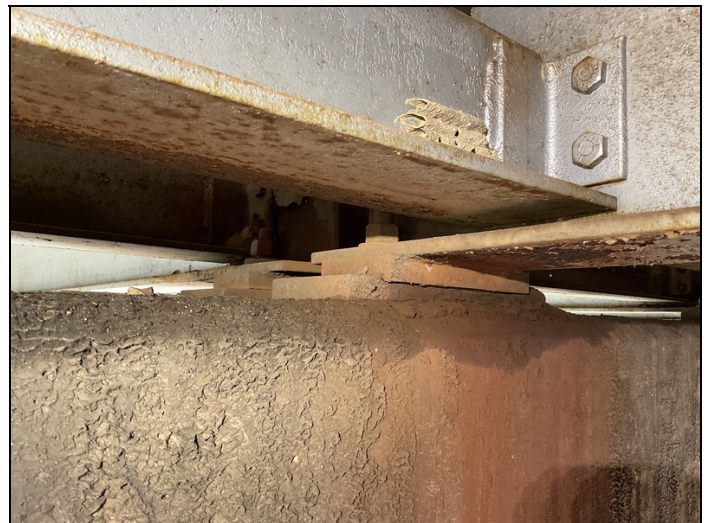
Beam 3, bent 5, span 5: bearing is floating

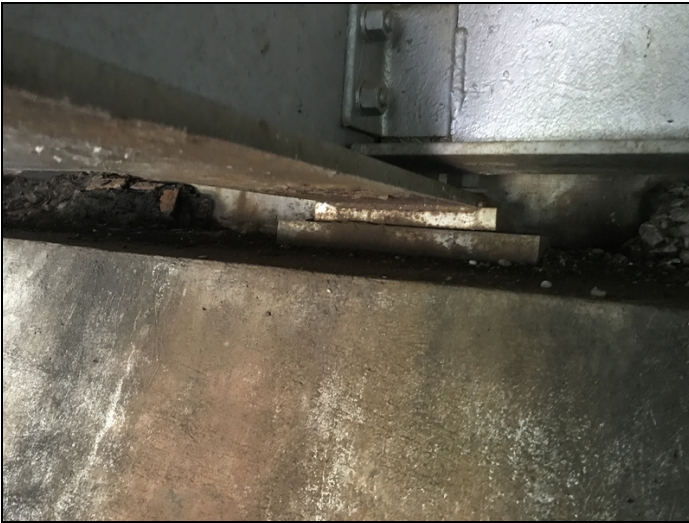
Bent 6 bearings 2, 3, 5 and 6 are floating.

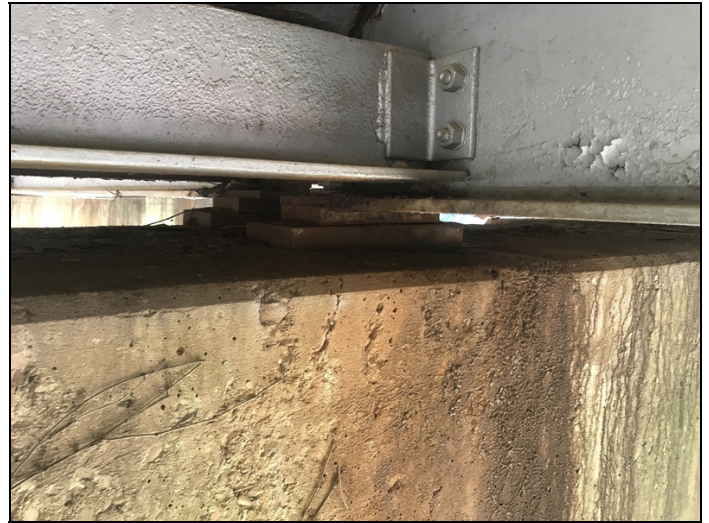
Bent 3 bearing 3 floating under load.

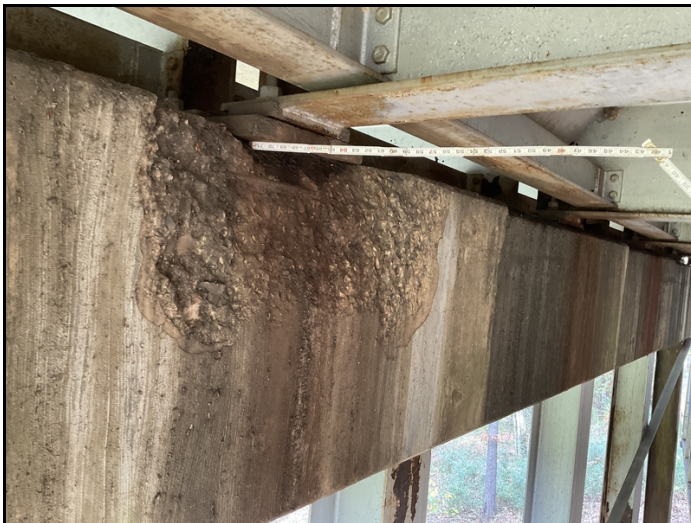
Span 5 bent 5, ahead side, spall on cap below bearing, reducing the bearing surface area by 2 3/4"

2 3/4" of bearing loss. Bent 5, beam 5, span 5

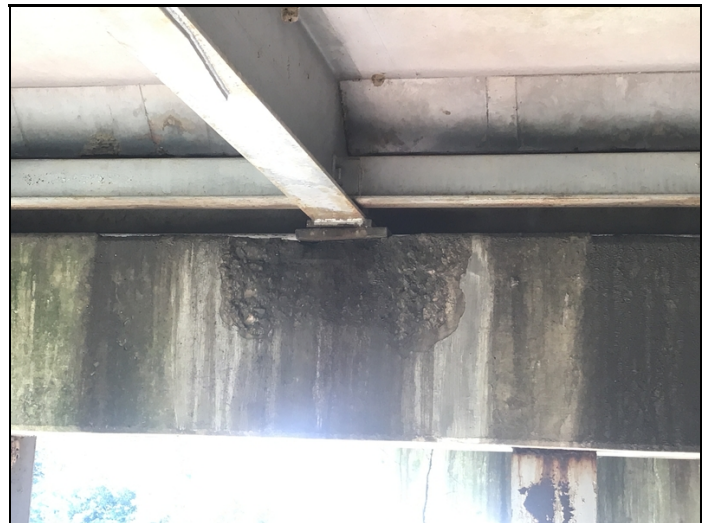
Span 5 bent 5, ahead side, spall on cap below bearing, reducing the bearing surface area.
Photo attached.

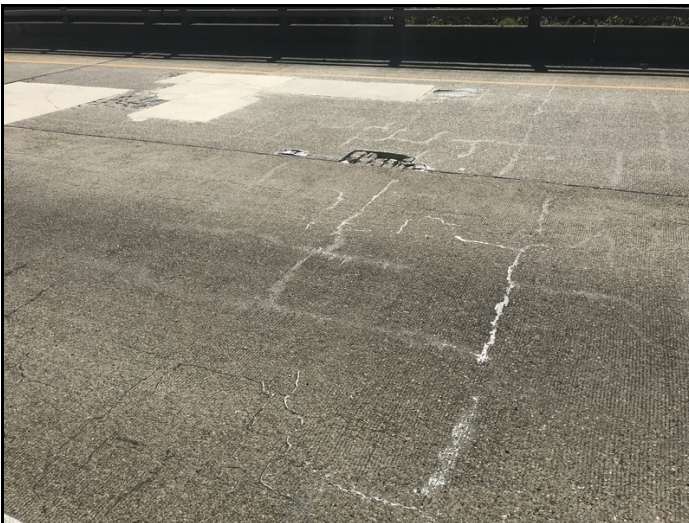
Span 1 has spall and delams in the rigid overlay.

Span 1 spalls and delam in the rigid overlay.

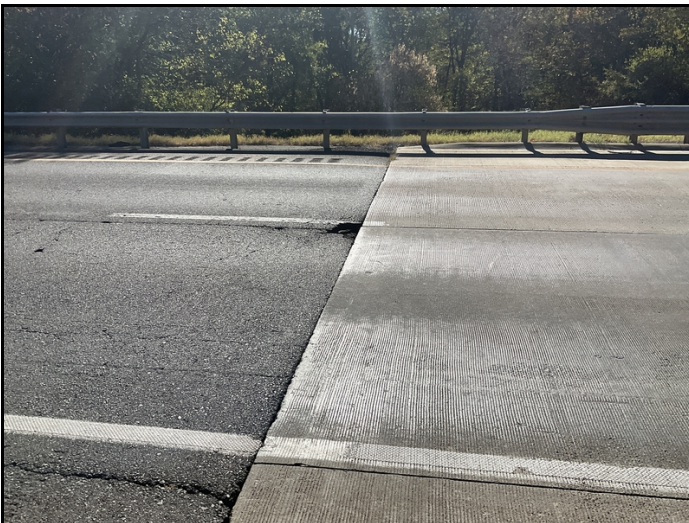
West bound approaching roadway at center line has a pothole in the asphalt surface adjacent to the approach slab.

West bound approach roadway with a pothole in the asphalt surface adjacent to the approach slab.

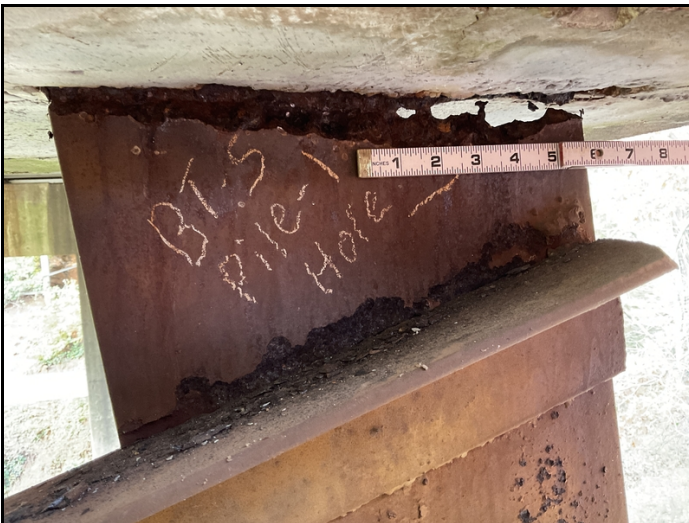
Bent 5 steel pile 1; 5" hole in the pile adjacent to the cap at the ahead side. 2022

Bent 5 steel pile 1; 5" hole in the pile adjacent to the cap
at the ahead side. 2022
