**Asset #B5027**(Routine, Underwater type 2)

**I-30 EB log 93.51 over CREEK**

**Location: 4.45 MI SW OF US 270**

**Team Lead: Chris Doggett, Inspection Date: 10/26/2022**

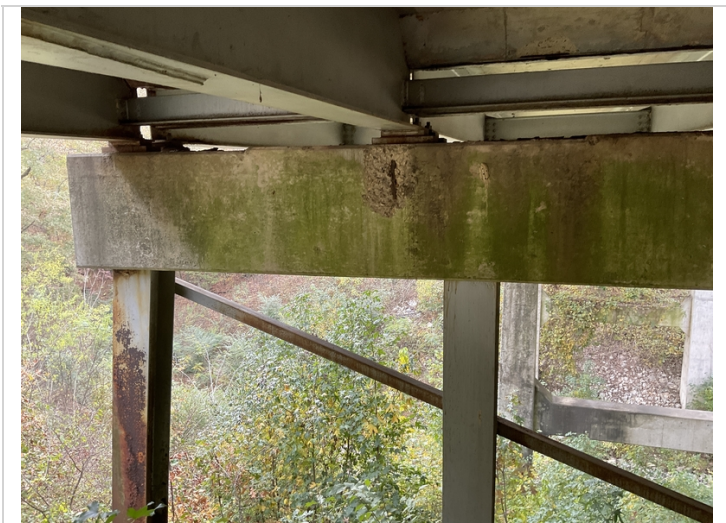
(234) Small horizontal cracks in the caps of bents 2 and 3. Bent 3 ahead face at the top between beams 5 & 6, small delam. Bent 4, back side, two exposed rebar and on the bottom of the cap on the right end. Bent 5 ahead side between piles 5 and 6 cap has a spall with exposed rebar.							
302	Compression Joint Seal	LF	254	0	189	65	0
2310	Leakage	LF	189	0	189	0	0
2330	Seal Damage	LF	65	0	0	65	0

Bent 5 ahead side: spall with exposed rebar under beam 5

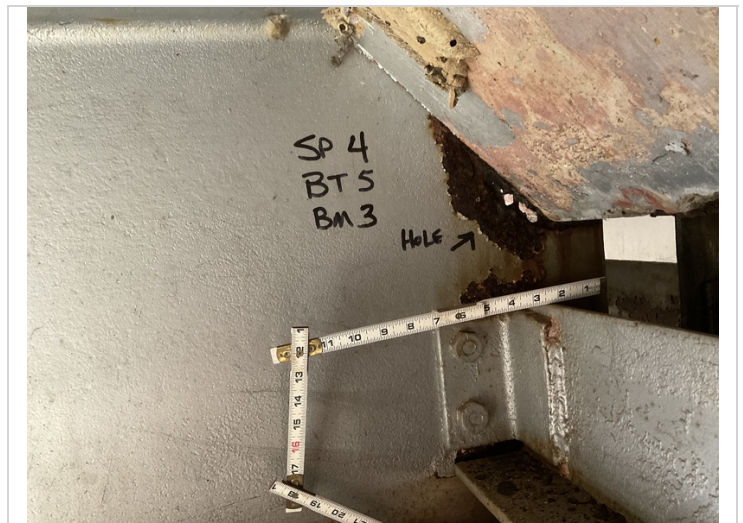
(107) Beam ends at bents 2 thru 5 have section loss up to 1/4" to bottom flange and top portion of web at the haunch. Span 4, bent 5, beam 3: 3" hole in the web at the haunch area. Span 4, bent 4, beam 5: 2" hole in the web at the haunch area.							
205	Reinforced Concrete Column	EA	4	2	2	0	0
1090	Exposed Rebar	EA	2	0	2	0	0

3" of holes  
200

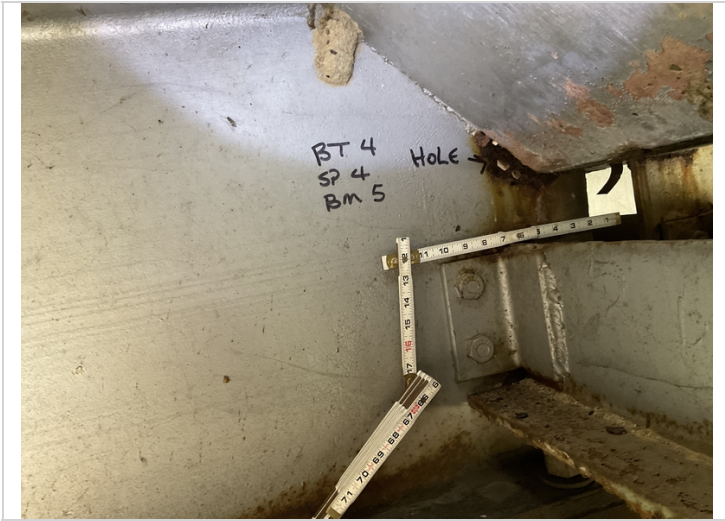
2" hole in web at the haunch  
2022

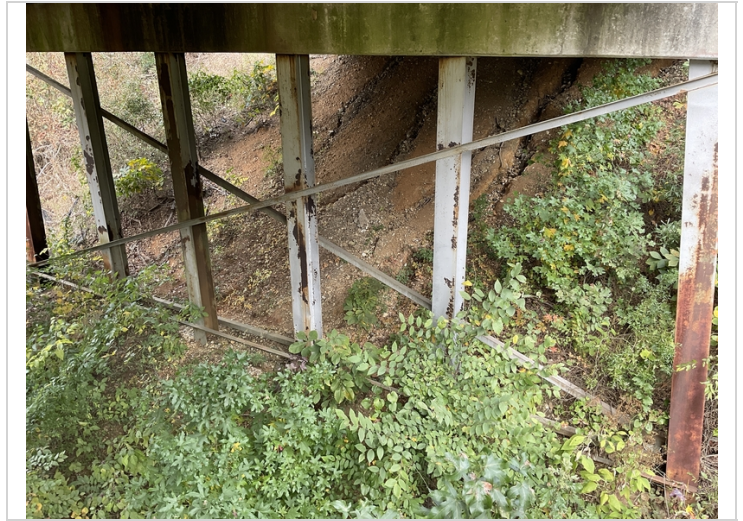
Bent 5: all pile with surface rust

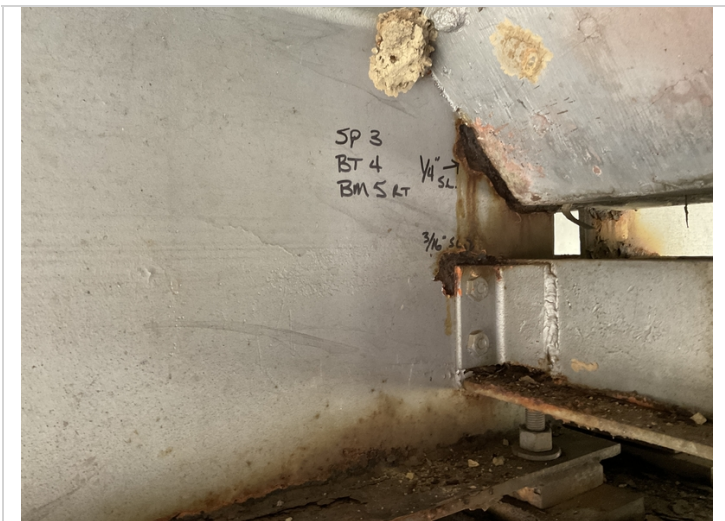
Section loss at the haunch and above diaphragm 2022

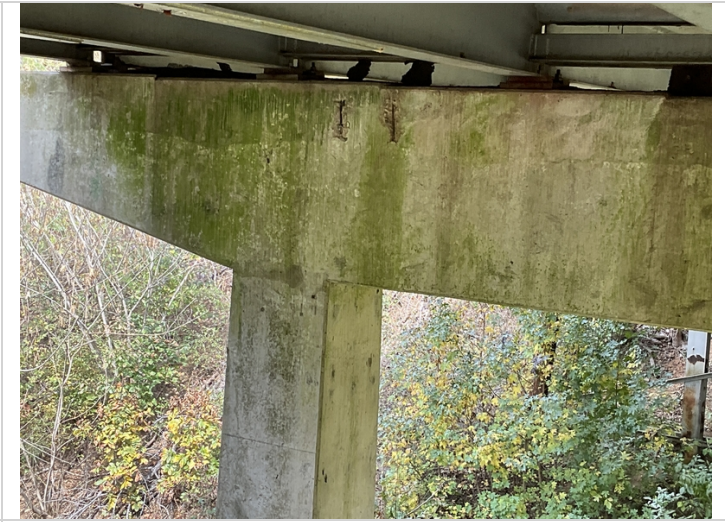
Backside of bent 4 cap has couple spalls with exposed rebar

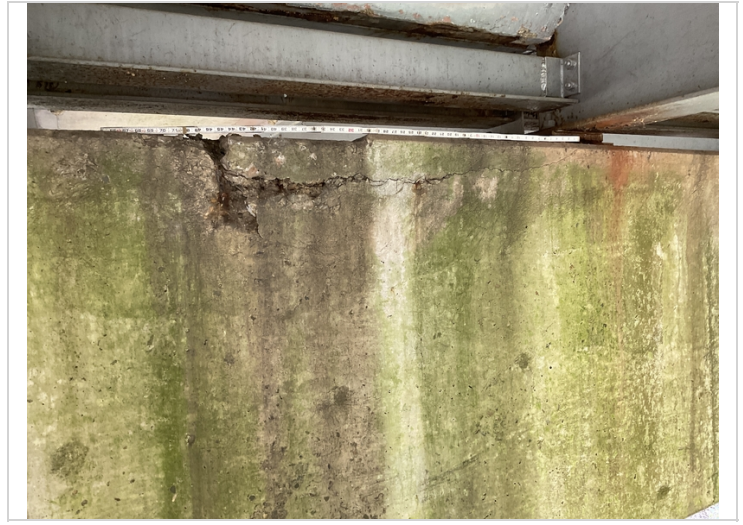
Ahead side of bent 3 between beams 5 and 6: spall and delam approximately 6 feet in length

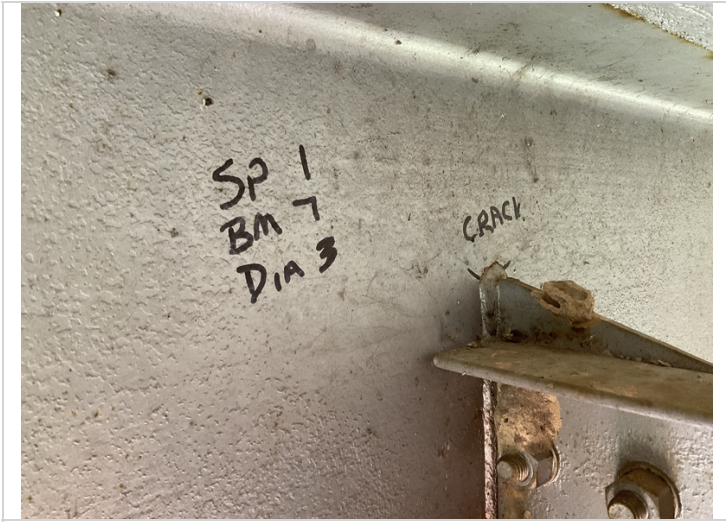
Span 1, beam 7, 3rd dia.: Crack to the weld  
2022

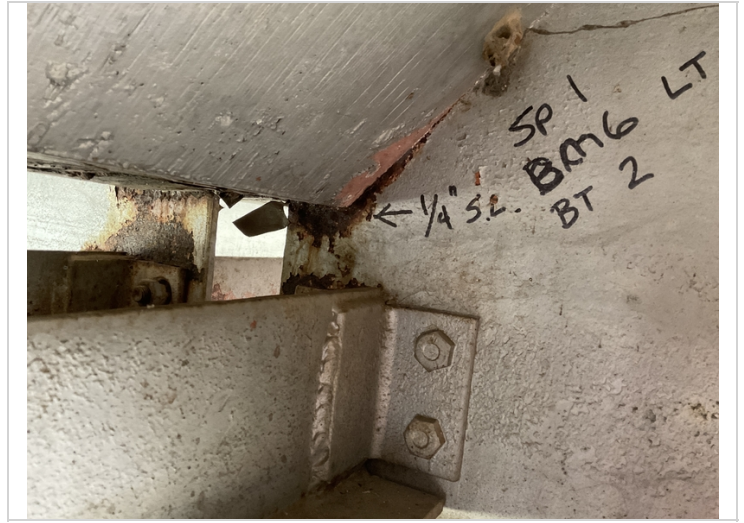
1/4" section loss at the haunch 2022

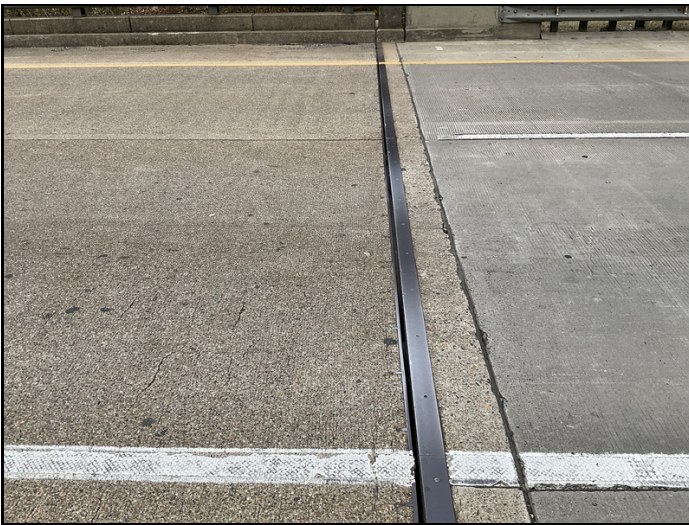
Bent 6: majority of joint seal missing.  
2022

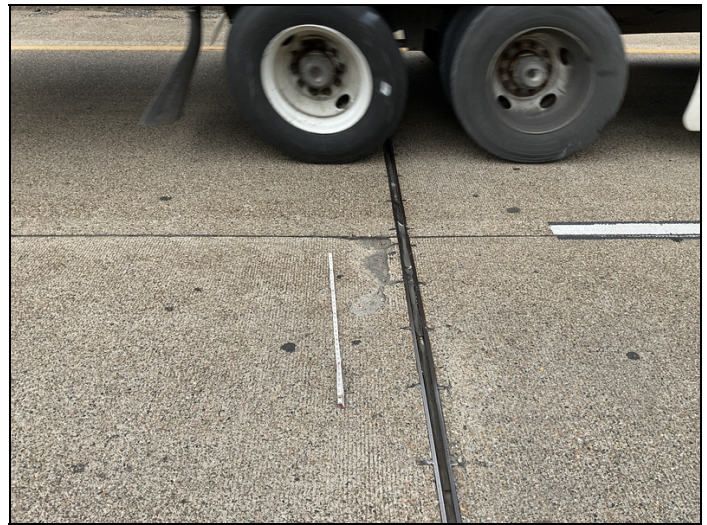
Bent 5: joint seal has lost bond allowing water to leak  
through.  
2022

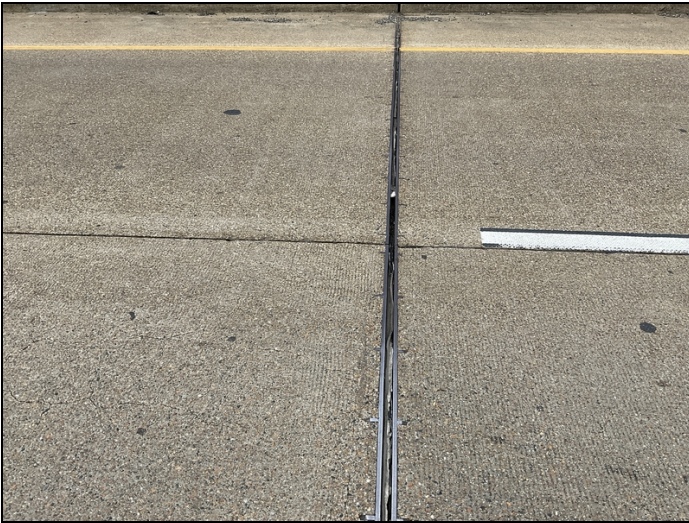
Bent 3: entire joint seal damaged

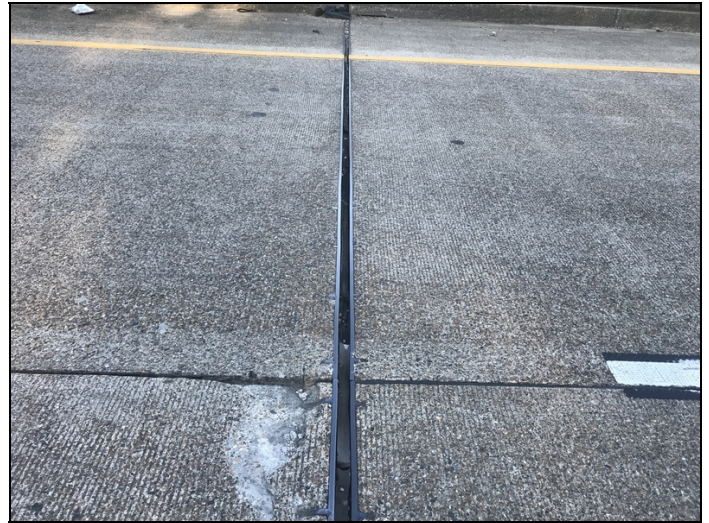
Bent 5 joint seal is damaged and leaking. Common all joints.

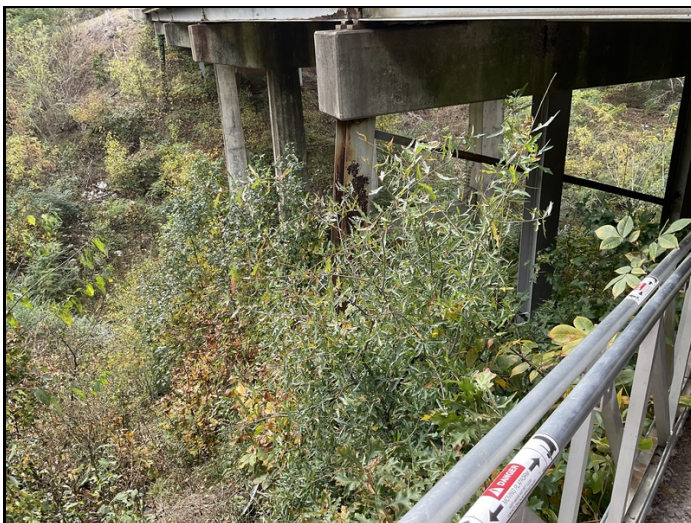
Both sides of bridge has trees and heavy vegetation making it difficult to use the Aspen inspection vehicle.

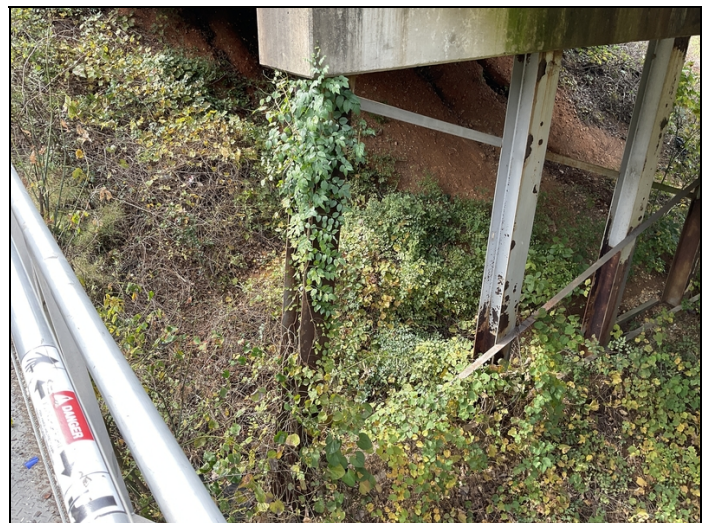
Bent 2: vines climbing onto pile 6

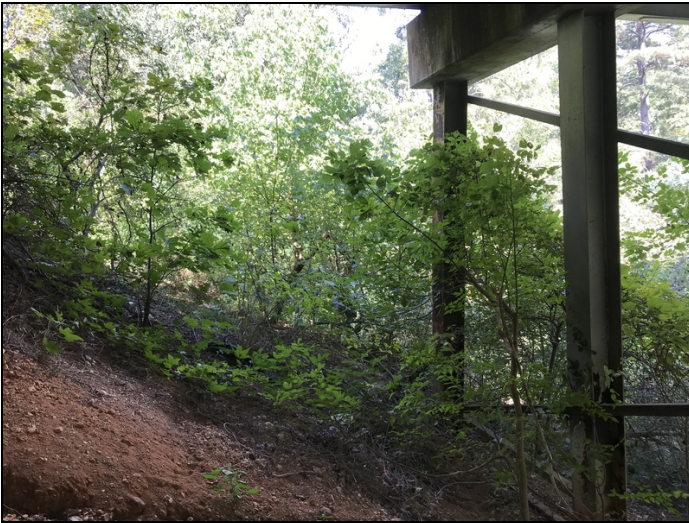
Trees growing under bridge in span 1.

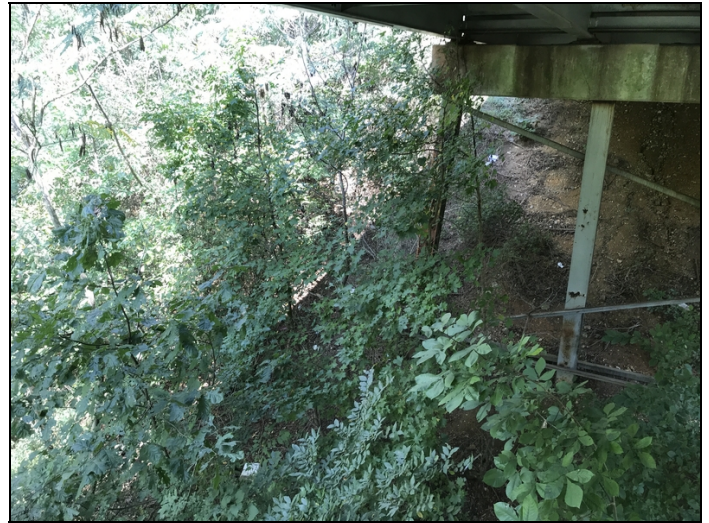
Trees growing in span 4.

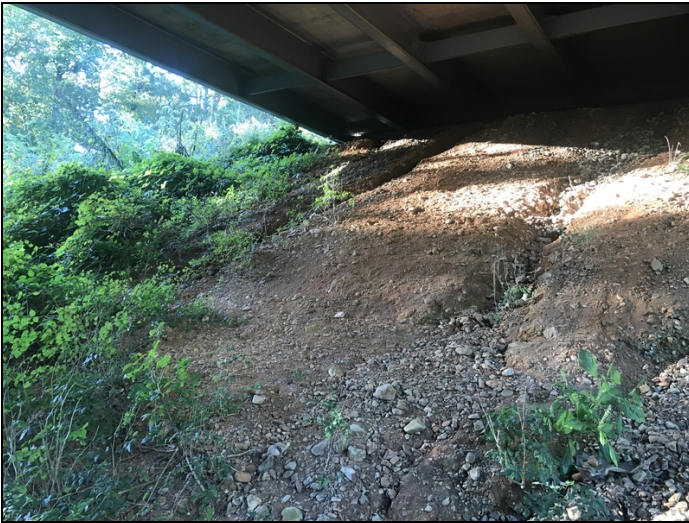
State forces have cut trees growing under span1.  
Common span 4.

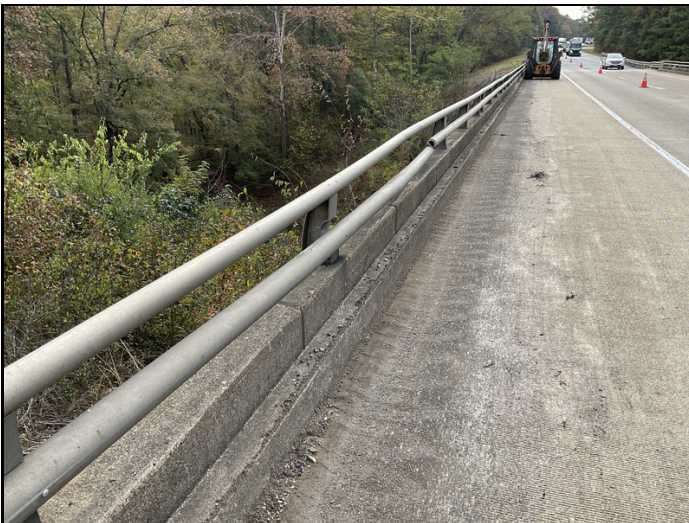
Span 5, right rail damaged due to traffic impact

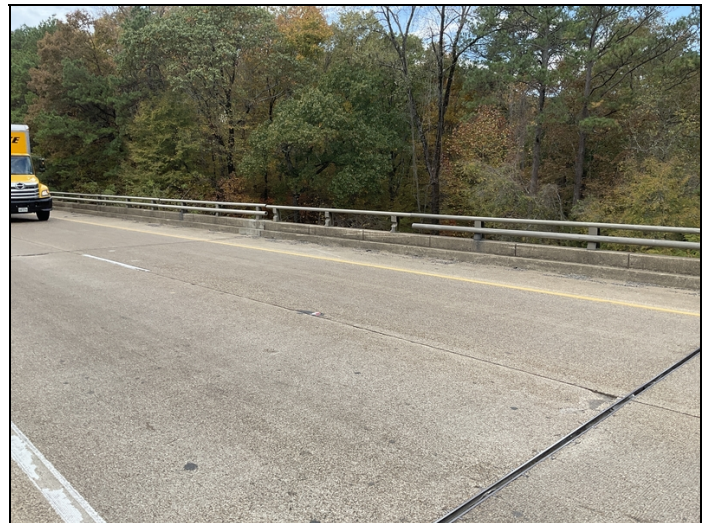
Span 4: left rail is damaged due to traffic impact. 2022

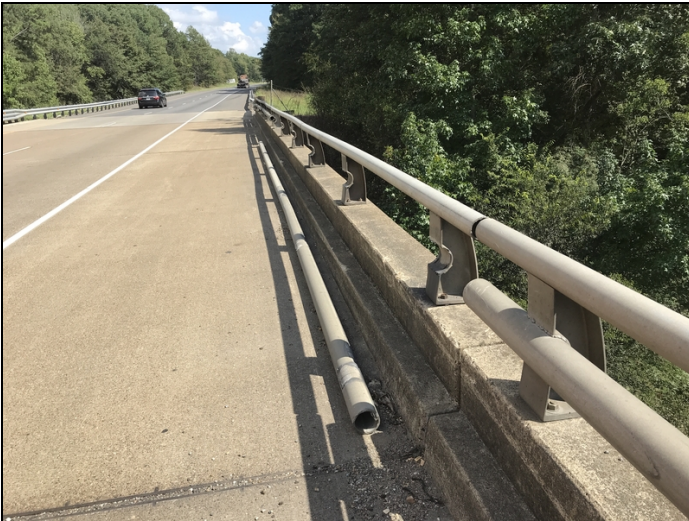
Span 4 collision damage to bridge rail, bottom rail section is missing. Right side

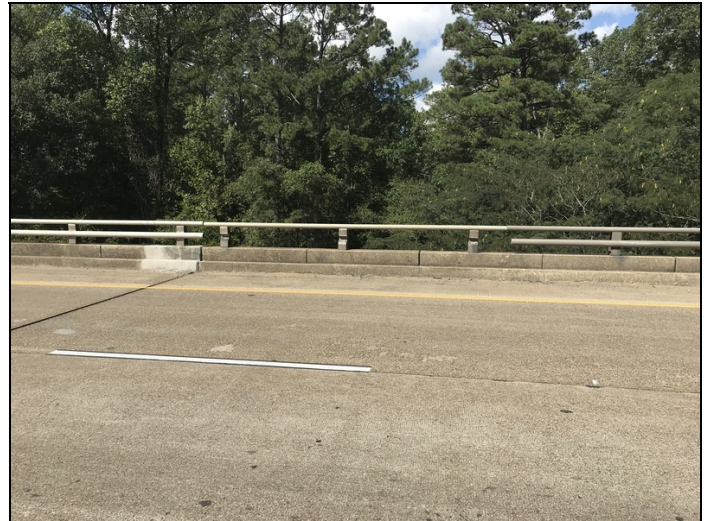
Span 4 left side collision damage to metal bridge rail.

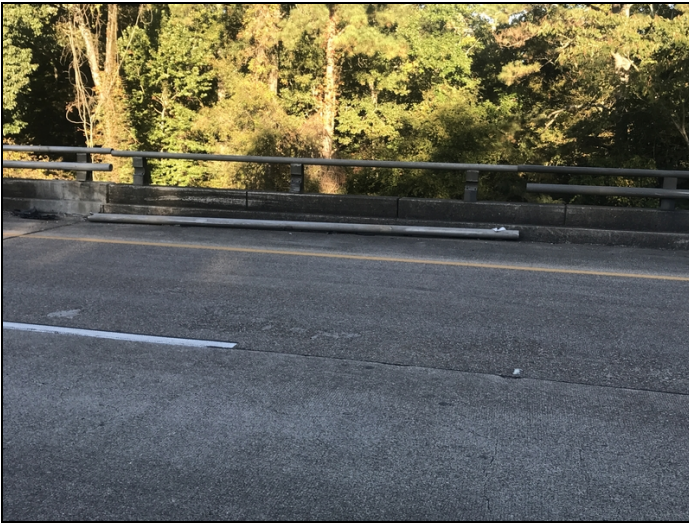
Left bridge rail at span 4 is damaged due to traffic impact.

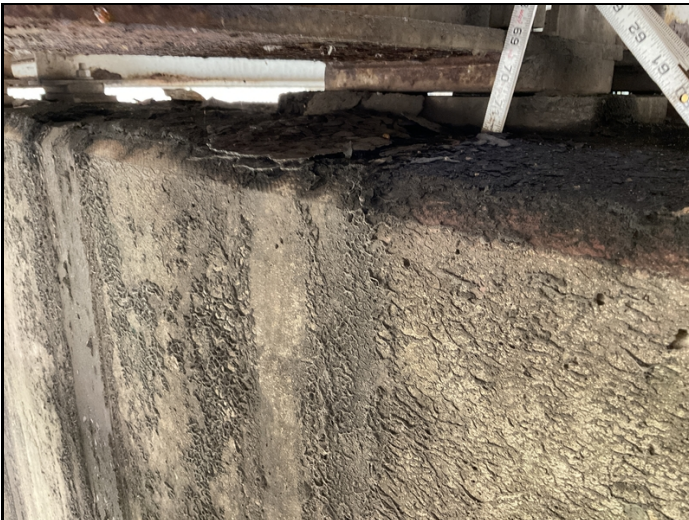
Bent 4, beam 5, span 4: beam floating

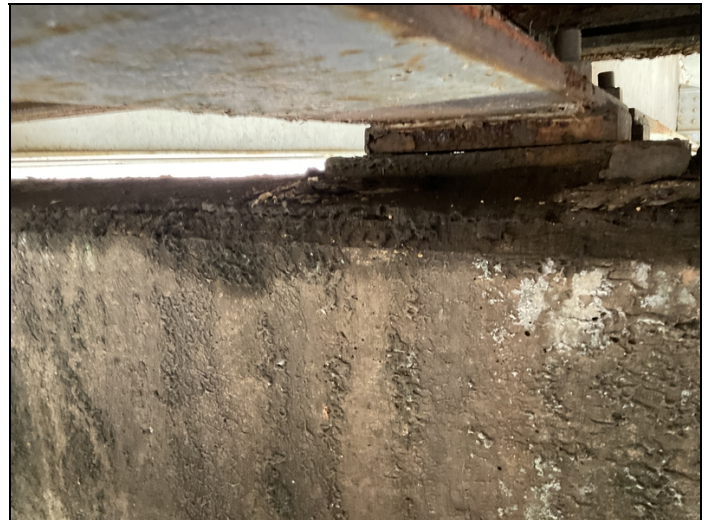
Span 3, bent 4, beam 5: beam is floating and causing a rattling sound

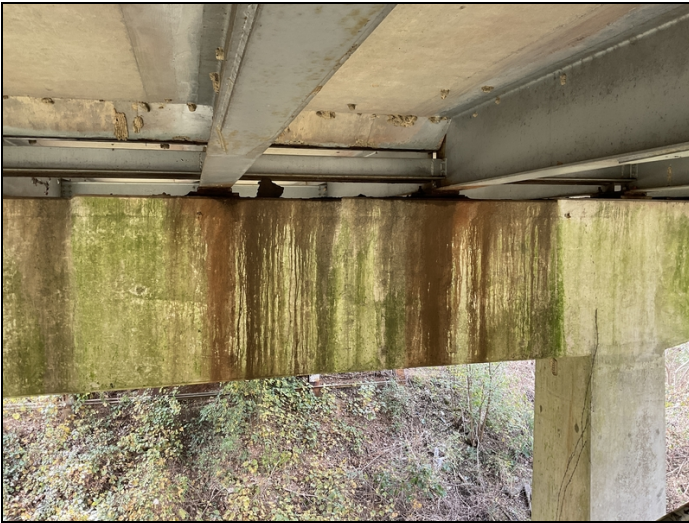
Looking back at bent 3: beams 3&4 the beams are floating causing the bearings to have getting rust

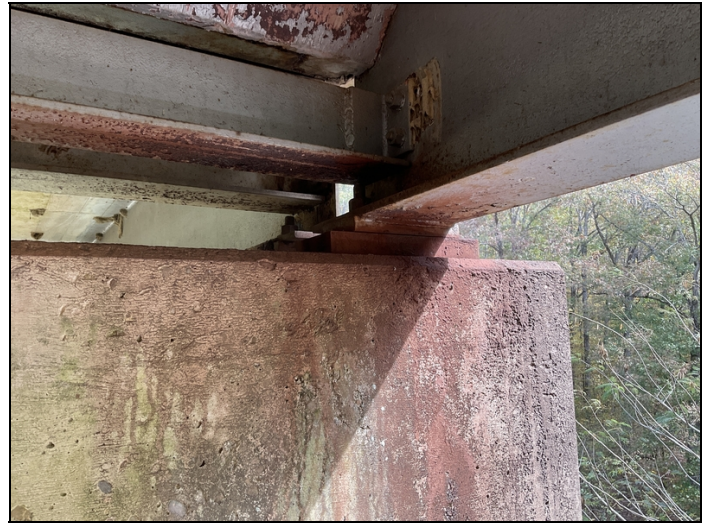
Span 1, bent 2, beam 7: beam is floating.

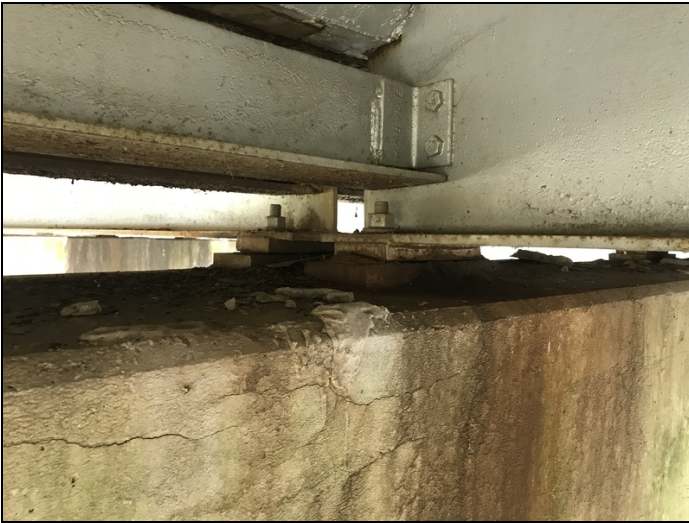
Bent 3 bearings 3 ahead and back have movement.

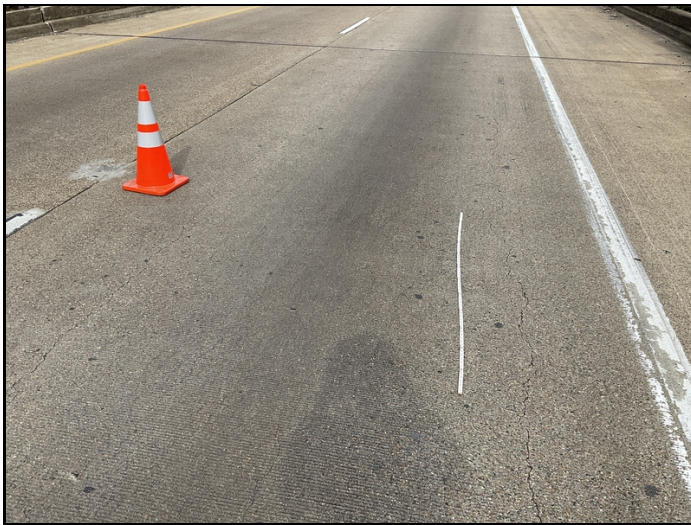
Span 1: multiple unsealed longitudinal cracks

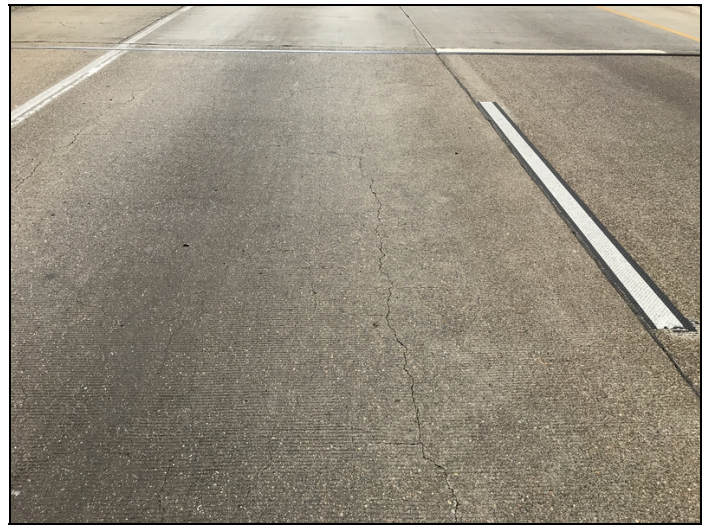
Span 1 longitudinal cracks.

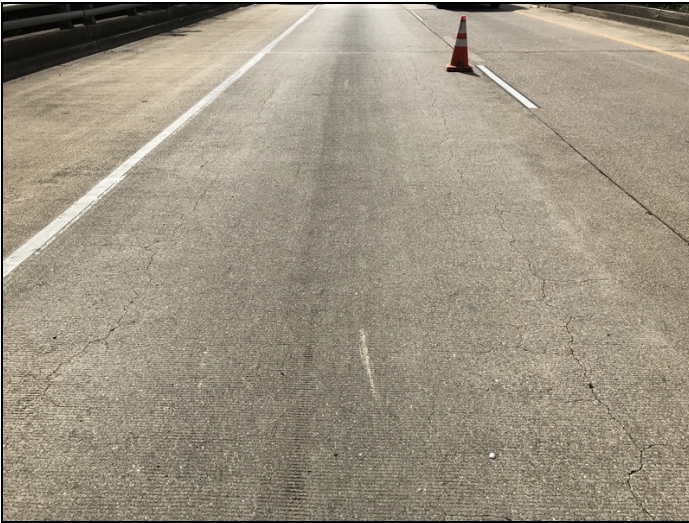
Span 2 large longitudinal cracks.

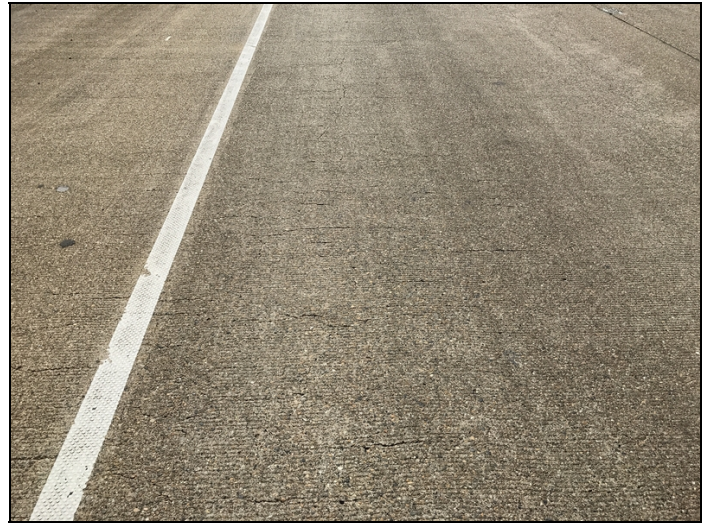
Span 5 longitudinal and transverse cracks.

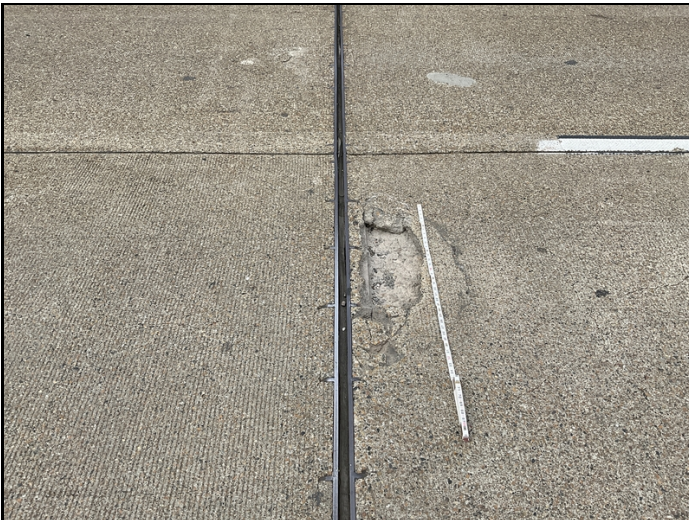
Bent 4: small spall in the lane just right of centerline.

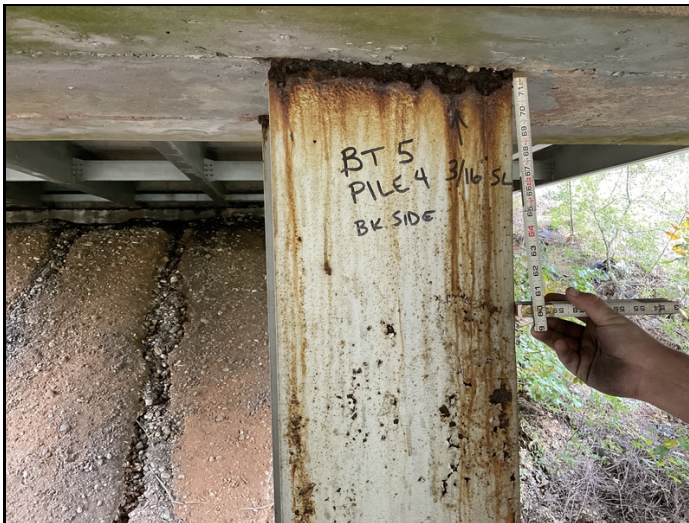
Bent 5, pile 4: top of the pile has up to 3/16" section loss adjacent to the cap. Similar condition at piles 2,3&4.

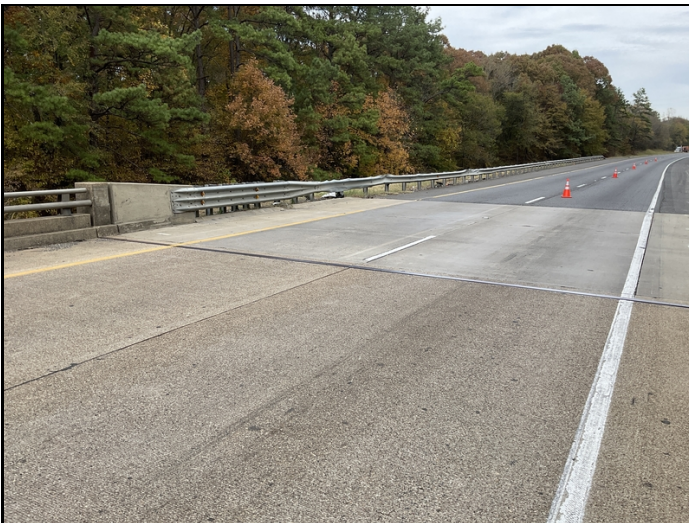
North west end: Left guard rail damaged from traffic impact

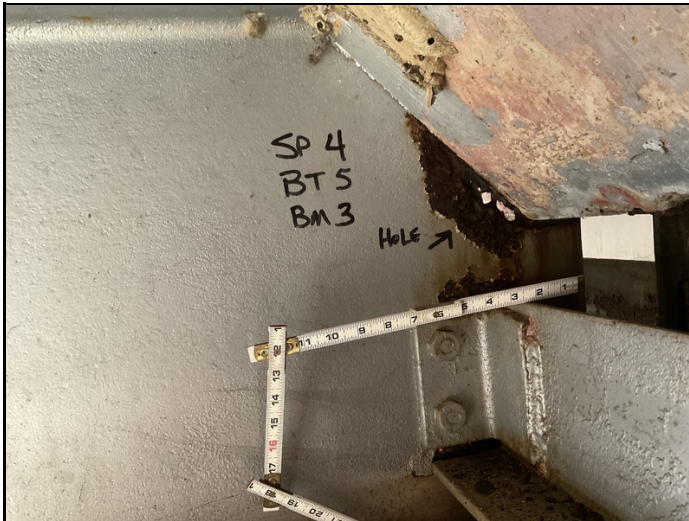
Span 4, bent 5, beam 3: 3" hole in the web at the haunch area.

3" of holes

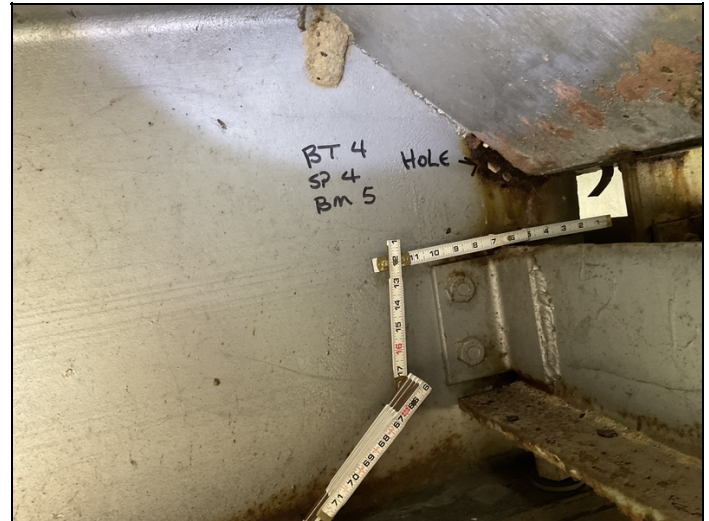
Span 4, bent 4, beam 5: 2" hole in the web at the haunch area.

2" hole in web at the haunch

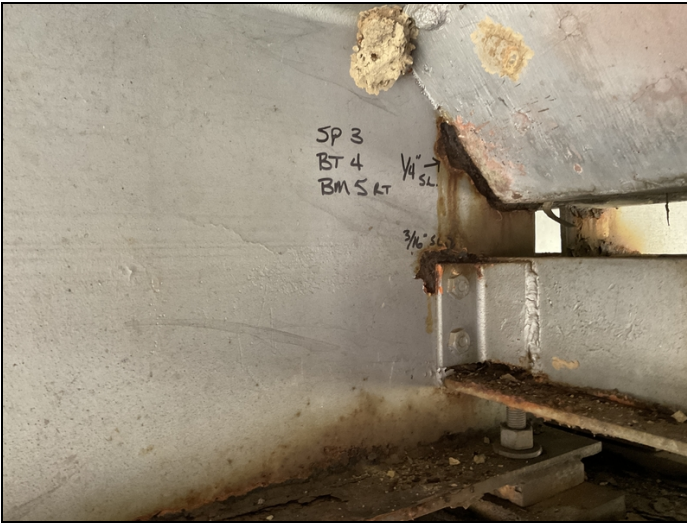
Beam ends at bents 2 thru 5 have section loss up to 1/4" to bottom flange and top portion of web at the haunch.

Section loss at the haunch and above diaphragm 2022

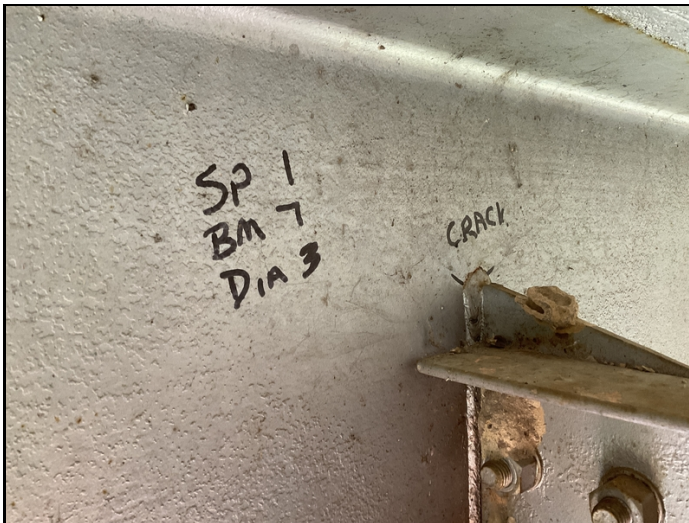
Span 1, beam 7, 3rd dia.: Crack to the weld
