Asset #03158(Routine)

US 67-SEC 10 NB over I40-SEC 33 LOG 154.85

Location: 1.5 MI W OF SH 161/I-6

Team Lead: Chris Doggett, Inspection Date: 07/26/2021

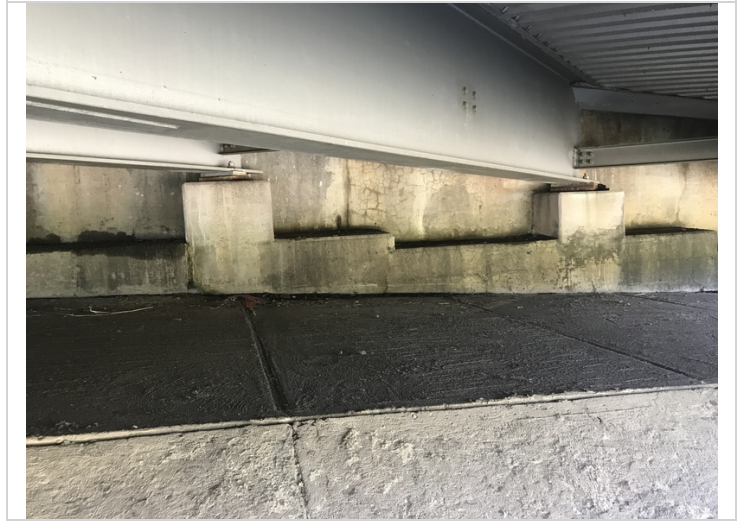
(215) Bent 1 has scattered cracks in the original section. Bent 6 has some scattered cracks.							
234	Reinforced Concrete Pier Cap	LF	271	232	35	4	0
1080	Delamination/Spall/Patched Area	LF	6	0	4	2	0
1090	Exposed Rebar	LF	2	0	0	2	0
1130	Cracking (RC and Other)	LF	31	0	31	0	0

Bent 1: backwall with map cracking between girders 3&4.

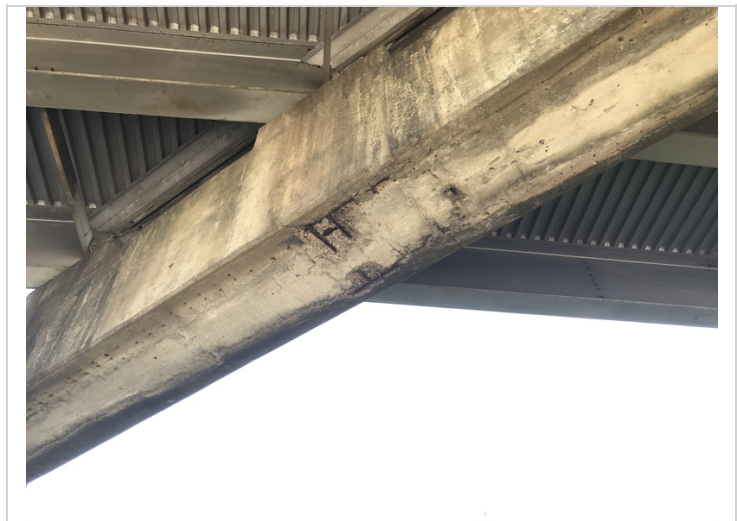
(234) Bent 3 has a spall with exposed rebar on the back face and areas of delaminations on the ahead side. Bent 4 spall with exposed rebar, on the bottom between cols. 1&2. Bents 3, 4 and 5 have map cracking.							
301	Pourable Joint Seal	LF	130	130	0	0	0

Bent 4 cap: bottom of cap between columns 1&2 has spall with exposed rebar

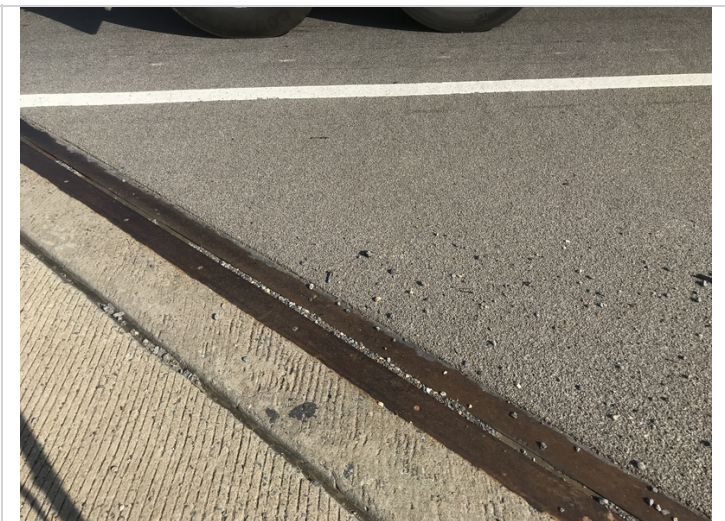
7/26/2021 A wearing surface has been placed throughout the entire deck surface.

Entire deck surface has had a wearing surface added to it since last inspection

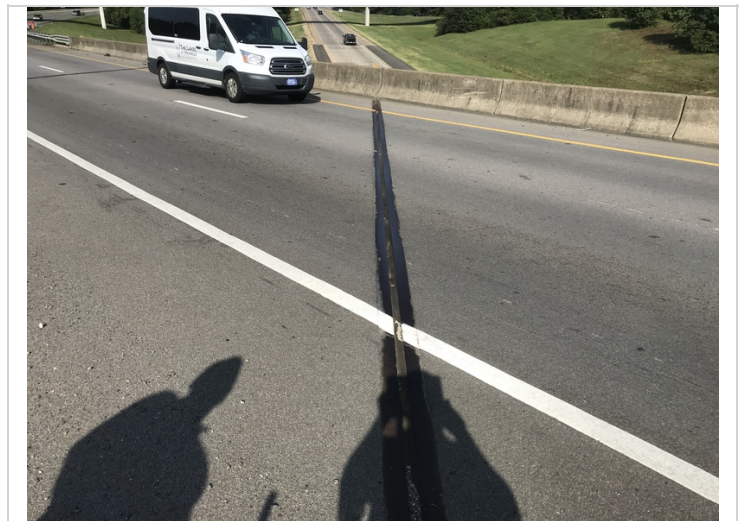
Joint seals have been replaced. 2021

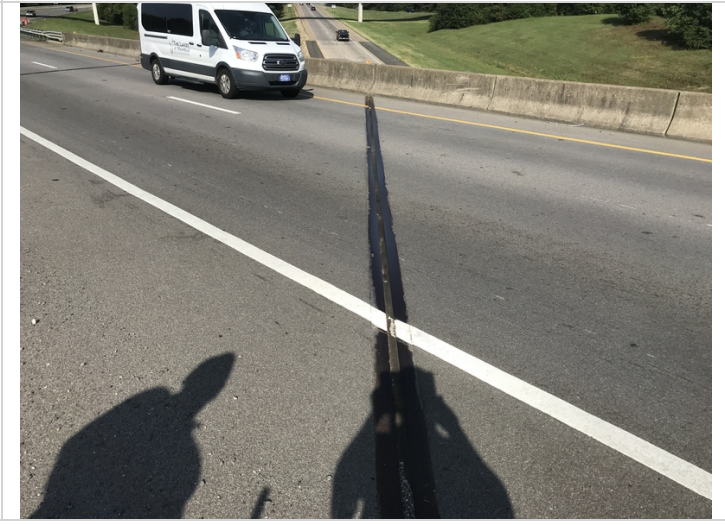
Joint seals have been replaced. 2021

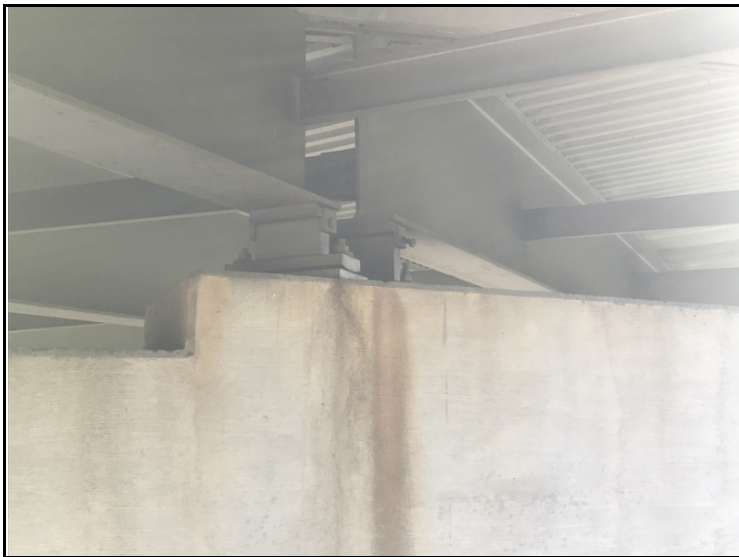
Bent 2 span 2 on beam 6 has a broken bearing bolt.

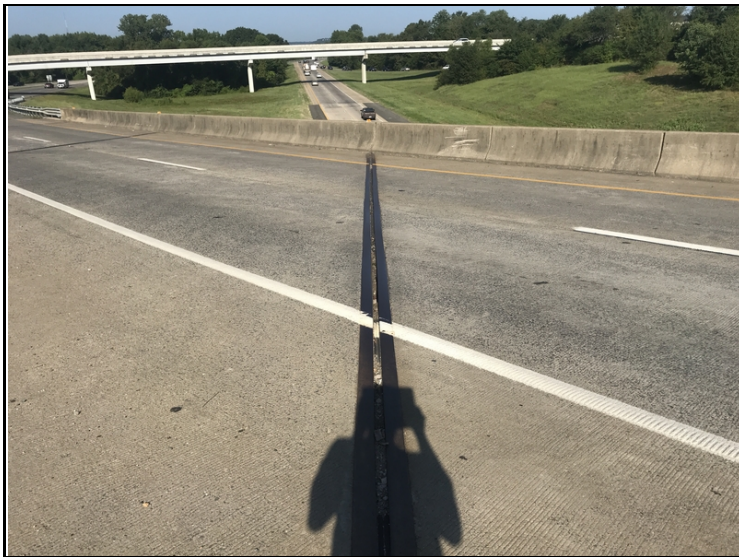
Joint seal at bents 3 and 6 have lost bond allowing dirt to accumulate on abutment and bearings.

Bent 3 joint seal has lost bond allowing dirt and debris to accumulate. Common bent 6.

Joint seals have been replaced. 2021

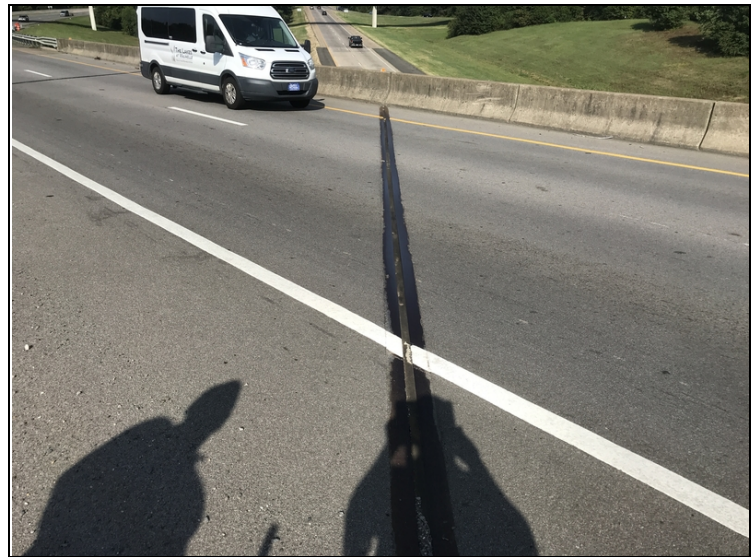
Joint seals have been replaced. 2021

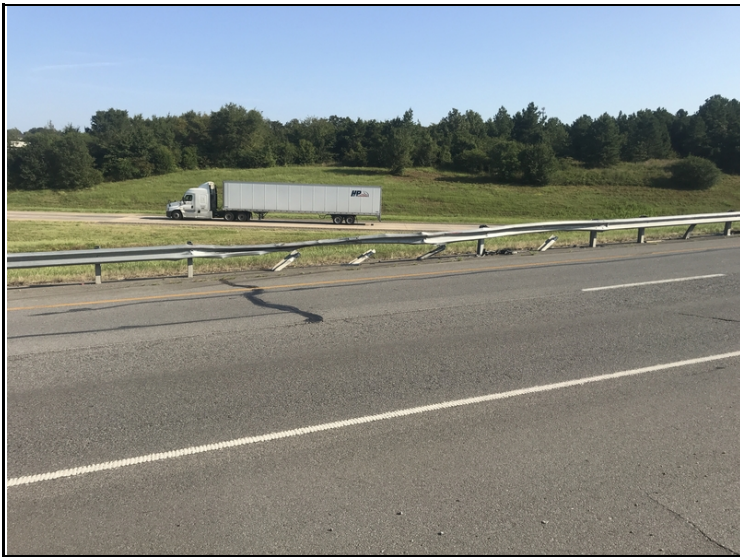
Right rail and end treatment has been damaged due to traffic accident.
Left approach rail and end treatment has been damaged due to traffic accident

Left approach guard rail damaged due to traffic impact.

Assigned to Pulaski I 5/24/21.

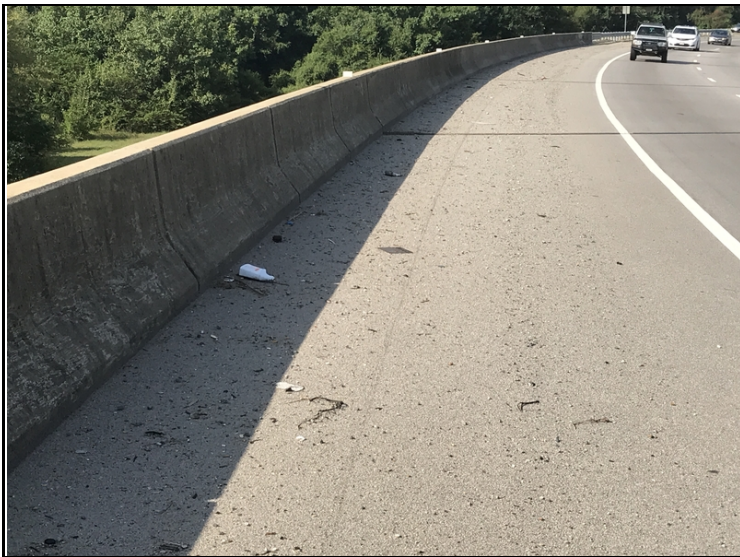
Right shoulder with large amount of debris
