Asset #06641 (Routine)

Spring Hill O.P. over I-40 Log 155.93

Team Lead: Chris Doggett, Inspection Date: 03/16/2022

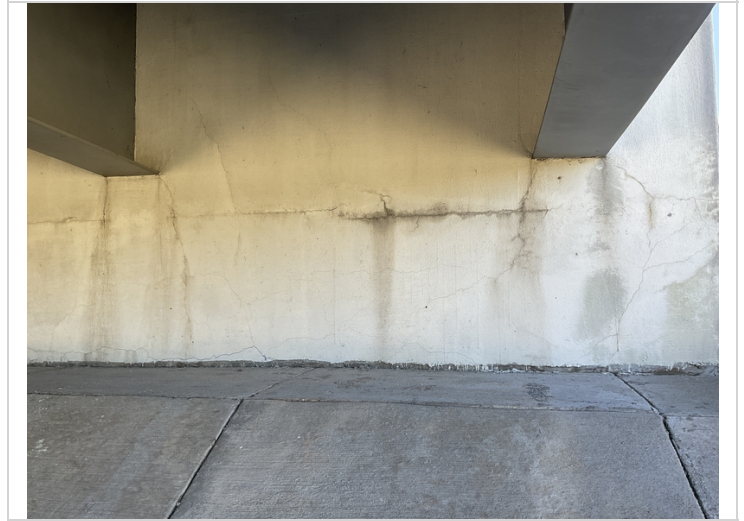
(215) Abutments have multiple vertical/horizontal cracks. Bent 3 has large horizontal cracks near the bottom between girders 4-6.							
234	Reinforced Concrete Pier Cap	LF	54	52	2	0	0
1130	Cracking (RC and Other)	LF	2	0	2	0	0

Bent 1: numerous horizontal and diagonal cracking  
throughout the entire abutment.  
Bent 3 is in similar condition

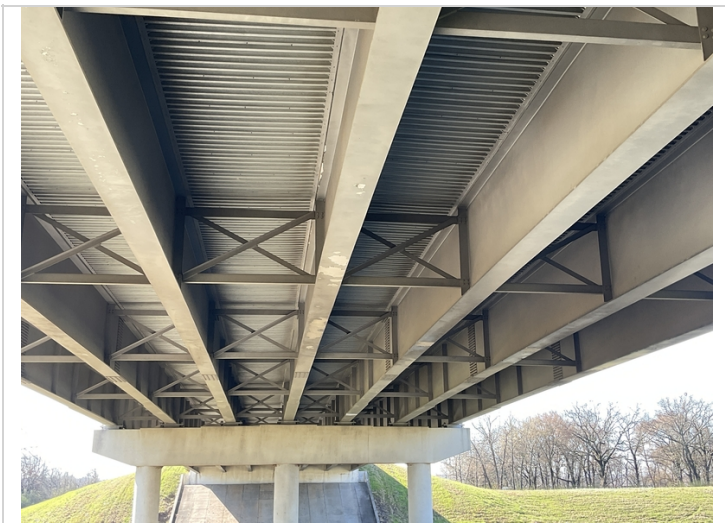
(107) Spans 1 and 2 have areas of peeling paint on the diaphragms and bottom and top flanges of the girders. Outside girders have chalking.							
(515-107) Areas of peeling paint.							
205	Reinforced Concrete Column	EA	3	1	2	0	0
1130	Cracking (RC and Other)	EA	2	0	2	0	0

Span 2: girders 3&4 have areas on the bottom flange with  
peeling paint

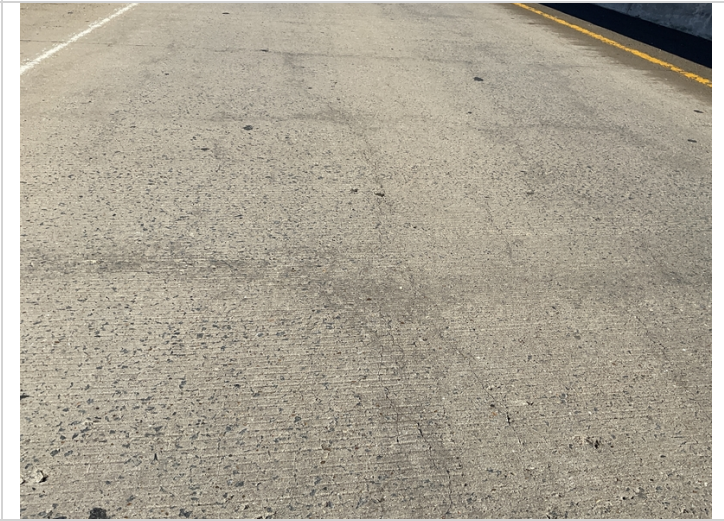
Span 2: multiple longitudinal cracks

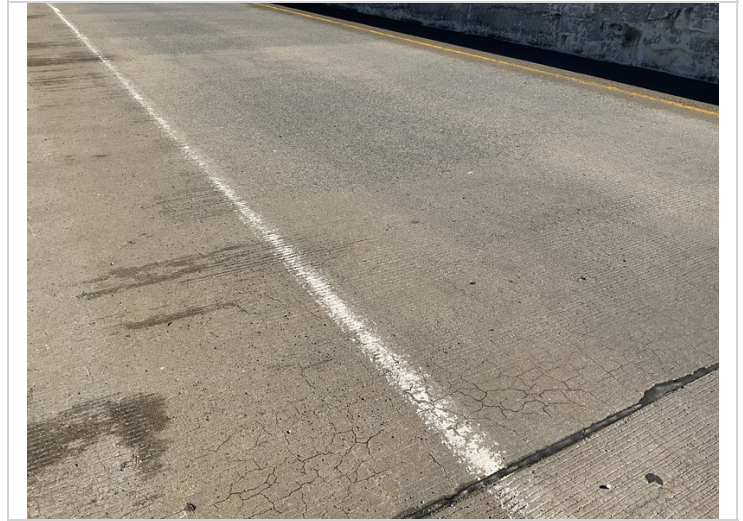
Span 1: map cracking

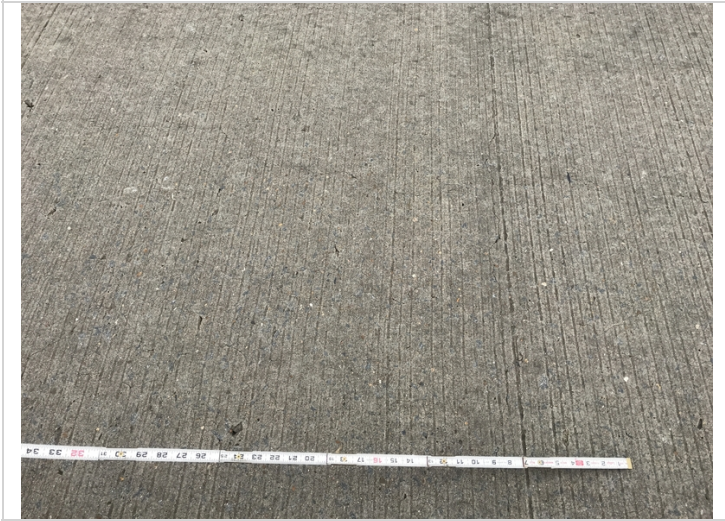
(12) Deck has longitude/transverse cracks in all spans and cracks in soffit with light efflorescence.							
107	Steel Open Girder/Beam	LF	2065	2065	0	0	0
515	Steel Protective Coating	SF	32400	28673	3727	0	0
3410	Chalking (Steel Protective Coatings)	LF	3627	0	3627	0	0
3420	Peeling/Bubbling/Cracking	LF	100	0	100	0	0

Span 2 deck cracking longitudinal and transverse cracks, common span 1.

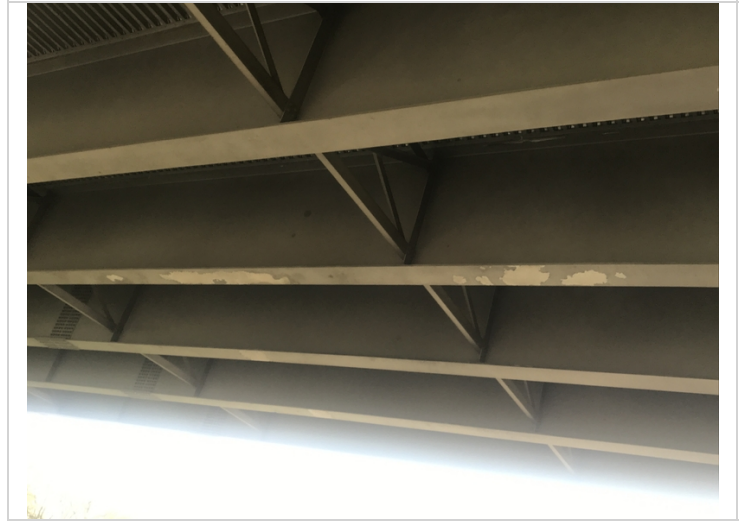
Span 2 beams have peeling paint on bottom flanges.

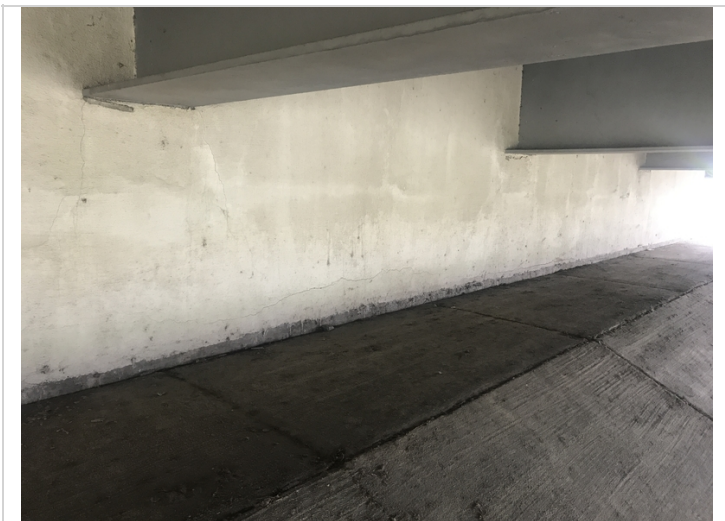
Bent 3 abutment has horizontal cracks under beams 4-6.

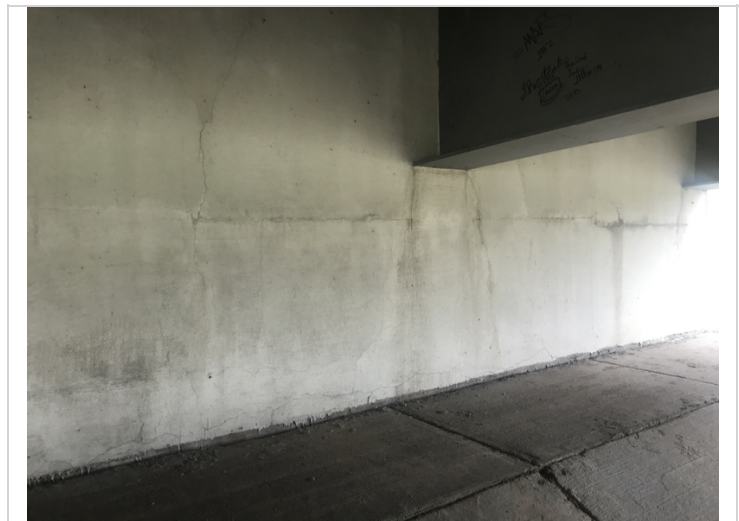
Abutment 1 has horizontal cracking and vertical cracking at beam 2.

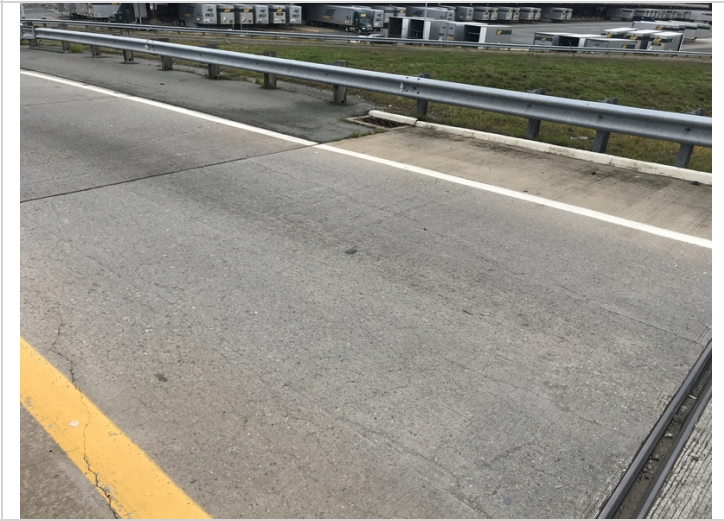
ELEMENTS	DESCRIPTION	UNITS	TOTAL	CS1	CS2	CS3	CS4
(321) All approach slabs have large longitudinal and diagonal cracks.							
331	Reinforced Concrete Bridge Railing	LF	894	0	596	298	0
1130	Cracking (RC and Other)	LF	894	0	596	298	0
(331) Median wall has large horizontal cracks. Outside bridge railing have longitudinal and horizontal cracks.

Approach slab at North end of bridge has unsealed longitudinal and transverse cracking.

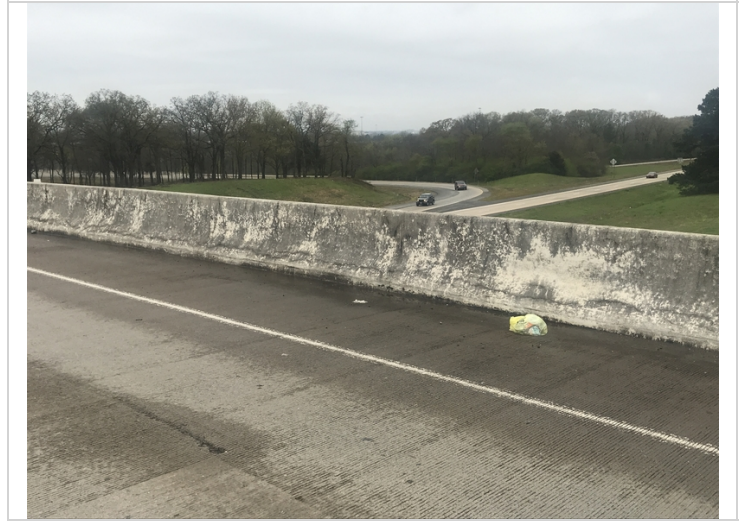
Concrete bridge railing has cracking, both left and right sides.

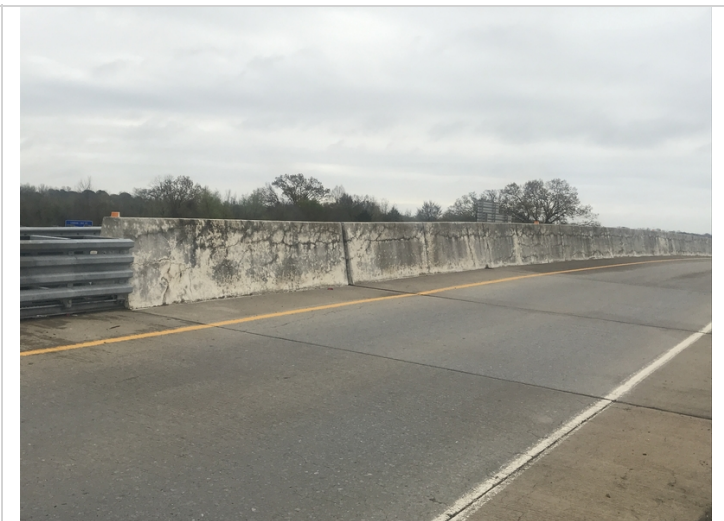
Median concrete barrier wall has cracking.

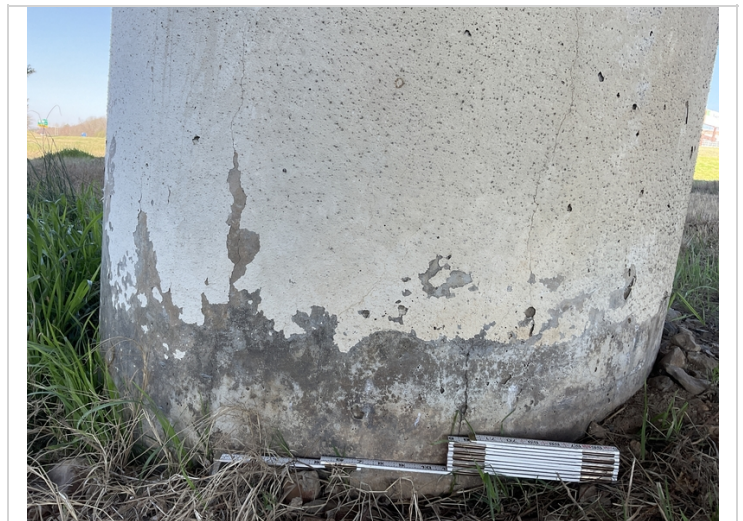
(205) Bent 2 columns 1 & 3 have vertical cracks near the bottom of the columns.							
215	Reinforced Concrete Abutment	LF	172	0	162	10	0
1130	Cracking (RC and Other)	LF	172	0	162	10	0

Bent 2, Column 1: has vertical cracks near bottom of column. Similar condition at column 3.

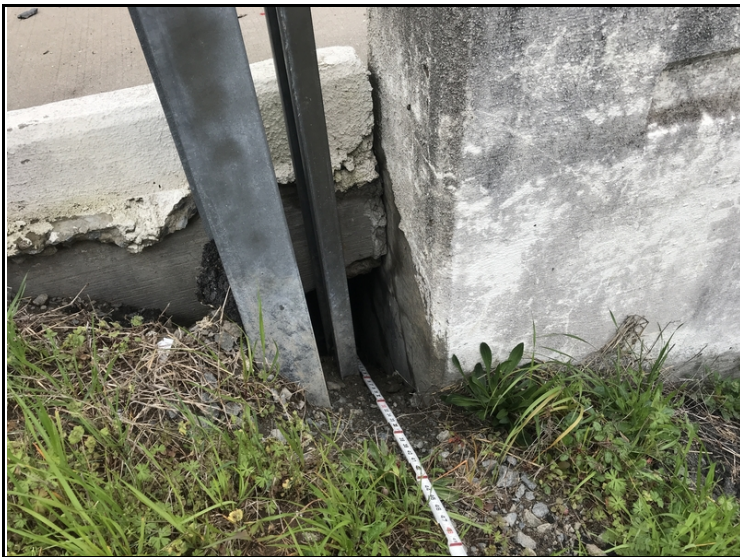
Approach slab at bent 1 northbound has 2' void under approach slab at abutment.

Approach slab at bent 1 northbound has 2' void  
under approach slab at abutment.

**Date Reported:** 03/24/2020  
**Priority:** C - Important  
**Type of Work:** Repair (General)  
**Status:** Assigned  
**Component:**

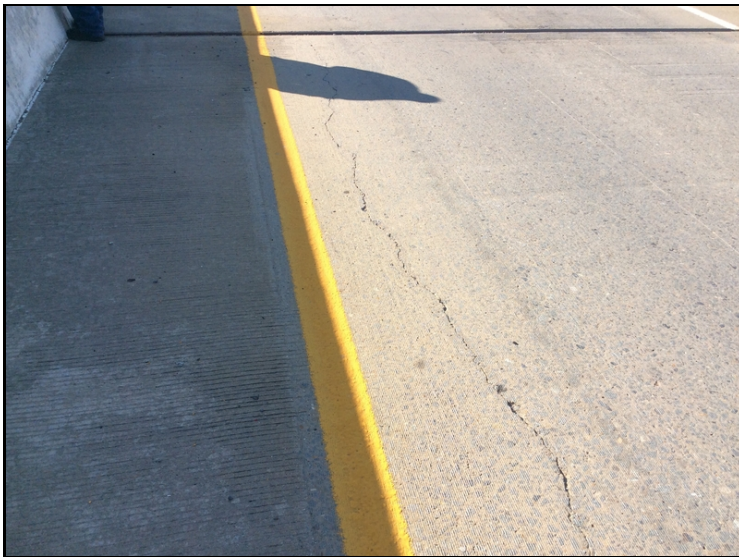
Approach slabs: Approaches have large longitude cracks and smaller diagonal cracks.

Northeast approach, large unsealed cracks.

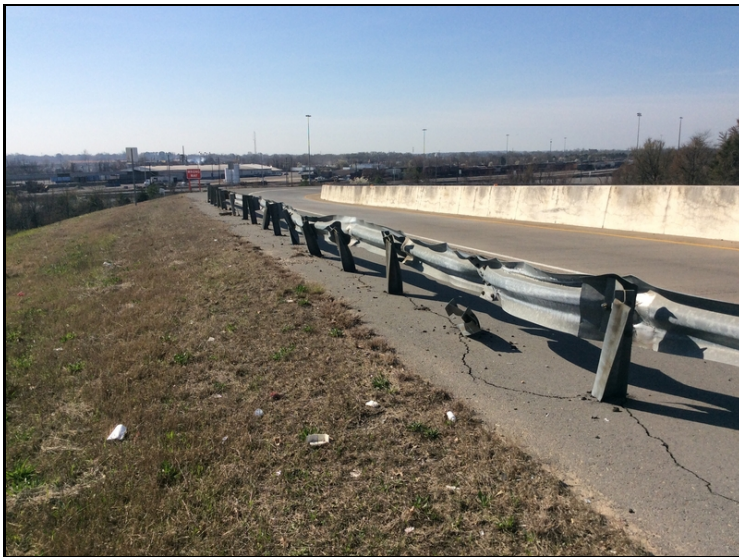
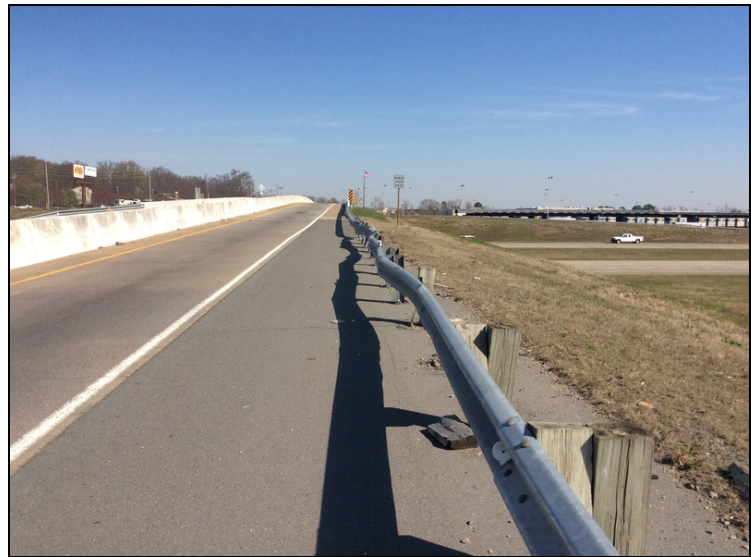
Northbound approach guardrail damaged due to traffic impact.

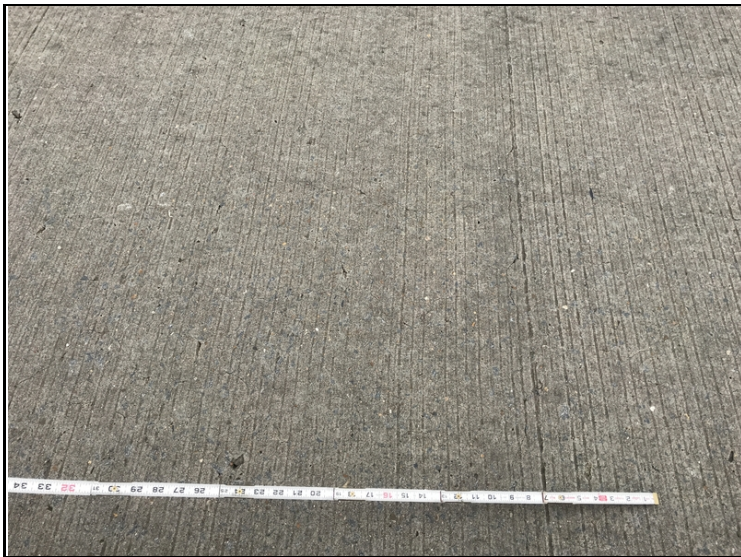
Deck has large unsealed cracks.

Span 2 deck cracking longitudinal and transverse cracks, common span 1.

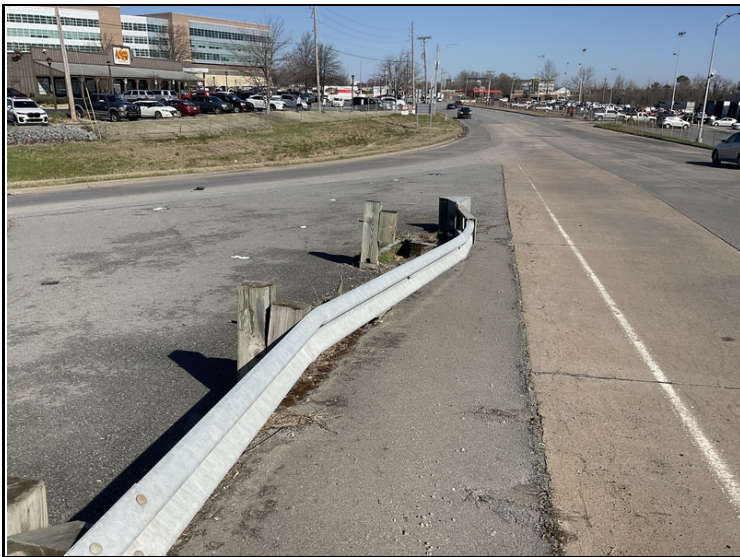
South bound approach rail has been damaged due to traffic impact.

**Date Reported:** 03/17/2022  
**Priority:** C - Important  
**Type of Work:** Repair (General)  
**Status:** Open  
**Component:** Approach
