Asset #06658(Routine)

US 67 SB RAMP/40 over I-40 & US67 RAMPS

Location: .3 MI SO MCCAIN BLVD

Team Lead: Keith Harris, Inspection Date: 12/27/2021

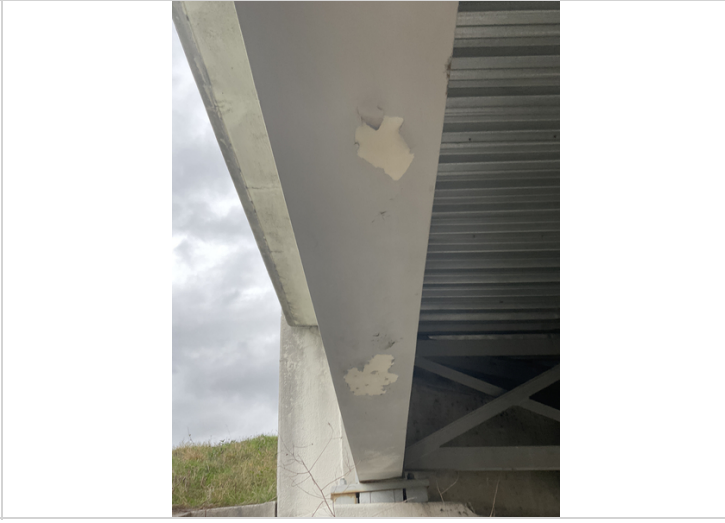
(107) Span 7 at bent 7 girder 1 & span 12 at bent 13 girder 3, Small area of active rust on the bottom of the bottom flange. The outside faces of girders 1&4 have chalky paint. There are scattered ares in all spans of peeling paint, the finish coat is peeling, exposing the primer coat (515-107) The outside faces of girders 1&4 have chalky paint. There are scattered ares in all spans of peeling paint, the finish coat is peeling, exposing the primer coat							
205	Reinforced Concrete Column	EA	11	11	0	0	0
210	Reinforced Concrete Pier Wall	LF	30	30	0	0	0

Span 1 girder 4 peeling paint

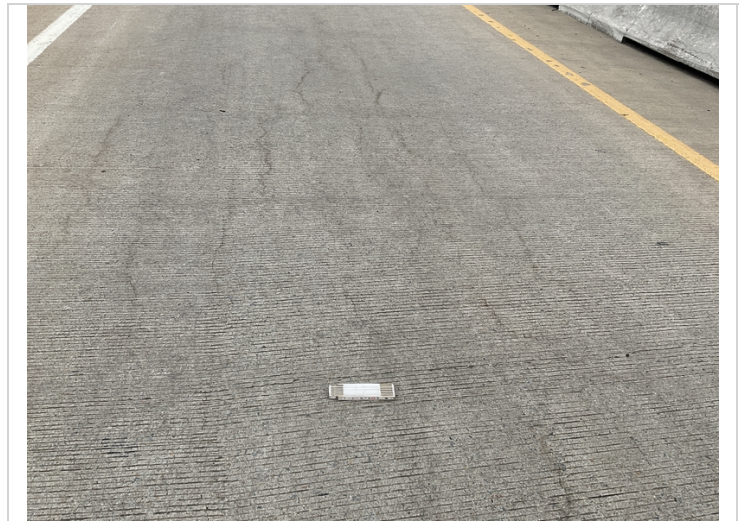
(12) All spans have transverse cracks and small areas of map cracks. Other spans have some random transverse cracks. 0.025 inch avg. some of the cracks were sealed during construction.							
107	Steel Open Girder/Beam	LF	6178	6176	2	0	0
1000	Corrosion	LF	2	0	2	0	0
515	Steel Protective Coating	SF	94462	70395	24067	0	0
3410	Chalking (Steel Protective Coatings)	LF	23547	0	23547	0	0
3420	Peeling/Bubbling/Cracking	LF	520	0	520	0	0

Span 10 deck cracking up to 0.025"

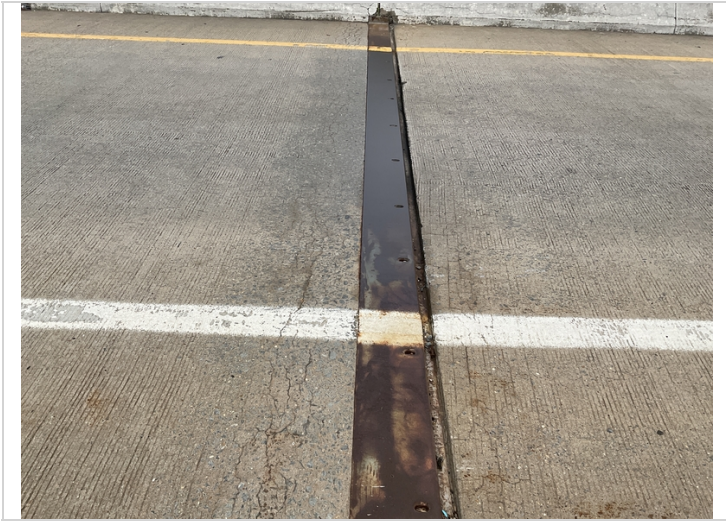
(303) The deck at bent 10 has a few small Spalls along the joint. Bent 16 joint has debris in trough							
310	Elastomeric Bearing	EA	80	80	0	0	0
321	Reinforced Concrete Approach Slab	SF	1152	980	172	0	0
1130	Cracking (RC and Other)	SF	172	0	172	0	0

Map cracking around joint at bent 10

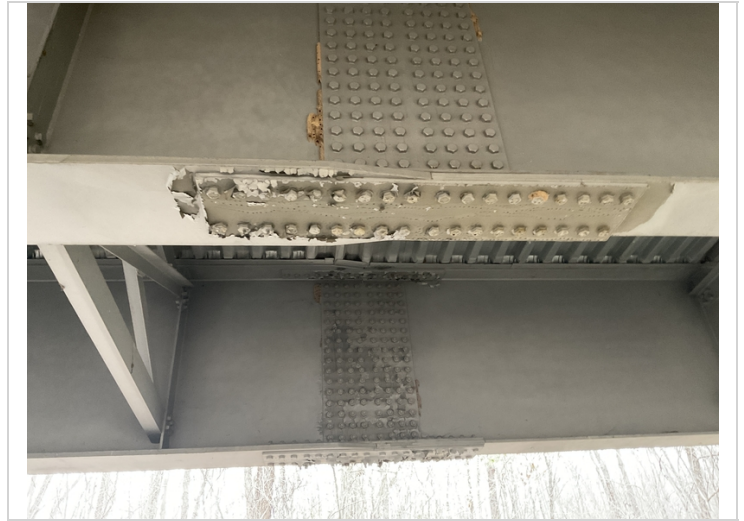
Span 13 peeling paint

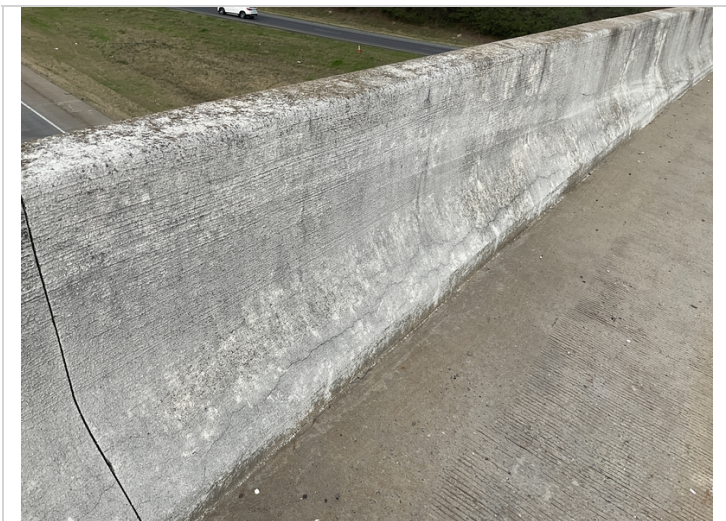
ELEMENTS	DESCRIPTION	UNITS	TOTAL	CS1	CS2	CS3	CS4
	(331) All of the rail has vertical cracks on 4 to 6 foot centers and several sections have horizontal cracking along the base of the railing.

Typical cracks in bridge rail

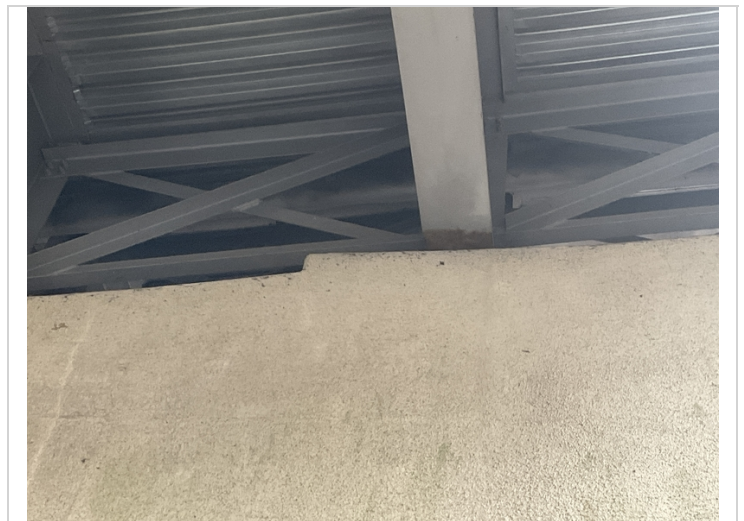
Span 12 at bent 13 girder 3 small area of active corrosion

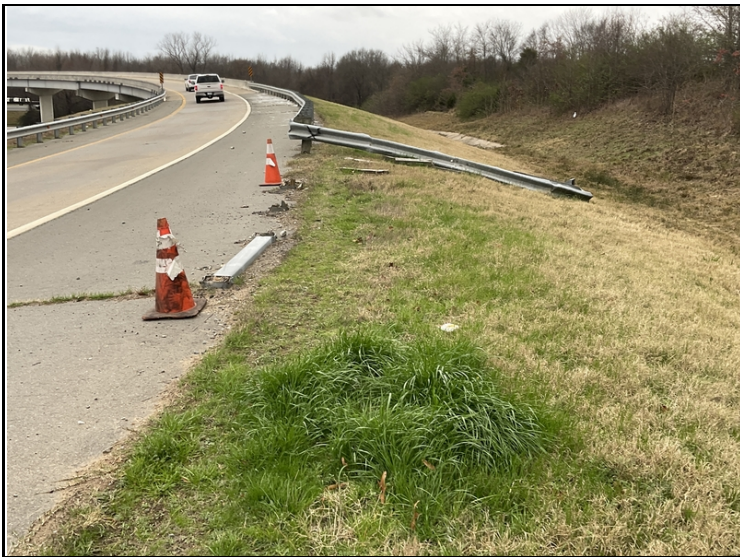
Approach guardrail is damaged from traffic impact.

Date Reported: 12/28/2021
Priority: C - Important
Type of Work: Repair (General)
Status: Open
Component:
