Asset #A3193(Routine)

I-40 WB Log 156.03 over UPRR

Location: 0.75 MI E OF SH 67

Team Lead: Keith Harris, Inspection Date: 07/21/2022

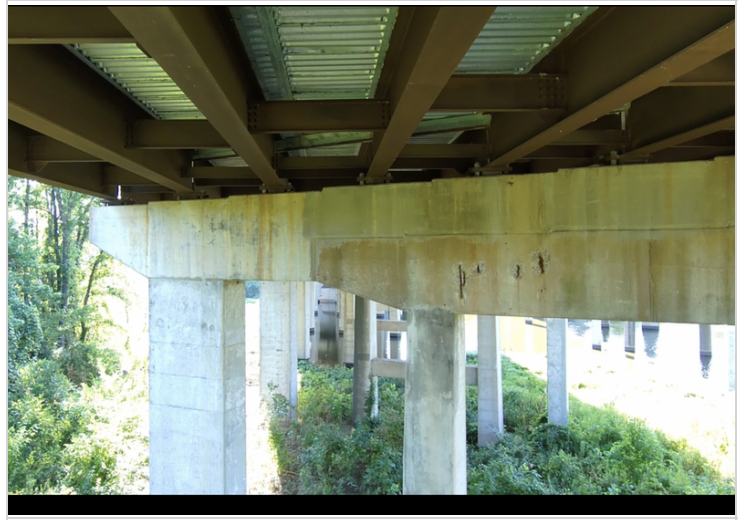
(234) Spalls with exposed rebar in the caps of bents 6,7,8 & 9 Scattered small cracks in several caps.							
301	Pourable Joint Seal	LF	407	207	200	0	0

Bent 7 spalls with exposed rebar

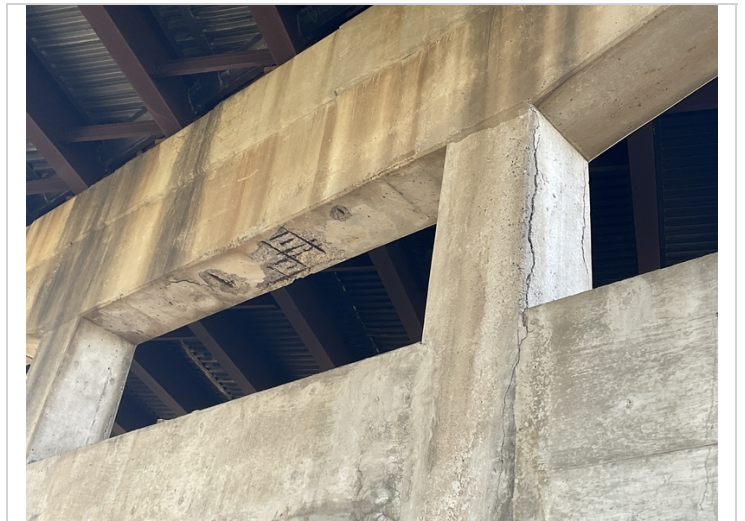
Spalls with exposed rebar on bottom of bent 3.
Large cracks in columns 2&3

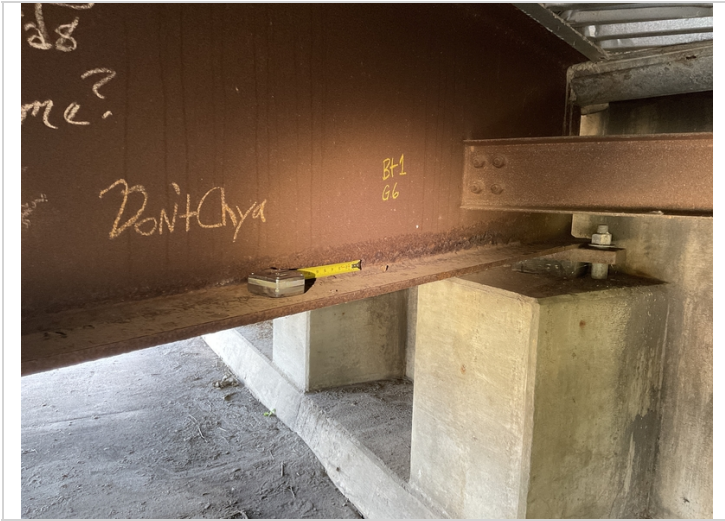
(107) All of the beams are brown with granular rust. Beam ends at bent 2 thru 12 have flaking rust to the bottom web & flange. Abutment 1 beam 5& 6, has flaking rust to lower web and bottom flange, (515-107) All girders have a granular texture							
205	Reinforced Concrete Column	EA	43	27	3	13	0
1130	Cracking (RC and Other)	EA	16	0	3	13	0

Bent 1, girder 6: laminating rust and active corrosion to the bottom flange and lower web. Common girder 5

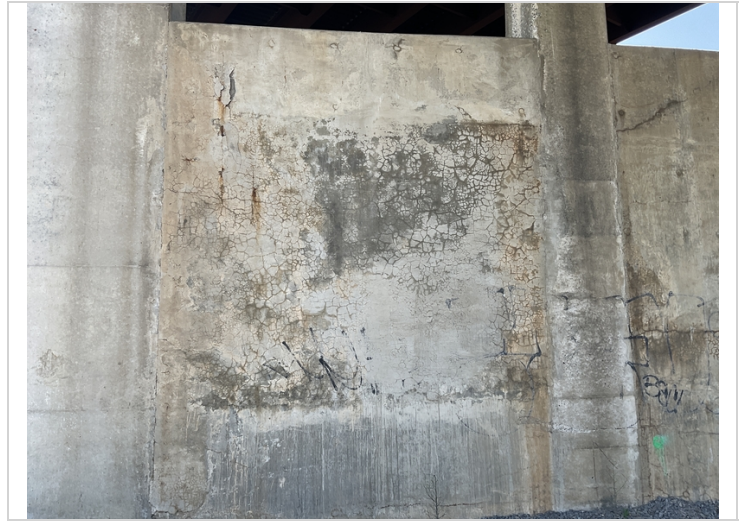
Bent 3 map cracking and exposed rebar in pier wall

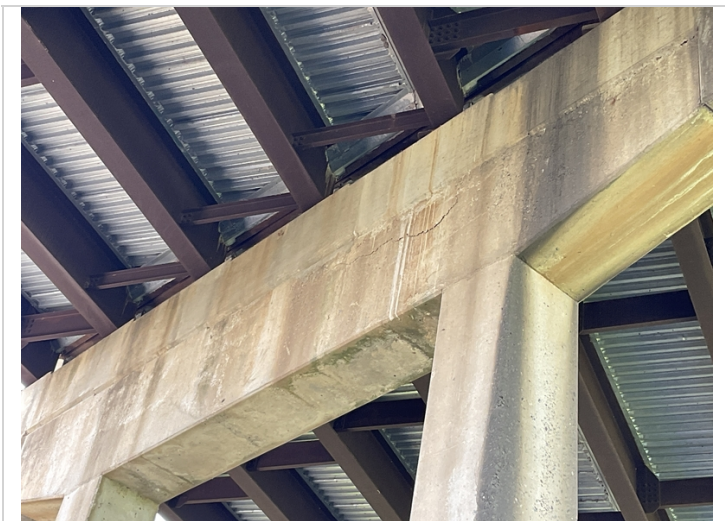
Bent 10 delam on ahead face

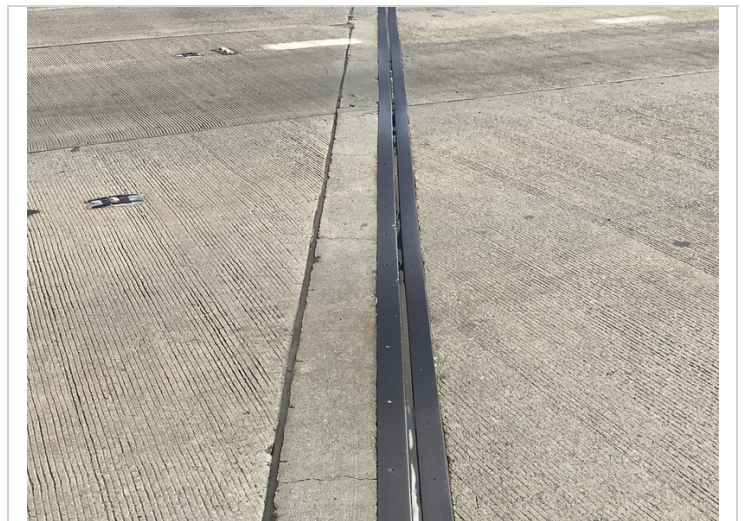
Bent 1: multiple areas of joint seal missing allowing water to flow through to the steel girders.

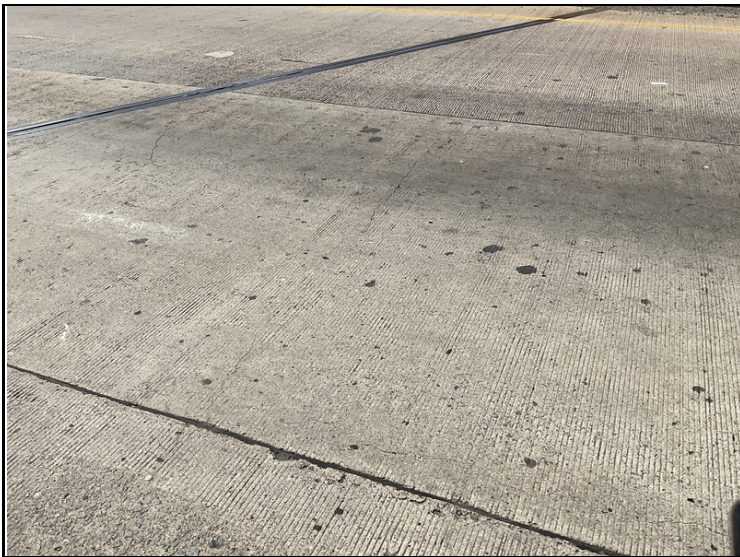
Deck has large unsealed Longitudinal and transverse cracks avg. width 0.040

Span 10 typical deck cracking

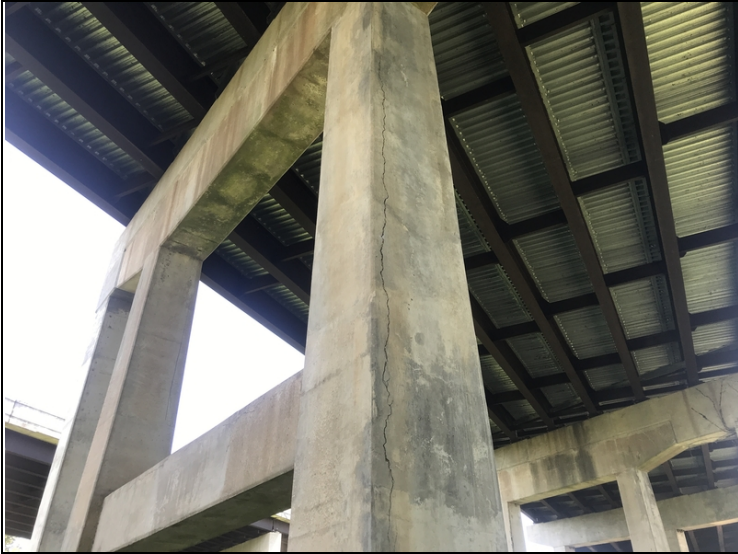
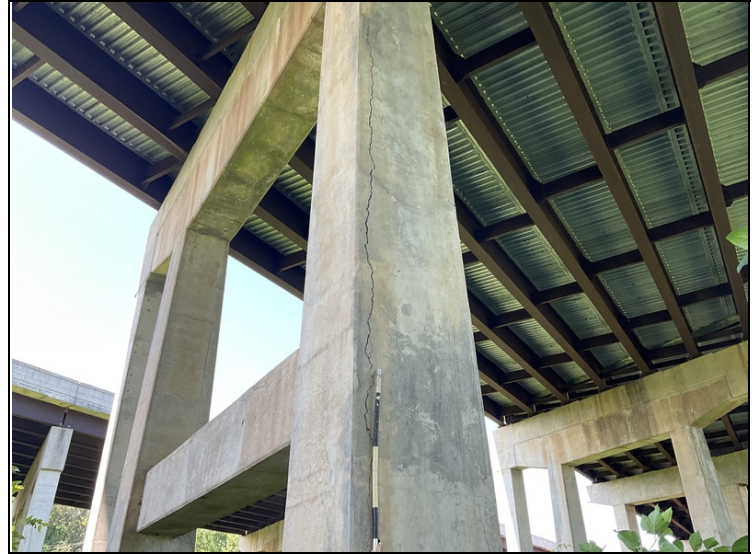
Large cracks in the columns of bent 2 column 3, bent 3 column 3, bent 7 column 2, bent 8 column 2, bent 9 column 2, bent 10 column 2, bent 11 column 2.

Bent 7, column 2: large vertical crack running the entire length of the column.
