Asset #B3193(Routine)

I-40 EB Log 156.02 over UPRR

Location: 0.8 MI E OF US 67

Team Lead: Keith Harris, Inspection Date: 07/21/2022

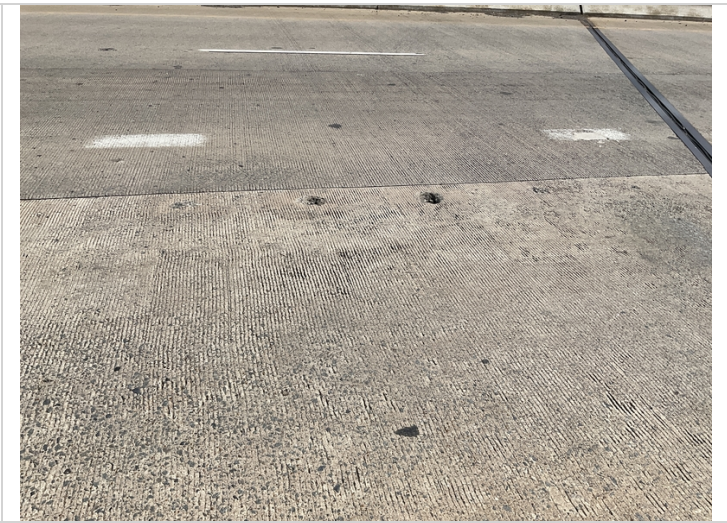
Small spalls in span 4

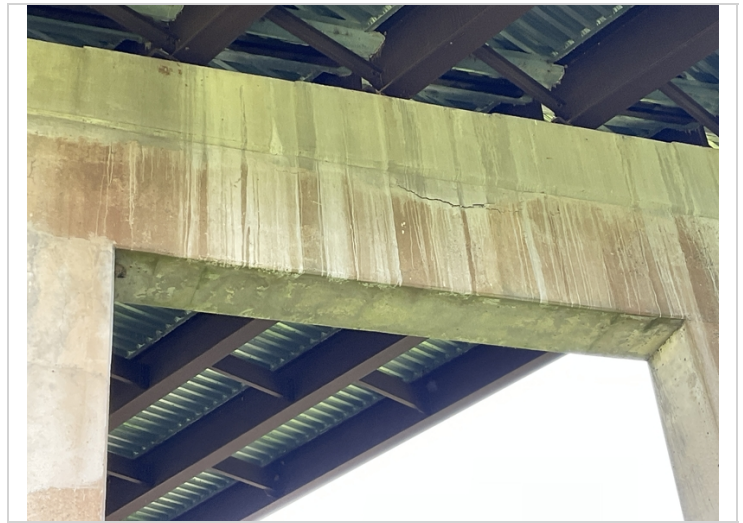
Bent 6 delams on ahead face

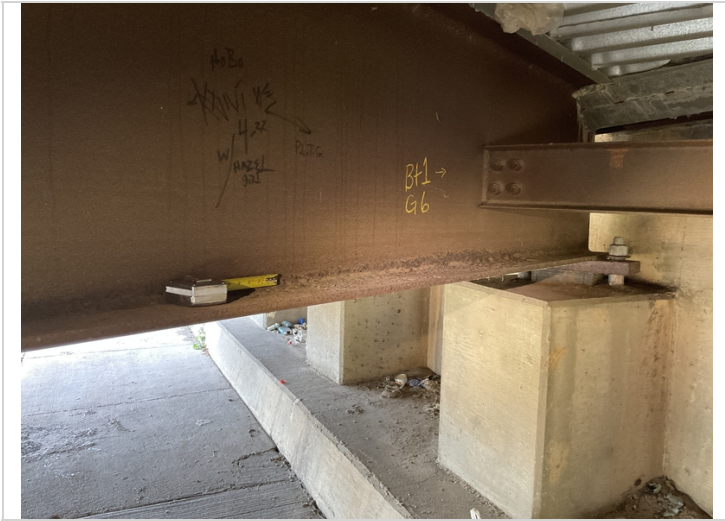
(107) All of the beams are brown with granular rust. Left side of beam 6 at bent 1 abutment has flaking rust to lower web and flange. Beams ends at bents 2 thru 12 have areas of flaking rust.							
205	Reinforced Concrete Column	EA	43	28	1	14	0
1090	Exposed Rebar	EA	2	0	0	2	0
1130	Cracking (RC and Other)	EA	13	0	1	12	0

Bent 1, girder 6: laminating rust and active corrosion to the bottom flange and lower web.

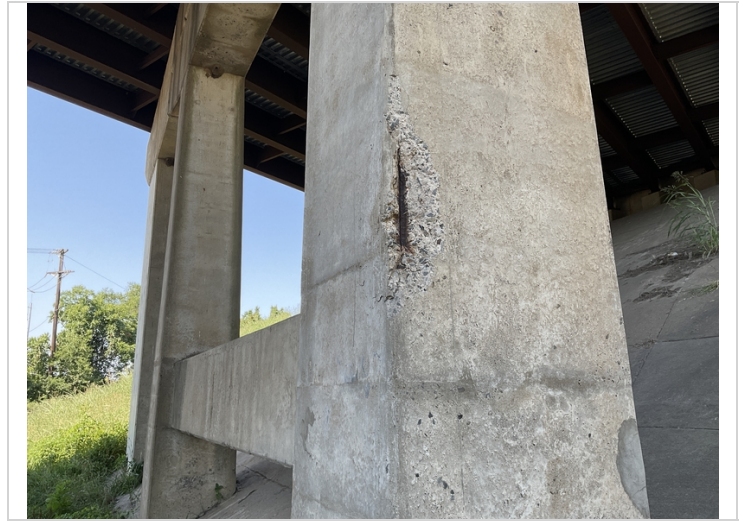
(205) Spall with exposed rebar at bent 2 column 2 and bent 11 column 2. Bent 2, column 3 full height crack. Bent 3, columns 2 and 3 vertical cracks. Bent 4, columns 2 and 3 large vertical cracks. Bent 6, column 2 crack on bottom 2 foot and vertical crack on column 3 Bent 7, column 2 and 3 large vertical cracks. Bent 8, column 2 and 3 vertical cracks. Bent 9 column 2 vertical cracks Bent 10 column 3 has large vertical crack. Bent 12 column 3 large vertical crack.							
210	Reinforced Concrete Pier Wall	LF	278	243	34	1	0
1010	Cracking	LF	9	0	9	0	0
1090	Exposed Rebar	LF	26	0	25	1	0

Bent 2 column 2 exposed rebar

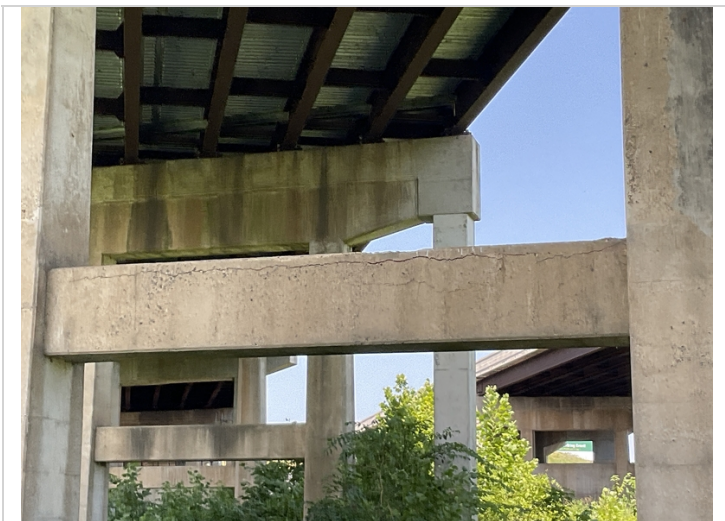
Bent 8 cracks in cross brace

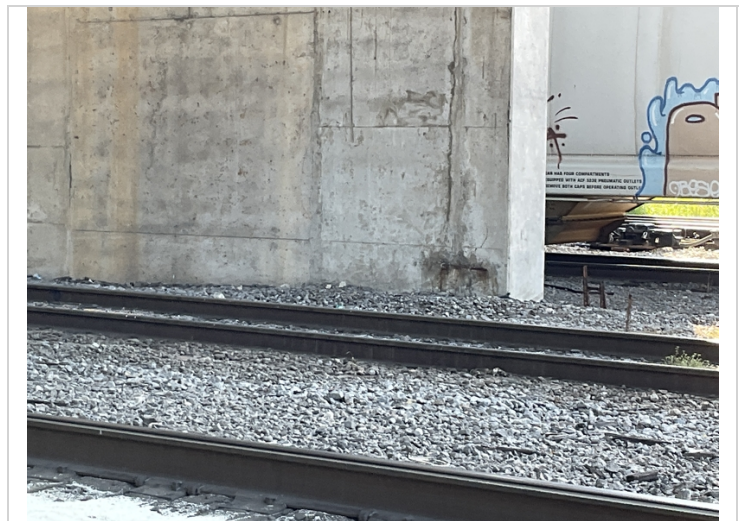
Bent 4 exposed rebar on bottom right side of pier wall

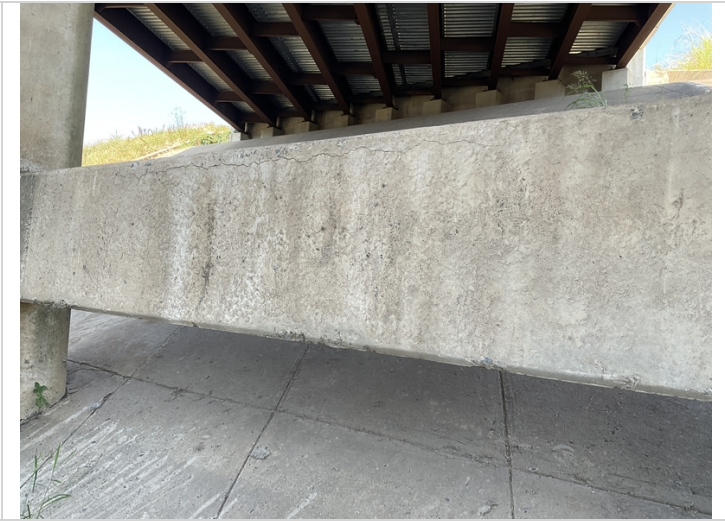
Bent 2 cracks in cross brace (pier wall)

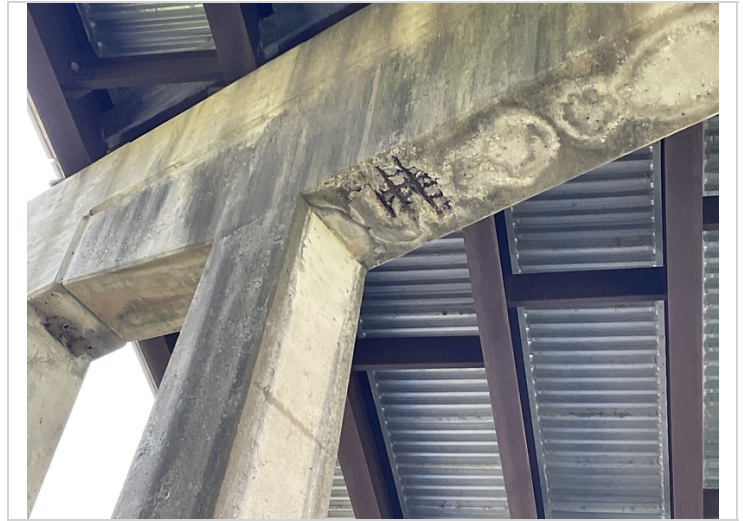
ELEMENTS	DESCRIPTION	UNITS	TOTAL	CS1	CS2	CS3	CS4
1090	Exposed Rebar	LF	6	0	6	0	0
1130	Cracking (RC and Other)	LF	16	0	16	0	0
(234) Spalls with exposed rebar on the sides and bottom of the caps at bents 2, 4, 9, 10 and 11. Scattered small cracks in several caps.							
301	Pourable Joint Seal	LF	407	201	200	0	6
2310	Leakage	LF	206	0	200	0	6

Bent 10 exposed rebar on bottom of cap next to column 2.

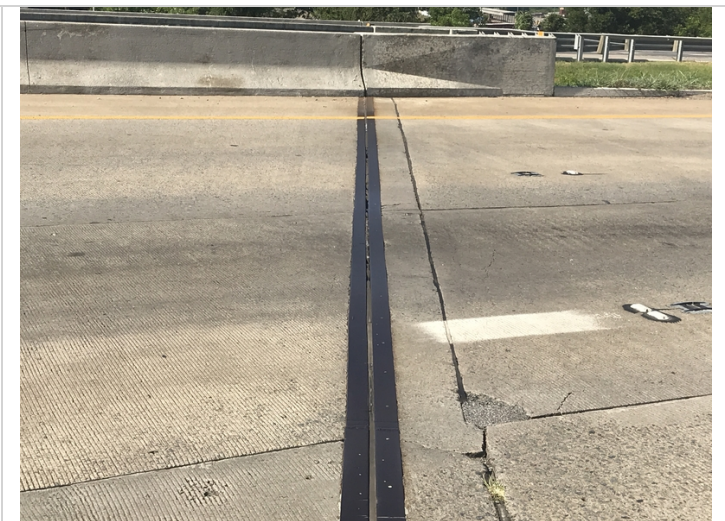
(301) Joint seals are torn and leaking. Bent 1: approximately 6 foot of joint seal missing, allowing water to freely flow through							
302	Compression Joint Seal	LF	254	0	248	6	0
2310	Leakage	LF	248	0	248	0	0
2360	Adjacent Deck or Header	LF	6	0	0	6	0

Bent 1: approximately 6 foot of joint seal missing, allowing water to freely flow through

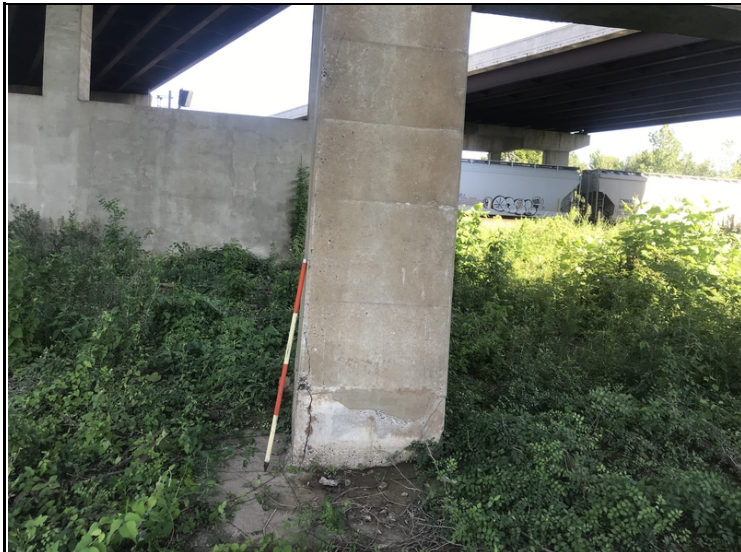
Spall with exposed rebar at bent 2 column 2 and bent 11 column 2.
Bent 2, column 3 full height crack.
Bent 3, columns 2 and 3 vertical cracks.
Bent 4, columns 2 and 3 large vertical cracks.
Bent 6, column 2 crack on bottom 2 foot and vertical crack on column 3
Bent 7, column 2 and 3 large vertical cracks.
Bent 8, column 2 and 3 vertical cracks.
Bent 9 column 2 vertical cracks
Bent 10 column 3 has large vertical crack.
Bent 12 column 3 large vertical crack.

Bent. 6 , column 3: large vertical crack.

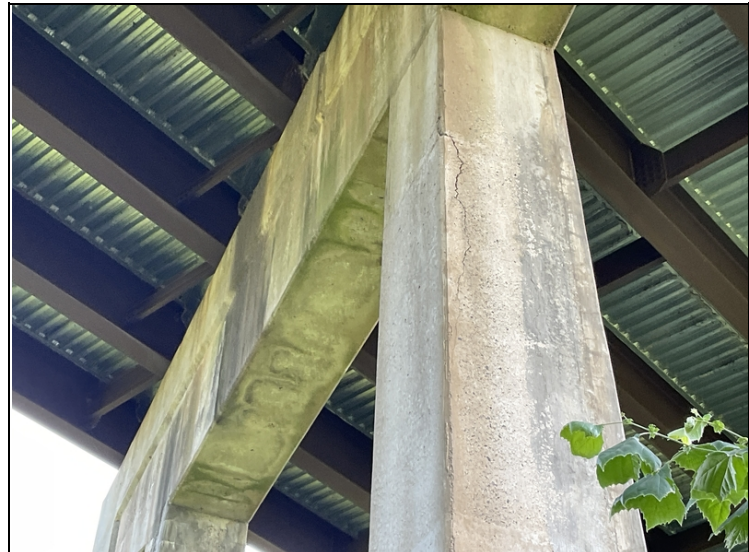
Bent 7 column 3 crack

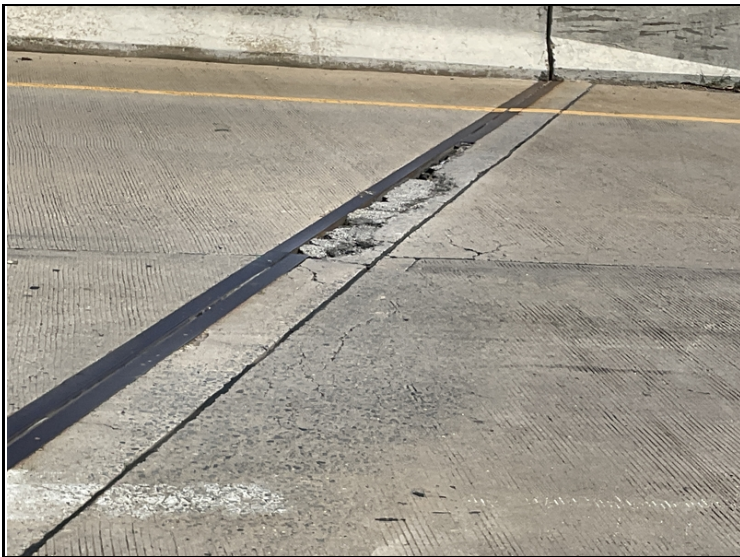
East abutment has spalls at top of back wall in the travel lanes

12' of spalls in top of back wall at bent 13

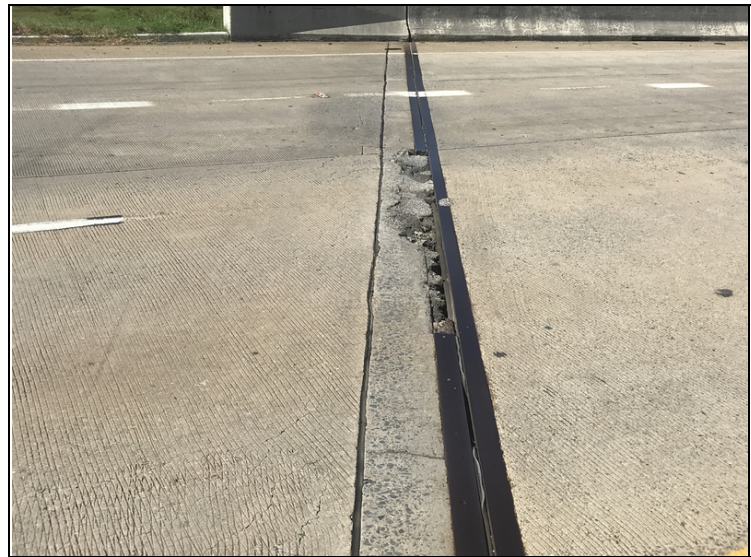
East abutment has spalls at top of back wall.

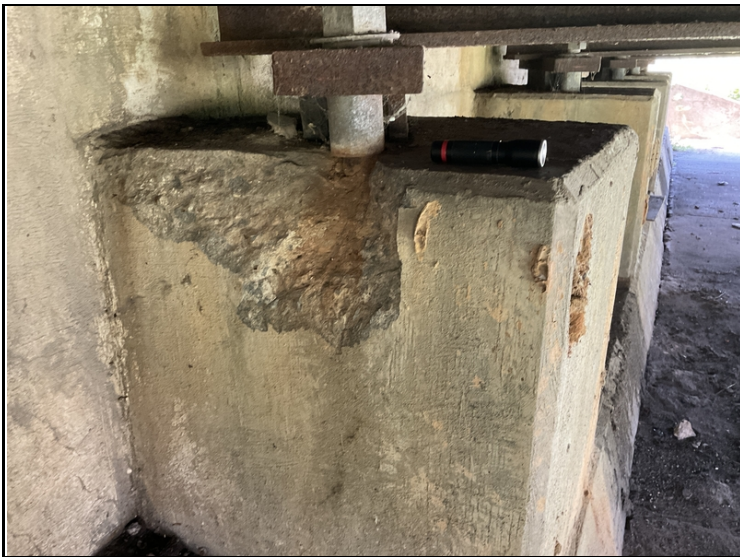
Bent 13 spall under beam 5 at anchor bolt.

Bent 13: abutment beam seat pedestal has a large spall adjacent to an anchor bolt.
