**Asset #07456**(Routine)  
**Hwy 5 over East Grand Ave.**  
**Location: 5.4 M Hwy 7**

**Team Lead:** Chris Doggett **Inspection Date:** 09/27/2022

**General Observation**

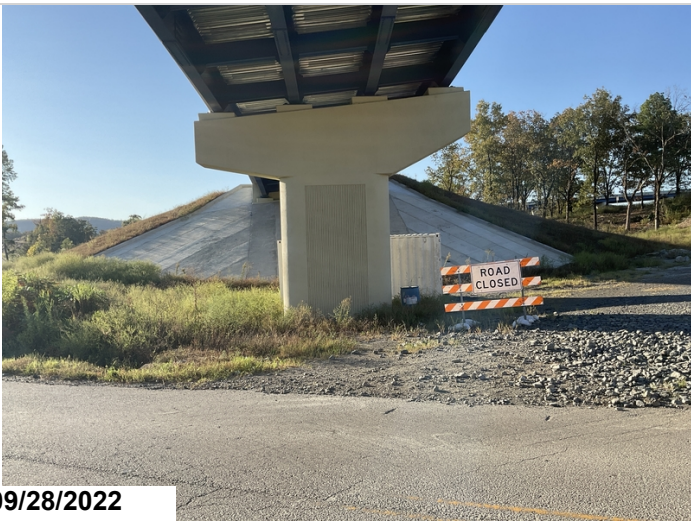
Looking back at bent 2 pier and cap

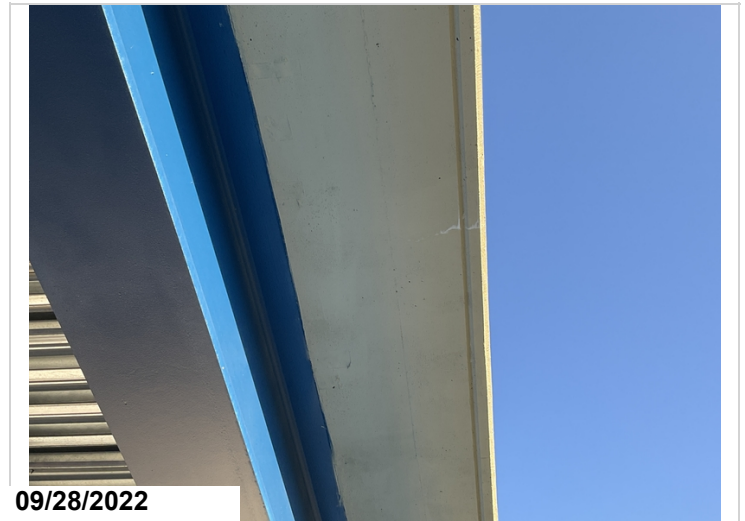
ELEMENTS	DESCRIPTION	UNITS	TOTAL	CS1	CS2	CS3	CS4
12	Reinforced Concrete Deck	SF	6300	6048	252	0	0
1130	Cracking (RC and Other)	SF	252	0	252	0	0
(12) Each span on either side of bridge, the overhangs have a few transverse cracks with efflorescence staining.							
107	Steel Open Girder/Beam	LF	900	900	0	0	0
515	Steel Protective Coating	SF	8298	8298	0	0	0
210	Reinforced Concrete Pier Wall	LF	22	22	0	0	0
215	Reinforced Concrete Abutment	LF	96	96	0	0	0
234	Reinforced Concrete Pier Cap	LF	54	54	0	0	0
301	Pourable Joint Seal	LF	56	56	0	0	0
310	Elastomeric Bearing	EA	16	16	0	0	0
321	Reinforced Concrete Approach Slab	SF	1976	1976	0	0	0
330	Metal Bridge Railing	LF	450	450	0	0	0

Span 1, right side of overhang has a transverse crack with efflorescence staining. Each span has several similar cracks with efflorescence staining.

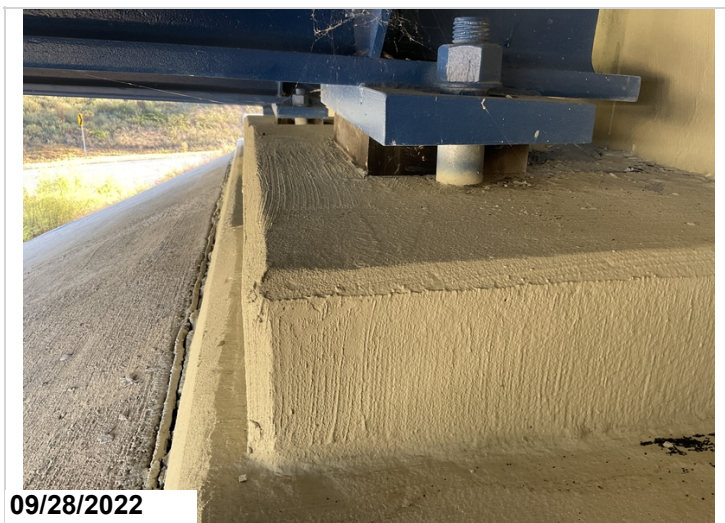
Bent 1, girder 2: elastameric bearing. Common

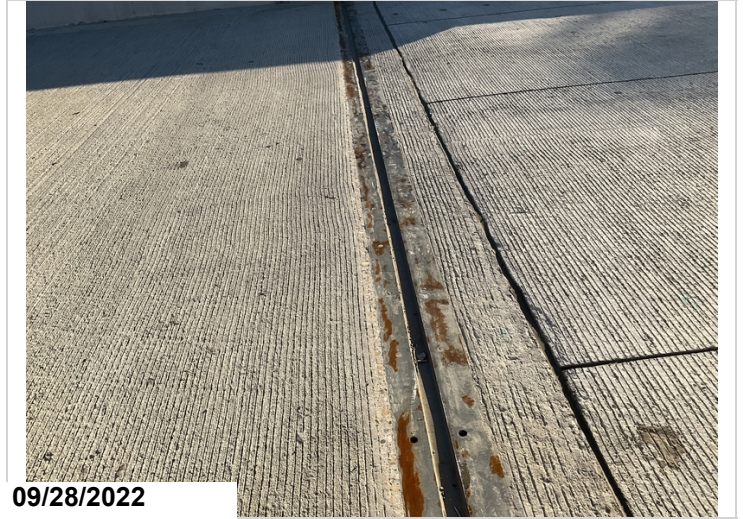
Bent 1: joint seal
