**Asset #07459**(Routine)  
**Mill Creek Rd. over Hwy 5**  
**Location: 6.5 MI W HWY128**

**Team Lead:** Shane Byrd **Inspection Date:** 05/09/2023

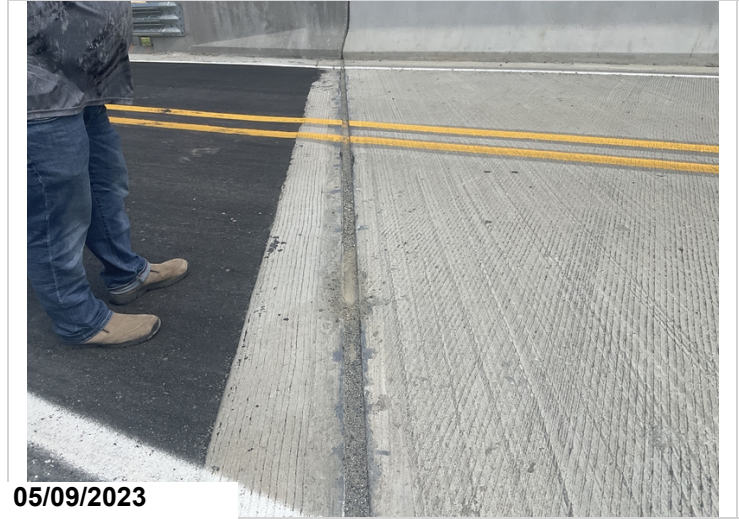
Bent 3 joint full of debris.

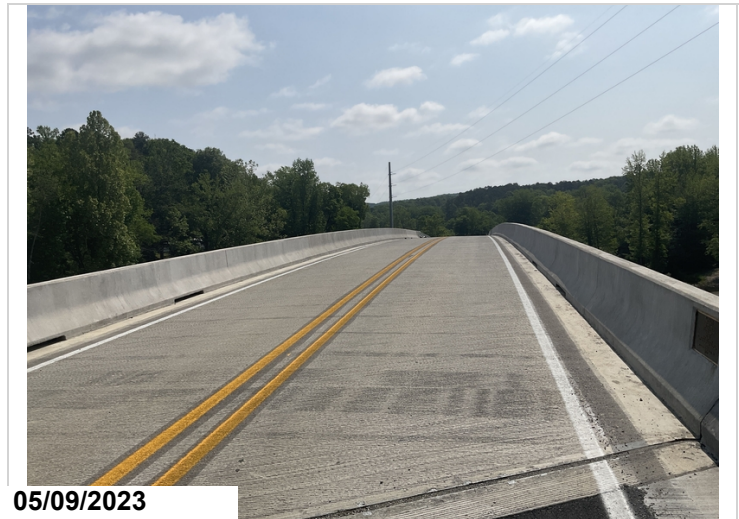
Deck overview.

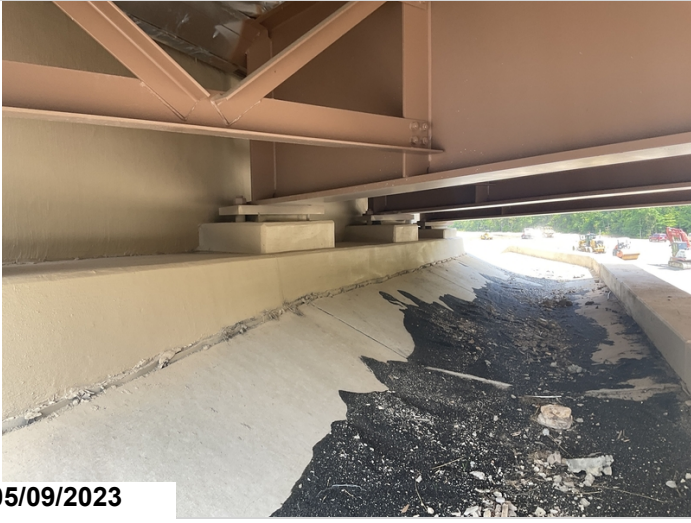
Bent 3 bearings.

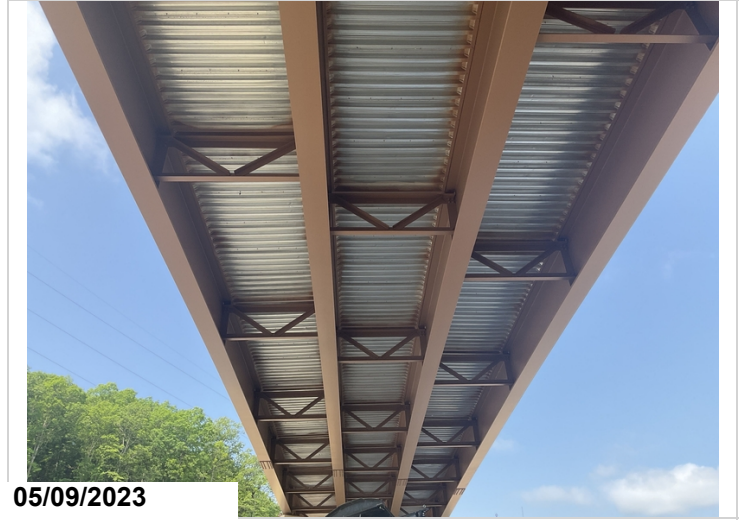
Soffit span 1

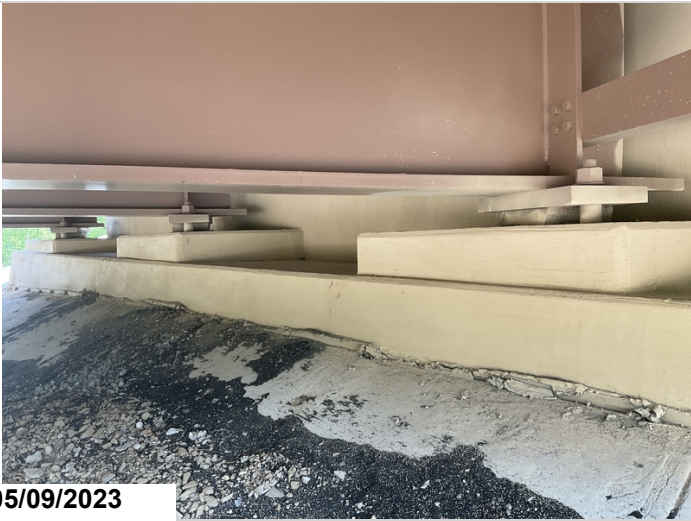
Bent 1 bearings.
